WPR26LA193

## INVESTIGATION PHOTOGRAPHS

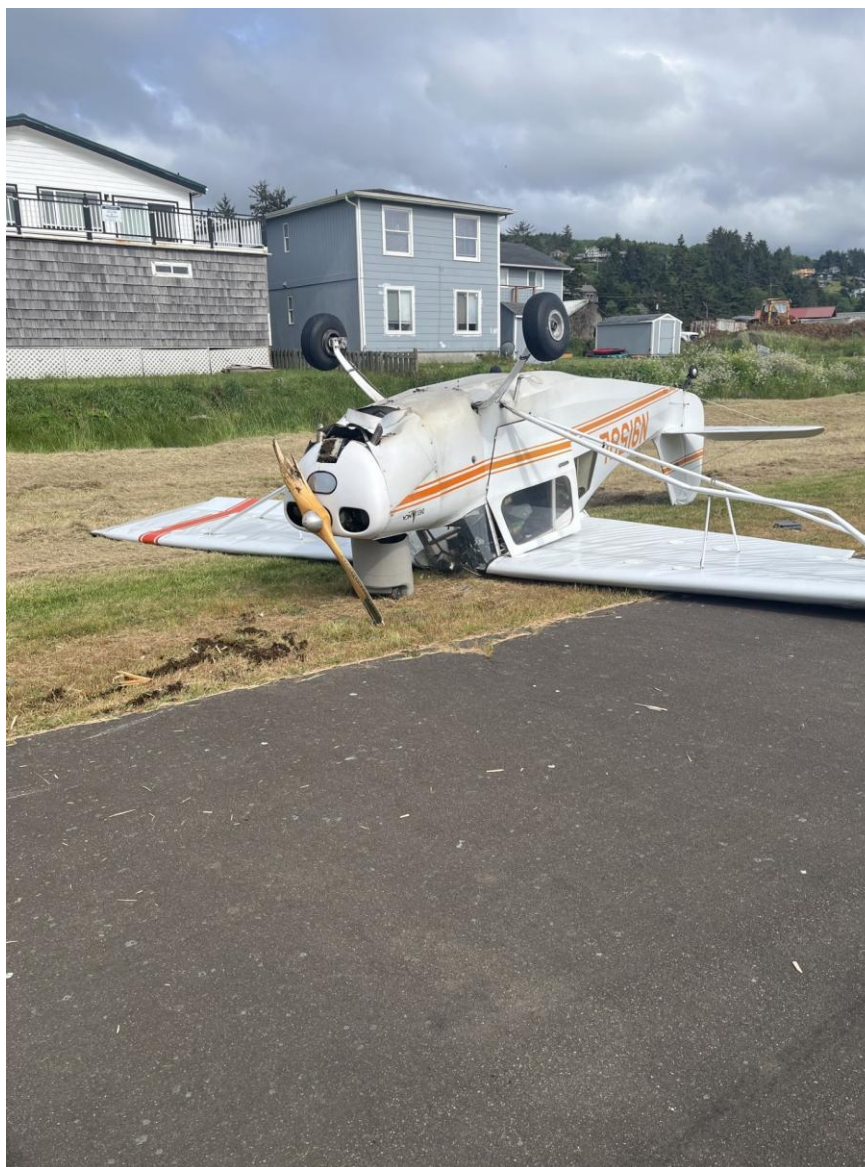
**Photograph 1 - View of right wing lift strut (Courtesy of first responders)**

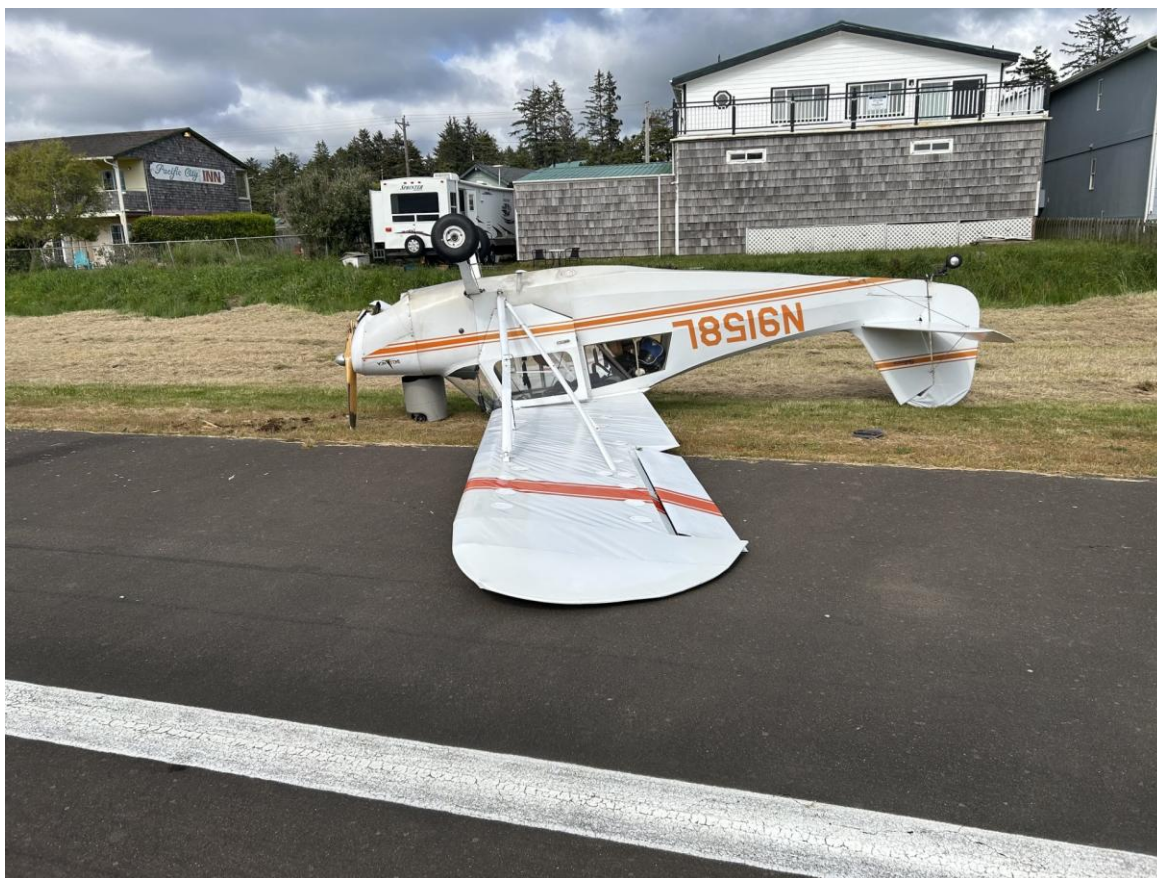
**Photograph 2 - View of rudder damage (Courtesy of first responders)**
