Eric M. Gutierrez  
Air Safety Investigator  
Western Pacific Region

**Subject:** WPR26LA193, Memorandum for Record

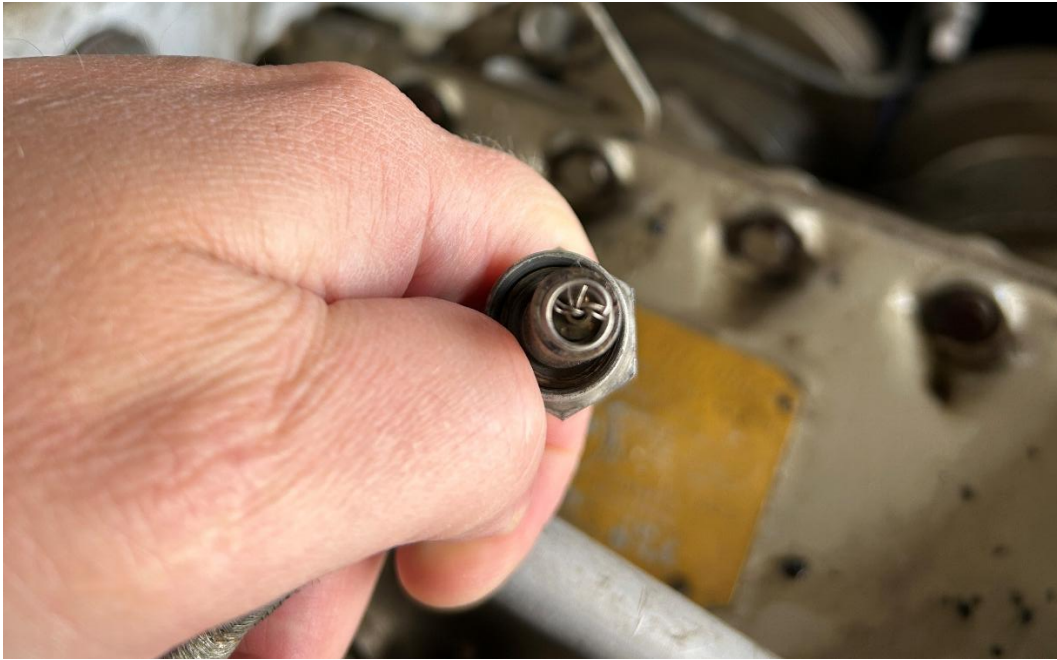
Examination of N9158L, Bellanca, 7ACA revealed that the spark plug wire end on the No. 3 cylinder was bad. The center conductor fell apart when the connector end was removed. The dielectric was worn and old and the center conductor was loose inside of the wire allowing it to vibrate with some of the wire strand actually touching the shield and spring at times. The ends for the remaining 7 leads were a newer version in much better conduction.

*Figure 1: View of number 3 cylinder frayed ignition lead (photo provided by the FAA)*

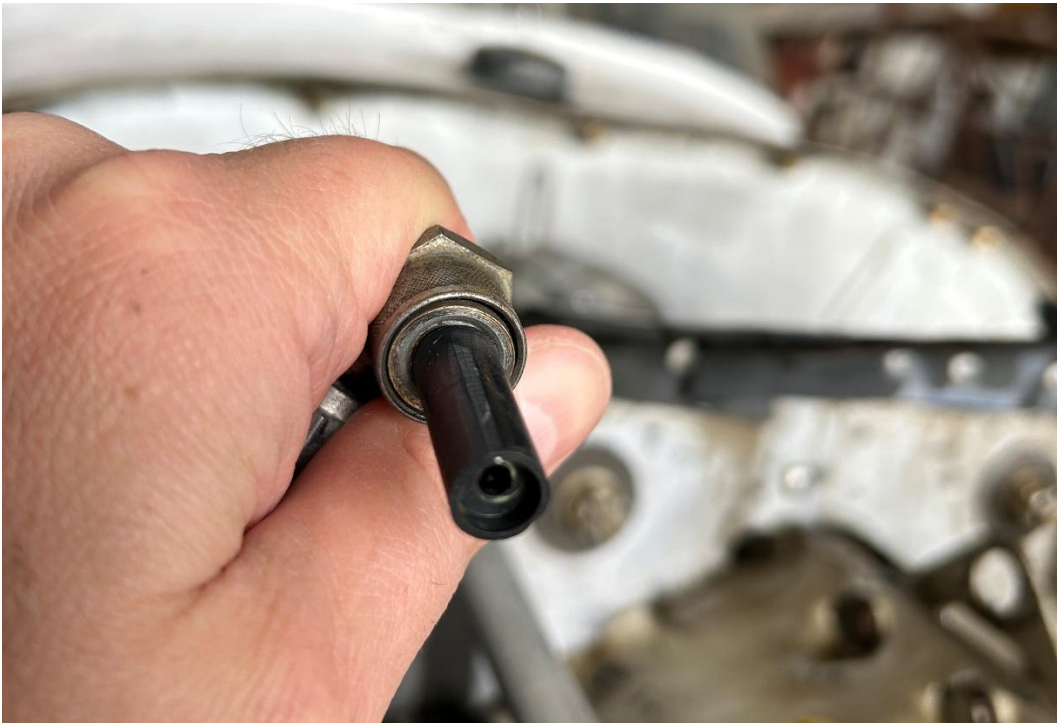
*Figure 2: View of number 3 cylinder ignition lead conductor separation (photo provided by the FAA)*
