Eric M. Gutierrez  
Air Safety Investigator  
Western Pacific Region

**Date:** July 6, 2026

**Subject:** WPR26LA193, Memorandum for Record

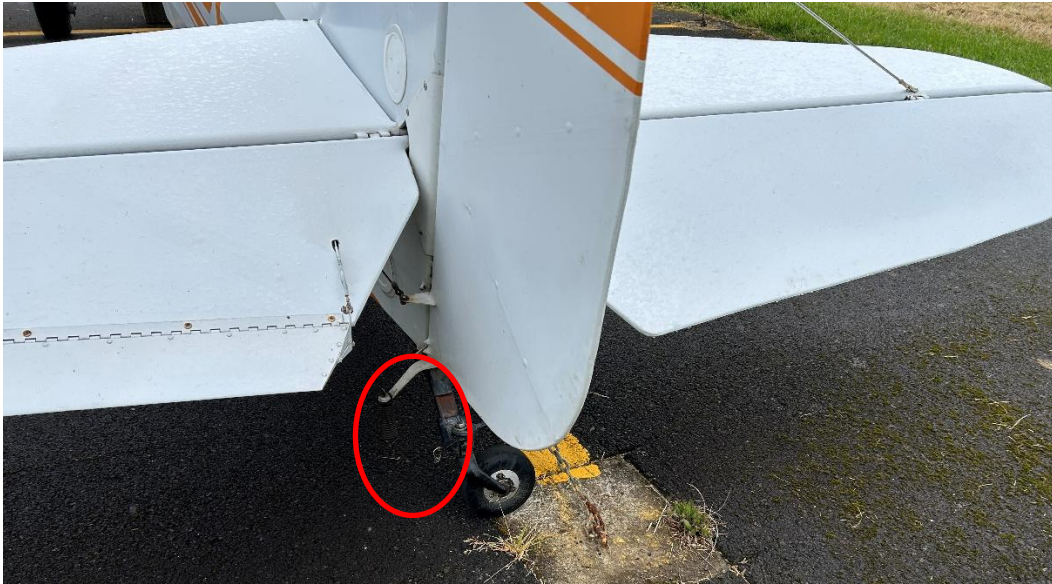
[REDACTED] responded to Pacific City, Oregon in regard to an airplane accident involving N9158L a Bellanca, 7ACA. During the examination of the accident airplane, he observed both tailwheel springs attached to the rudder control arms but disconnected from the tailwheel steering arms. [REDACTED] then contacted the Fire Chief that oversaw the recovery and asked about the tailwheel springs. According to the Fire Chief, the tailwheel springs were disconnected from the tailwheel steering arms to facilitate recovery.

*Figure 1: View of left tailwheel spring disconnected. (photo provided by the FAA)*

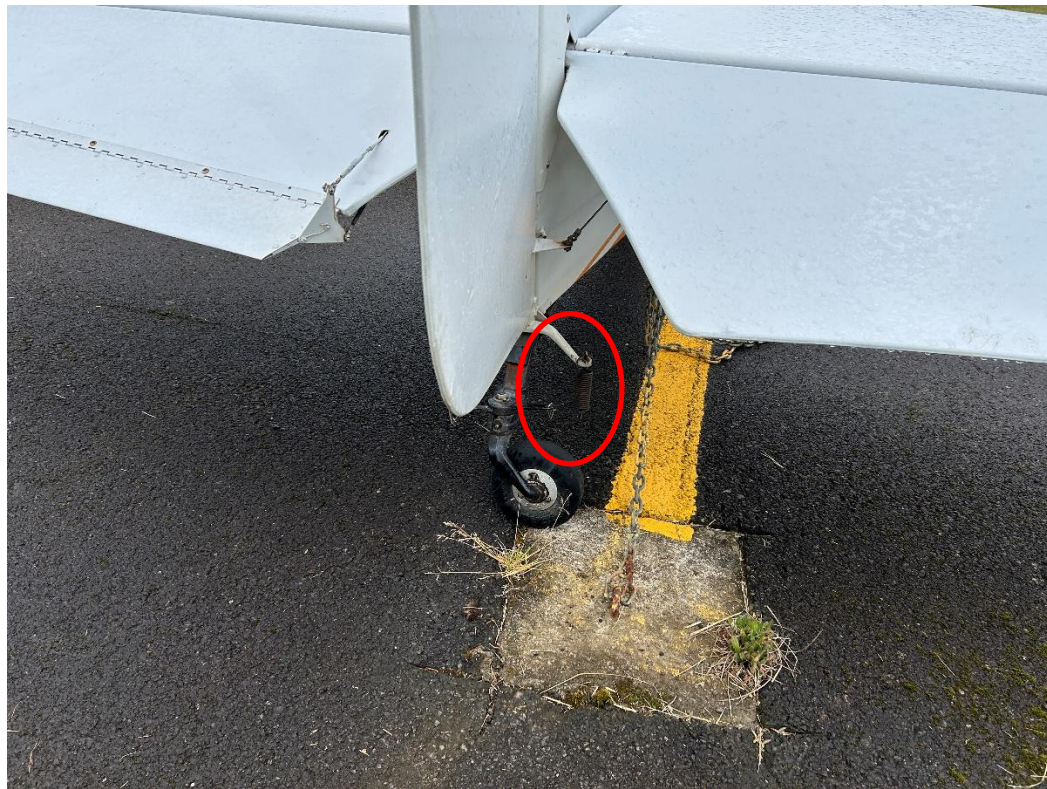
*Figure 2: View of right tailwheel spring disconnected. (photo provided by the FAA)*
