WPR26LA199

## INVESTIGATION PHOTOGRAPHS

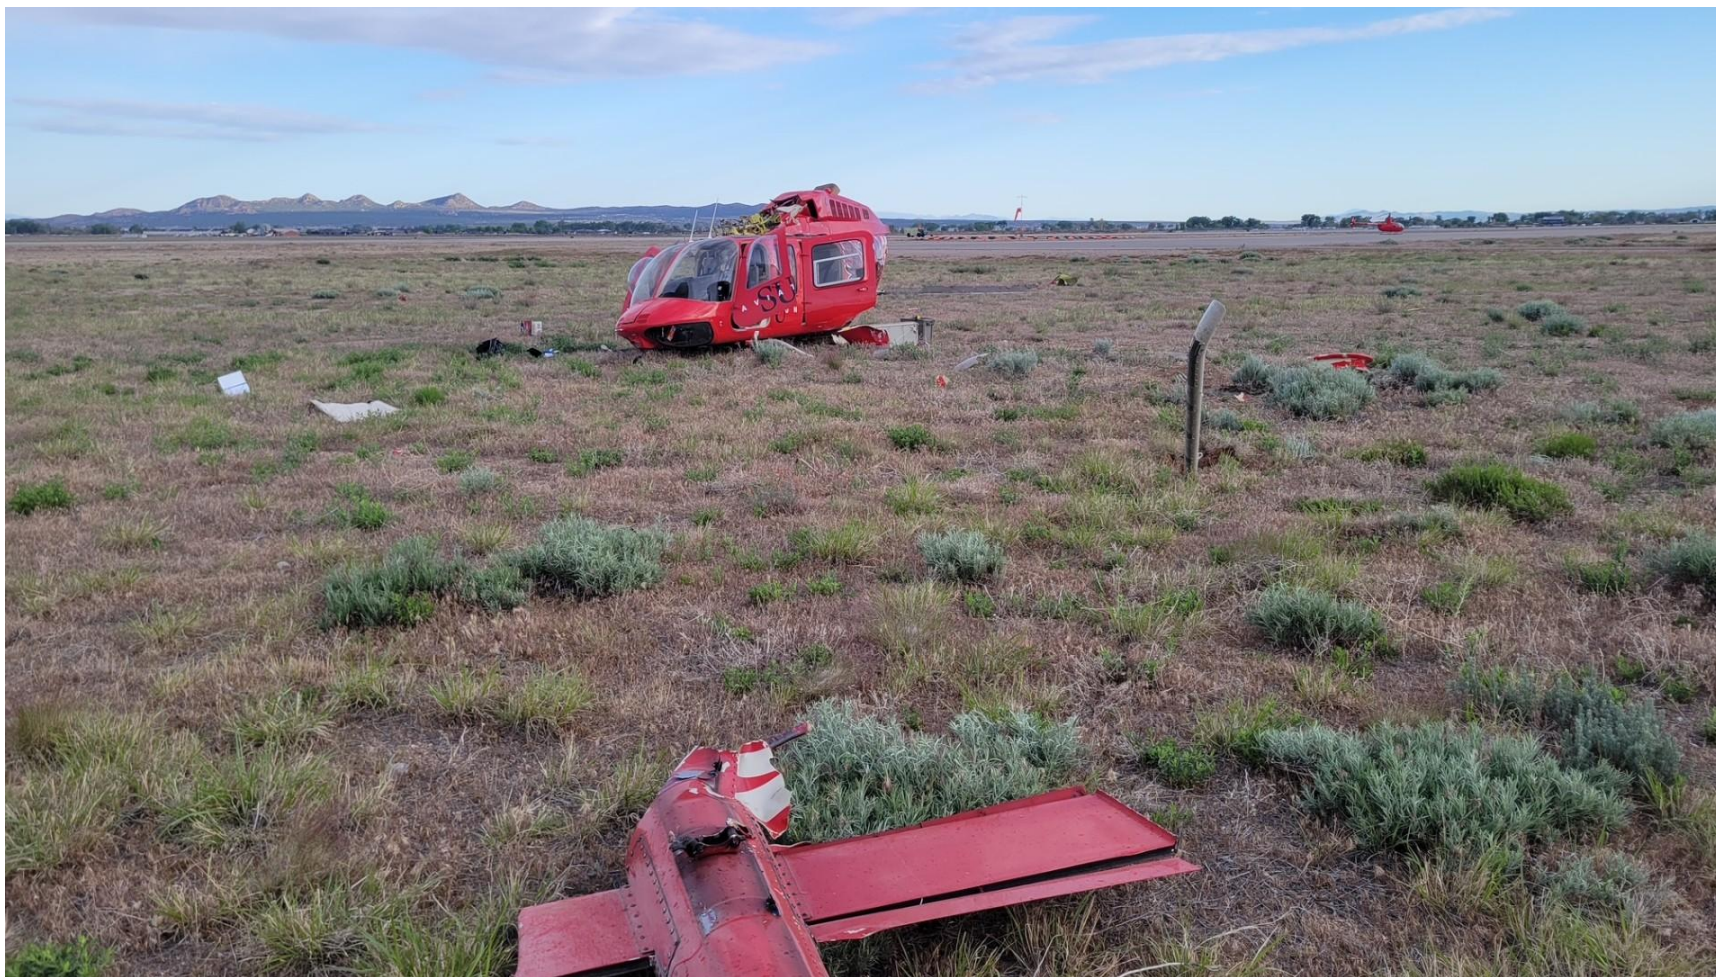
**Photograph 1 - View of helicopter at accident scene (Courtesy of airfield operations).**

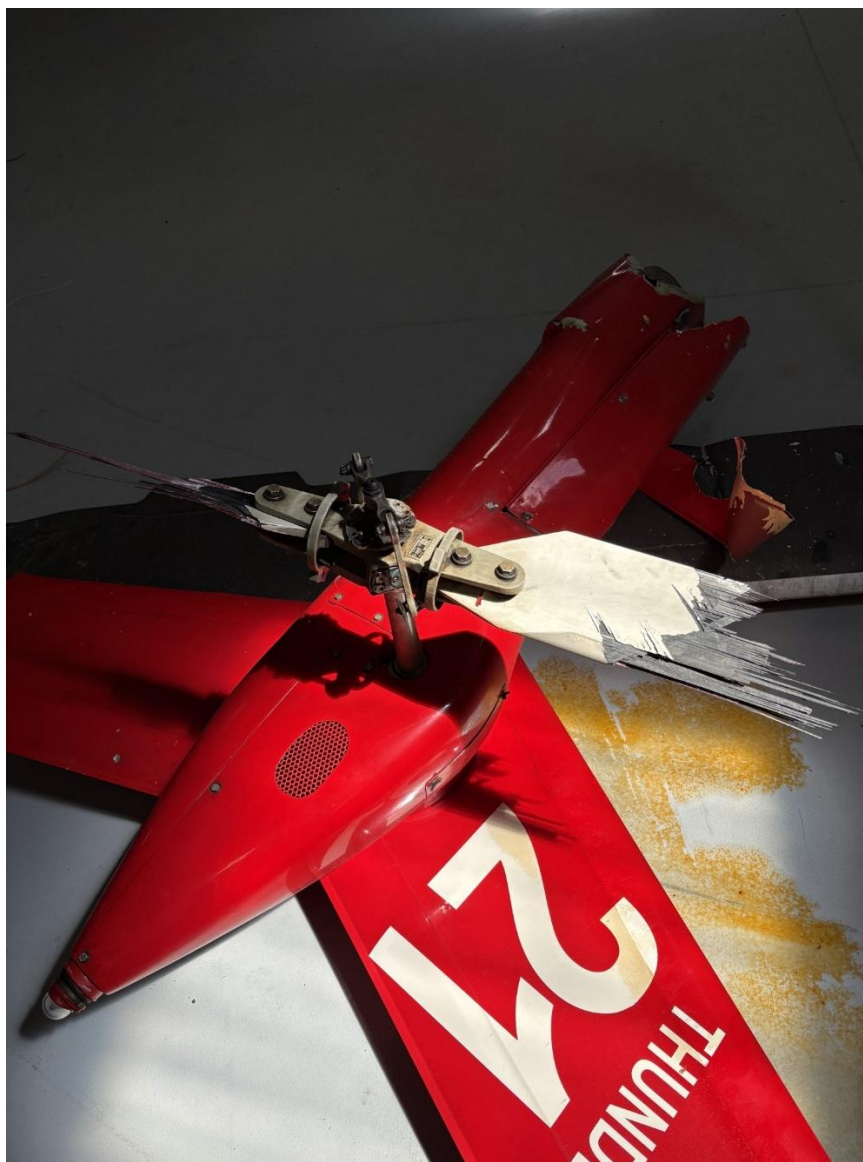
**Photograph 2 - View of tail rotor and tailboom damage.**

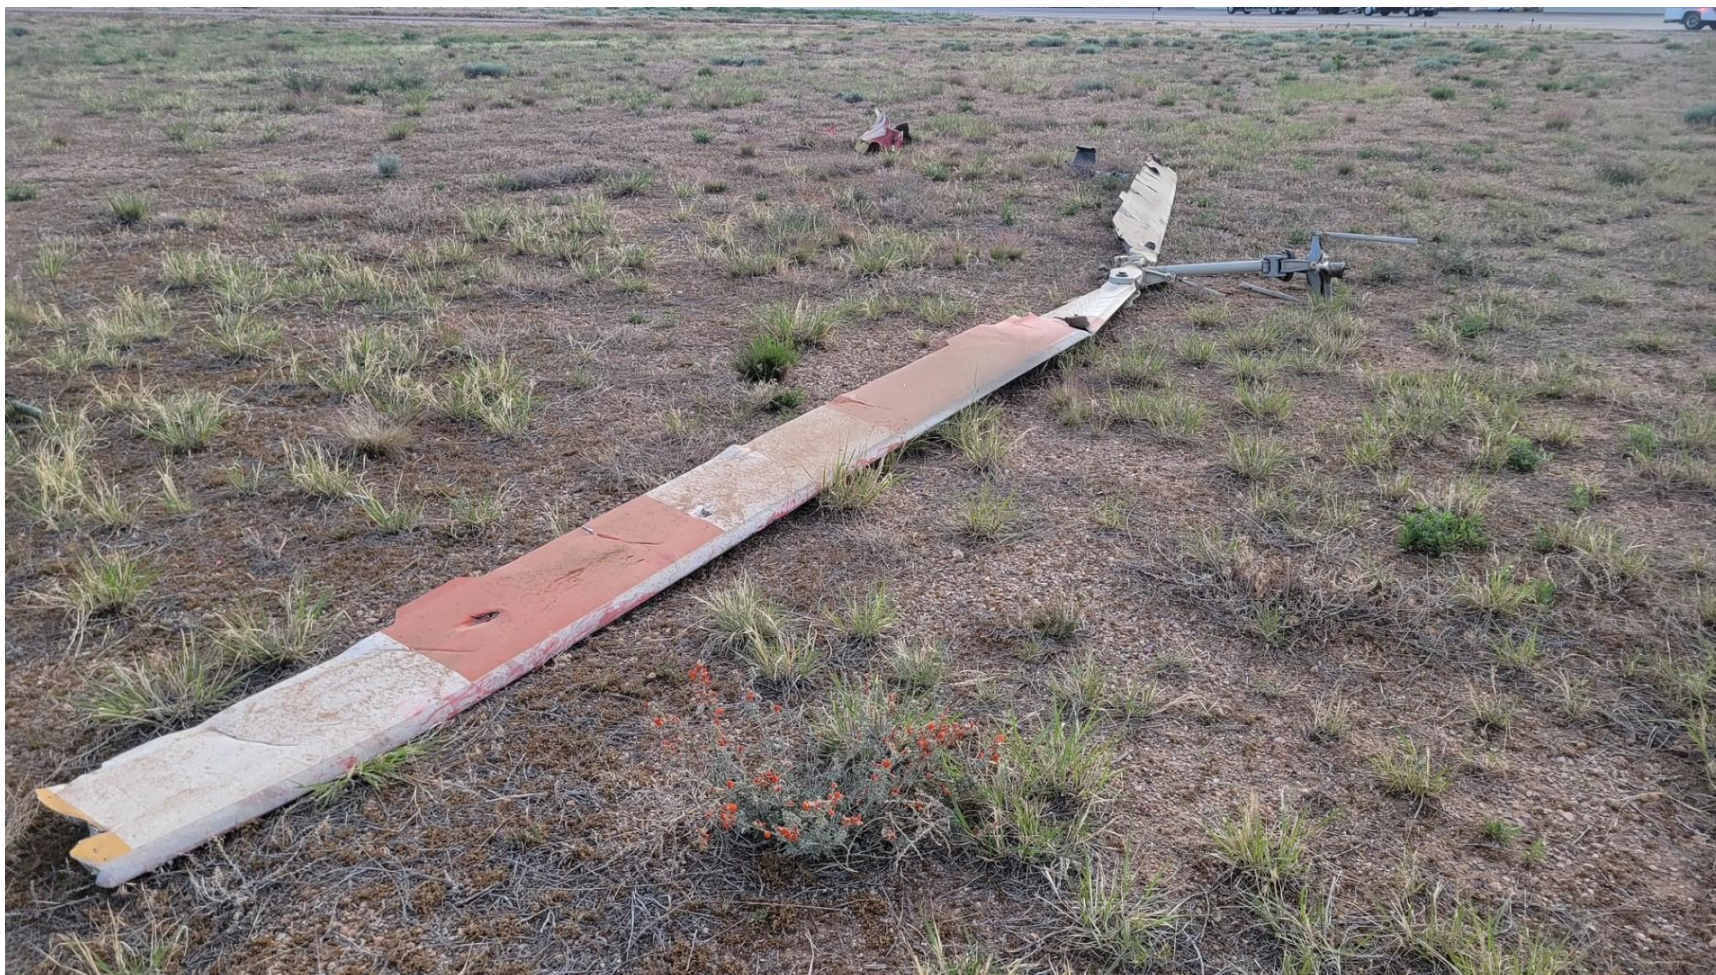
**Photograph 3 - View of separated main rotor system (Courtesy of airfield operations).**

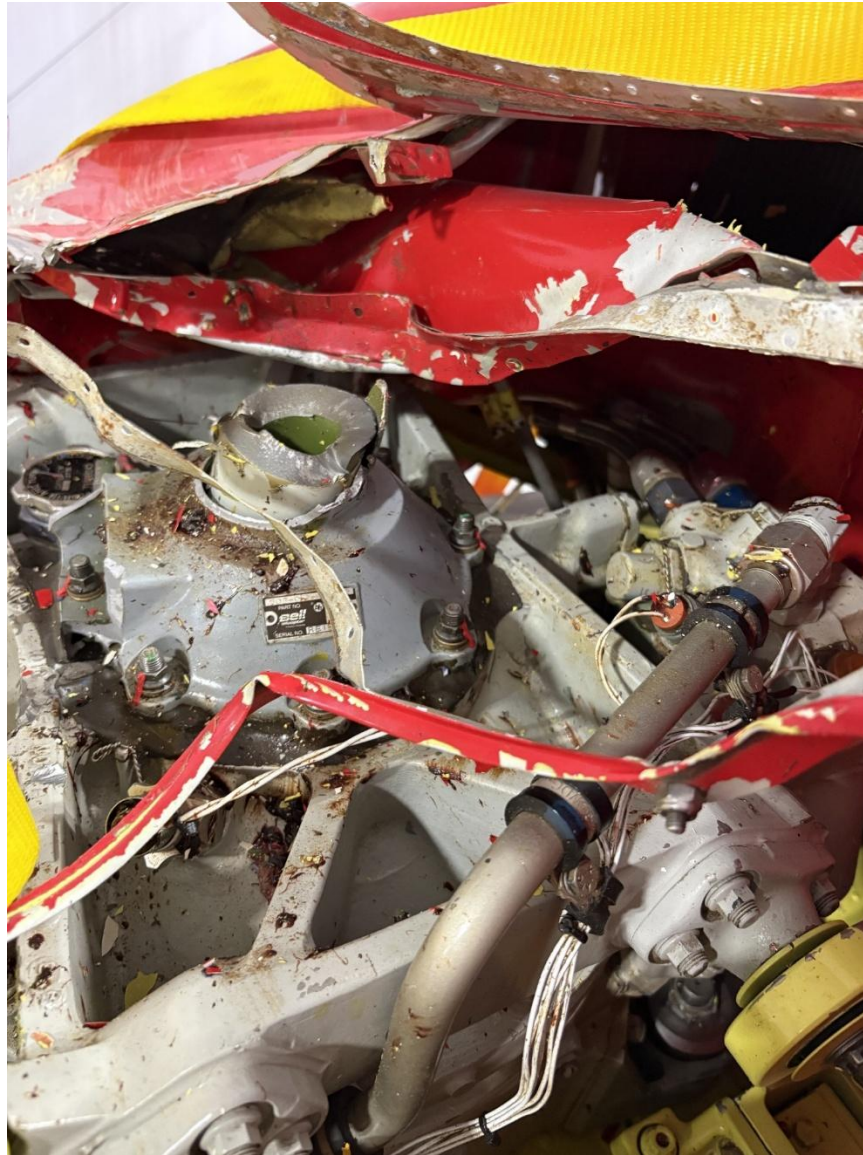
**Photograph 4 - View of mast separation point.**
