WPR26LA203

## INVESTIGATION PHOTOGRAPHS

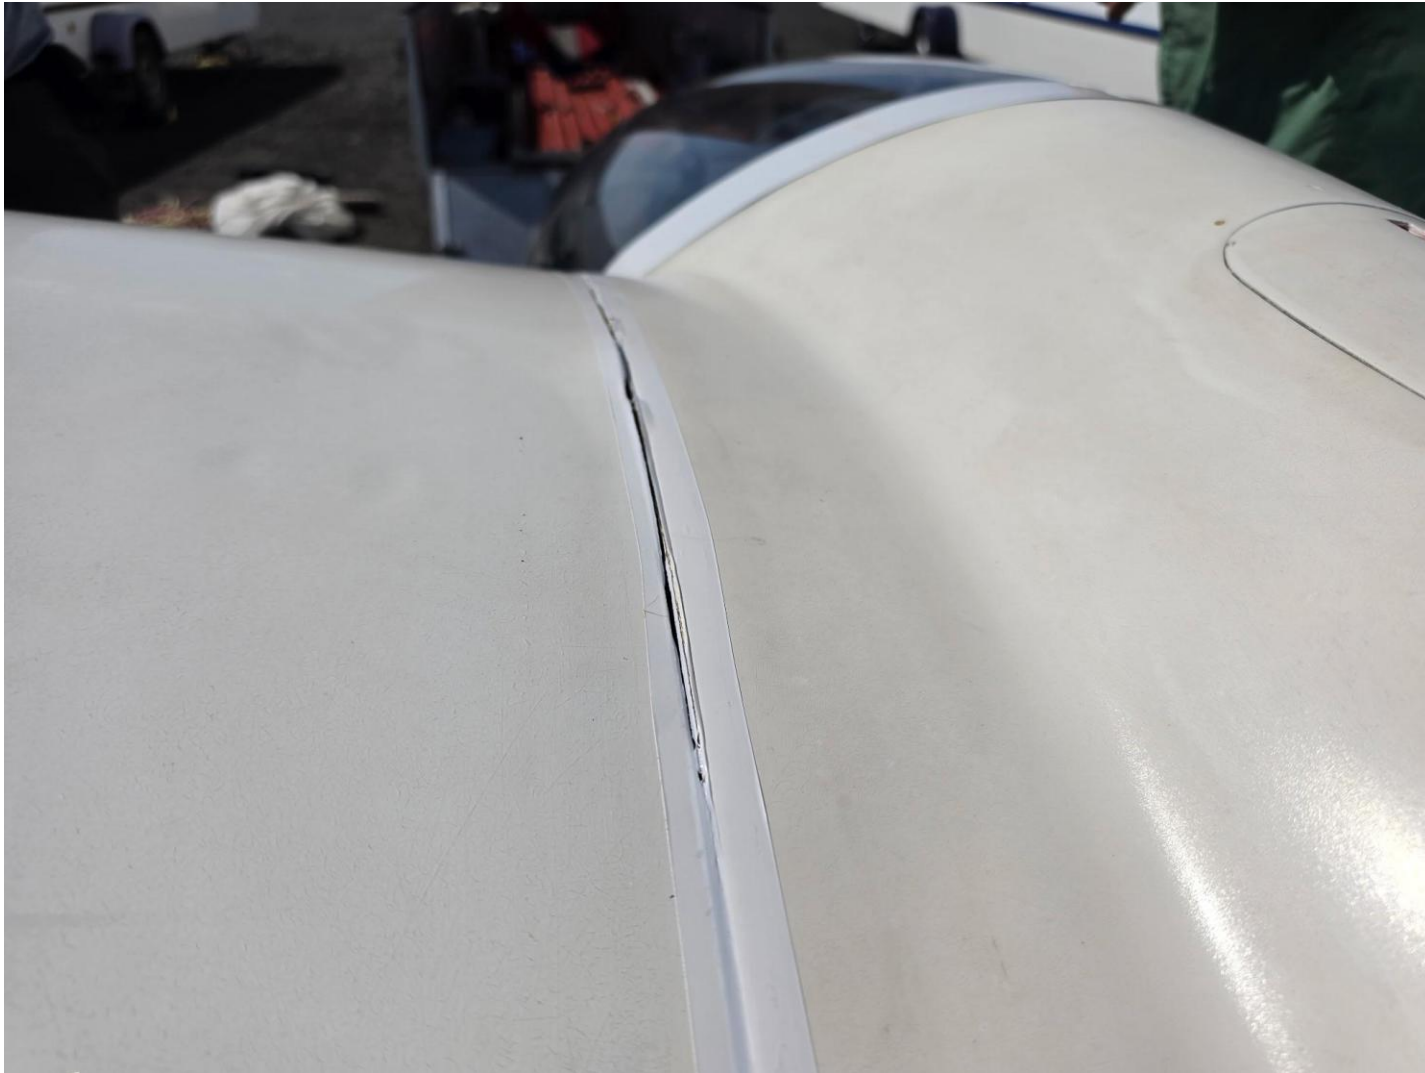
**Photograph 1 - View of top left wing broken tape. (Courtesy of Pilot)**

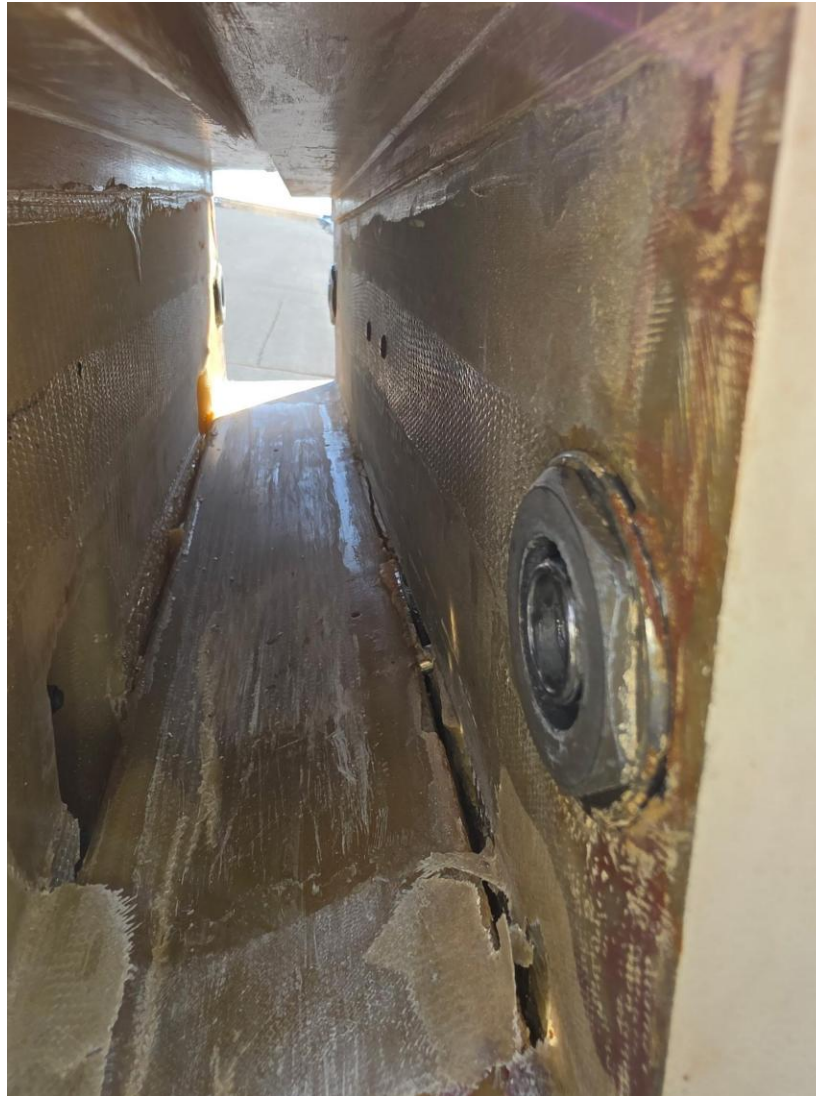
**Photograph 2 - View of spar root box crack. (Courtesy of Pilot)**

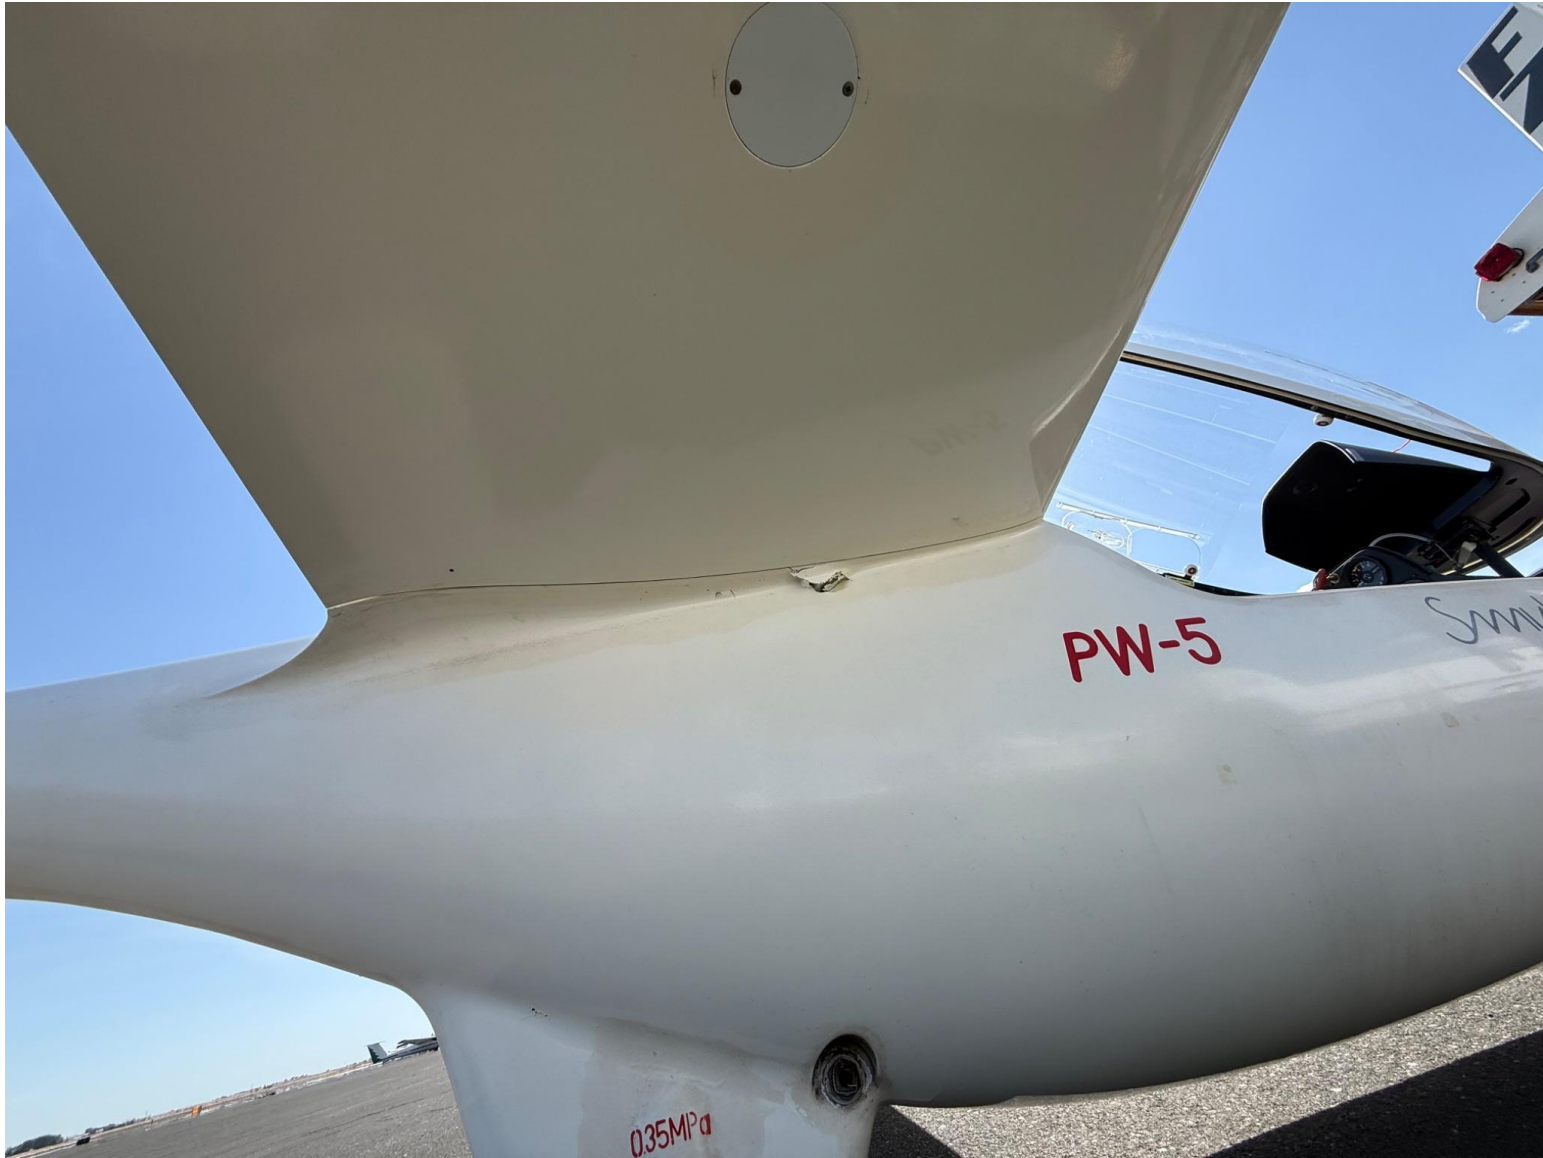
**Photograph 3 - View of puncture under right wing. (Courtesy of Pilot)**
