WPR26LA208

## INVESTIGATION PHOTOGRAPHS

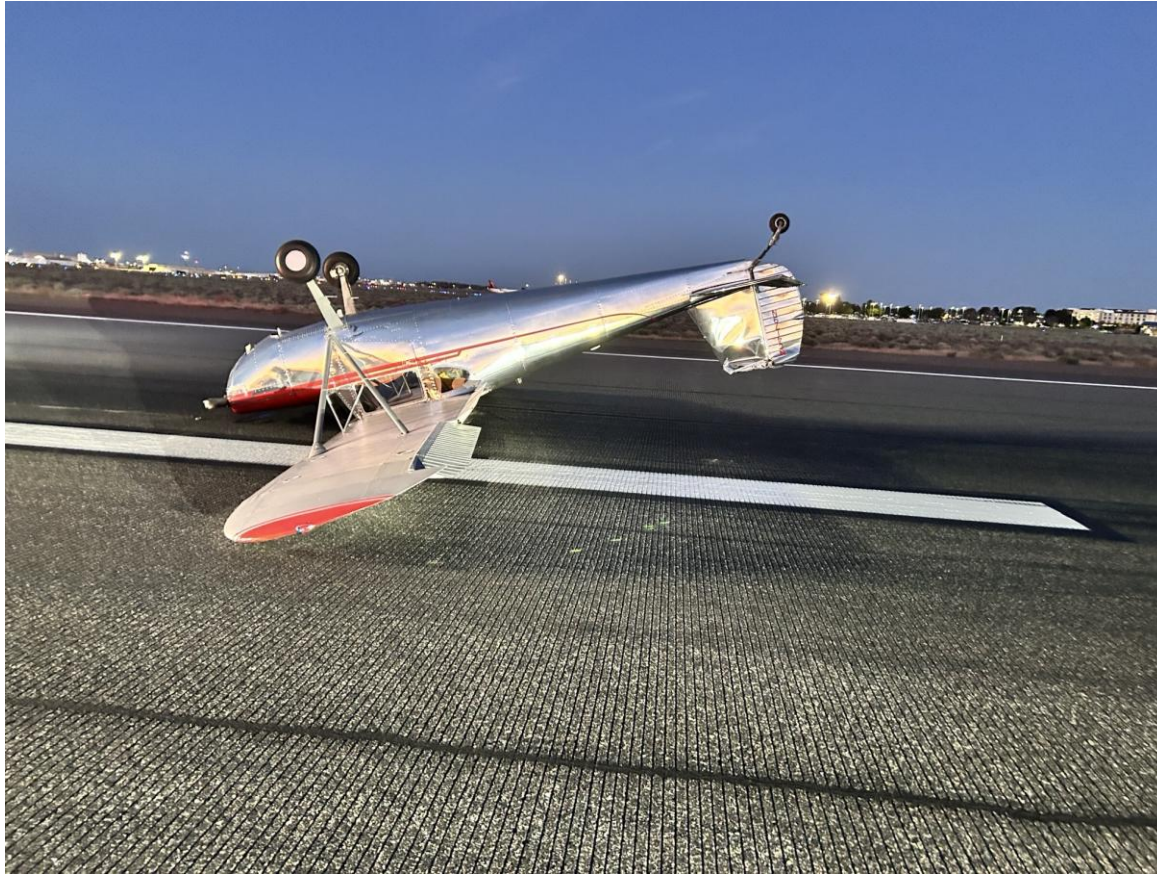
**Photograph 1 - View of accident airplane (Courtesy of Airport Operations)**

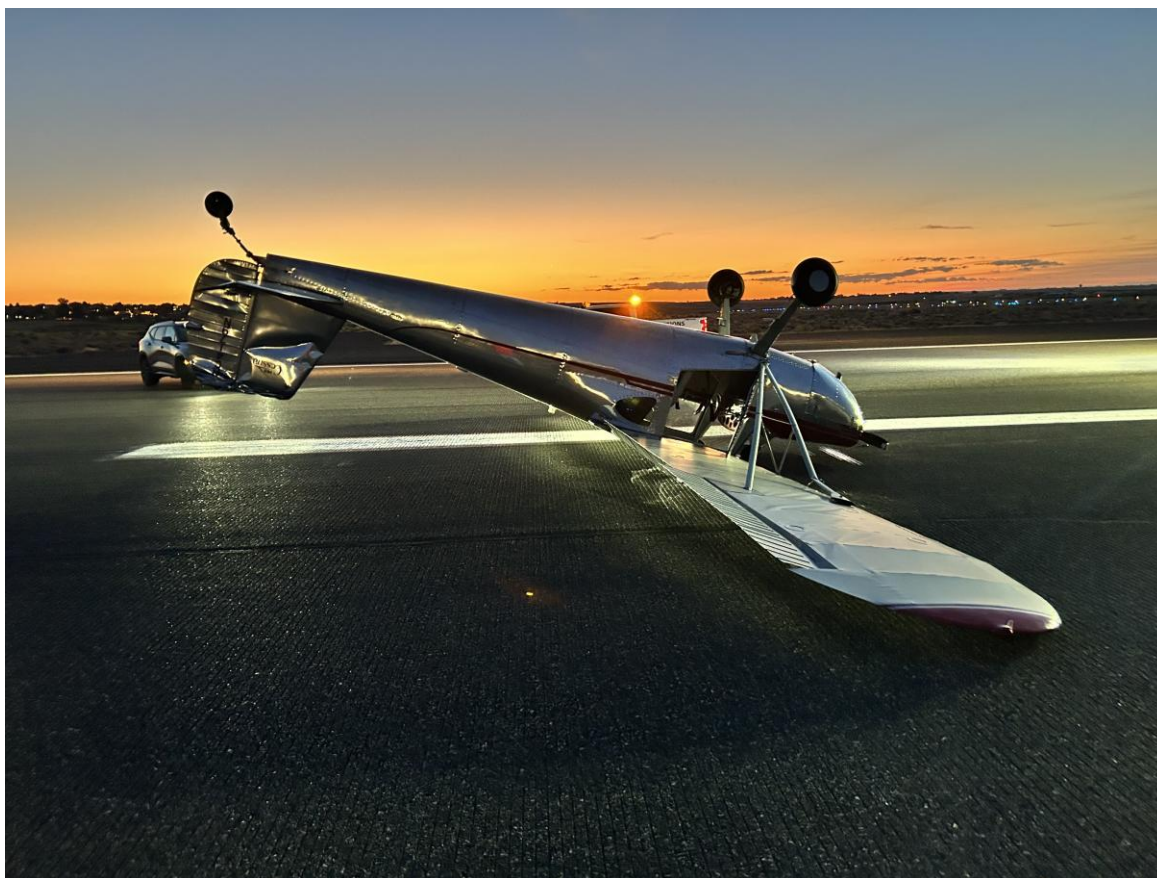
**Photograph 2 - View of accident airplane (Courtesy of Airport Operations)**

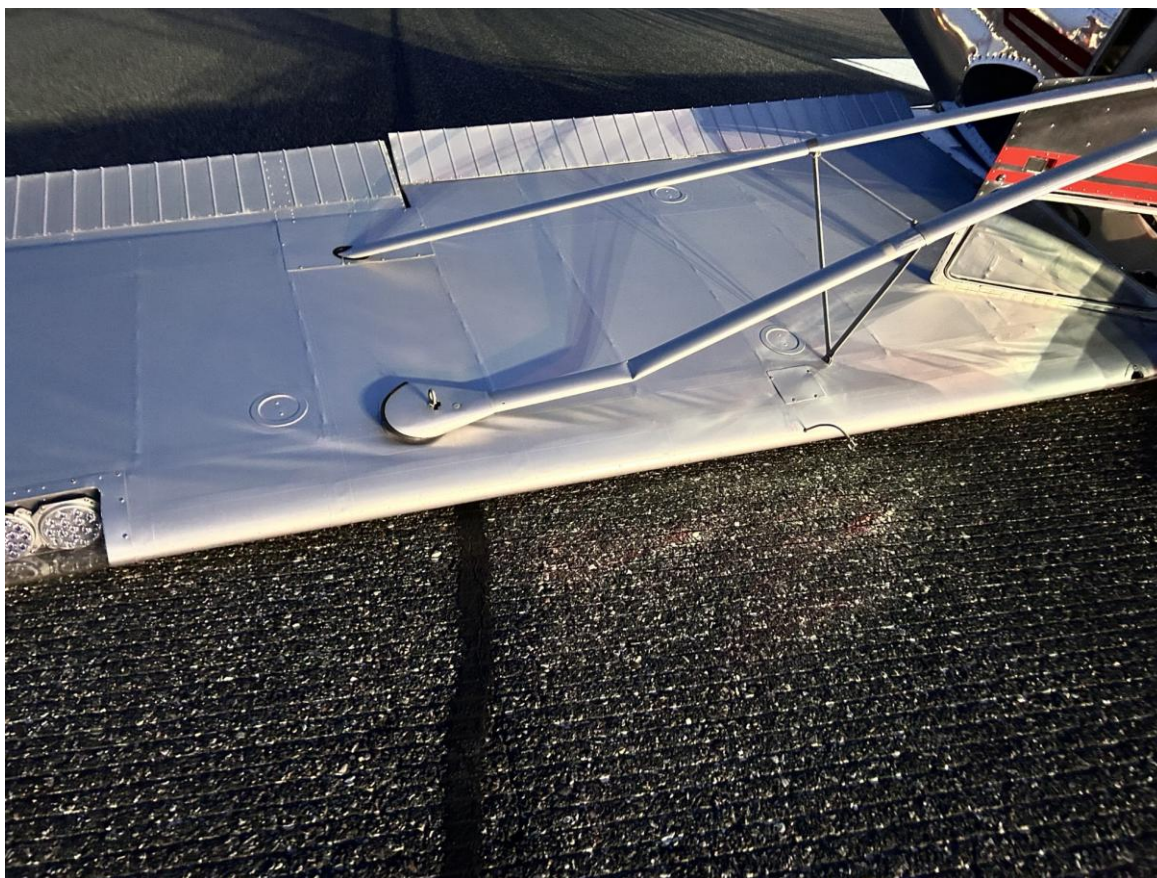
**Photograph 3 - View of left wing lift strut damage (Courtesy of Airport Operations)**

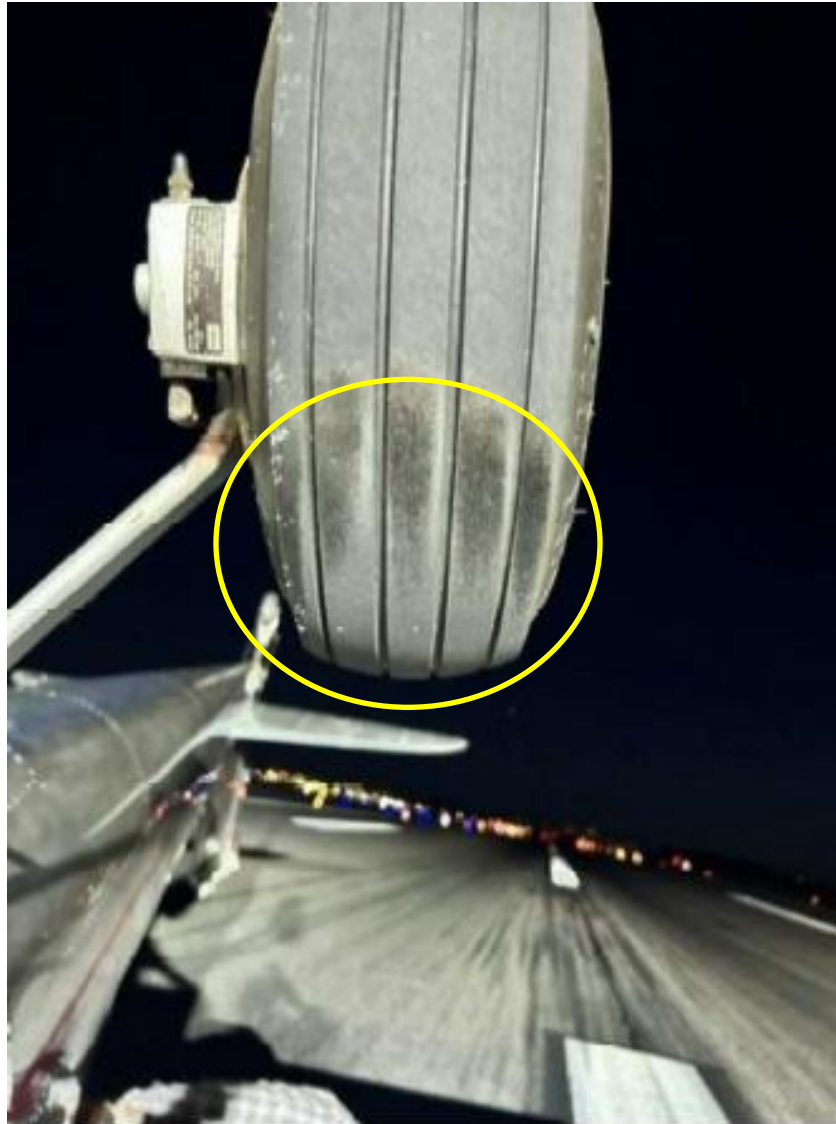
**Photograph 4 - View of right main landing gear tire wear marks (Courtesy of Airport Operations)**

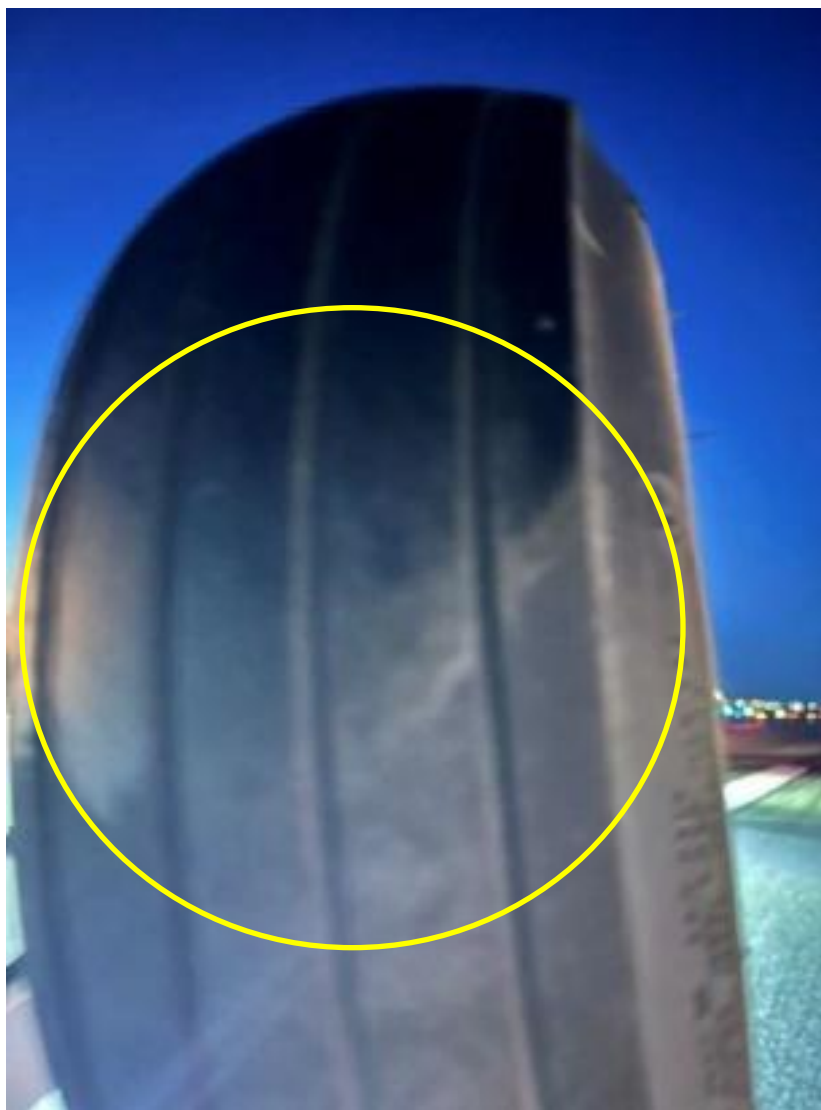
**Photograph 5 - View of left main landing gear tire wear marks (Courtesy of Airport Operations)**
