## Two-Stroke Fuel System Safety Issues

### ROTAX 2-STROKE FUEL SYSTEM DESIGN:

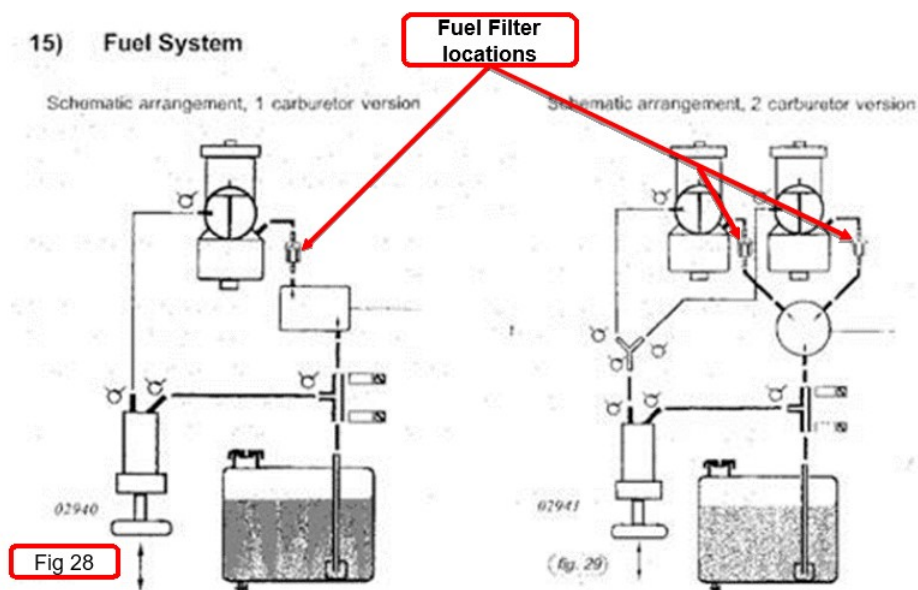
A lot of people are using paper fuel filters in their fuel systems and there are some major issues in doing so. The paper element can absorb water and at altitude this water can freeze, starving the engine from fuel. A suitable fuel filter of 0.15 mm mesh size should be used and must be fitted between the fuel pump and carburetor (See figure 28).

Below is an example of a type of fuel filters that *is* recommended - versus a type which is *not* recommended.

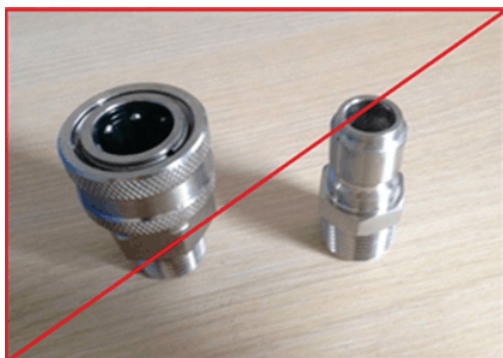
Zap straps/Tie wraps should not be used to secure the fuel line to a joint and some commercial clamps are often not very satisfactory on small pipes as they tend to tighten up oval creating a possible leak. "Crimp on" clamps can be unsatisfactory if incorrectly applied and are difficult to remove for servicing.

Quick release type connectors can cause air leaks, and also produce flow restrictions and possible blockage sites.

Replace all doubtful fuel line clamps with good quality approved ones. Rotax recommends a spring type clamp P/N 938 195. This type of clamp has been proven and is the most recommended.

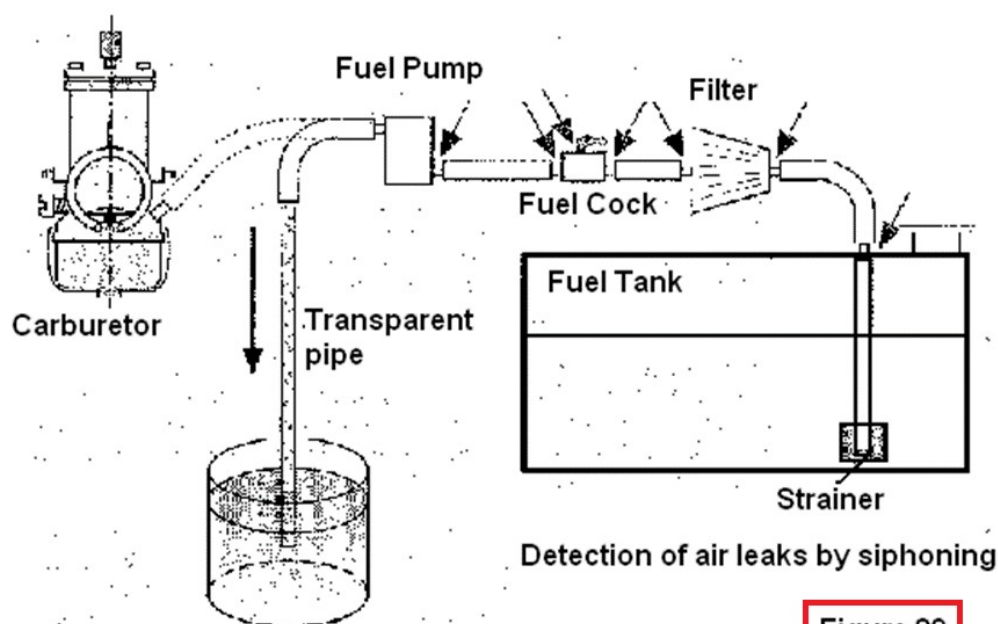
**Figure 29**

NOTE: Filter and fuel tap are shown on suction side of pump to illustrate air leakage sites possible. But it is recommended that these be installed on the pressure side of the pump.

If air leaks are indicated, seek to eliminate them. The arrow on the diagram show possible air leakage points. All connections on the suction side of the fuel pump are potential air leakage sites; the less there are, the less problems are likely to arise. It is far more satisfactory if the fuel tap and filter are fitted between the fuel pump and the carburetor, on the pressure side. On installations where this is not the case, extra care must be taken to eliminate air leaks.

Referring to Figure 29 above, disconnect the fuel line from the carburetor and connect a length of transparent fuel pipe, making sure the connection is absolutely airtight. Take the transparent pipe down to ground level and start siphoning fuel from the tank to a container on the ground. All parts of the fuel system above the level in the tank will be below atmospheric pressure, and any air leaks in the system will show up as bubbles in the transparent pipe. Continue siphoning for a considerable period of time.

After an initial settling period there should be no bubbles in the fuel. If bubbles persist, find the location of the air leak(s) by process of elimination.

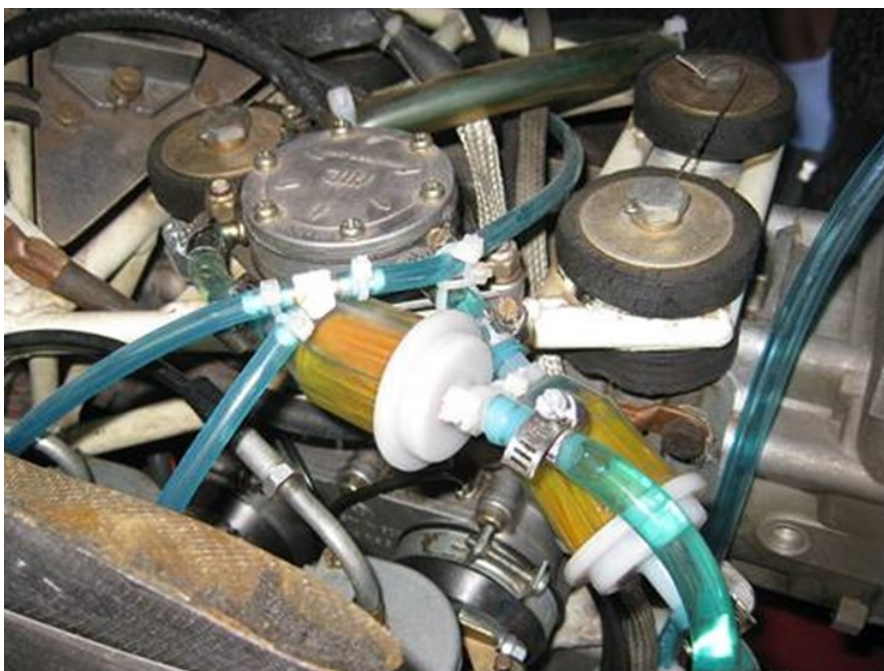
Below is an example of a bad fuel system installation on an aircraft that was involved in an accident. (See if you can spot the potential air leaks)
