NATIONAL TRANSPORTATION SAFETY BOARD  
Office of Aviation Safety  
Washington, D.C. 20594  
May 10, 2020

**Group Chairman's Factual Report**

**AIRWORTHINESS**

**DCA18FA144**

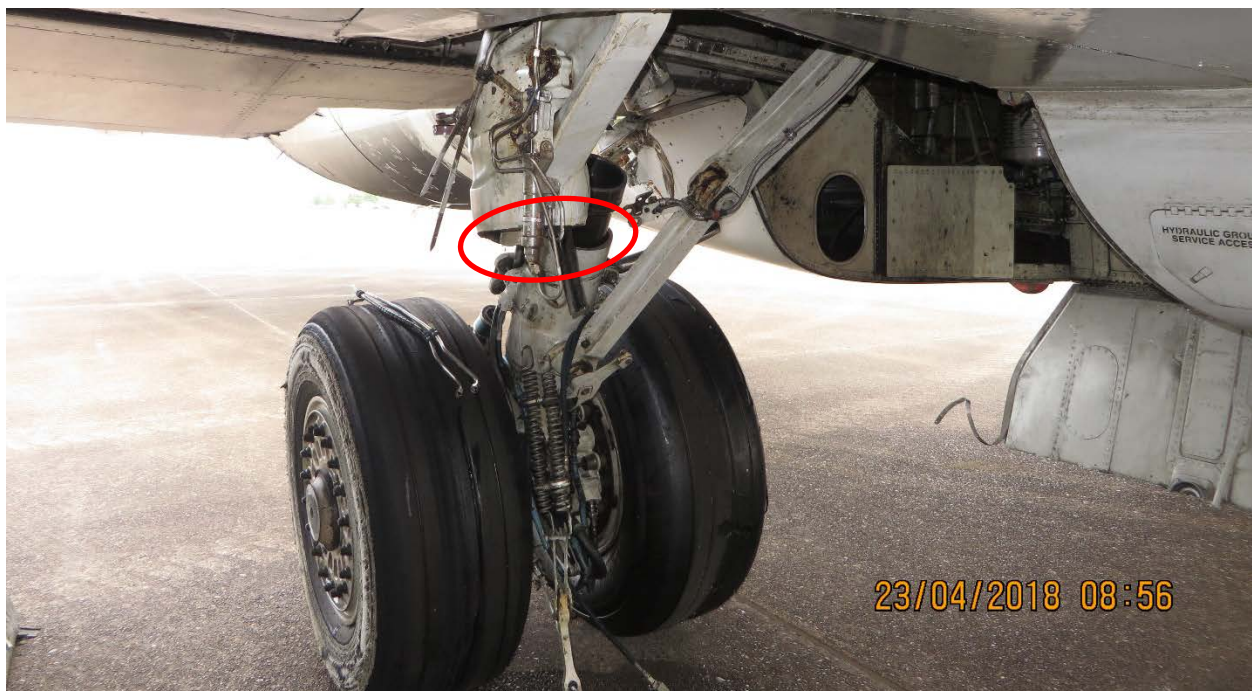
The right main landing gear (MLG) shock strut cylinder fractured upon landing at AEX. The cylinder fractured around its entire circumference and a preliminary examination of the cylinder revealed that the fracture originated in area exhibiting features consistent with fatigue. A repetitive inspection of the cylinder in the observed fatigue features in accordance with service bulletin (SB-MD80-32A286-004) and airworthiness directive (AD-2004-05-03).

Figure 1 – Right main landing gear fracture looking aft and inboard.

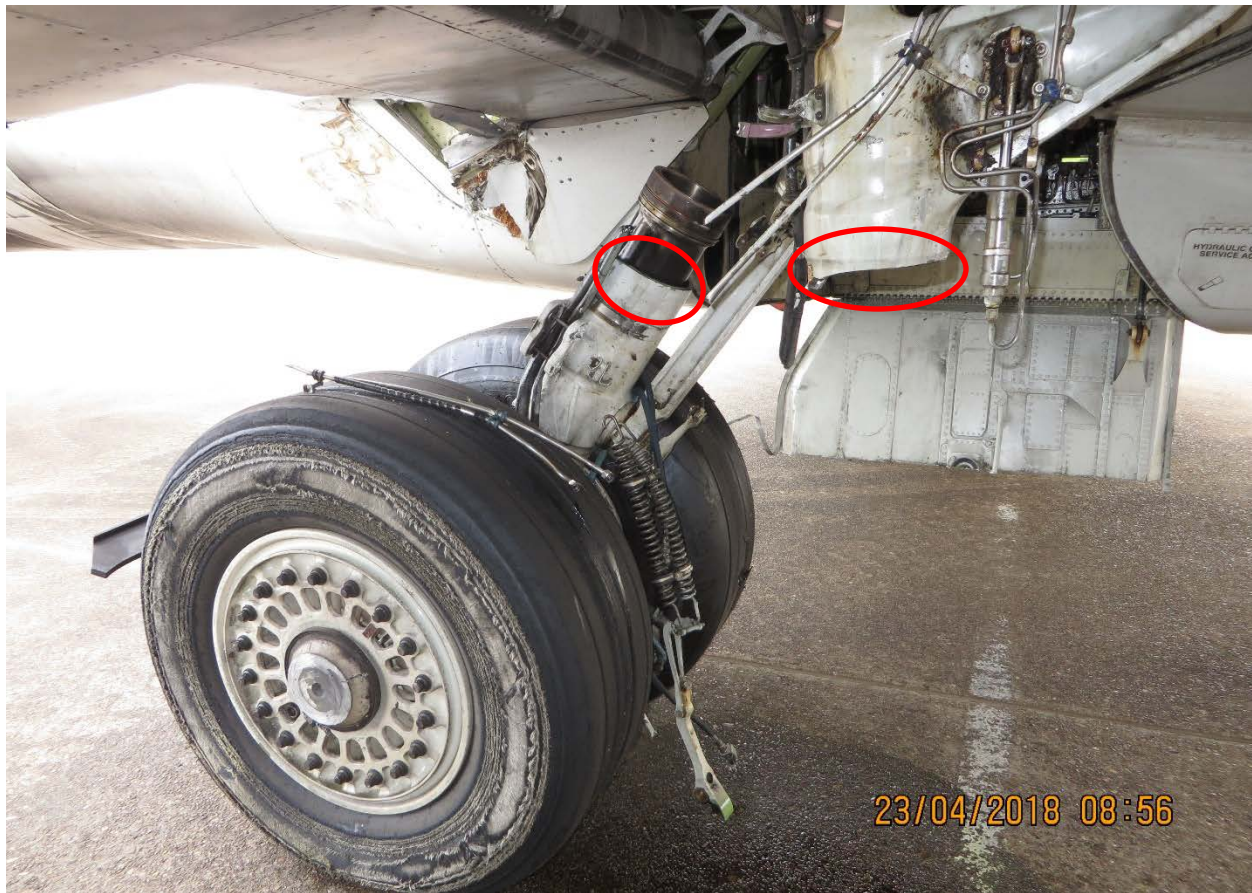
Figure 2 – Right main landing gear fracture looking inboard.

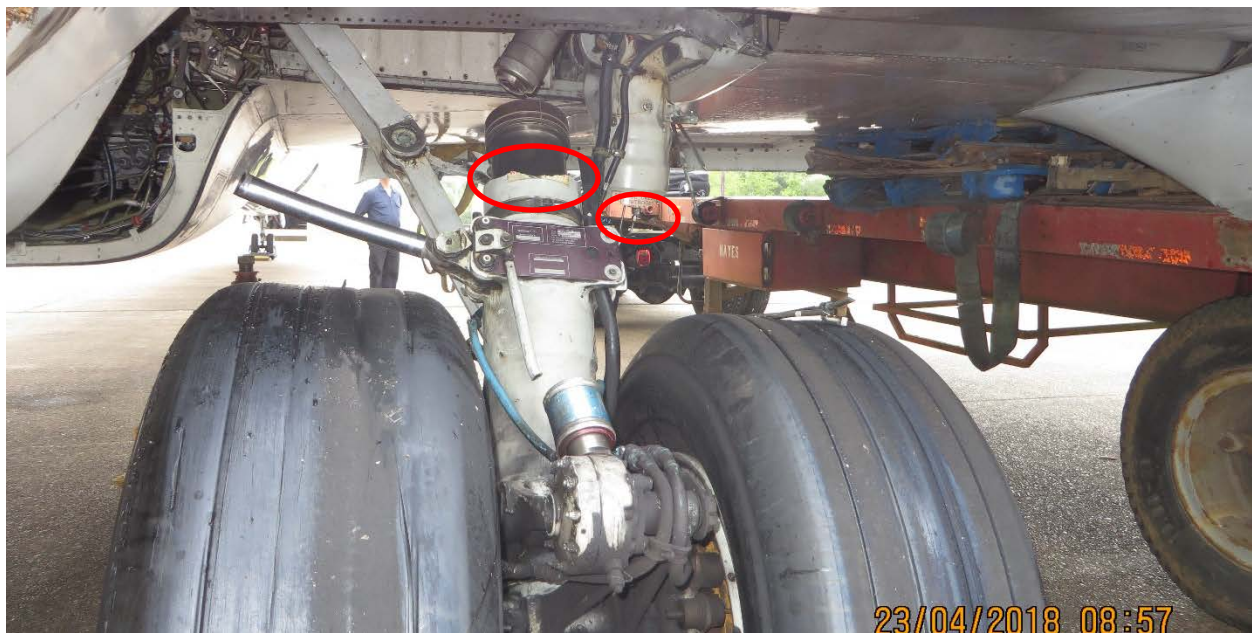
Figure 3 – Right main landing gear fracture looking forward.

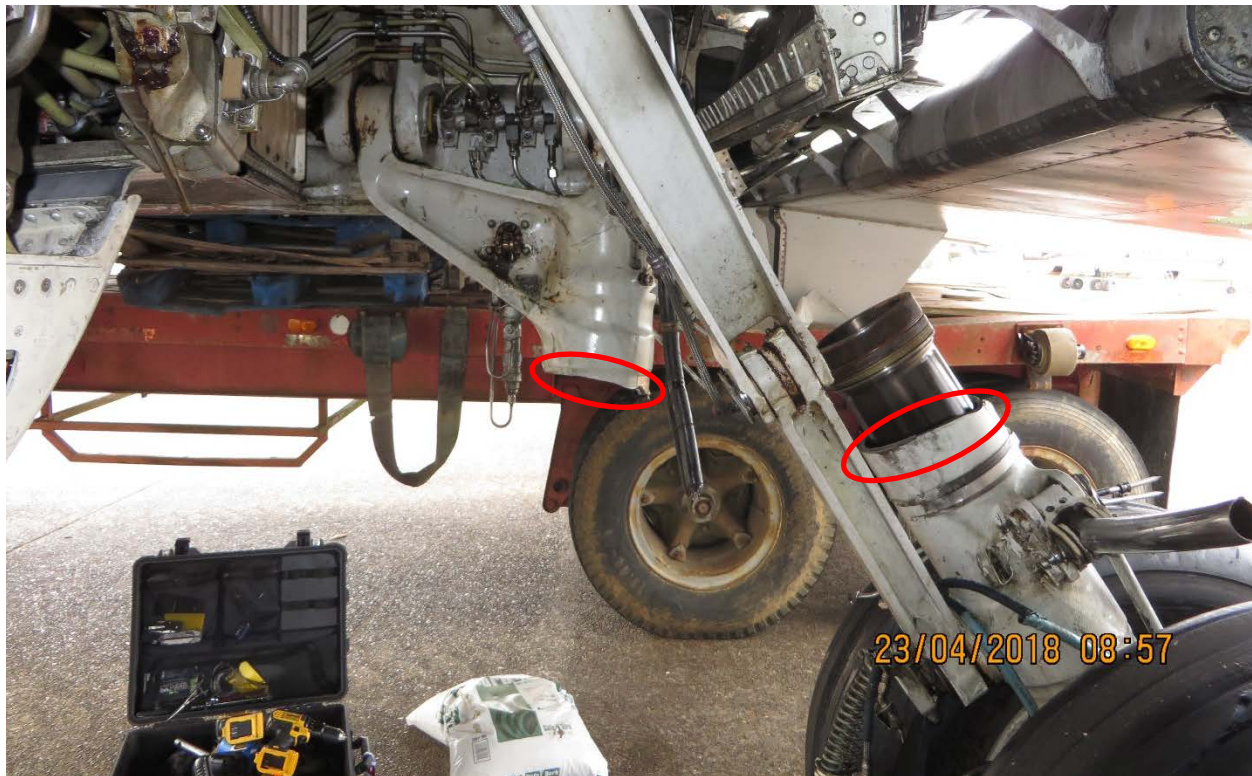
Figure 4 – Right main landing gear fracture looking outboard.

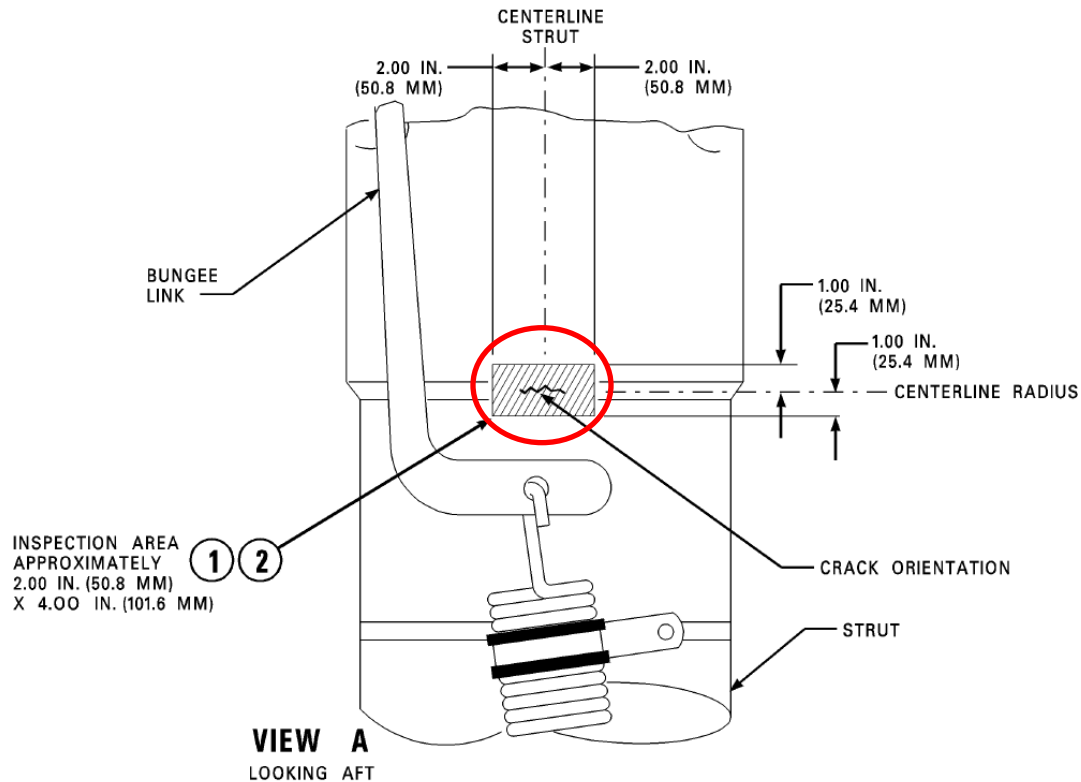
Figure 5 – Service Bulletin inspection area (forward side).

The performance of repetitive dye penetrant and magnetic particle inspections will determine if a crack exists. Installing brake line hydraulic restrictors, if not previously accomplished per Service Bulletin MD80-32-276, would minimize vibration induced stress loads and minimize possibility of cylinder fracture.

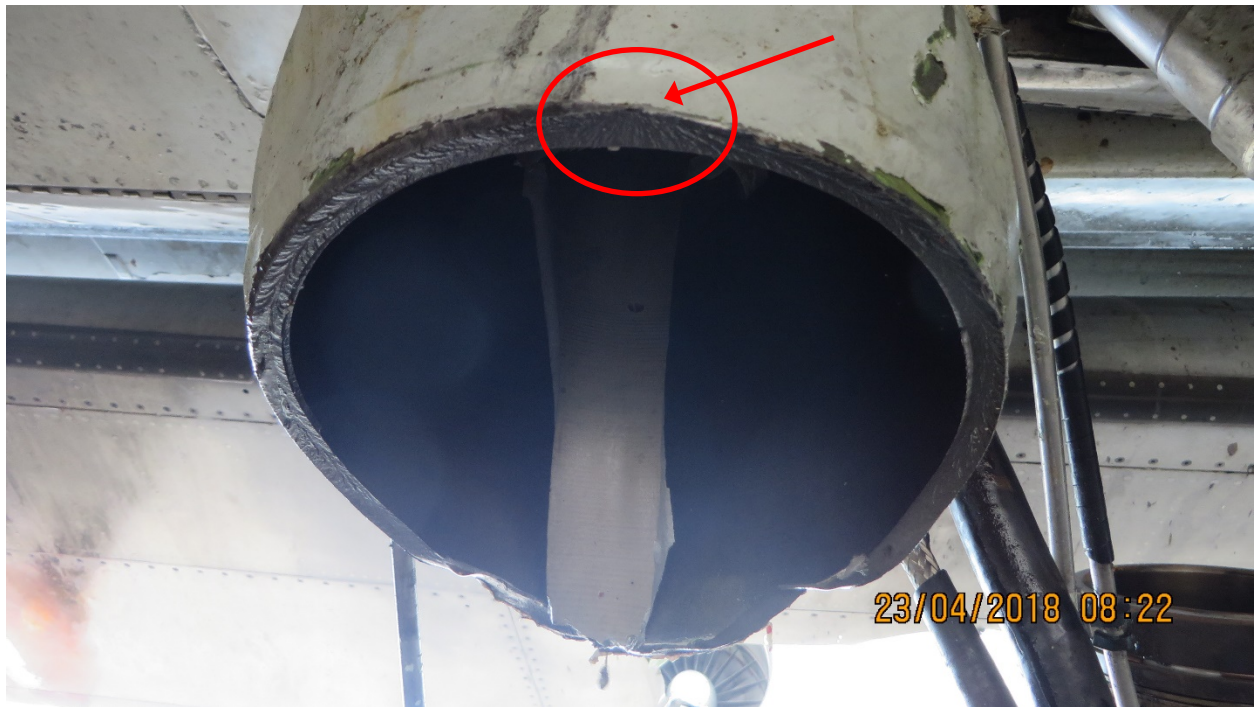
Figure 6 - Upper cylinder fatigue crack initiation site (forward side).

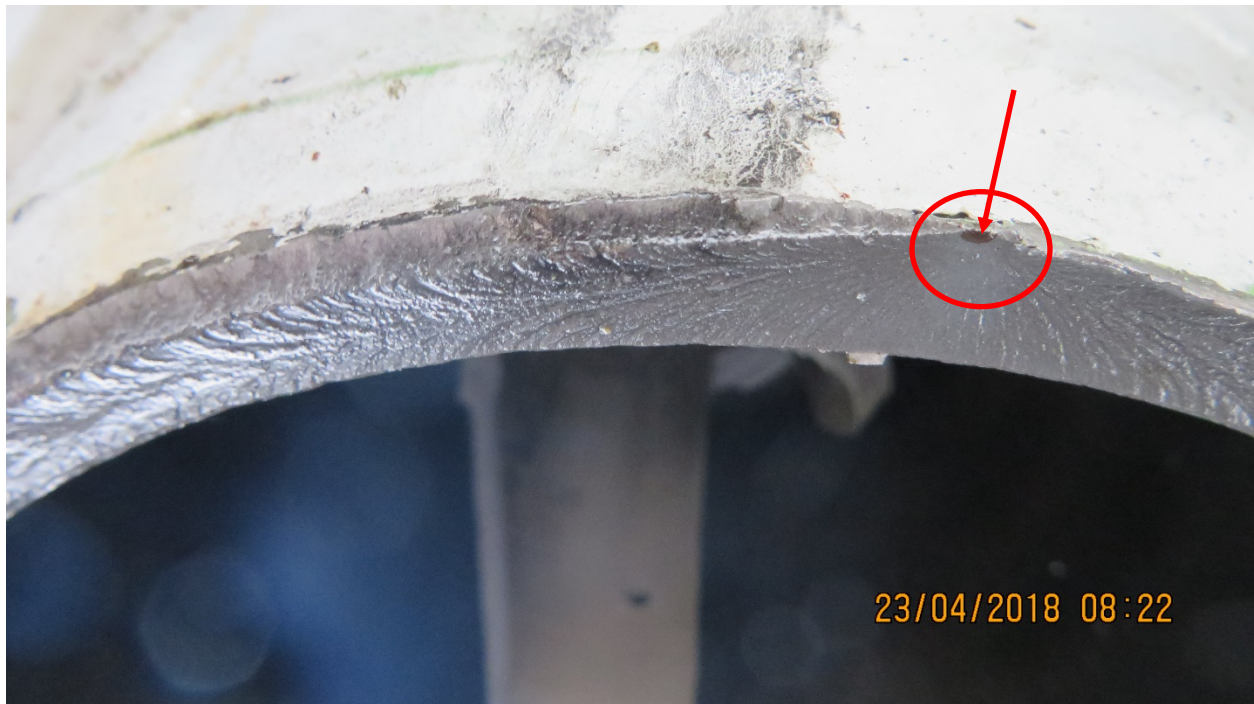
Figure 7 – Upper cylinder fatigue crack initiation site (forward side).

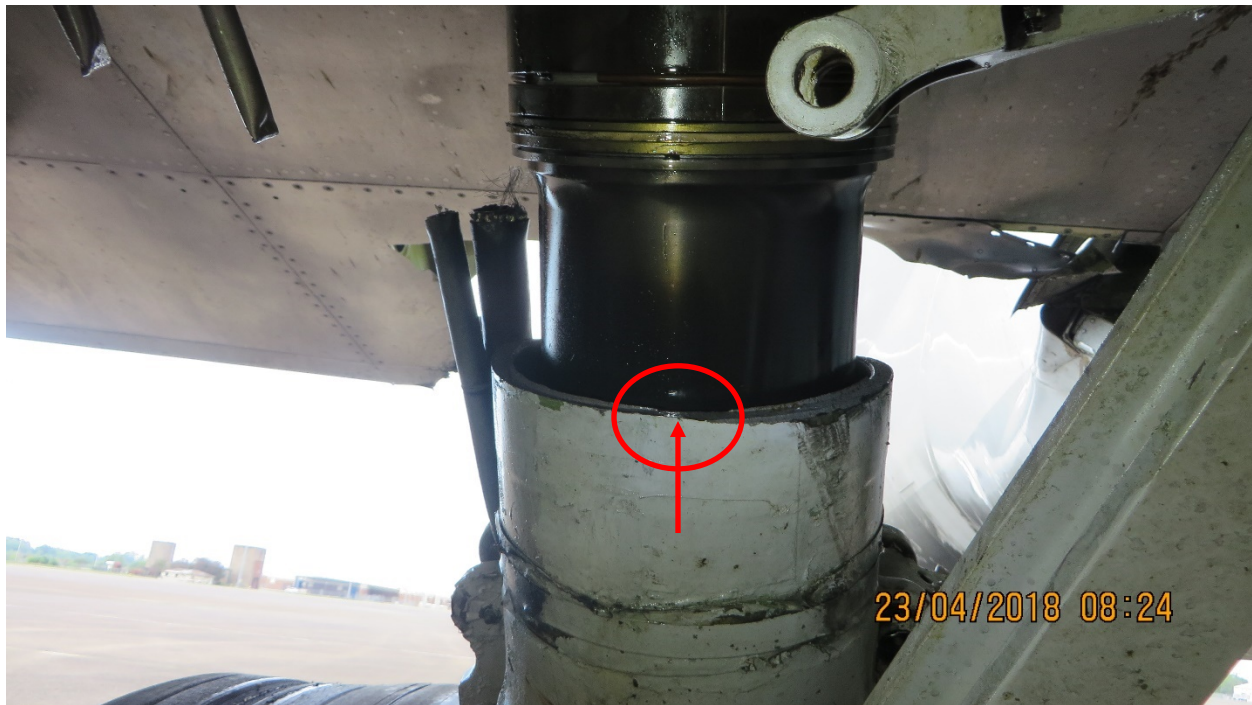
Figure 8 – Approximate fatigue crack initiation site on the lower cylinder (forward side).

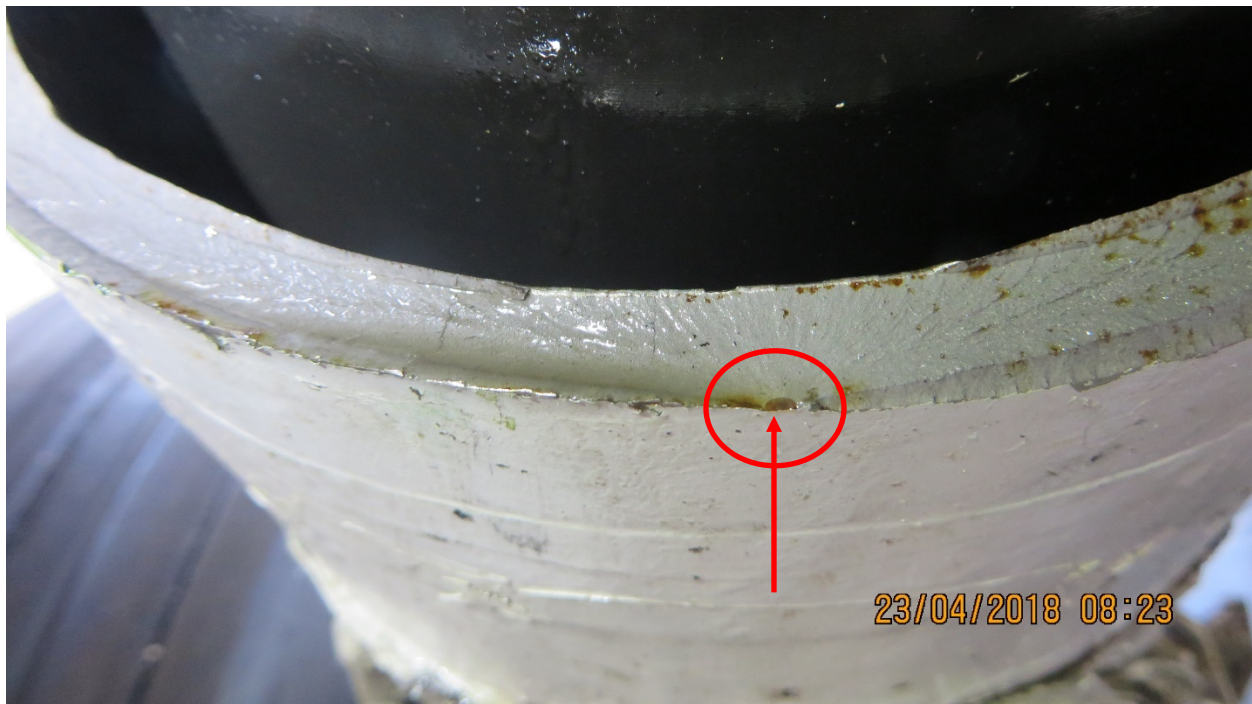
Figure 9 – Lower cylinder fatigue crack initiation site (forward side).

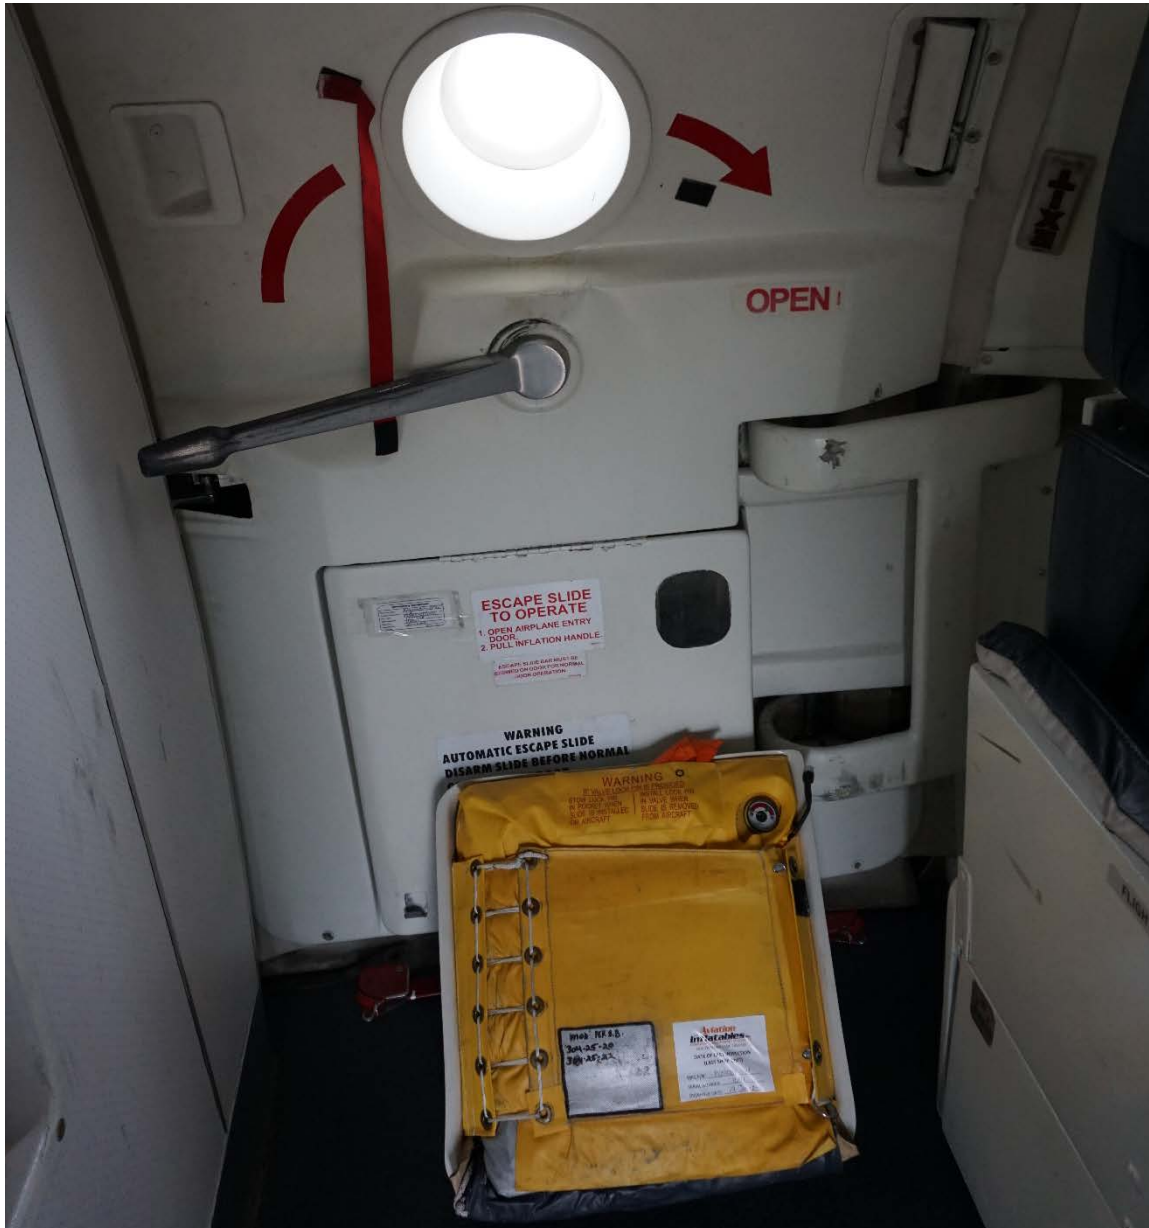
The L1 slide did not deploy nor did it inflate and was sent to the manufacturer for further examination (Survival Factors Group Chairman's Factual Reports – Slide and Inflation Valve Teardowns).

Figure 10 - L1 door evacuation slide.

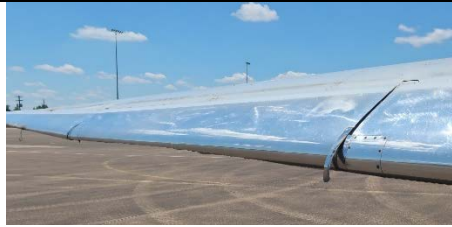
| ID | Aircraft Location | Part | Location | Damage Description | Figure |
|---|---|---|---|---|---|
| 1 | R/H Wing | Leading Edge Slats | Figure 20 | Runway contact damage | <br>Figure 11 – Inboard Slats |

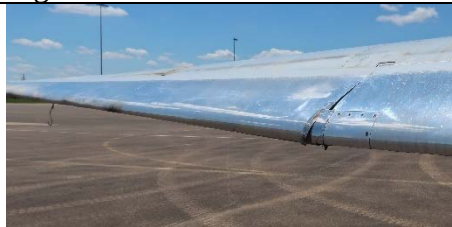
| ID | Aircraft Location | Part | Location | Damage Description | Figure |
|---|---|---|---|---|---|
| 2 | R/H Wing | Leading Edge Slats | Figure 20 | Runway contact damage | <br>Figure 12 – Outboard Slats |

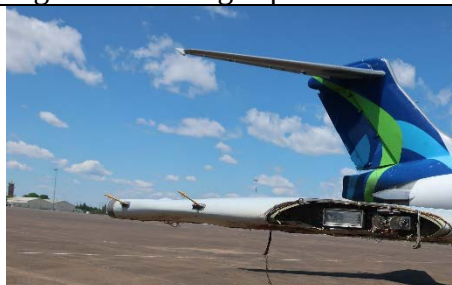
| ID | Aircraft Location | Part | Location | Damage Description | Figure |
|---|---|---|---|---|---|
| 4 | R/H Wing | Navigation light | Figure 20 | Runway contact damage | <br>Figure 14 – Navigation Light |

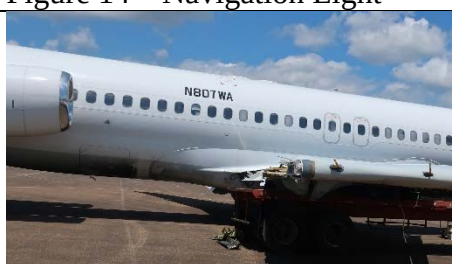
| ID | Aircraft Location | Part | Location | Damage Description | Figure |
|---|---|---|---|---|---|
| 5 | R/H Wing | Navigation lights | Figure 20 | Runway contact damage | <br>Figure 15 – Navigation Lights |

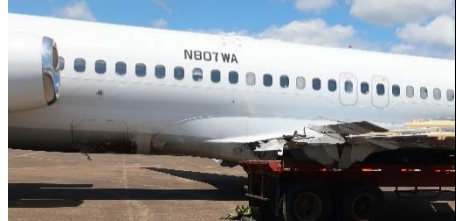
| ID | Aircraft Location | Part | Location | Damage Description | Figure |
|---|---|---|---|---|---|
| 6 | R/H Wing | Trailing Edge | Figure 20 | Runway contact damage | <p>Figure 16 – Trailing Edge</p> |

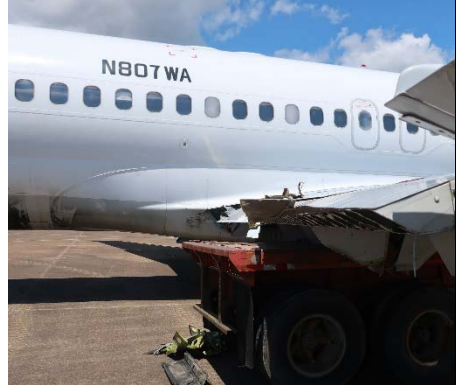
| ID | Aircraft Location | Part | Location | Damage Description | Figure |
|---|---|---|---|---|---|
| 7 | R/H Wing | Inboard Flap | Figure 20 | Runway contact damage | <p>Figure 17 Inboard Flap</p> |

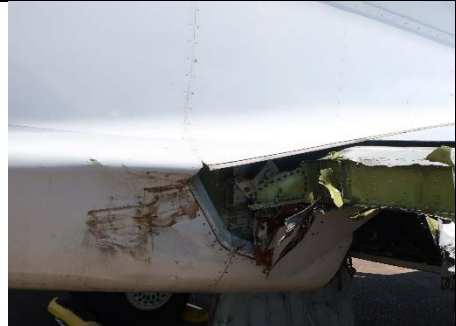
| ID | Aircraft Location | Part | Location | Damage Description | Figure |
|---|---|---|---|---|---|
| 8 | R/H | Inboard Flap & SOB Fairing | Figure 20 | Failed gear contact with the flap and the SOB | <p>Figure 18 Inboard Flap &amp; SOB</p> |

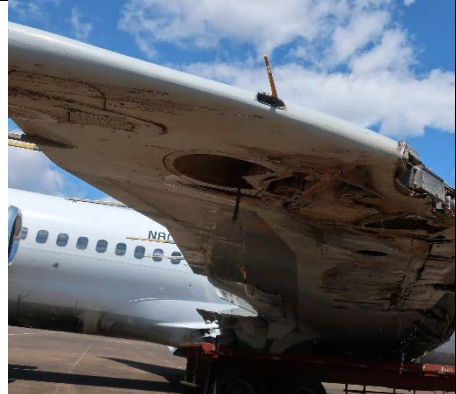
| ID | Aircraft Location | Part | Location | Damage Description | Figure |
|---|---|---|---|---|---|
| 9 | R/H Wing | Lower Wing Skin | Figure 20 | Abrasion damage | <p>Figure 19 – Lower Skin Panel</p> |

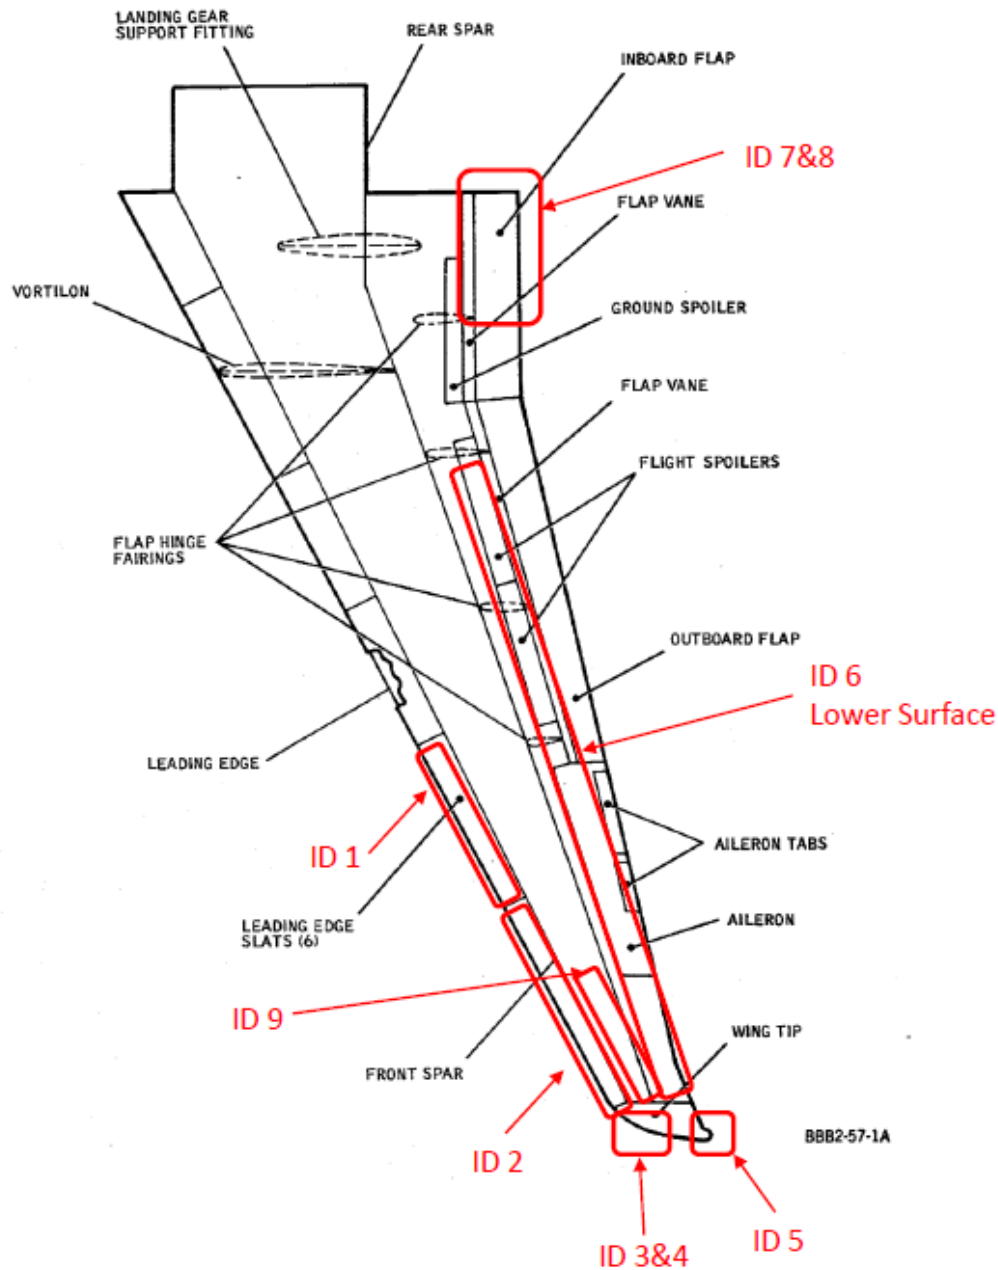
The airplane sustained substantial damage to the right-wing.

Figure 20 - Right wing damage (lower surface).
