## MEMORANDUM OF RECORD

**Subject:** ERA14LA330 – Examination of engine and airframe by inspectors from the Federal Aviation Administration and a representative from Lycoming engines.

**Date of Examination:** July 10, 2014

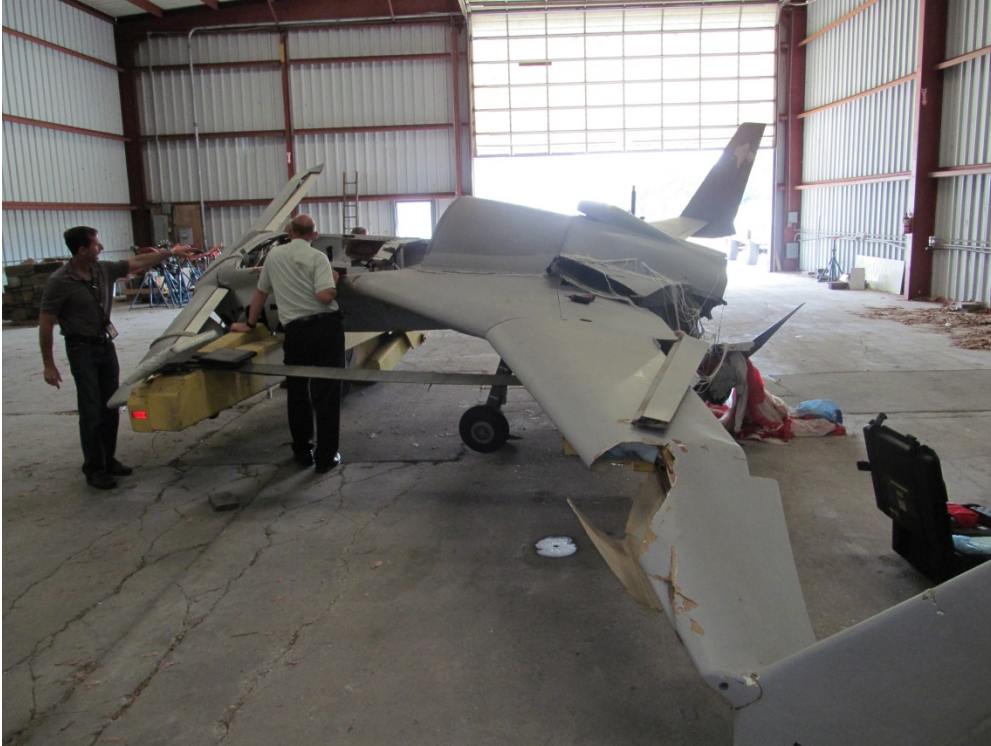
Examination of the airplane by a Federal Aviation Administration inspector and a representative from the engine manufacturer revealed damage to fuselage, left wingtip leading edge, and the right canard trailing edge. The pilot had a personal parachute pack, and when recovered, the parachute had been deployed, remained attached, and was found trailing behind the airplane. Examination of the canopy brackets attached to the fuselage and both hinges revealed no tearing or shearing of the bolts; however, no bolts nor the canopy were present.

Photo 1: Airplane - Post Recovery (Courtesy of Lycoming)

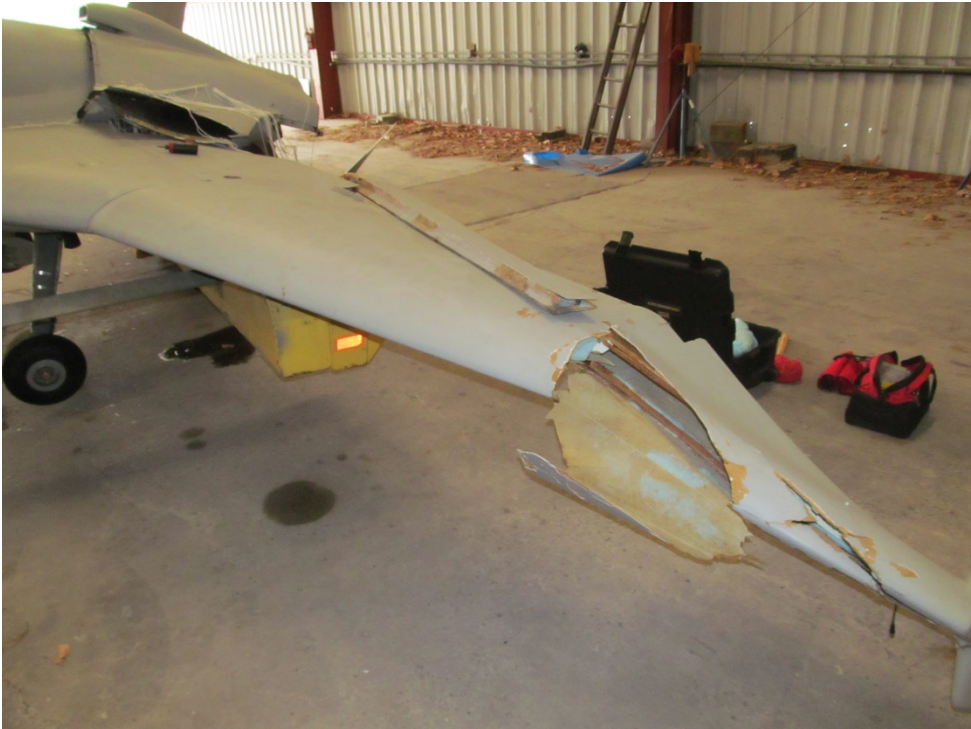
The left wing and left canard remained attached to the fuselage. The left wing exhibited leading edge damage which extended from the wingtip inward approximately 4 feet

Photo 2: Damage to Left Wing - Post Recovery (Courtesy of Lycoming)

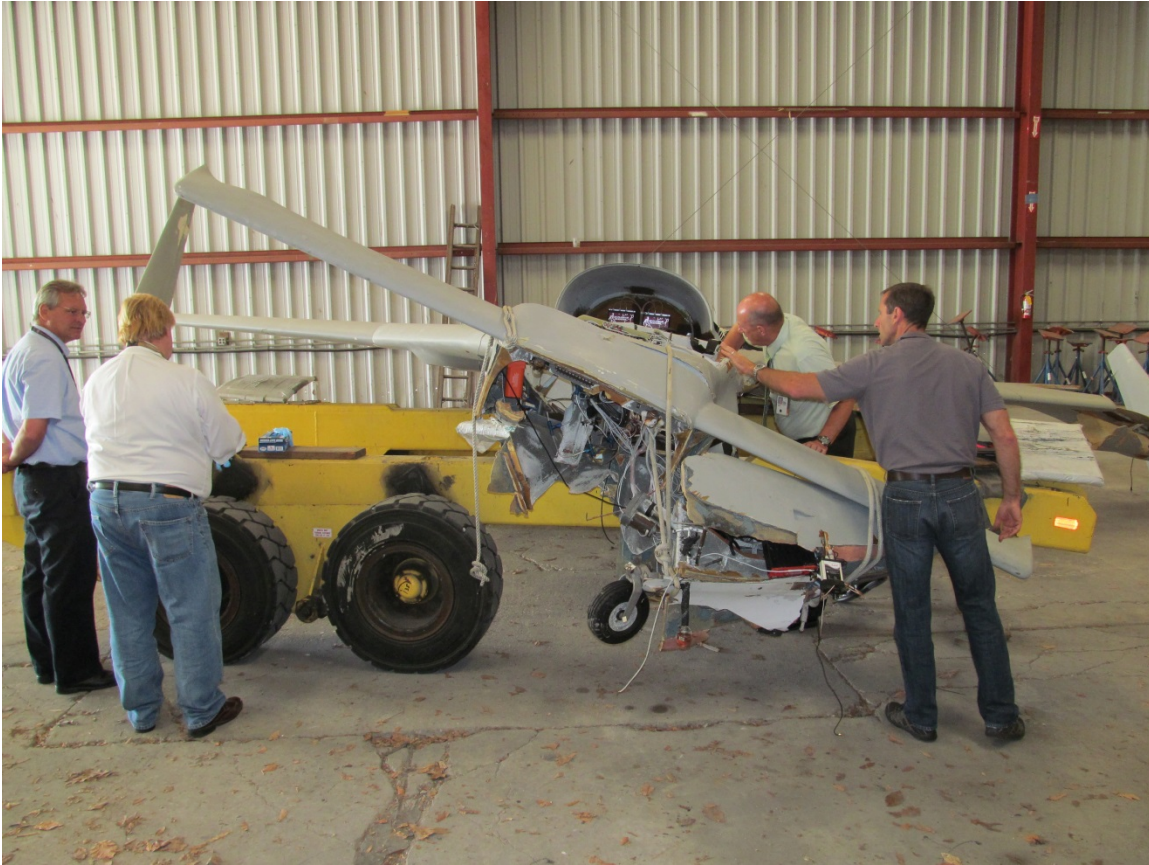
The nose section exhibited impact damage and was partially fractured on the right side circumferentially around the bottom of the nose but remained partially attached on the

left side. The nose wheel remained attached and was partially extended. Examination of the canopy brackets attached to the forward section of the fuselage and both hinges revealed no tearing or shearing of the bolts; however, no bolts nor the canopy were present.

Photo 3: Front View of Airplane - Post recovery (Courtesy of Lycoming)

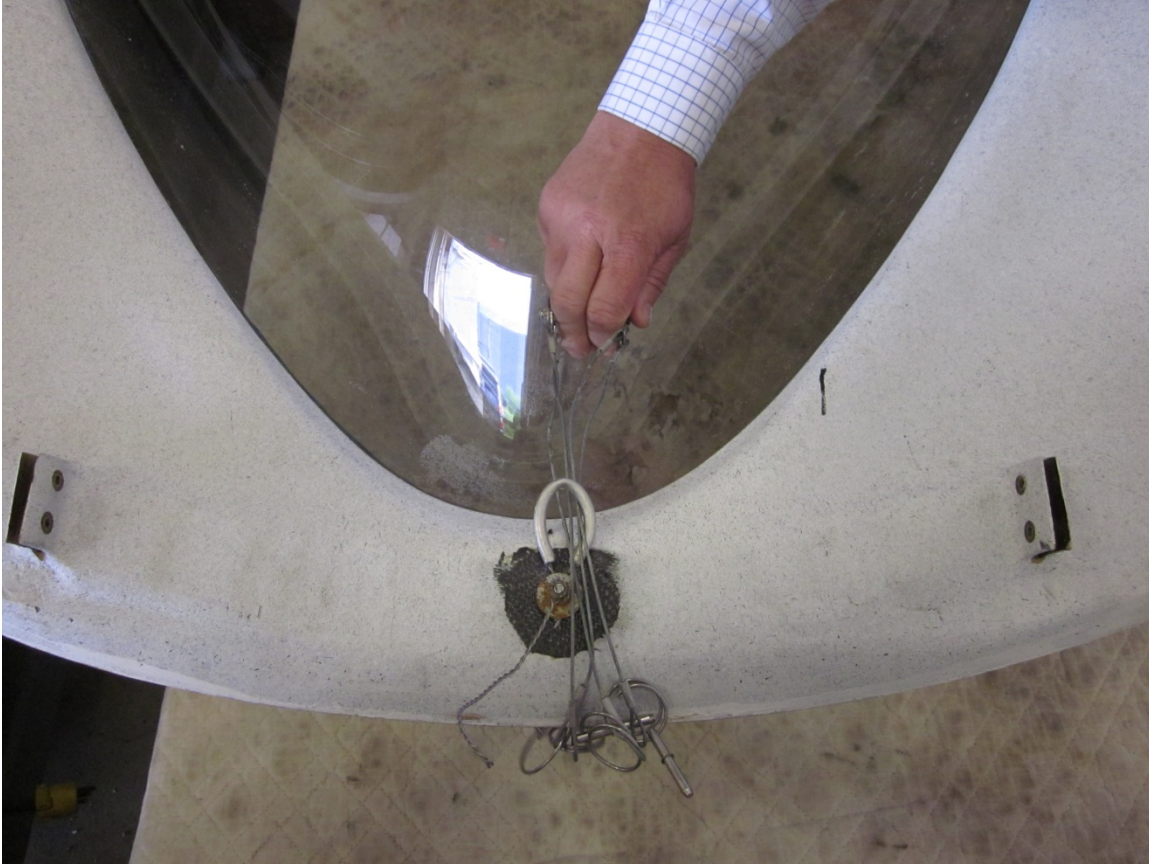
The canopy was subsequently located July 9, 2014, floating in the water, about 39 miles northeast of the last recorded radar return. The canopy remained intact and the windscreen was not damaged. The canopy quick release remained attached to the canopy; however, was found in the released position. The four locking pins and associated locking pin holes exhibited no distortion and was unremarkable. The four pins were reinstalled into the locking pin holes and appeared to lock into place. The quick release line was pulled by an FAA inspector and all four pins released and operated normally.

Photo 4: Canopy Locking Pins after operational check (Courtesy of the FAA)

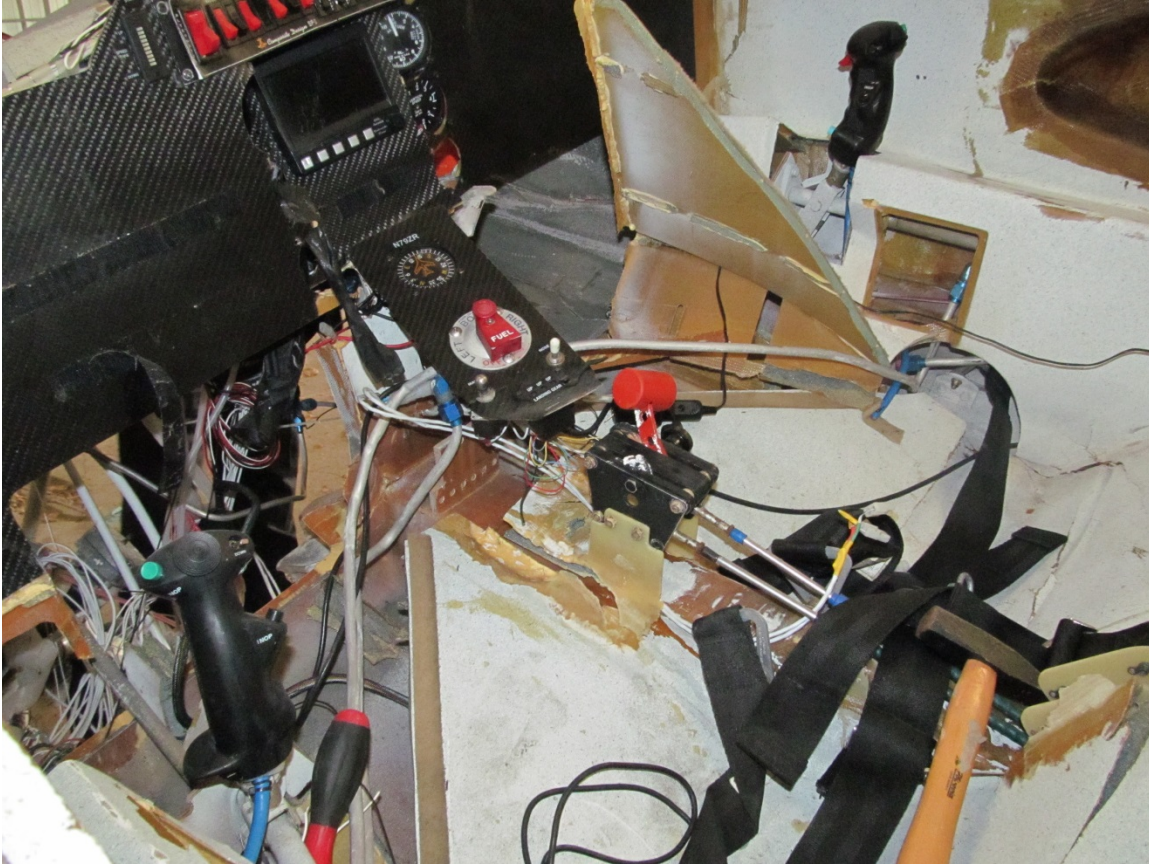
The instrument panel exhibited impact damage but remained attached to the forward portion of the cockpit. The throttle lever handle was impact separated; however, the lower portion of the throttle lever arm remained attached and was in the full forward or "OPEN" position. The mixture lever was in the full forward or full "rich" position. The fuel selector valve was in the "BOTH" position. The landing gear position indicator located aft of the fuel selector valve indicated three "UP" positions. Both ignition switches were found guarded and in the "ON" position. The glareshield consisted of circuit breakers and several switches. The following switches were found in the on position: Master, Radio Master, Landing Light, Strobe Lights, Pitot Heat, Spare Circuit, and Fuel Pump. The left side control stick remained attached to the control column. The left and right cockpit molded seats remained attached and had various fractures located along the back. Both seatbelts and shoulder harnesses remained attached to the associated attach point; however, the right seat belt and should harness had been cut by first responders to facilitate recovery of the occupant.

Photo 5: Cockpit Section - Post Recovery (Courtesy of Lycoming)

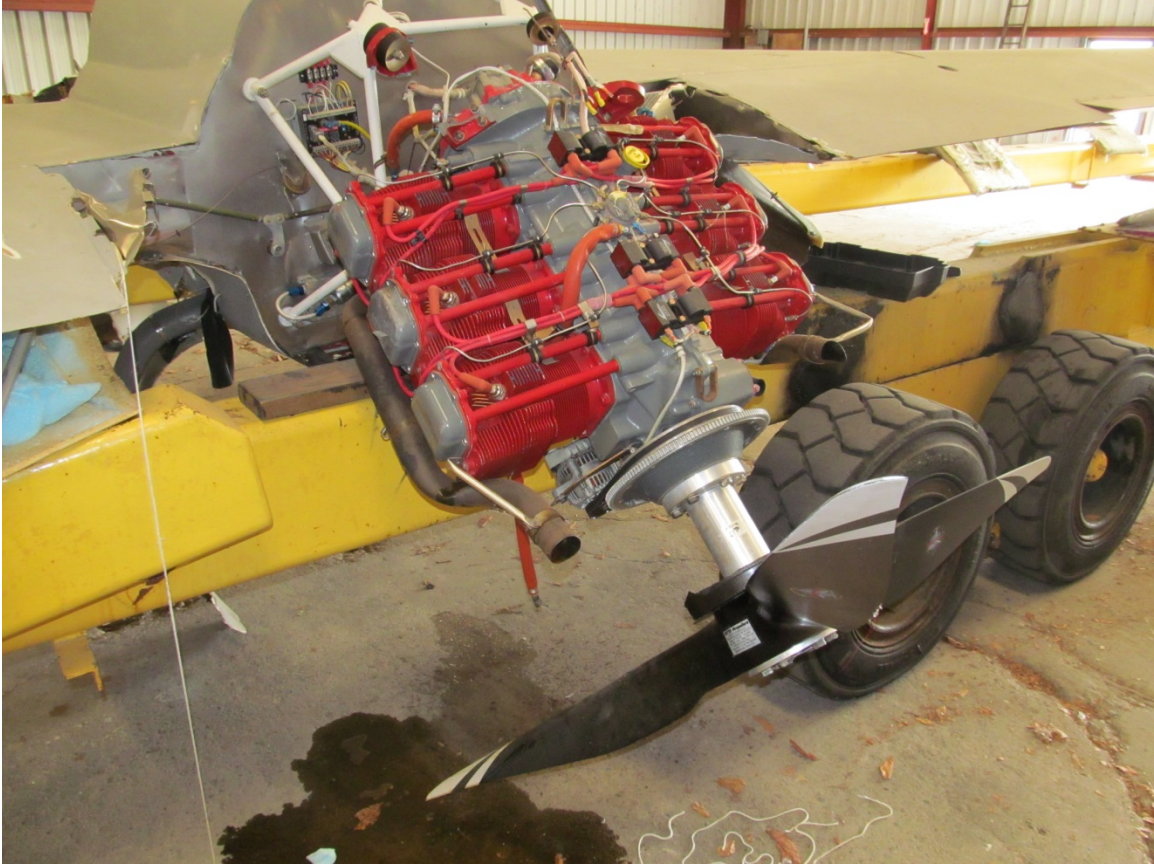
The aft pusher engine compartment remained attached to the fuselage and the firewall was not damaged. The lower and upper engine cowlings exhibited impact damage but remained attached to the fuselage. The engine assembly remained attached to all engine mounts. The composite three-blade propeller remained attached to the propeller crankshaft flange. The propeller blades were not damaged, and the personal parachute canopy and associated cords were found wrapped around the blades and hub.

Photo 6: Engine as found - Post Recovery (Courtesy of Lycoming)

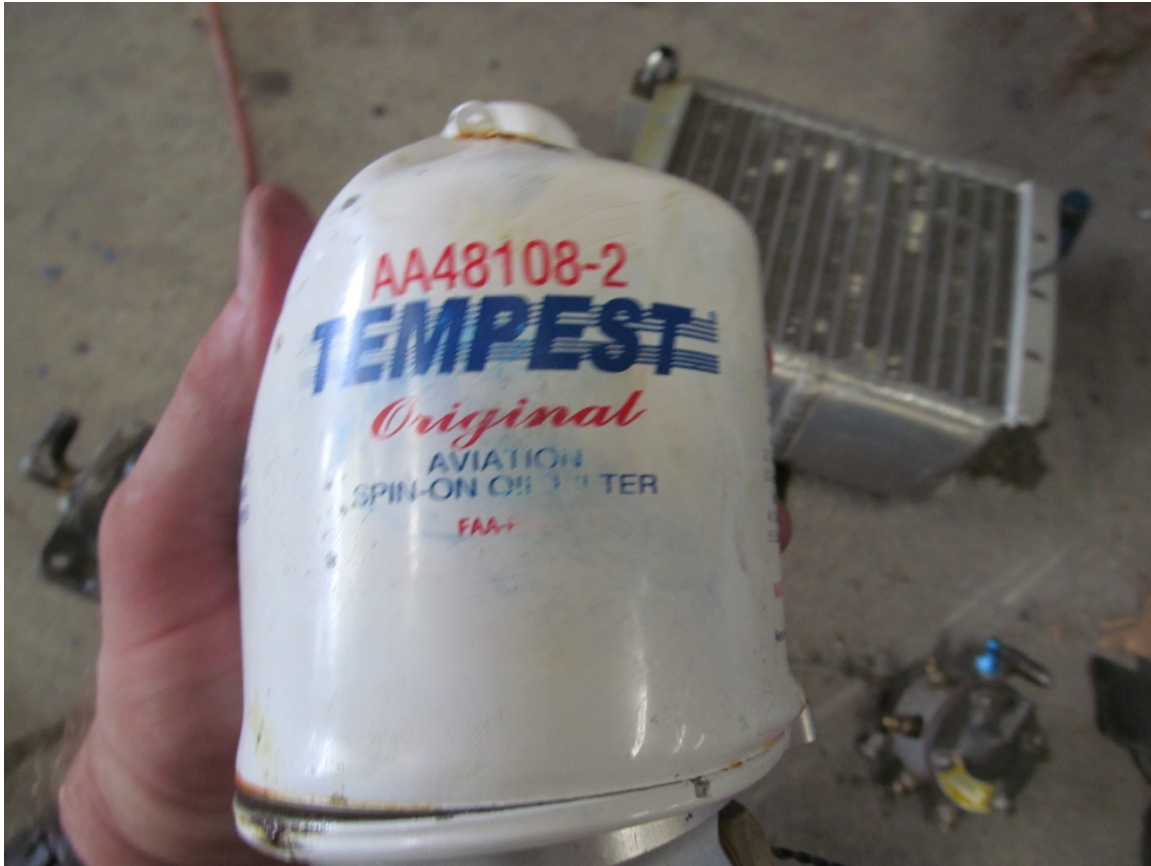
Examination of the engine assembly revealed the left and right engine exhaust pipes exhibited impact crush damage at the Nos. 1 and 2 cylinders. All induction tubes were attached to their respective attached points. The oil sump was intact and the oil dip stick remained in place. The oil suction screen was removed and no anomalies were noted. An unmeasured amount of oil was present in the oil sump. The oil cooler, mounted on the right side of the aircraft, aft of the firewall, was not damaged.

Photo 7: Oil Filter - Post Removal (Courtesy of Lycoming)

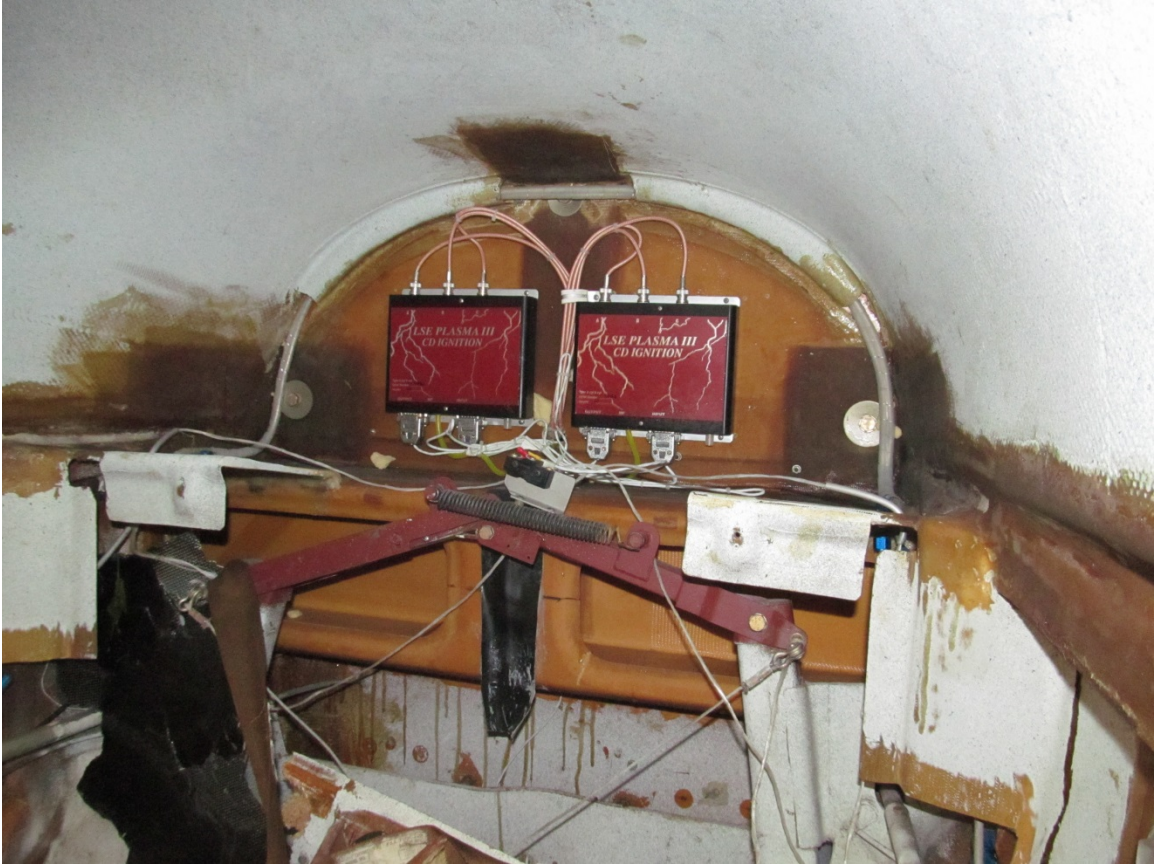
The alternator and drive pulley remained attached to the engine assembly and was not damaged. The alternator cooling fan was not damaged. The starter remained attached to the engine and the drive pinion was retracted. A Light Speed Engineering plasma capacitive discharge (CD) ignition system was installed in lieu of magnetos with an ignition box installed behind the firewall. Six ignition coil packs were installed on top of the engine with automotive style ignition leads. The CD ignition was not tested due to the manufacturer reporting that the ignition would be operable as long as there was even a small amount, approximately 2 amps, of electrical power either being produced or in the battery. Due to the radar return recorded near the area of the impact location, electrical power was still available on the aircraft.

Photo 8: Dual Light Speed Ignition System as found - Post Recovery (Courtesy of Lycoming)

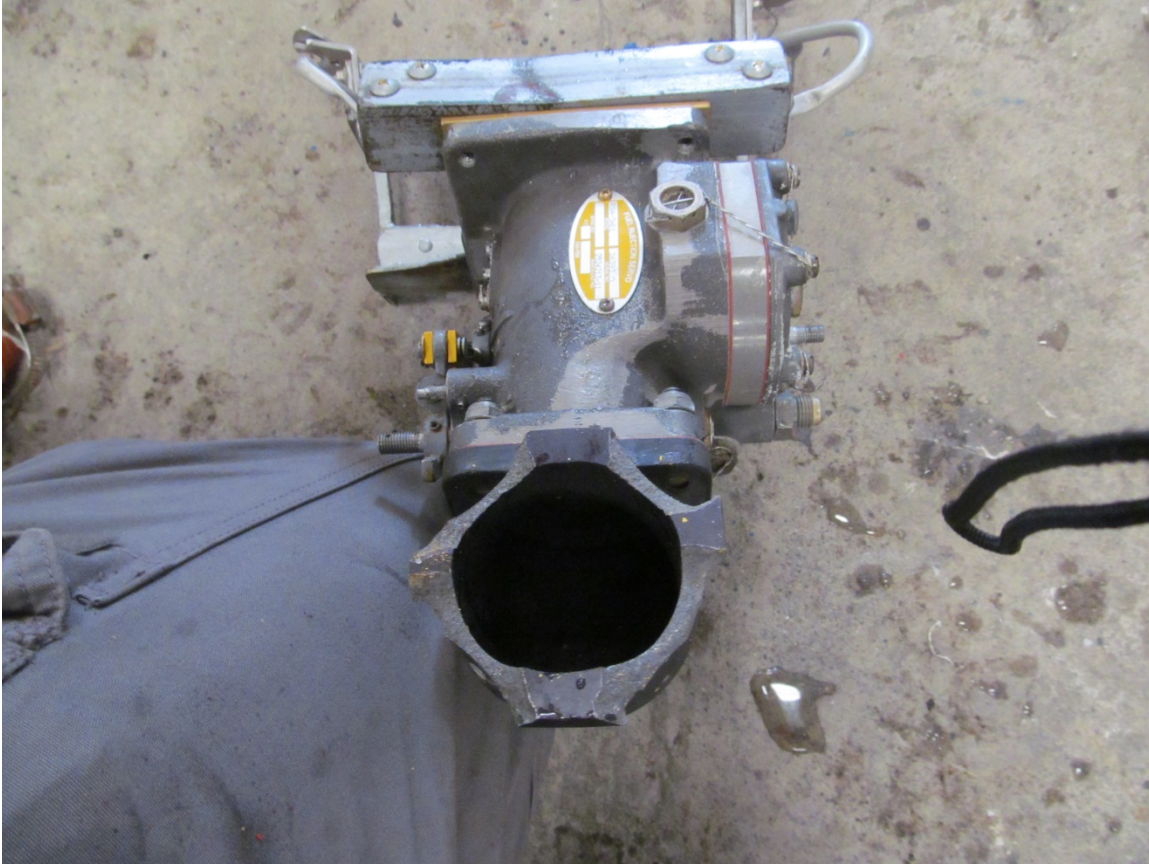
The aircraft fuel injection servo was impact separated from its mount but retained by the mixture and throttle cables and contained about 1 teaspoon of blue liquid that smelled similar to 100LL aviation fuel. The fuel screen was removed and was free of contaminants. The fuel lines leading to engine driven fuel pump and the fuel injector servo were removed and contained fuel. The engine driven fuel pump was removed and contained fuel. The engine driven fuel pump produced pressure at the outlet port and suction at the inlet port when it was actuated by hand.

Photo 9: Fuel Injector Servo - Post Removal (Courtesy of Lycoming)

The throttle cable remained attached to the throttle control arm on the fuel injector servo and was at mid-range. The mixture control remained attached to the mixture control arm and was in the full rich position. The fuel injector servo fuel inlet screen was removed and free of contaminants. The fuel flow divider was removed, disassembled and no anomalies were noted. The fuel injector nozzles were removed from all cylinders and no anomalies were noted.

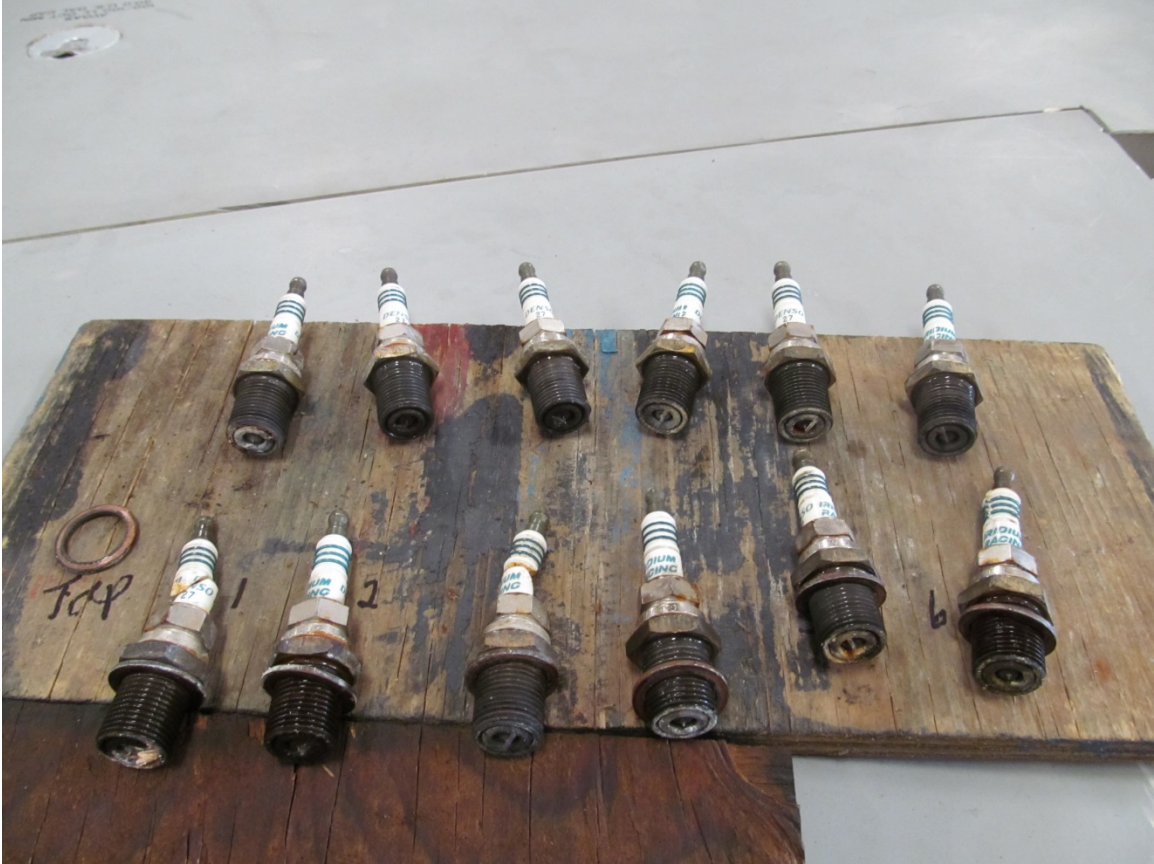
The spark plugs were automotive type sparkplugs and were removed. The upper spark plugs displayed dark gray combustion deposits and exhibited normal wear condition. The bottom spark plugs associated with cylinders Nos 2, 3, and 6 exhibited dark brown combustion deposits and were oil wet. All of the bottom spark plugs exhibited normal wear conditions.

Photo 10: Spark Plugs - Post Removal (Courtesy of Lycoming)

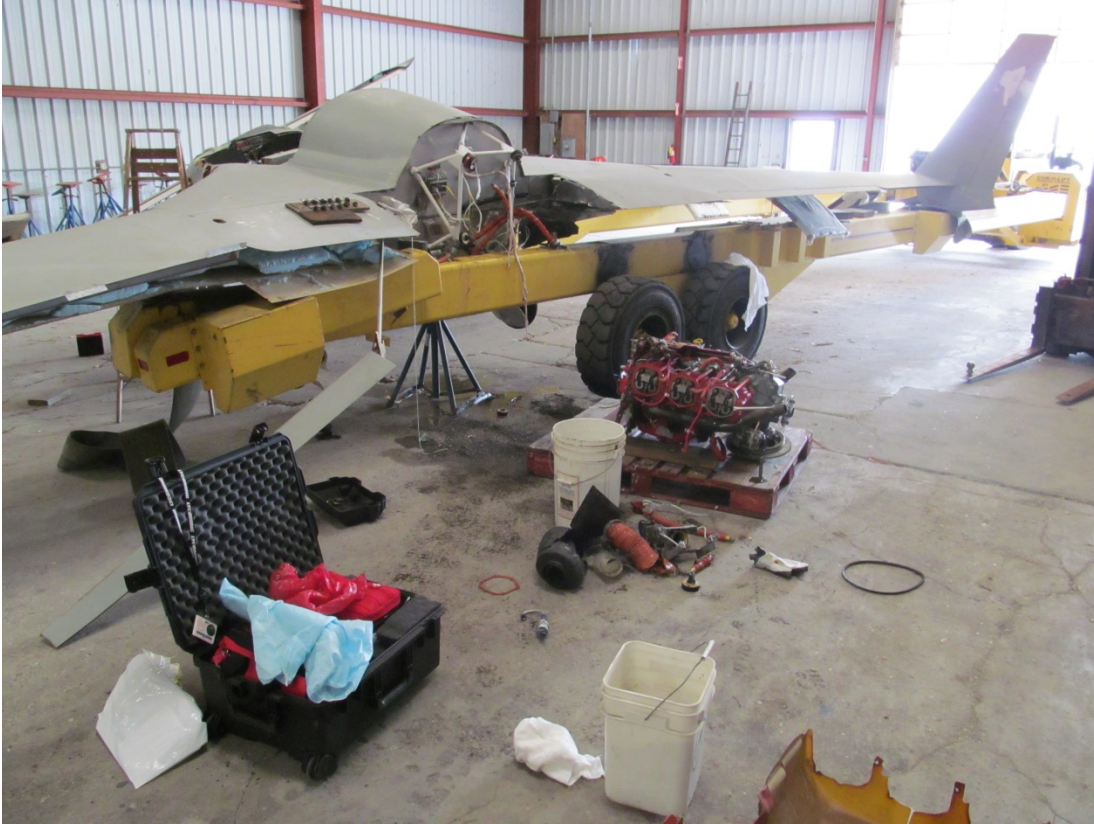
The engine was partially disassembled. The engine was rotated by hand using the propeller. Suction and compression was obtained on all cylinders. Valve train continuity was observed through all cylinder rocker arms. The accessory drive gears were observed rotating. Crankshaft and valve train continuity was verified.

Photo 11: Engine as Left - Following Examination (Courtesy of Lycoming)

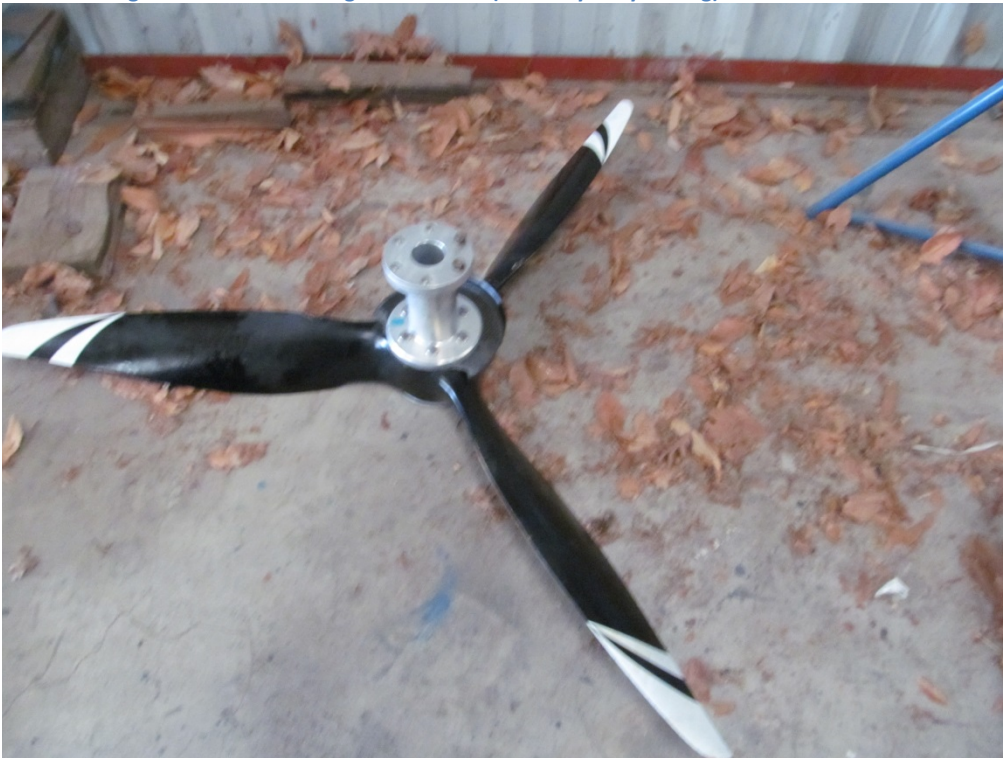
Photo 12: Propeller as Left Following Examination (Courtesy of Lycoming)
