# ATTACHMENT A

## Airplane Differences Report

**Analysis of Over Temperature Switch (OTSW) Contacts  
(Failure Analysis)**

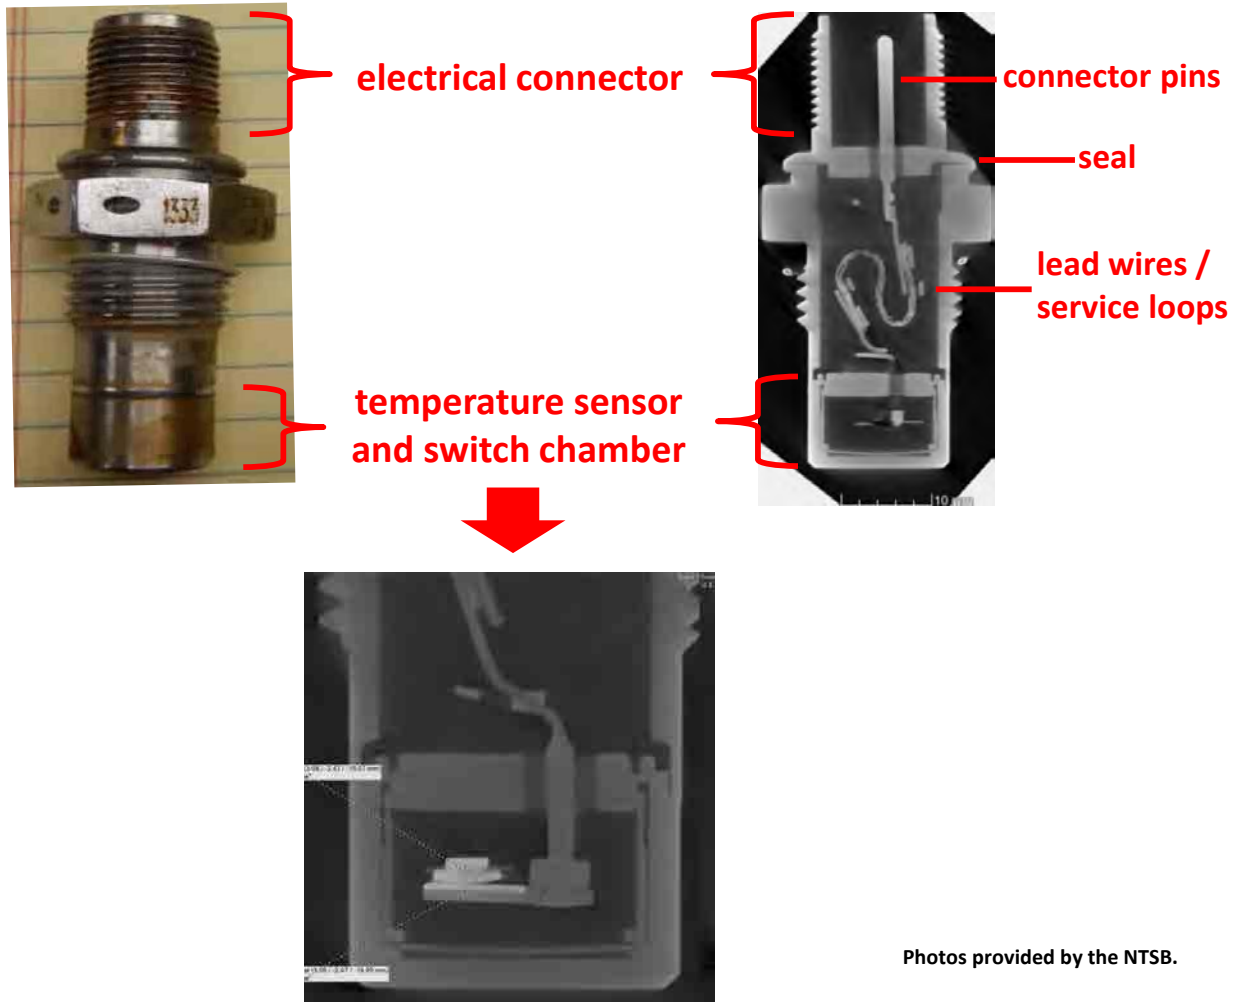
During disassembly of the OTSW from the accident airplane at Honeywell, it was reported the internal chambers were found filled with sea water, and thus the electrical contacts were in direct contact with saltwater for an indeterminate amount of time. Resistance values measured before disassembly should be deemed invalid, as the measurements would have been corrupted by the presence of sea water.

Figure 1. Photo and radiograph of the incident OTSW.

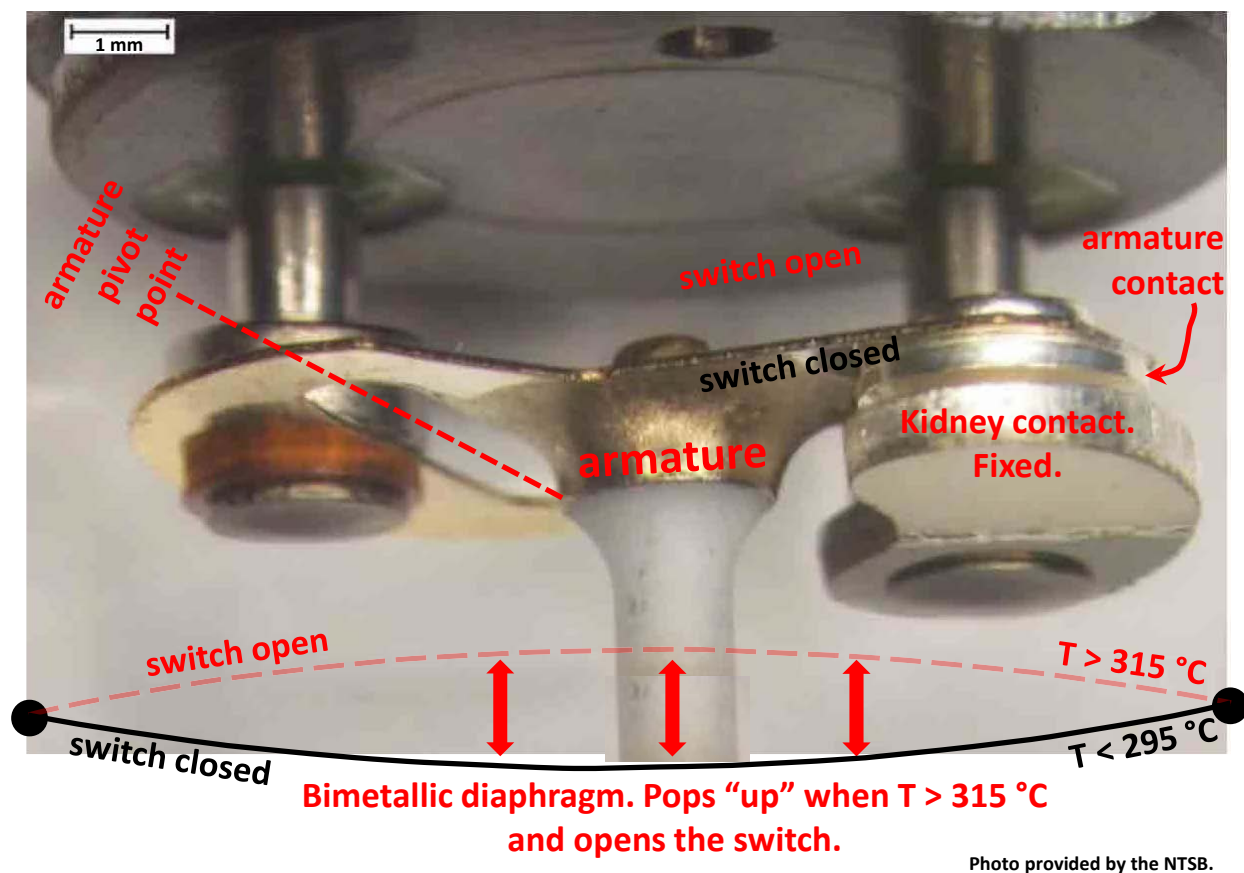
Figure 3. Photo (with annotations) of contacts in an OTSW.

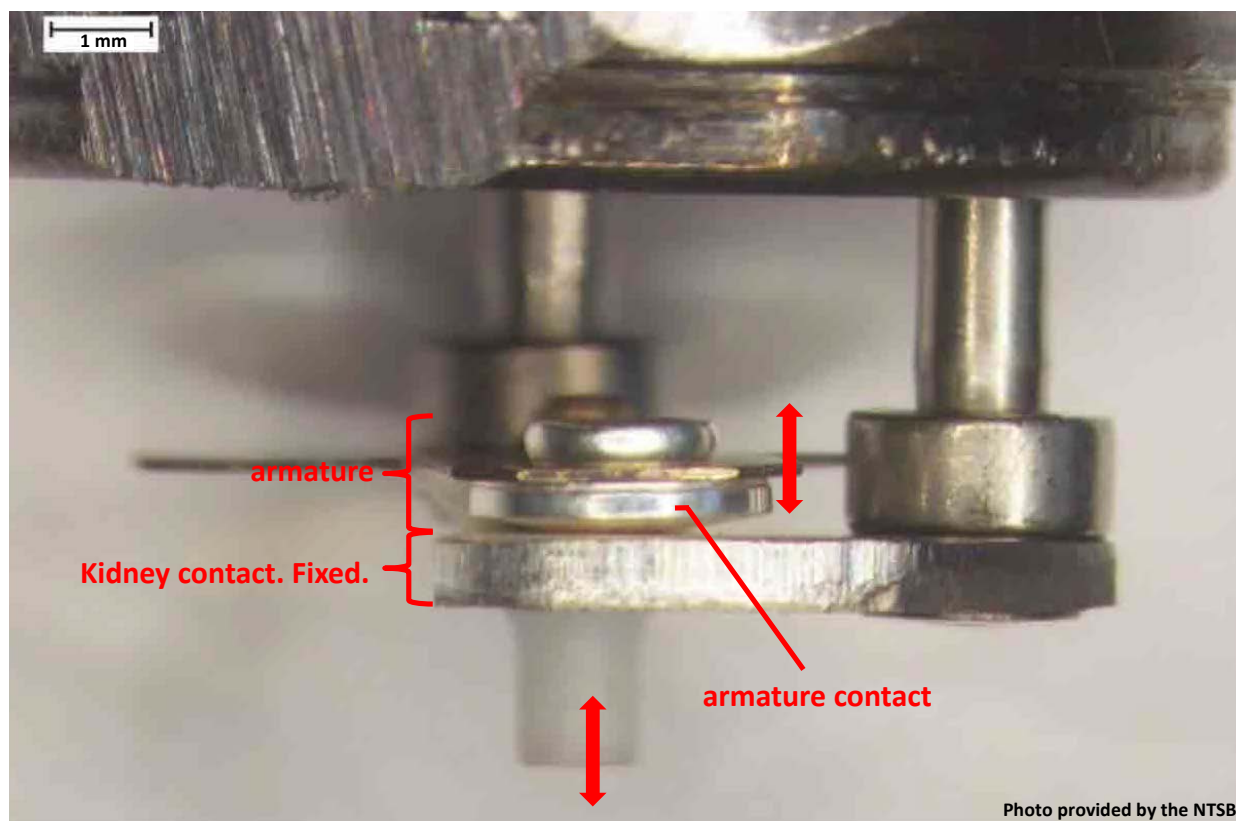
Figure 4. Photo of contacts in an OTSW.

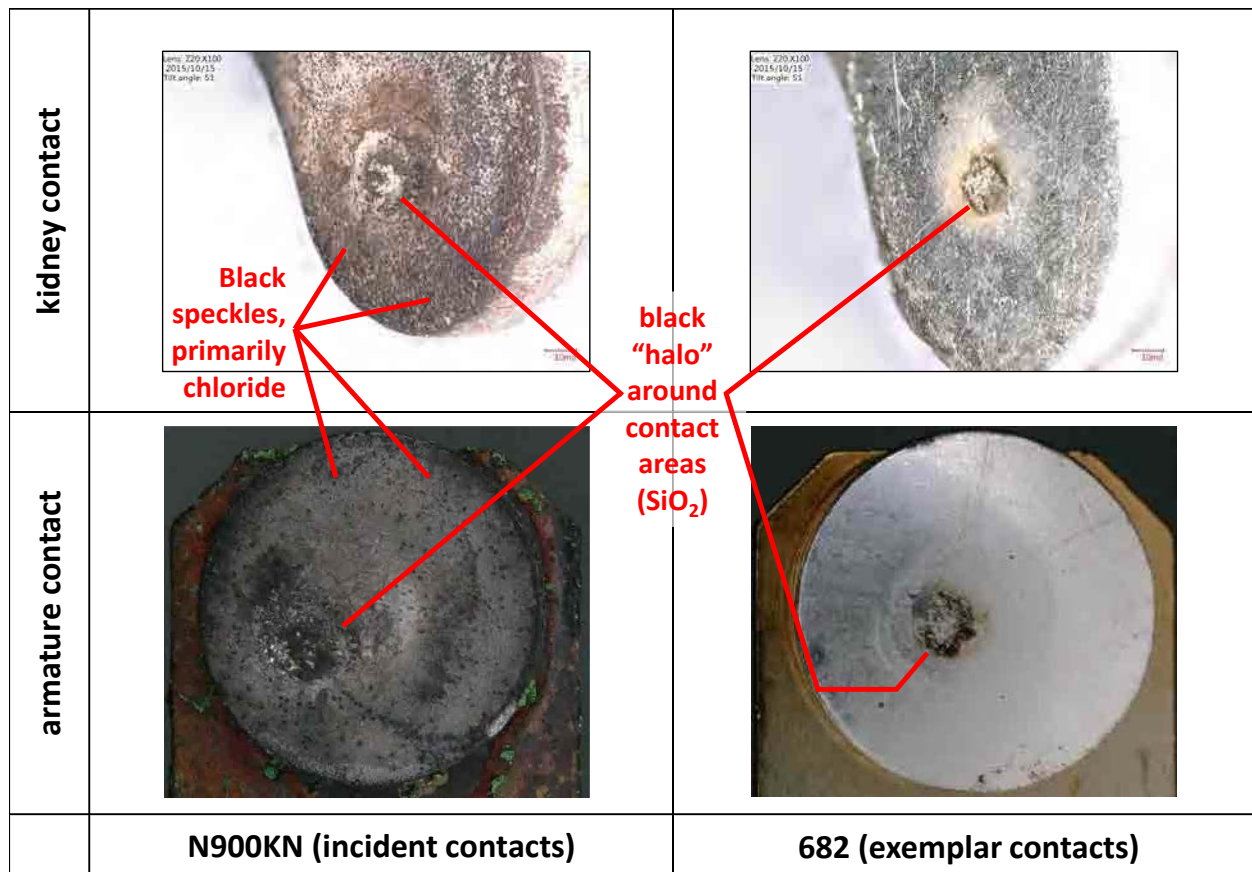
The overall condition of the N900KN (incident) contacts were considered "average." Though the contacts showed evidence of arc erosion, it was not deemed excessive. Material transfer between the two contacts was also not excessive.

Figure 5. Digital microscope images of N900KN and 682 contacts.

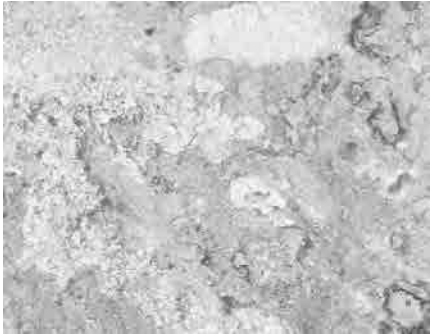
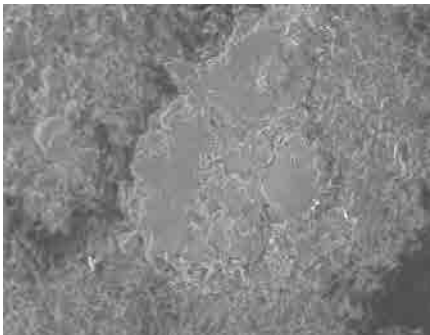
The only significant difference observed between the contacts analyzed by RXSA was the presence of chloride on the N900KN contacts. The chloride presence is believed due to saltwater infiltration inside the incident OTSW while the aircraft was at the bottom of the ocean.

Figure 6. SEM images of N900KN and 682 contacts.

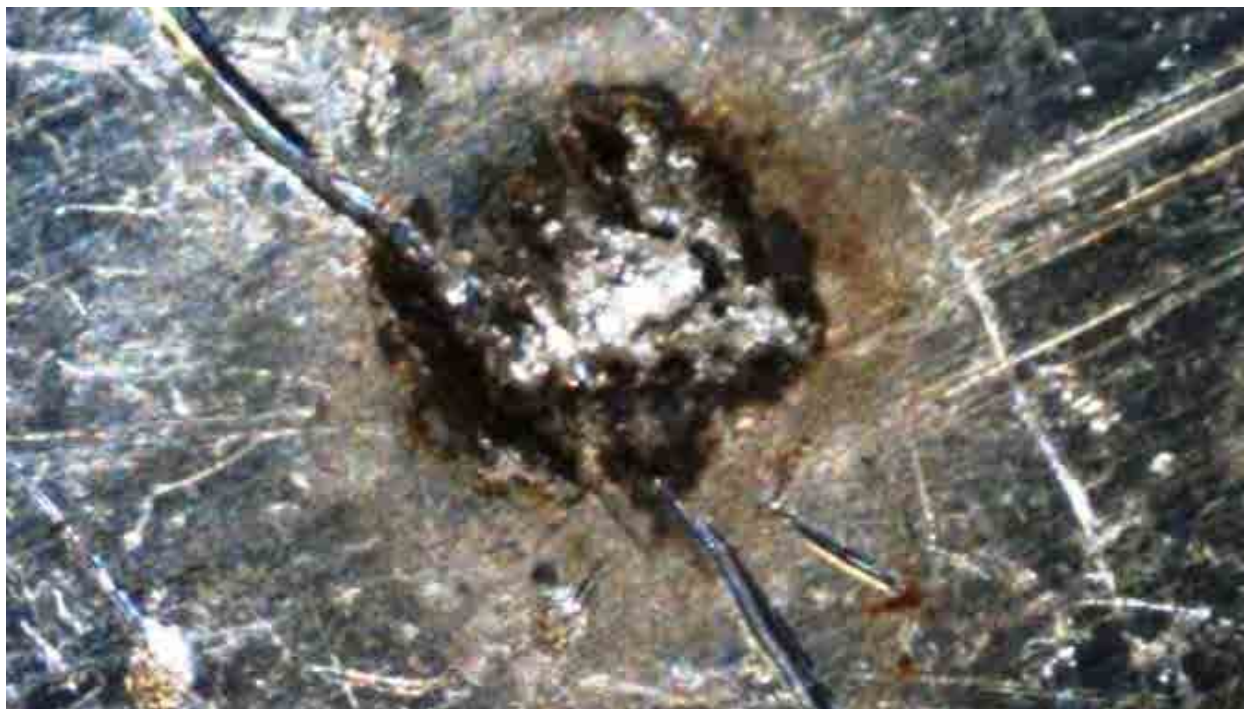
Samples of two silver contacts identified as Armature 682 and Kidney 682 were submitted for examination of a dark “halo” ring around an area in which the two pieces had been in contact. The ring areas on each sample were very similar in appearance. The samples are referenced as Project 2774. Figure A-1 shows an image of the dark ring area as received 682 Kidney sample.

Figure A-1 – Image of Dark Ring Area on 682 Kidney Sample

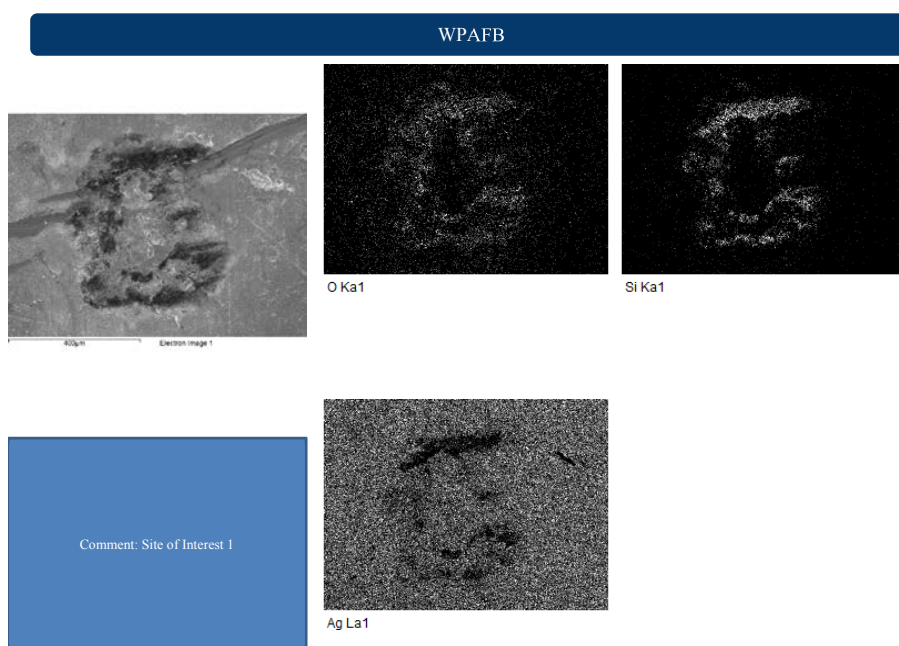
The discolored area of the kidney sample was examined for elemental composition. Figure A-2 shows an overview image and elemental map of the ring area. A higher magnification image of the ring area with the corresponding elemental map is shown in Figure A-3. Both elemental maps show the ring areas to contain silicon and oxygen while areas off of the ring show only the presence of silver.

Figure A-2 – Overview Image and Elemental Map of Examined Area of Dark Ring Area on 682 Kidney Sample

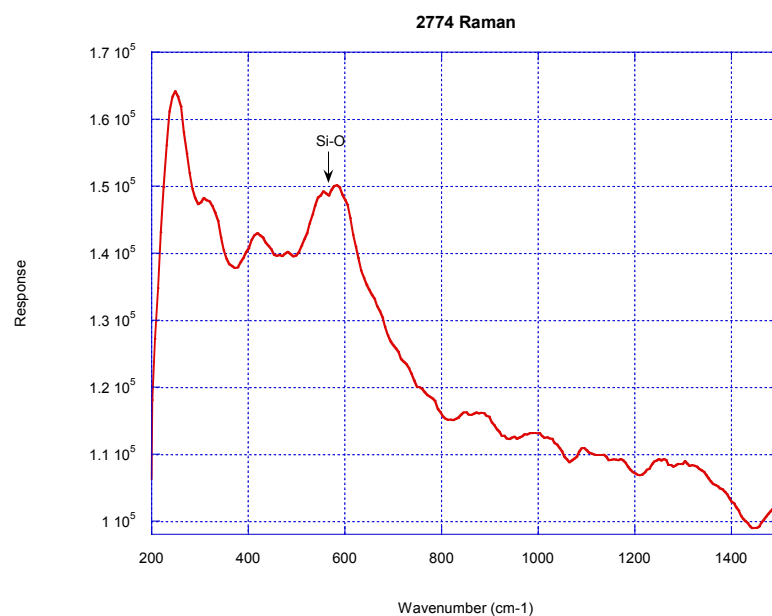
The dark ring residue area was also examined by Raman spectroscopy. The Raman spectrum is shown in Figure A-10. The Raman analysis shows the characteristic peak structure of the Si-O bond at around 580 wavenumbers, which further suggests that the material is a form of silicon dioxide.

Figure A-10 – Raman Spectrum of Sample 2774 Dark Ring Material

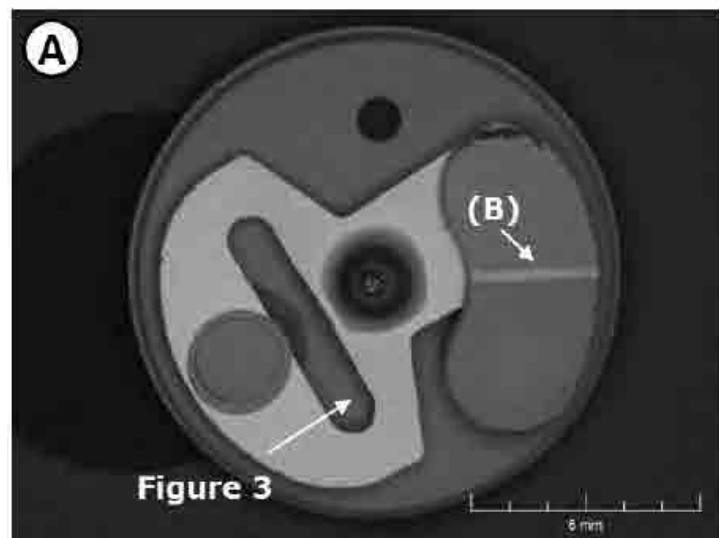
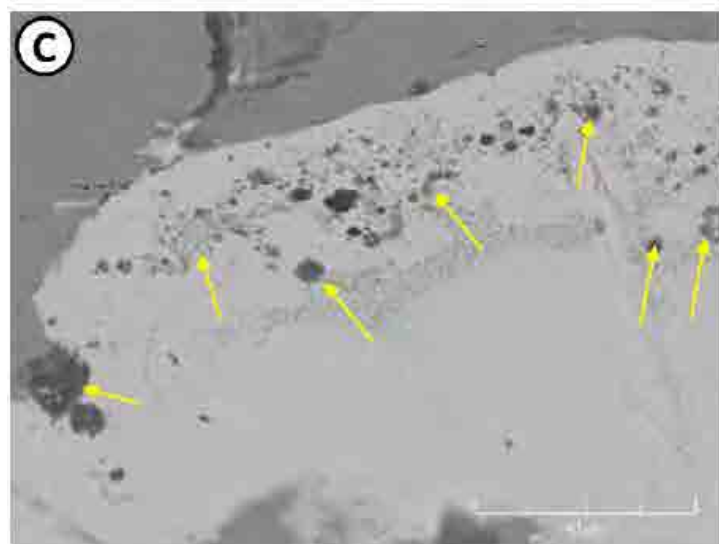
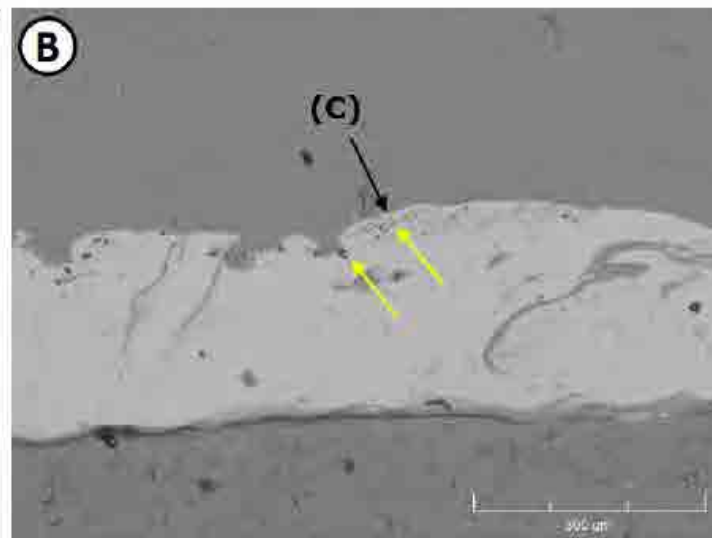
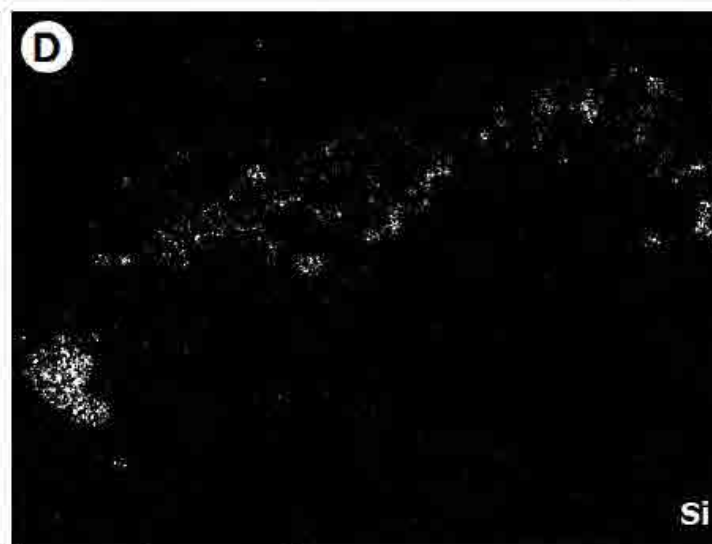
**Figure 2.**

(A-C) Backscattered electron (BSE) SEM images of Header Assembly 1 showing the location where silicon-rich deposits (yellow arrows in (B) and (C)) were detected in the silver plating on the surface of the fixed contact.

(D) Elemental dot map produced for silicon in the area shown in (C). Note that the light (white) areas in (D) indicate the presence of silicon on the surface. A higher magnification image of the area indicated in (A) is shown in Figure 3.

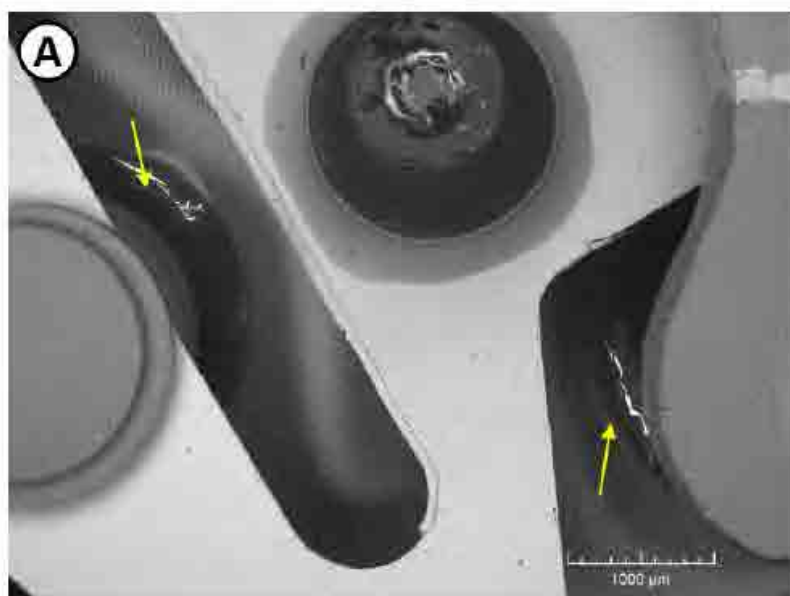
**Figure 3.**

(A) BSE SEM image identifying the silicon-rich glass (yellow arrows) detected between the header assembly and the base of the header posts (reference Figure 2). (B) EDX spectrum generated from analysis of the glass identified in (A).

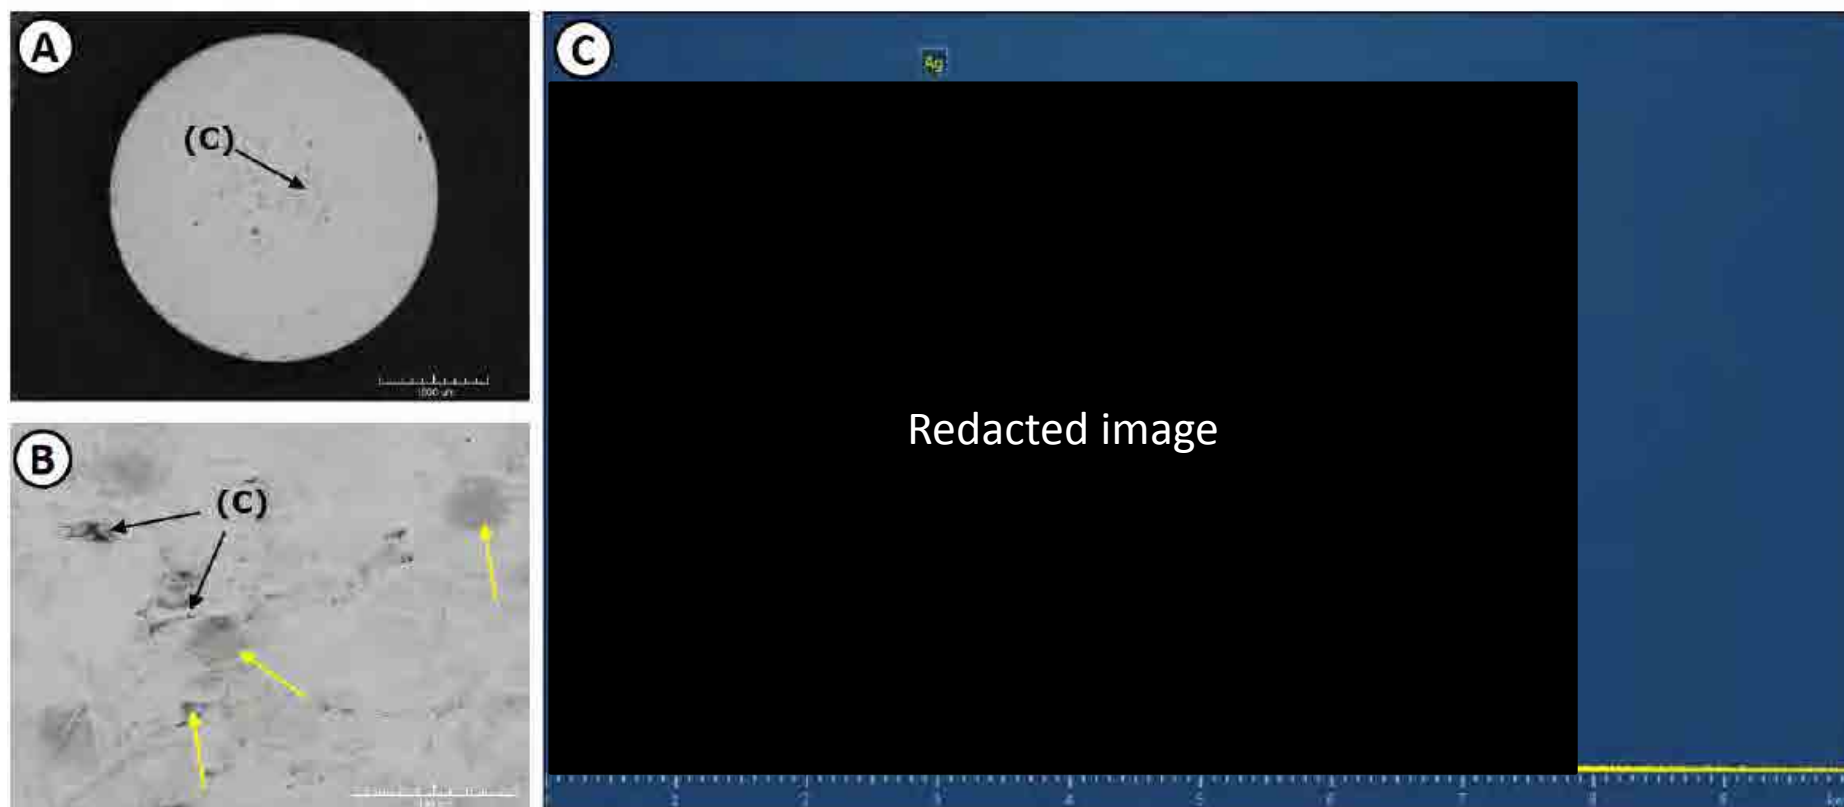
**Figure 5.**

BSE/EDX analysis of the flat side of Contact 1 detected silicon-rich particles embedded in the surface in some locations (Figure 5). The particles were generally confined to damaged areas in the silver plating.

(A-B) BSE SEM images showing the location of some silicon-rich material detected in the surface of Contact 1. The yellow arrows in (B) point to carbon-rich deposits detected on the surface. (C) EDX spectrum generated from analysis of the silicon-rich material indicated in (B).

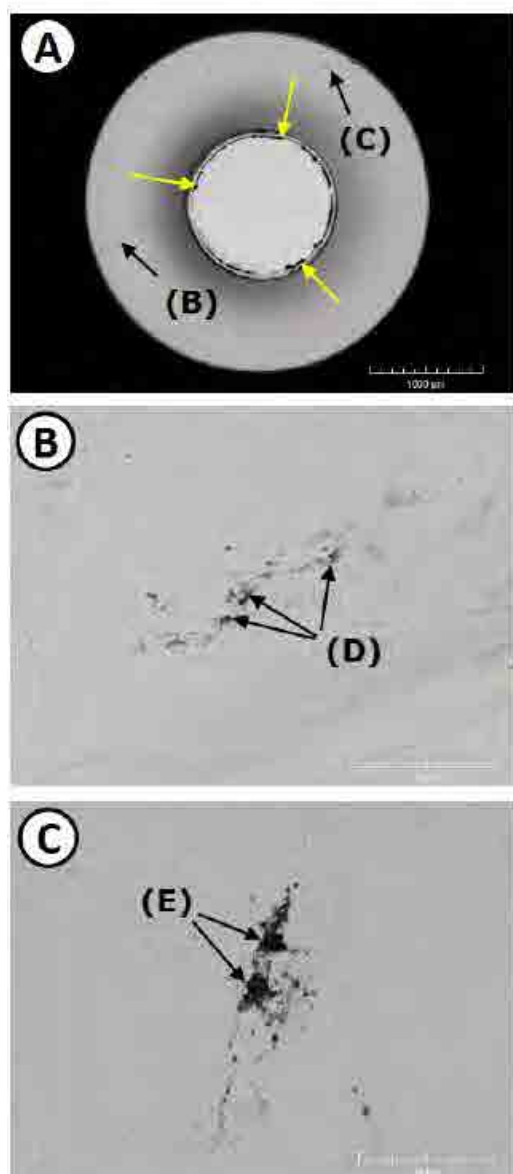
**Figure 6.** (A-C) BSE SEM images showing the location of some silicon, aluminum, and/or magnesium-rich material detected in the surface of Contact 2 (stem side). The yellow arrows in (A) point to carbon-rich deposits detected on the surface. (D-E) EDX spectra generated from analysis of the material indicated in (B) and (C), respectively.

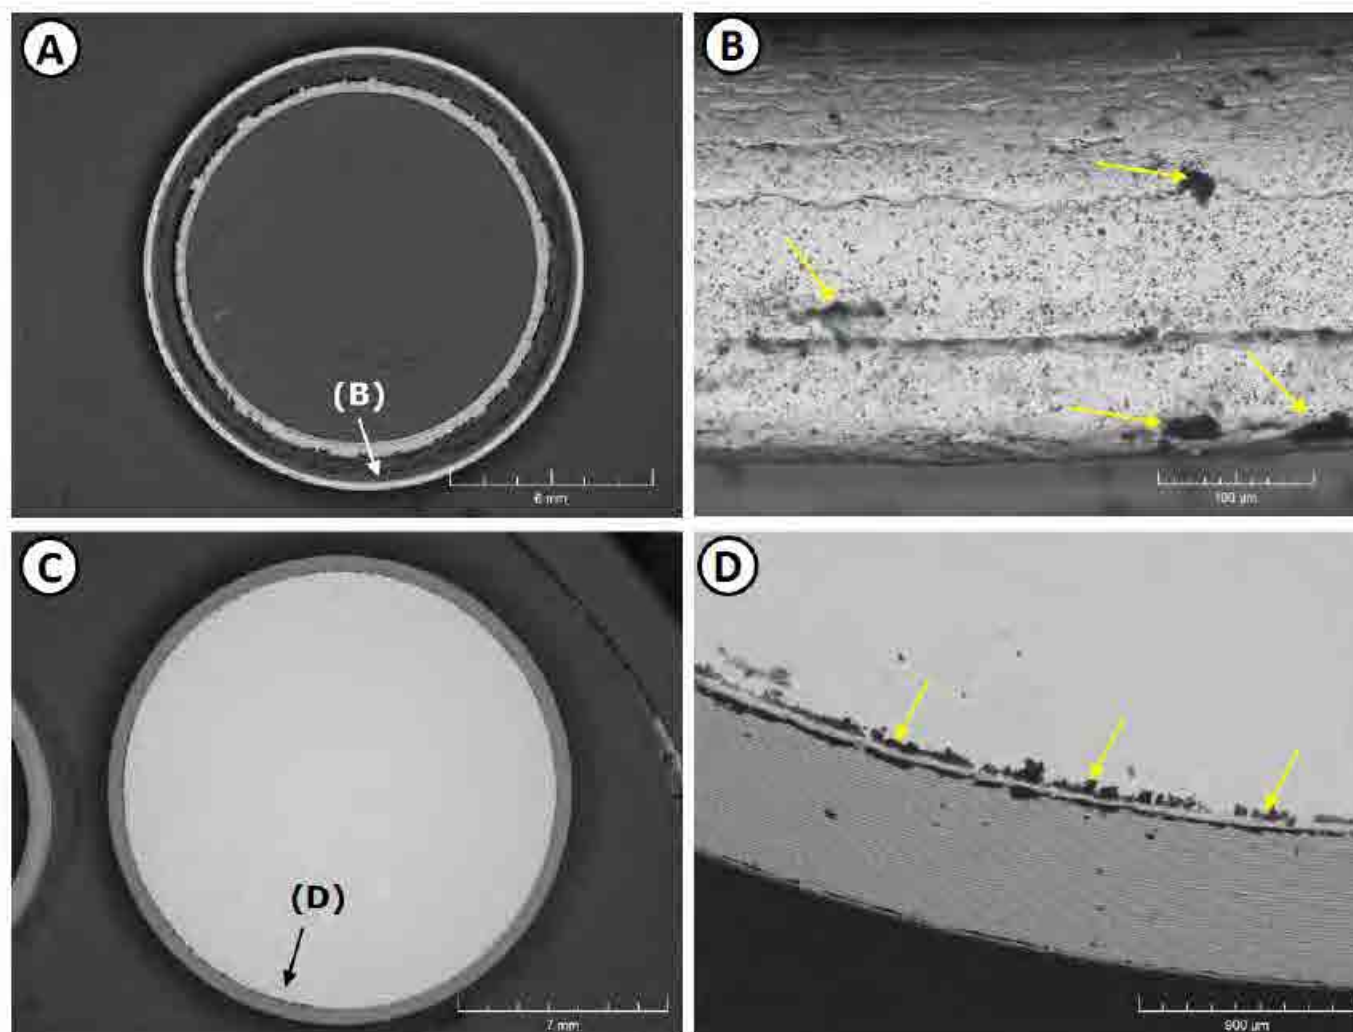
**Figure 7.**

BSE SEM images showing representative areas of (A and B) Spacer 1 and (C and D) Case 1. The yellow arrows in (B) and (D) point to some of the carbon-rich deposits detected on the surfaces of both components. The small, dark embedded particles in the surface of Spacer 1 in (B) were aluminum-rich oxides.
