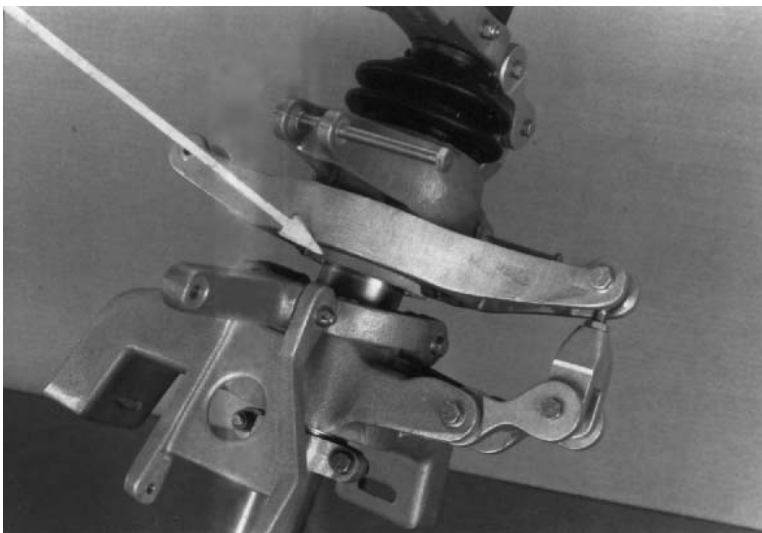
**Photo #16:** Tighten set screws in collar.

If incorrectly adjusted, the slider ball adjustment collar will produce a feedback through the cyclic controls that feels like the cyclic wants to travel in any one direction independent of any input from the pilot. The amount of feedback felt by the pilot indicates how much the collar is incorrectly adjusted. (Feedback usually means the collar is too tight rather than too loose). If feedback through the cyclic continues, you may back off the adjustment collar another 1/4", for a total 3/4" maximum from the starting index mark. If an undesirable condition still exists, contact the factory.

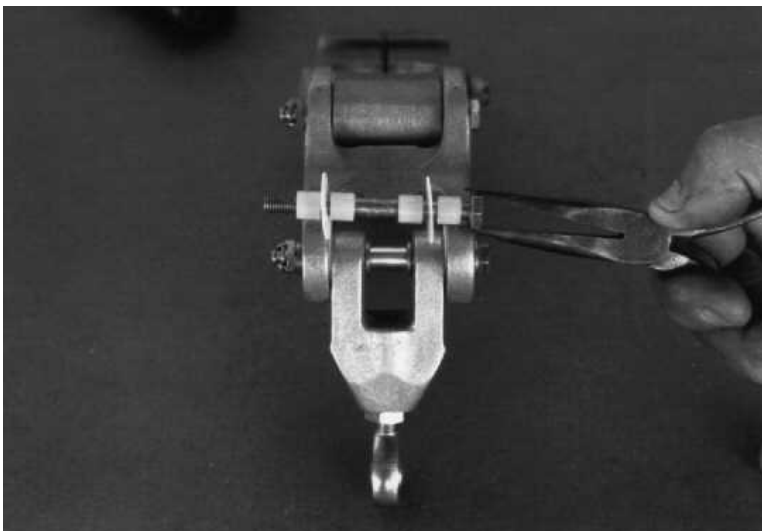
**Photo #17:** Position of bushings.

Photo #17 illustrates the positioning of the nylon bushings in the swash plate assembly. To determine if the castings need new bushings, measure the lateral deflection of the parts. If a total of .125 inch or greater is indicated, the nylon bushings should be replaced. The maximum the castellated nut should be tightened is two flats past finger tight. Further tightening may damage the aluminum castings.
