# National Transportation Safety Board

ERA19FA163

## **WRECKAGE EXAMINATION SUMMARY**

Location: Kent Island, Maryland  
Date: May 4, 2019  
Time: 1210 EDT  
Airplane: Guimbal Cabri G2, N572MD

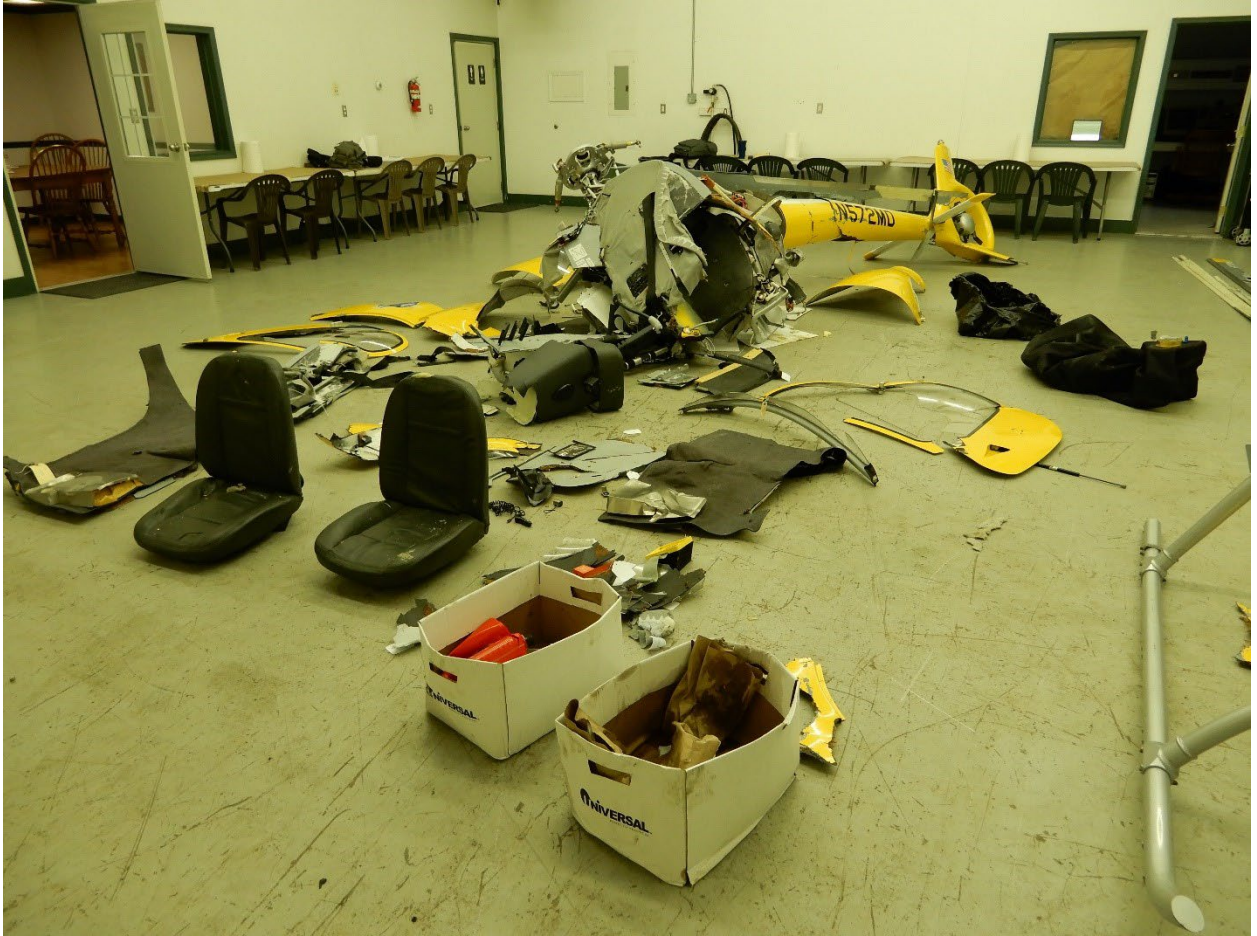
The helicopter impacted the Chesapeake Bay, about 1 mile from the shoreline. It was located in about 62.8 feet of water. All major components of the helicopter were recovered and an oil sheen was noted on the water by first responders.

*Figure 1. View of helicopter after recovery.*

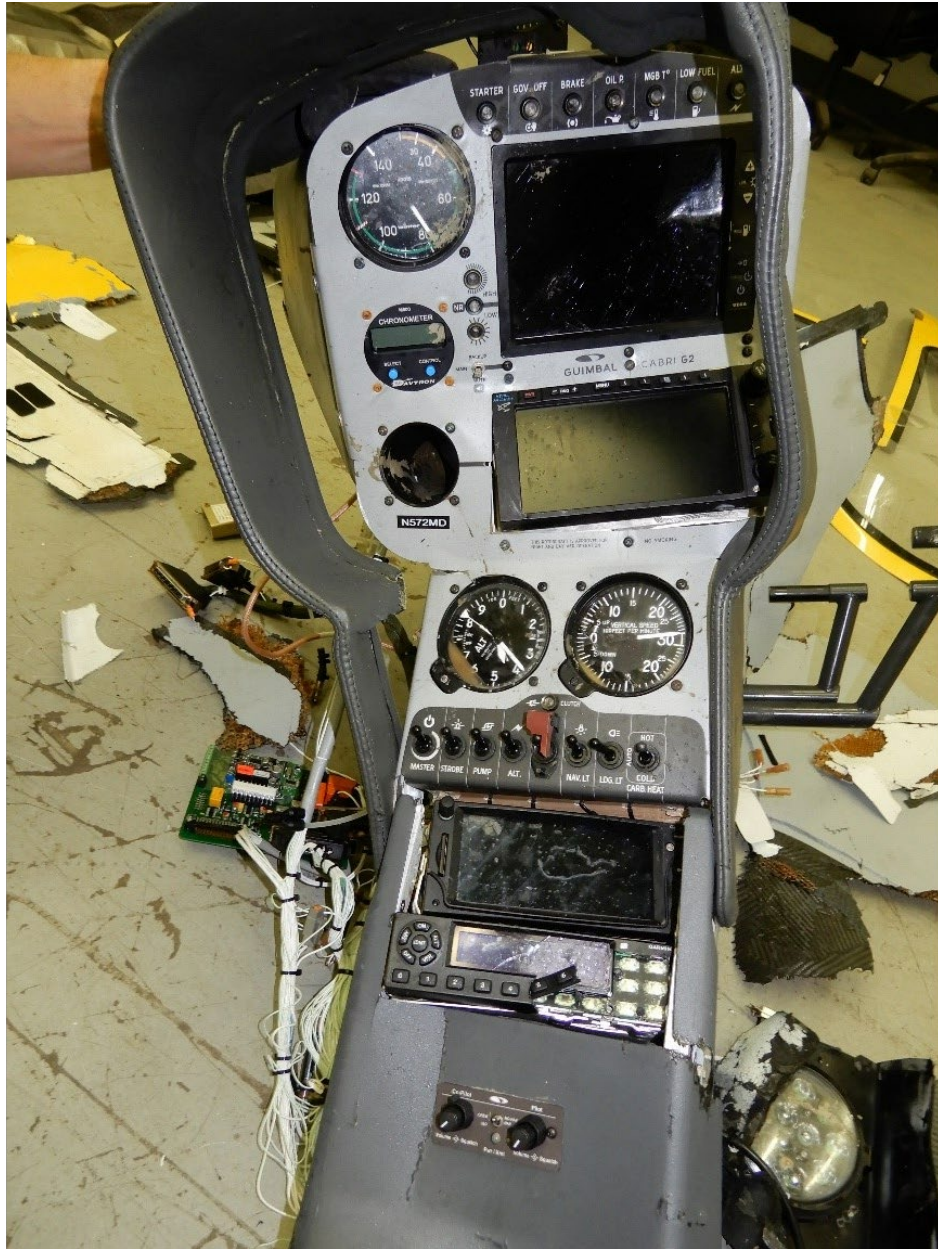
Instrument Panel

Airspeed - about 80 knots

Altimeter - 4,380 ft

Vertical Speed Indicator - Up 3000 ft/min (maxed)

Carb Heat - HOT (normal position is "AUTO")

*Figure 2. View of instrument panel.*

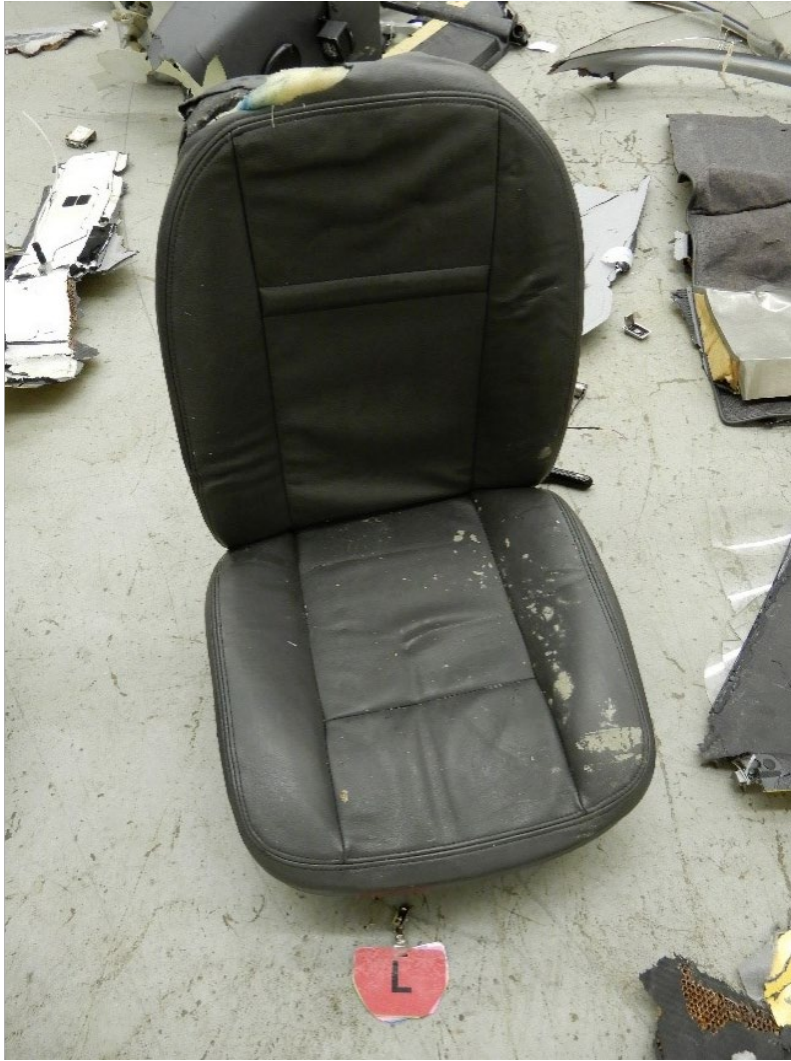
Figure 3. Left Seat

The left seat was impact separated and remained attached to the seatbelt. The seatbelt was unbolted to facilitate recovery. Three of the 4 seat attachment brackets remained connected to the seat. The fourth attachment bracket was separated and not located. All 3 of the 4 brackets connected to the seat were splayed out. The seat back was impact separated but remained attached to the lower section of the seat by fabric. The strut remained attached to the seat but the was impact separated from the aft wall of the cabin. The left seatbelt remained attached to the aft wall of the cabin. The top attach point remained in place. The inertial reel operated when the belt was pulled by hand. The belt buckle operated when moved by hand. The left seat left side energy attenuation rail was impact separated and not located. The left seat right side rail remained attached to the aft cabin wall. The bottom section of the rail was impact separated from the top section and located in the water. Impact damage was noted to the left seat right side rail.

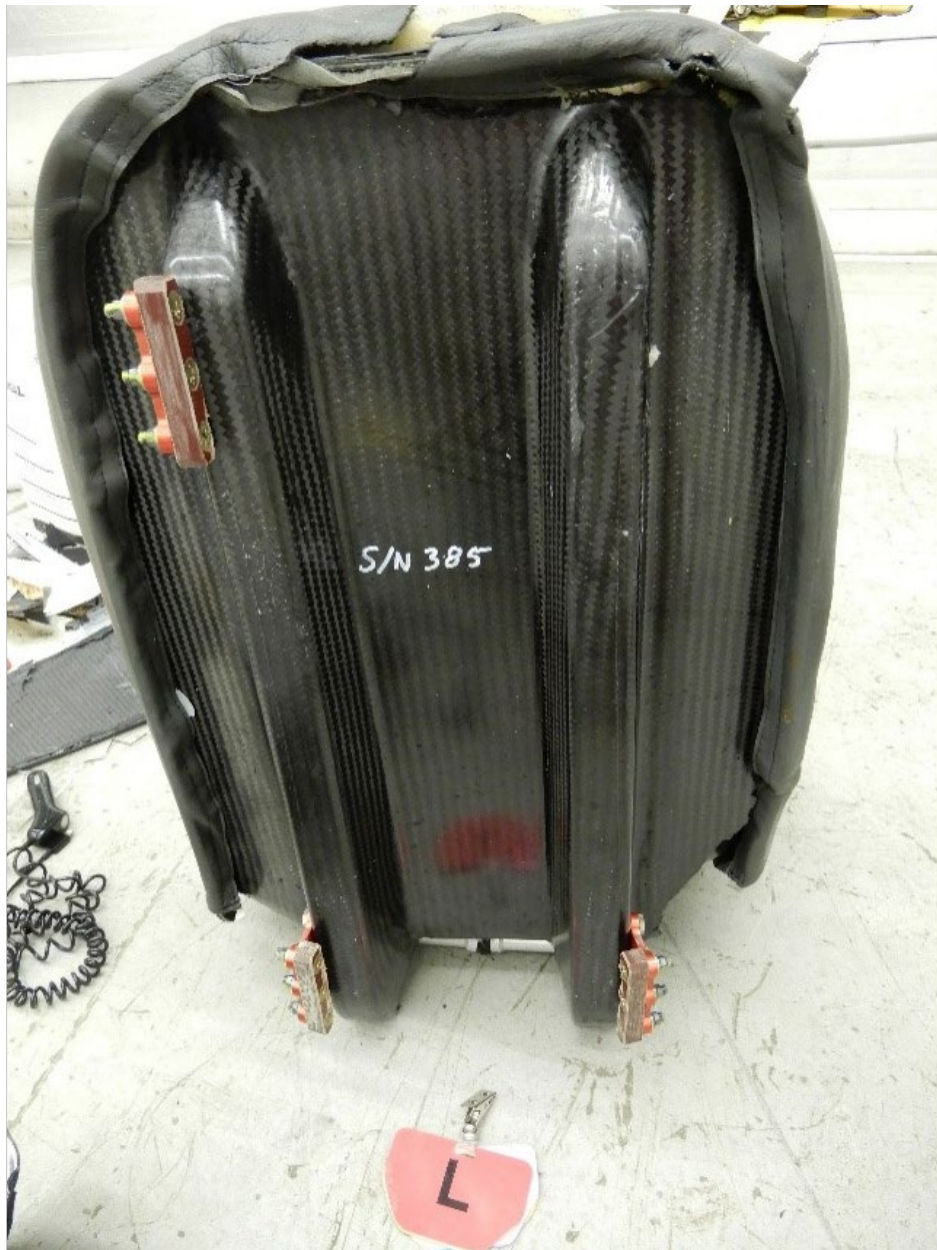
Figure 4. Aft view of left seat.

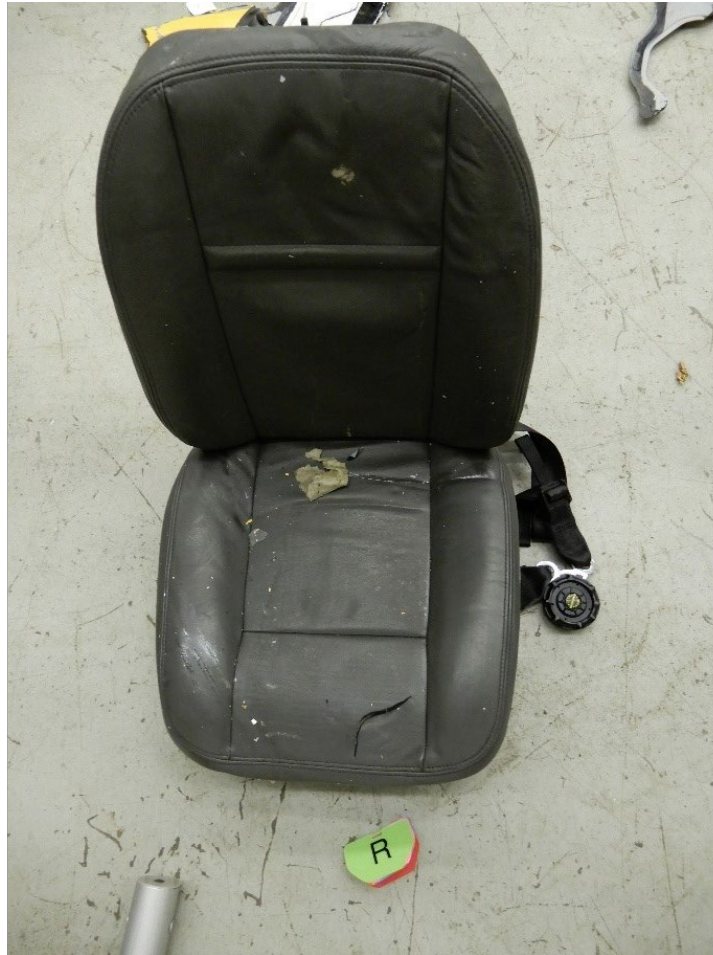
Figure 5. Right seat.

The right seat was impact separated, but remained attached to the fuselage by the seatbelt. The seatbelt was unbolted to facilitate recovery. One side of the seatbelt remained attached to the seat. All 4 of the seat brackets remained attached to the back of the seat. The top two and bottom right side were splayed out. The seat back was partially separated from the seat pan where the strut attached to the seat. The seat strut was also impact separated, but the cylinder remained attached to the seat. The section of the seat belt that remained attached from the seat the buckle was cut

by first responders. The top right side shoulder harness was cut. The harness was partially extended from the inertial wheel. The inertial reel operated when tested by pulling on the harness. The right energy absorption rail was bent at the top and bottom of the rail. A portion of the seat strut remained attached to the fuselage. Web stretch was noted on the top right side of the shoulder harness. The top tether point was impact separated and not located. The belt buckle operated when moved by hand.

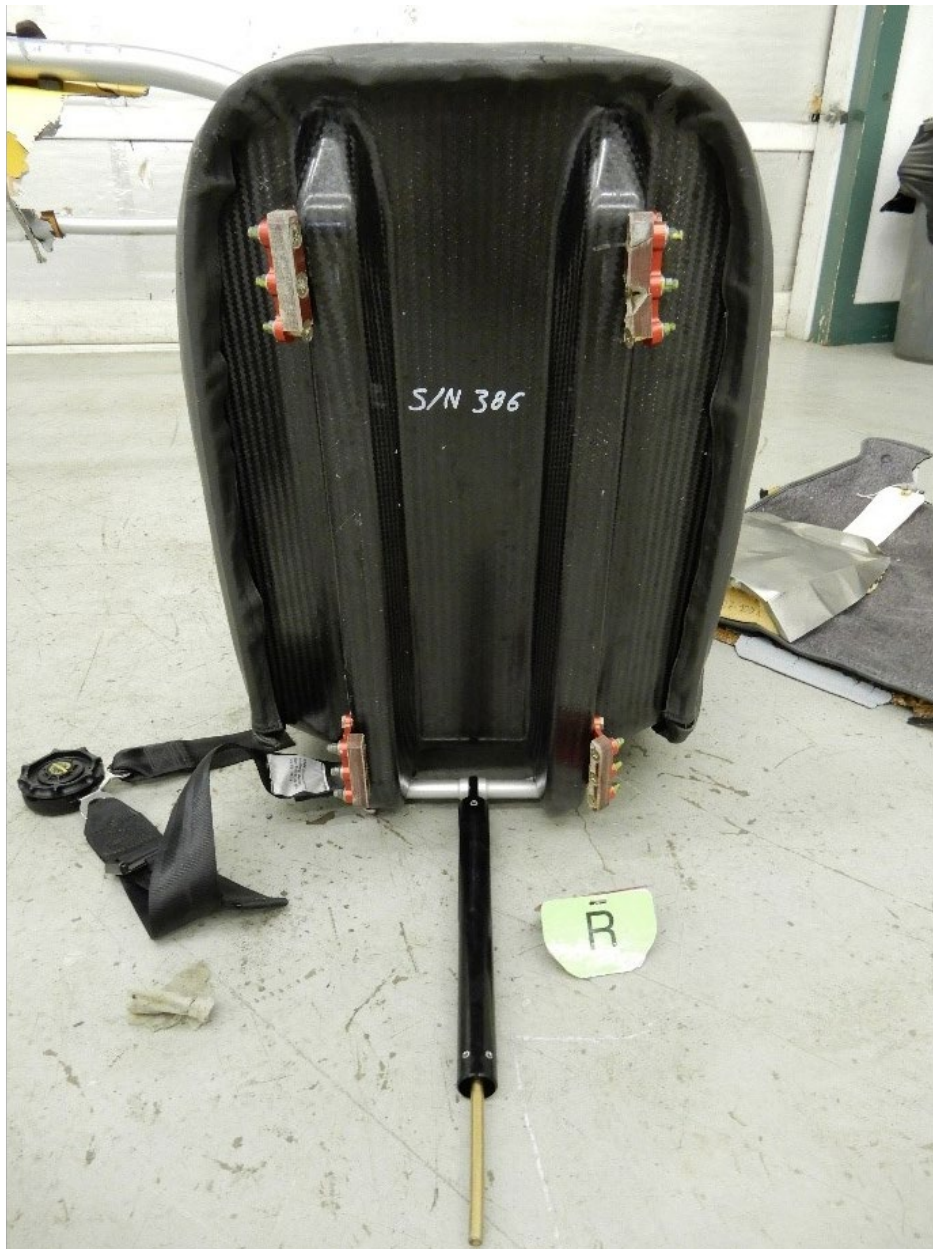
Figure 6. Aft view of right seat.

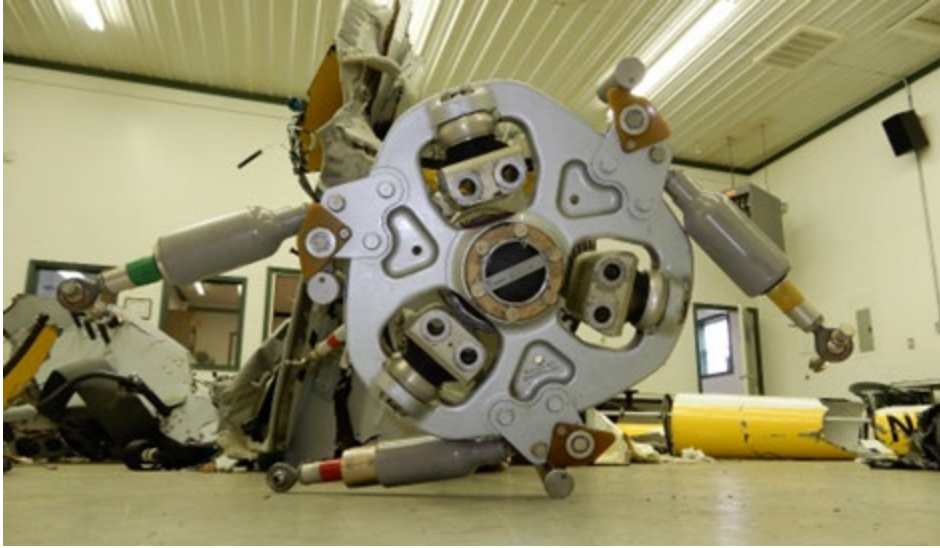
The rotor head was turned by hand and the transmission fly wheel rotated. When the rotor head was rotated in reverse, the flywheel did not move, which confirmed the operation of the sprag clutch. The main transmission chip detector was removed and ferrous material was noted.

*Figure 7. View of rotor head.*

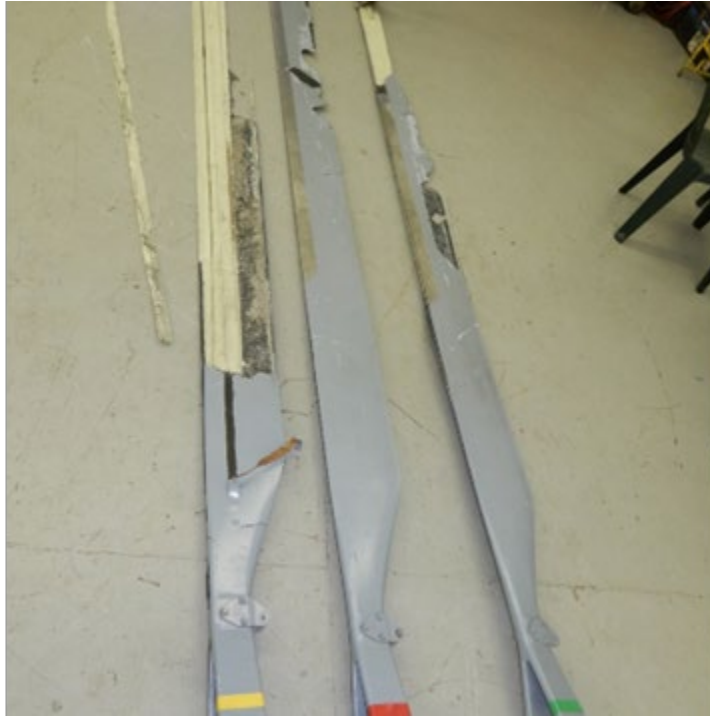
All main rotor blades remained attached to the rotor head but were removed to facilitate recovery. The yellow rotor blade exhibited impact damage and was fragmented. The lead/lag damper was not extended.

The green rotor blade was impact damaged and the outboard portion of the blade was partially separated. The lead/lag damper was extended about 0.5 cm.

The red rotor blade was impact damaged and sections of the trailing edge were splayed open. The red lead/lag damper was extended about 4 cm.

*Figure 8. View of main rotor blades.*

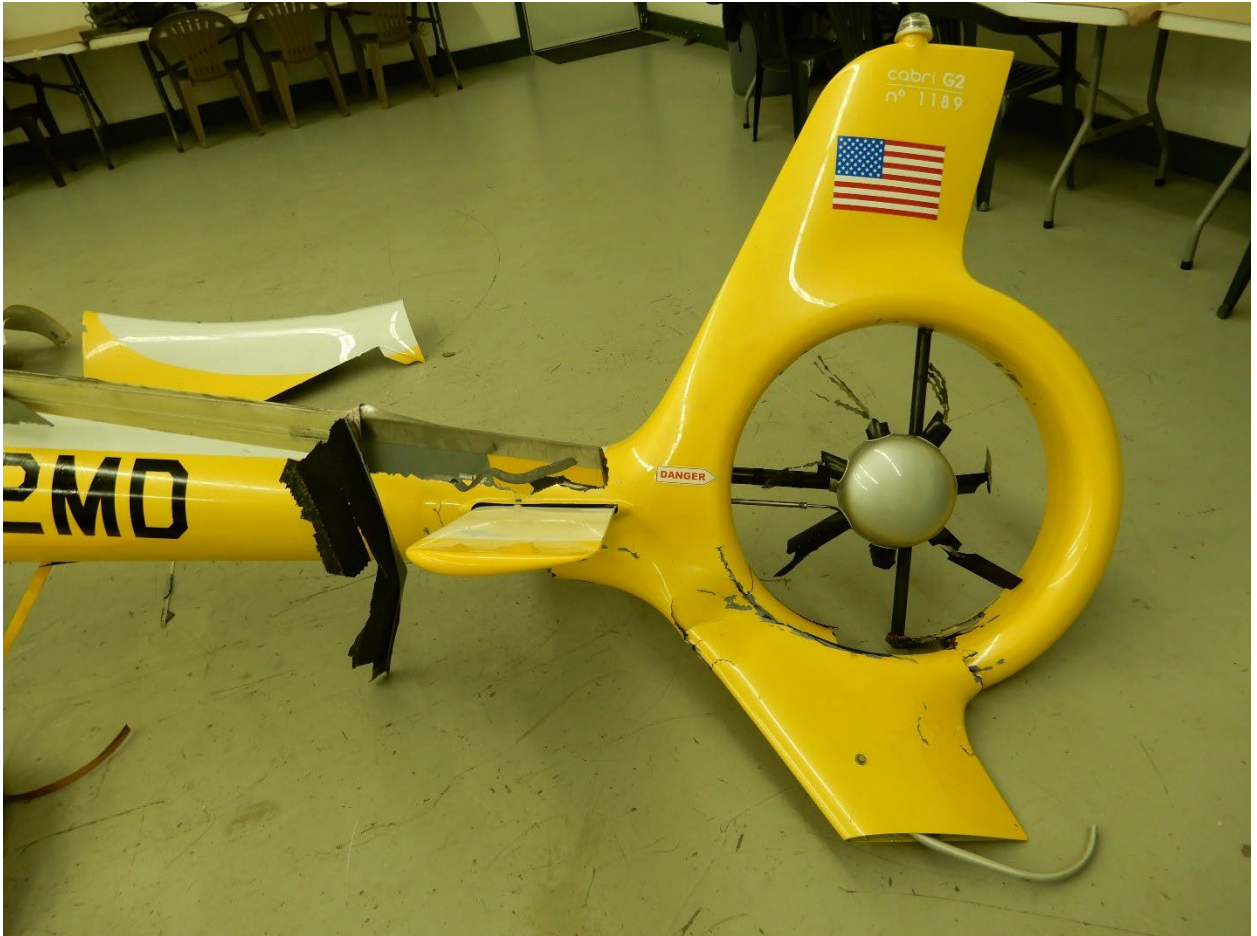
Figure 9. Fenestron

The fenestron remained attached to the tailboom. Chordwise scratching was noted on the fenestron housing. All fenestron vanes were bent the opposite direction of travel. Furthermore, the tail rotor rotated freely when the tail rotor drive shaft was rotated by hand. Several of the fenestron blade shrouds were stripped and the metal interior remained attached to the tail rotor. The tail rotor drive shaft was bent and was separated from the transmission. Continuity was confirmed from the anti-torque pedals to tail rotor. The tail rotor pitch change links remained attached to the assembly. The chip detector was examined from the tail rotor gear box and was free of debris.

The horizontal stabilizers remained attached to the tail boom. The leading edge of the right horizontal stabilizer was impact damaged.

The top section of the vertical fin on the fenestron was undamaged and remained attached to the tailboom. The lower section of the vertical fin was partially impact separated.

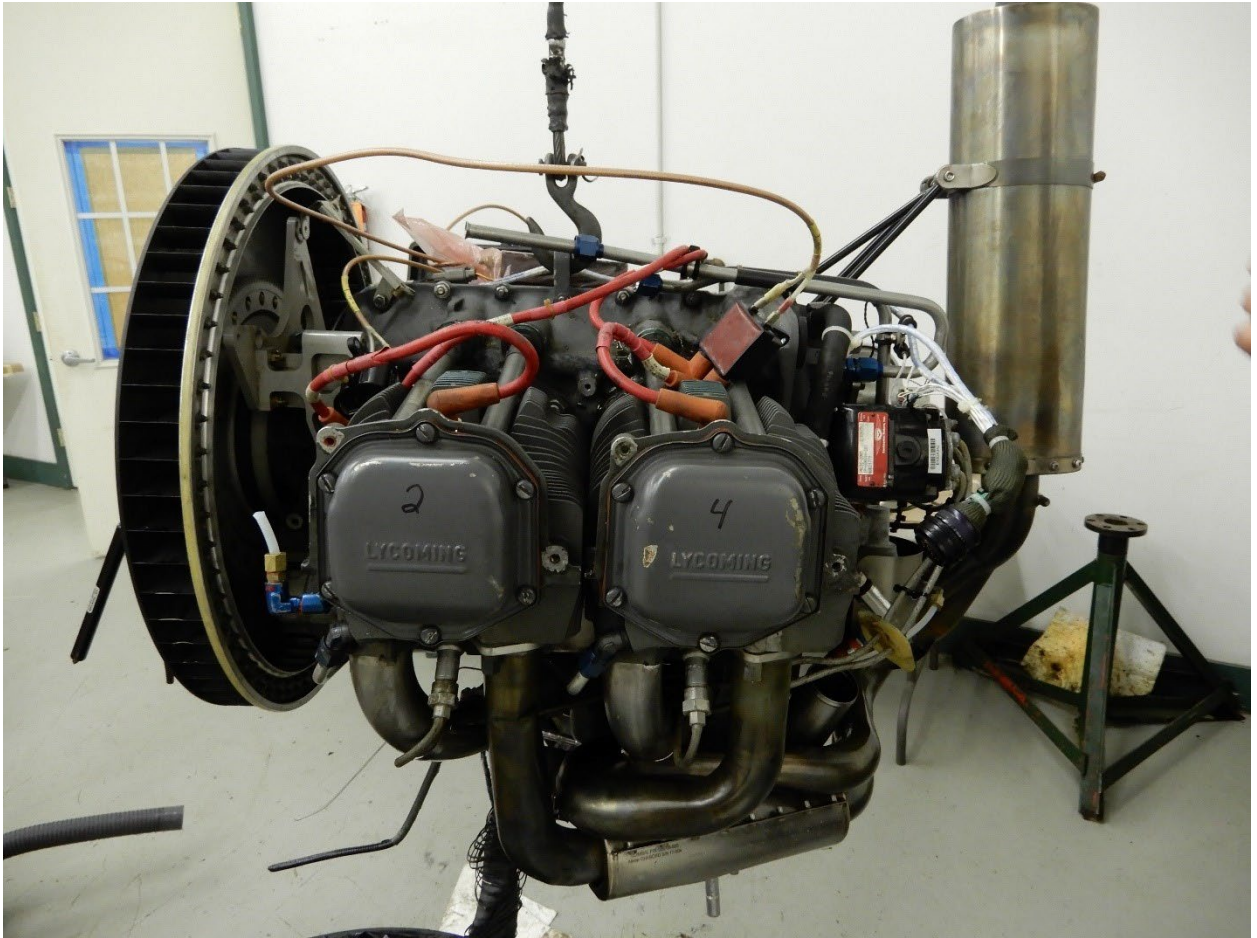
*Figure 10. View of engine.*

Multiple gallons of water were drained from the engine. Crankshaft continuity was confirmed by rotating the scroll assembly by hand. The scroll assembly exhibited impact damage about 1/3 around the circumference. Thumb compression and suction was noted on the Nos. 2, 3, and 4 cylinders. There was no damaged noted to the engine crankcase or the oil sump.

The No. 1 cylinder was removed and examined. Water was placed in the cylinder to determine where the air was leaking out and water drained a majority through the exhaust and a minor amount through the intake valve seats. The No. 1 piston rings were not aligned.

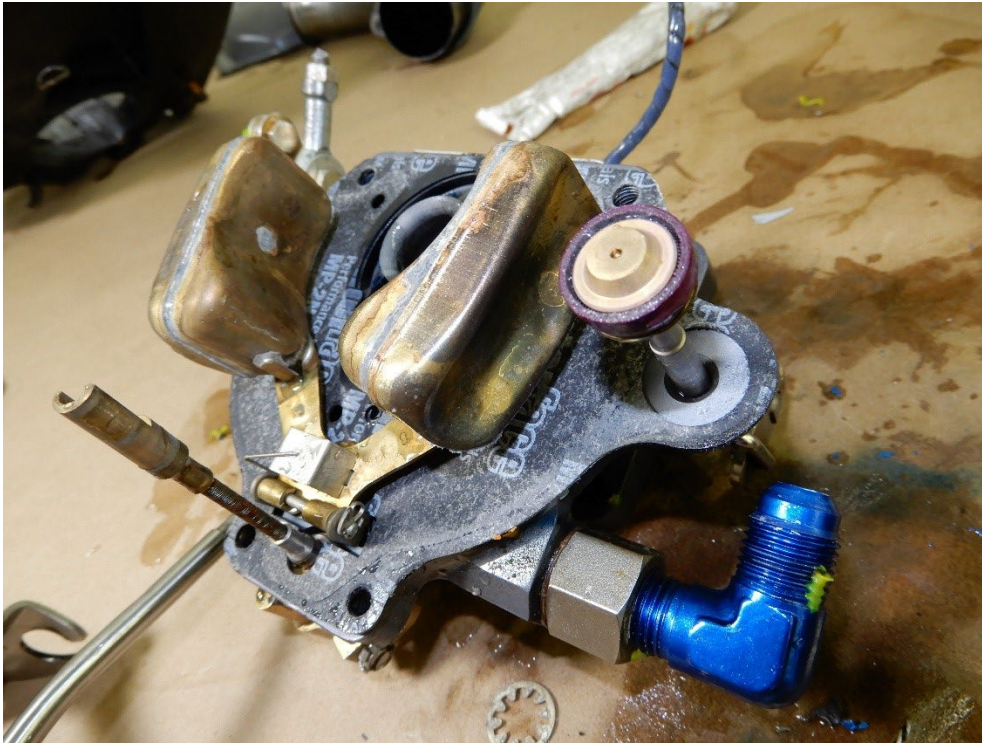
The carburetor was removed from the engine. Fuel was noted in the bowl and had the presence of water. The floats exhibited hydraulic deformation. The accelerator pump operated when the throttle arm was moved by hand. The carburetor fuel inlet screen was removed and no debris was noted. The carburetor gasket was removed and no tears were noted. There was fuel staining noted on the throttle body arm and side of the carburetor in the vicinity of the throttle body arm.

The carburetor heat door was located in the closed position. The assembly was impact damaged and pushed up onto the carburetor. The automatic carburetor door was tested using a 12V battery. When the wires were connected to the battery, the door operated and moved to an open position. The wires were then moved to the opposite poles of the battery and the carburetor door moved to the closed position.

*Figure 11. View of disassembled carburetor.*

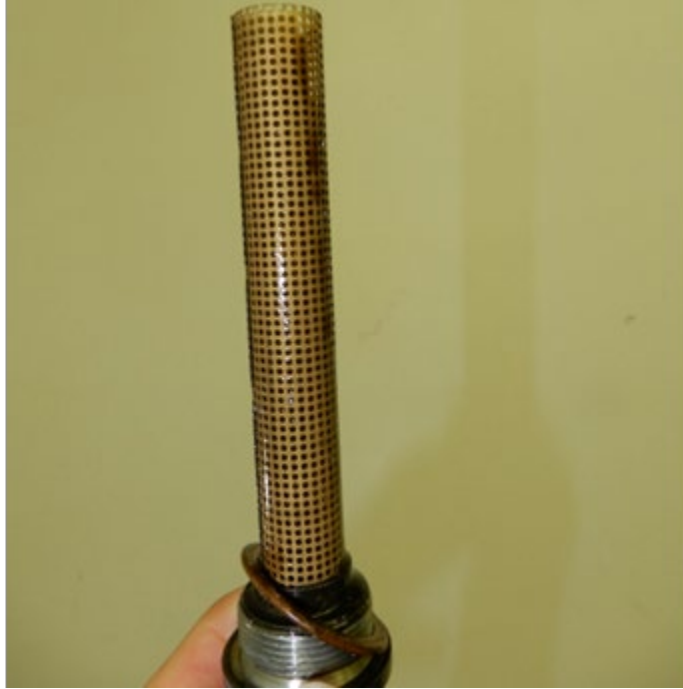
The oil suction screen was removed and no debris was noted.

Figure 12. View of oil suction screen.

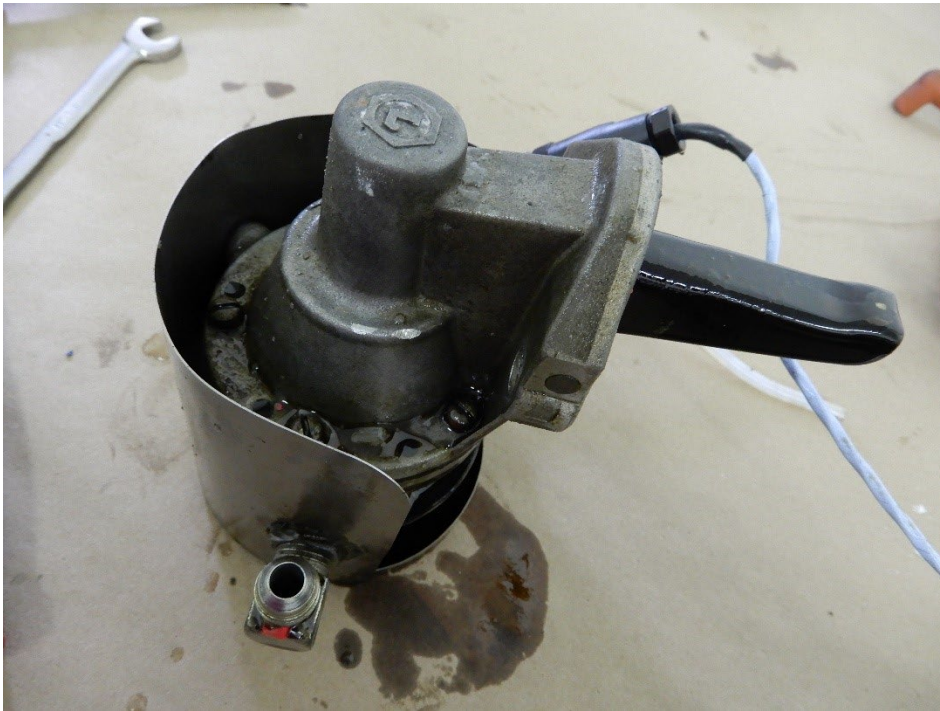
The engine driven fuel pump was removed from the engine and it operated when moved by hand.

Figure 13. View of mechanical fuel pump.

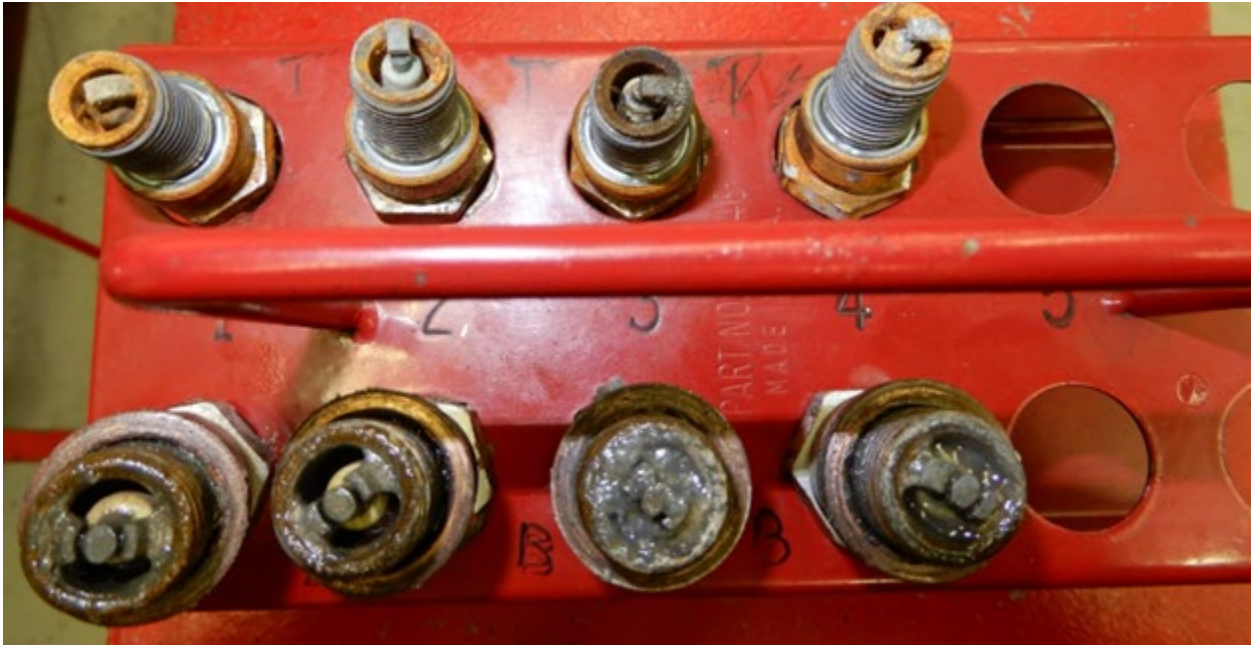
The spark plugs were removed. The top spark plugs were automotive conversions. The bottom spark plugs were aviation spark plugs. All top spark plugs were corroded. The bottom spark plugs were wet, exhibited normal wear, and were light grey in color. The Nos. 3 and 4 spark plugs exhibited wet lead deposits.

*Figure 14. View of spark plugs.*

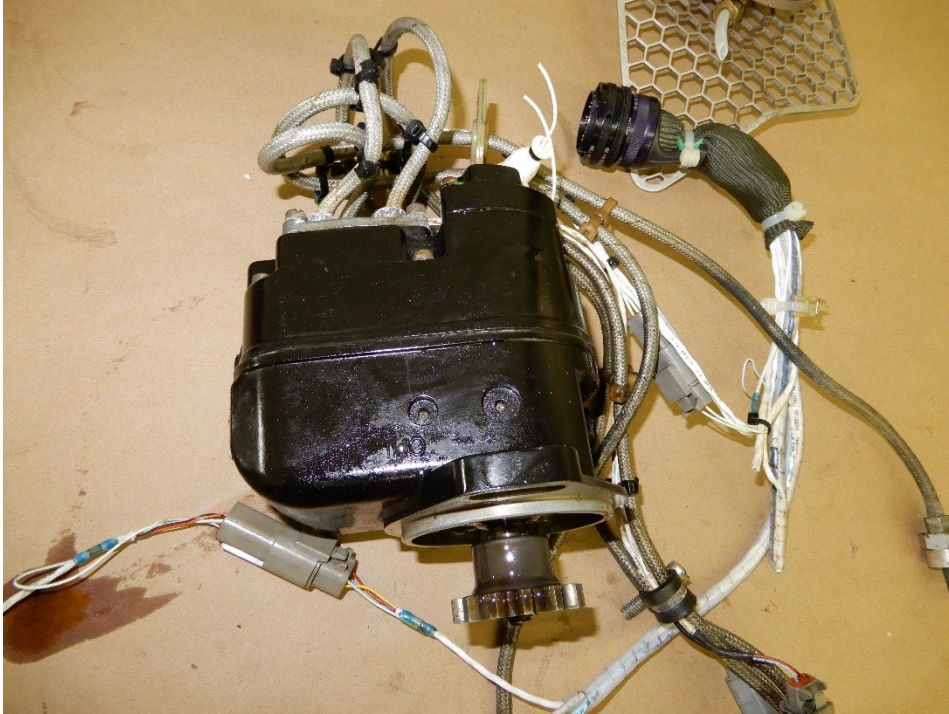
The conventional magneto was removed from the engine and produced spark on all towers.

Figure 15. View of magneto.

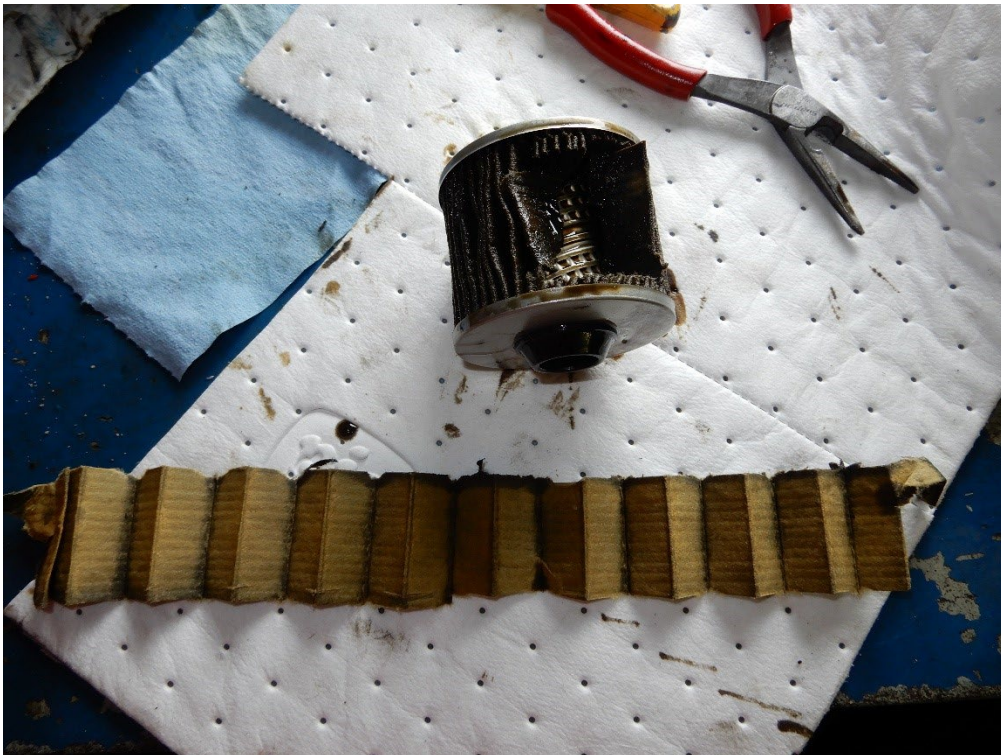
The oil filter was removed and disassembled. No debris was noted in the filter.

Figure 16. View of disassembled oil filter.

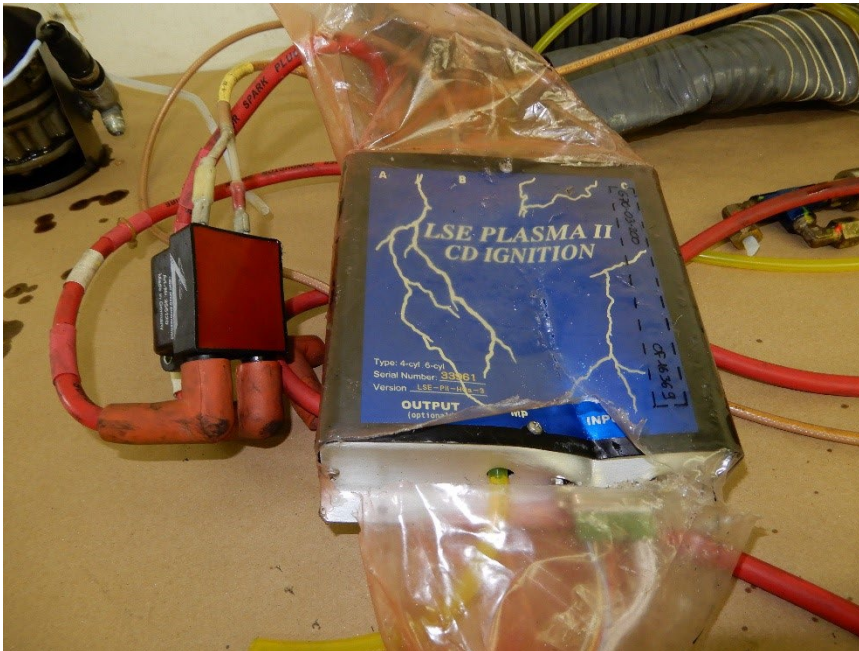
The electronic magneto was recovered and impact damaged was noted to the case. Furthermore, a note on the case of the electronic magneto stated that it was only to be used on experimental type aircraft certificated by the FAA.

Figure 17. View of electronic magneto.
