# NATIONAL TRANSPORTATION SAFETY BOARD

Office of Research and Engineering  
Materials Laboratory Division  
Washington, D.C. 20594

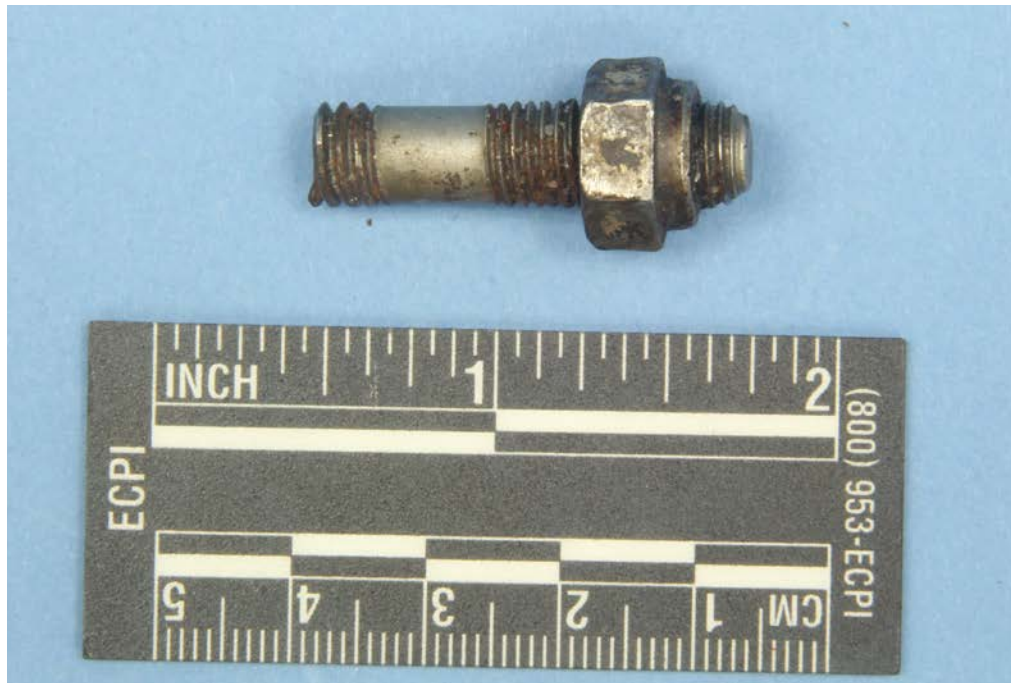
Figure 1: Portion of rocker arm stud as received.

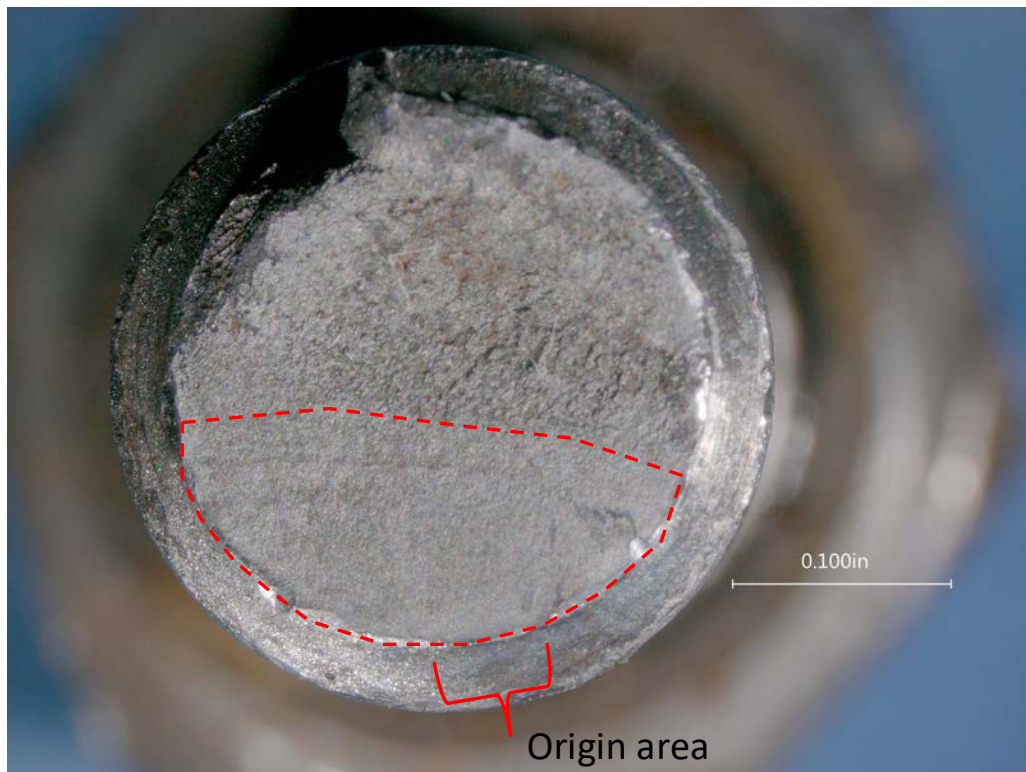
Figure 2: fracture surface with characteristics of a fatigue fracture.
