#### Checking and securing the L'Hotellier quick-close connections of the control circuit

#### Inspection program for extending service life

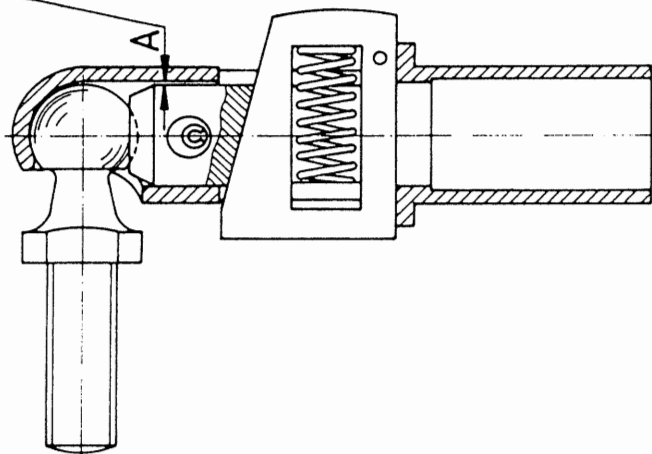
Clearance A must not exceed 0,15 mm (0,006 in);  
check by using a wire of 0,15 mm diameter !

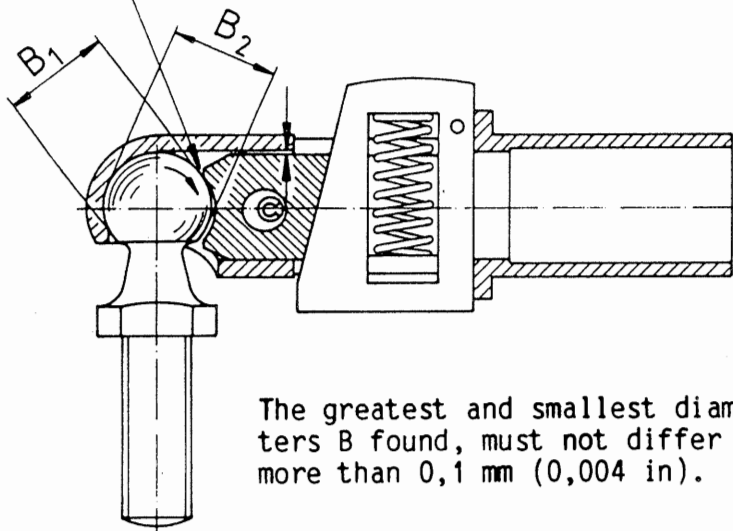
Bad wedging effect causing wear of the ball end.

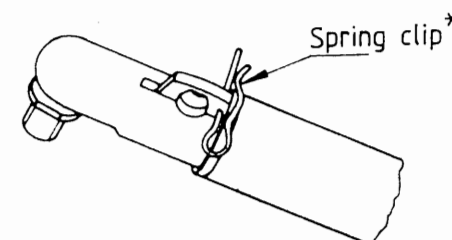
\*Spring pin no.50030771 can be ordered from Alexander Schleicher or from A.Würth, P.O.Box 1261, 7118 Künzelsau, F.R.Germany.

To do this on older ASW19B gliders the check hole must be drilled to 1,2 mm in diameter.
