**Hartzell Air Safety Investigator Examination Report**

Aircraft: Cirrus SR20

Aircraft Registration: N420PB

**Propeller Examination**

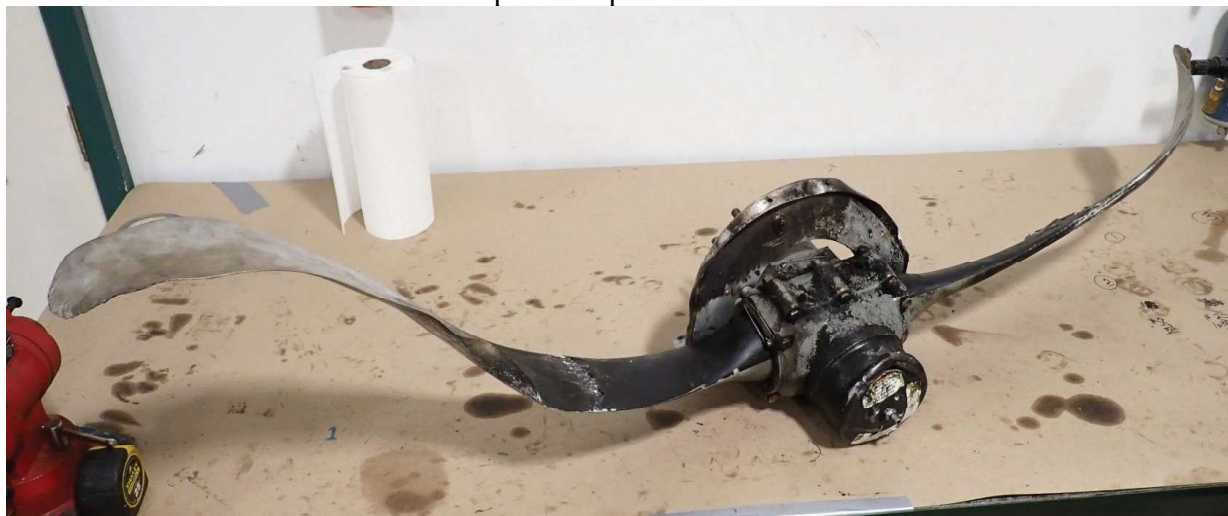
The propeller spinner dome was removed from the propeller and the propeller removed from the engine crankshaft flange by other Party Members prior to this propeller exam. The propeller and spinner were presented for examination as shown in Photos #1 and #2 on September 5, 2024. Both blades remained retained by the hub with no remarkable hub fractures. All hub thru- bolts were present and secure. Both blades exhibited thermal damage from the post-crash fire; the blades were charred outboard of the mid-blade and the tips partially consumed. The blades were numbered #1 and #2 with the S/N following #1 in the sequence of rotation.

Photo #1 – Propeller as presented for examination

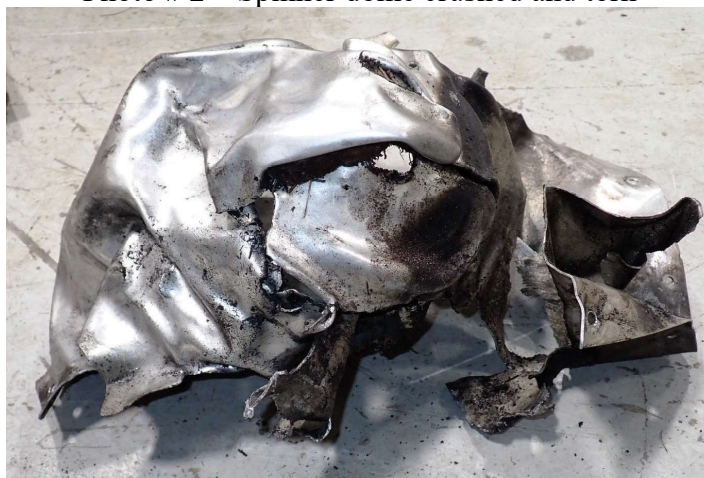
The aircraft wreckage was recovered to Anglin Aircraft Recovery in Clayton, DE. According to other NTSB Party Members, the propeller remained attached to the engine crankshaft flange throughout the impact sequence with all six mounting studs and nuts secure. The spinner dome crushed and tore with torsional deformation and impact compression damage to the cylinder. The spinner bulkhead remained attached to the hub and the flanges were bent aft on either side of the hub.

Photo # 2 – Spinner dome crushed and torn

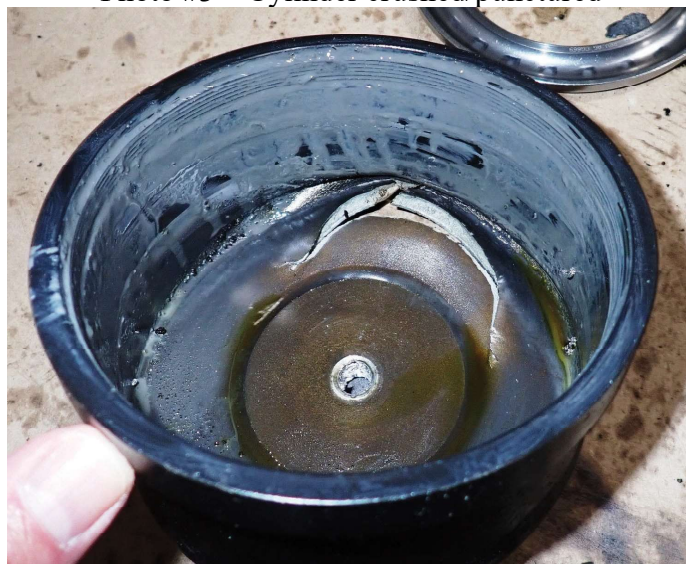
The cylinder unthreaded from the hub without difficulty and the mounting boss appeared intact and undamaged. The cylinder was crushed aft and punctured (Photo #3). The piston, pitch change rod and fork appeared intact (Photo #4). The pitch change rod bent in the fork section but unthreaded from the fork without difficulty. The low pitch stop and pitch change rod contact surfaces had damage from forceful contact (Photo #5). The high pitch stop was intact and appeared undamaged. The hub halves separated without difficulty. There was excessive grease in the hub cavity and the bearings were intact (Photo #6). There is a shank impact mark in aft hub aperture for Blade #1. Both blade retention pockets had impact damage to the preload plate shelves.

Photo #3 – Cylinder crushed/punctured

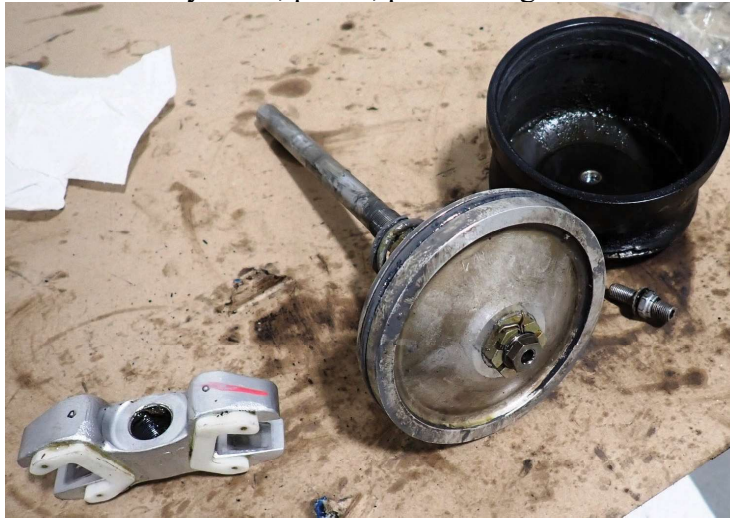
Photo #4 - Cylinder, piston, pitch change rod and fork

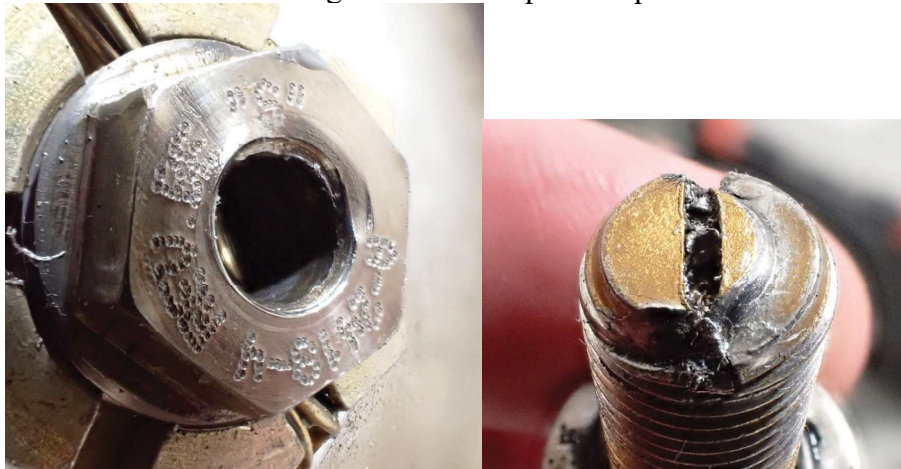
Photo #5 - Pitch change rod and low pitch stop contact surfaces

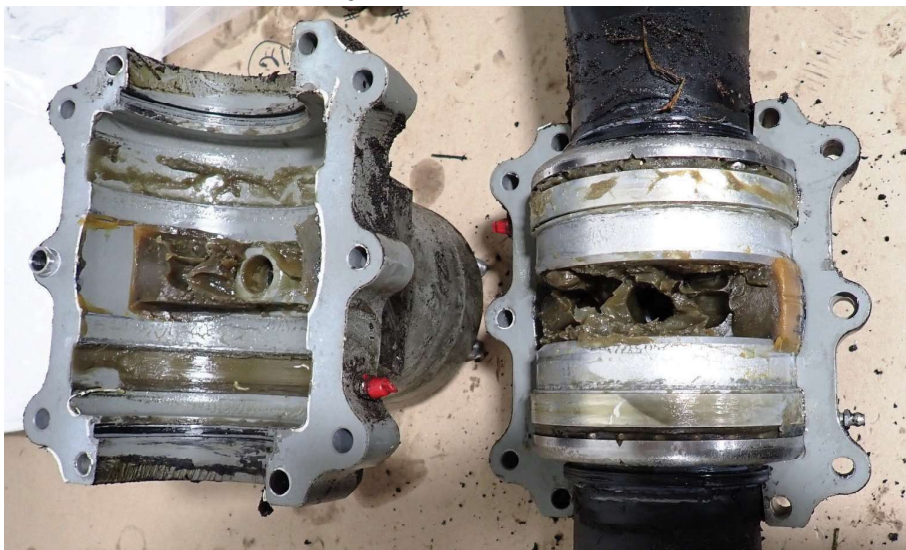
Photo #6 - Hub internal condition

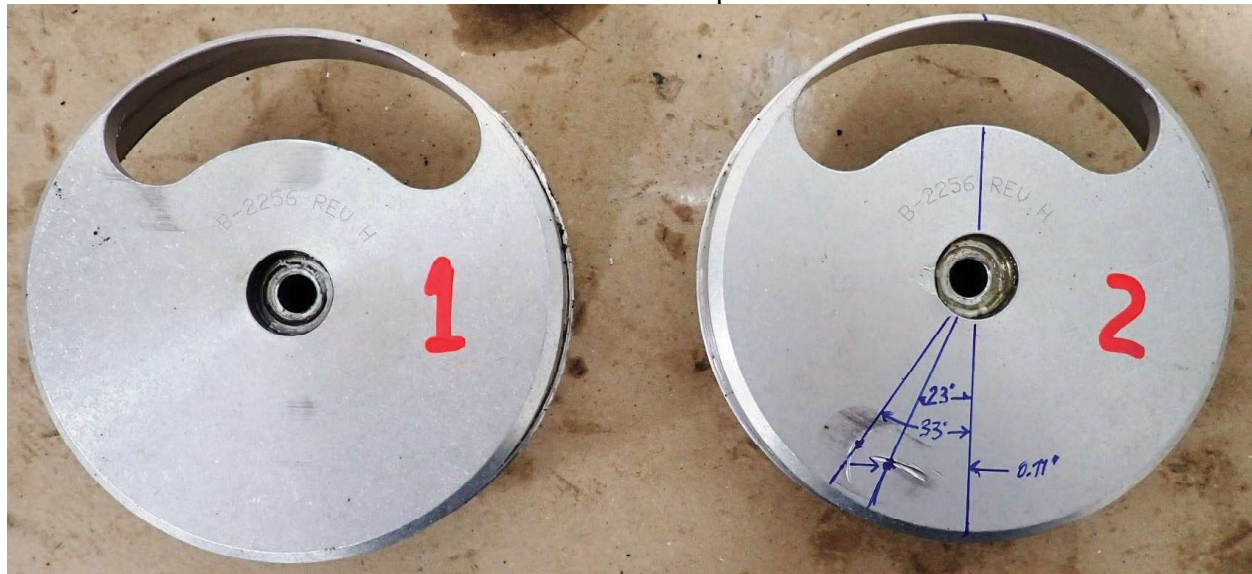
Both preload plate retention lips smashed and/or partially sheared. There was a remarkable pitch change knob block impact mark at 23° forward of the split line on preload plate #2 (Photo #7) which is approximately equal to 24° blade angle (IDS 1486 defines the low pitch stop as 14.6 +/- 0.1°). There were no remarkable impact marks on preload plate #1 but the low pitch end of the knob slot had contact damage, consistent with the fracture of the #1 knob.

Photo #7 - Preload plates

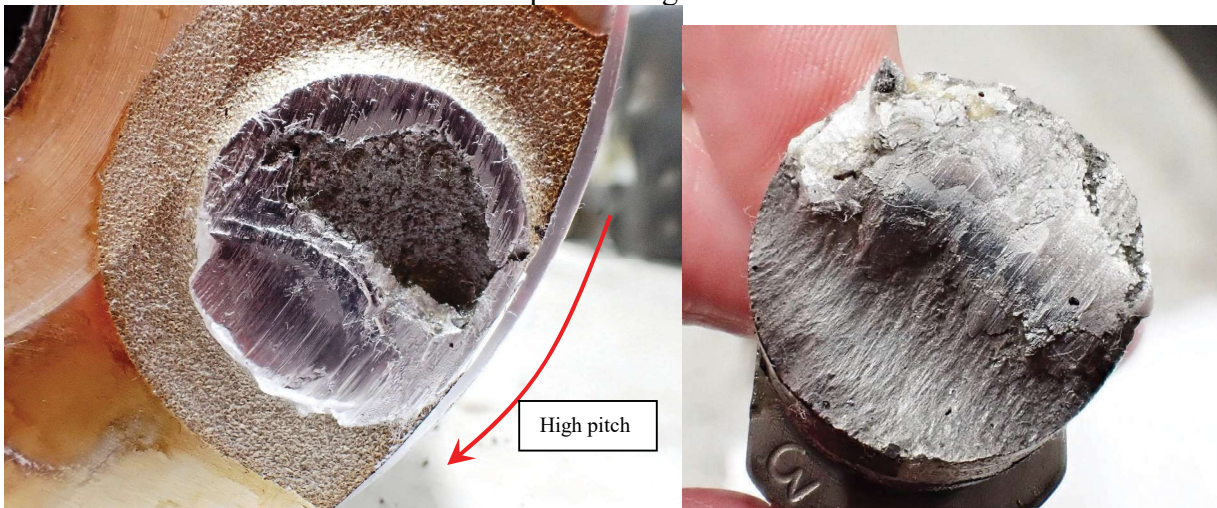
The Blade #1 pitch change knob fracture-separated from the butt with shear/overload fracture features, indicating forceful blade rotation towards high pitch (Photo #8). Blade #2 pitch change knob was intact but bent indicating forceful rotation towards high pitch.

Photo #8 – Blade #1 pitch change rod fracture surfaces

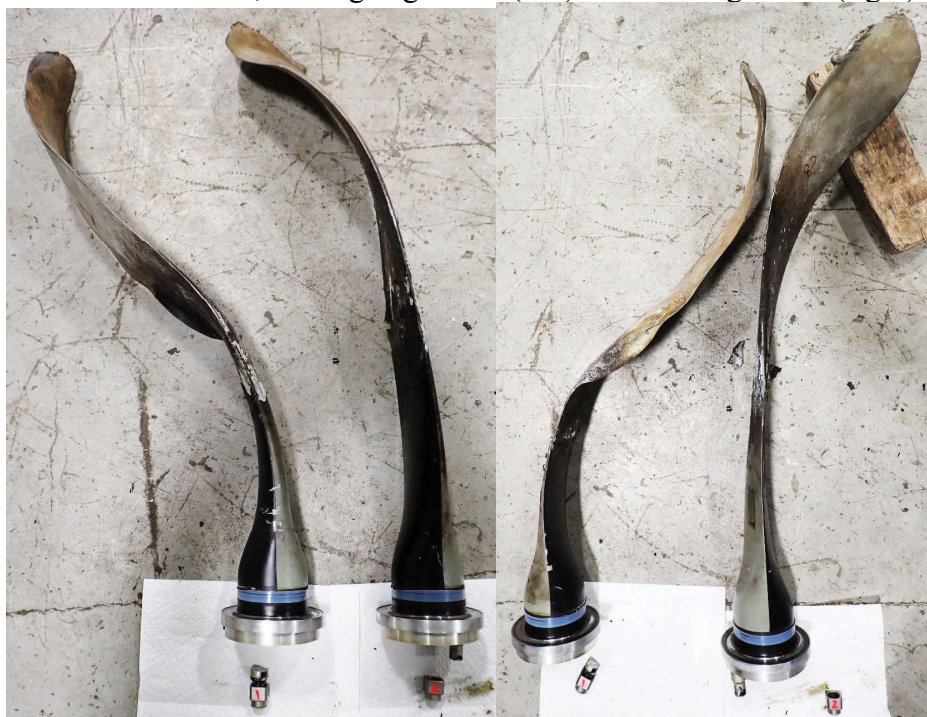
Blade #1 was rotationally loose and appeared to be in a feathered position and Blade #2 in a normal blade angle range of operation. Photos #9 through #12 show the blade damage described below. Blade #1 exhibited S-bending; forward/thrust direction at the tip and aft in the mid-blade area as well as bending opposite rotation in the major axis. The blade forcefully twisted towards high pitch and rotated by hand force in the hub indicating the pitch change mechanism fractured. The leading edge exhibited wave bends consistent with tree strikes as well as nicks and blunt impact damage consistent with rotation. There were also wave bends in the trailing edge.

Blade #2 bent aft and forcefully twisted towards low pitch. The leading edge exhibited wave bends consistent with tree strikes as well as nicks and blunt impact damage consistent with rotation.

Photo #9 – Blades, leading edge view (left) and trail edge view (right)

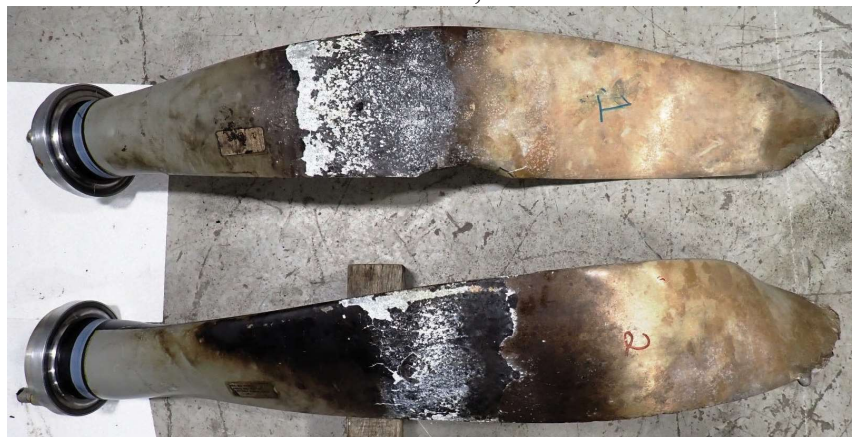
Photo #10 – Blades, camber side

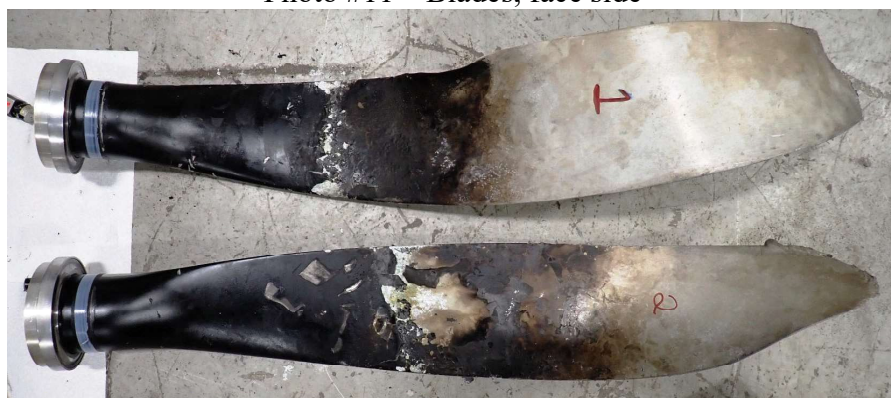
Photo #11 – Blades, face side

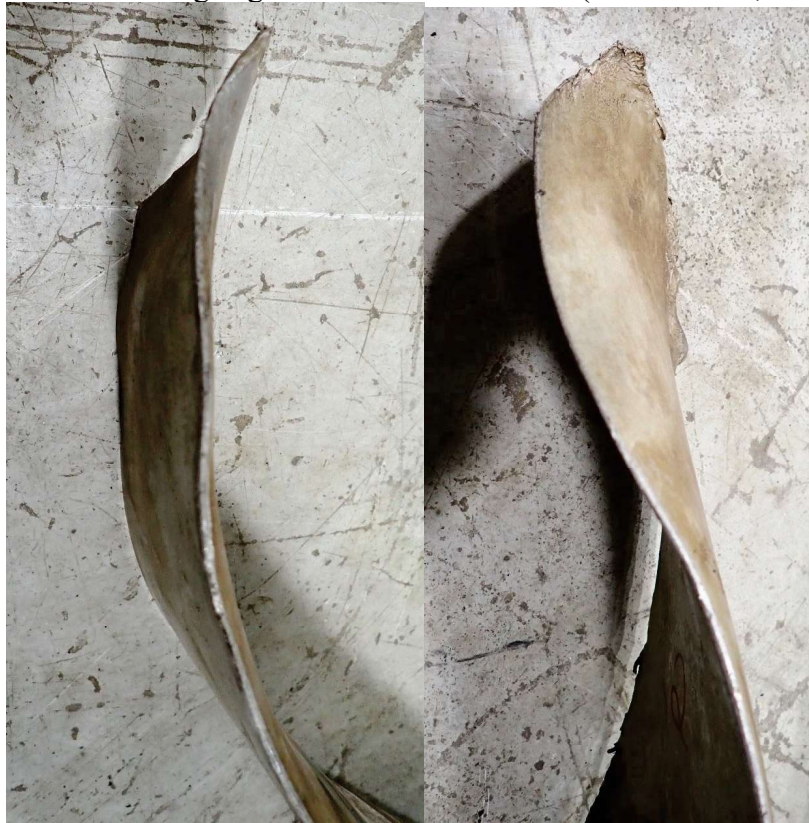
Photo #12 – Leading edge wave/tree strike bends (Blade #1 left, #2 right)
