# National Transportation Safety Board

Office of Research and Engineering

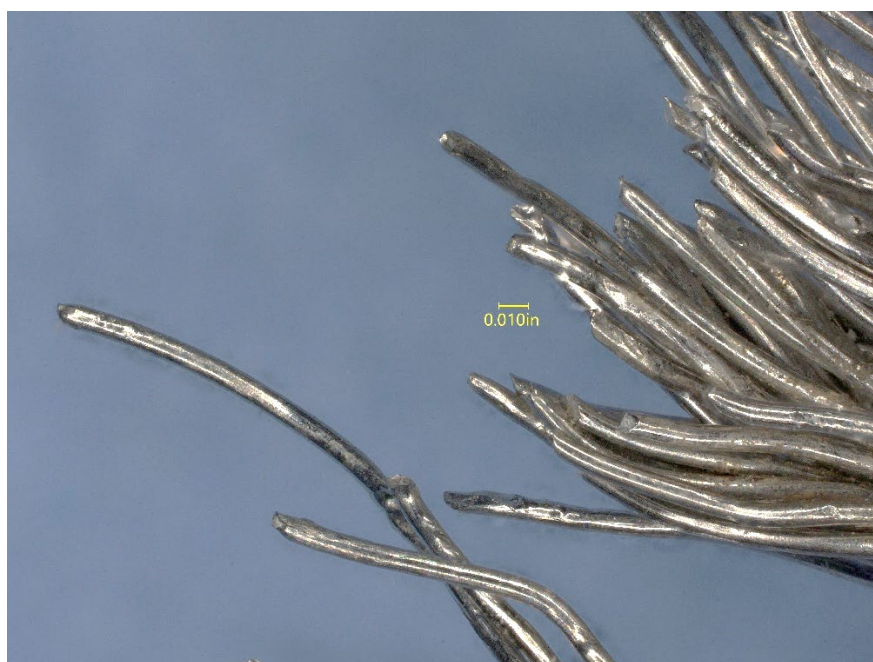
**Figure 2.** Wires exhibiting overstress fractures on "Control column interconnect" cable.

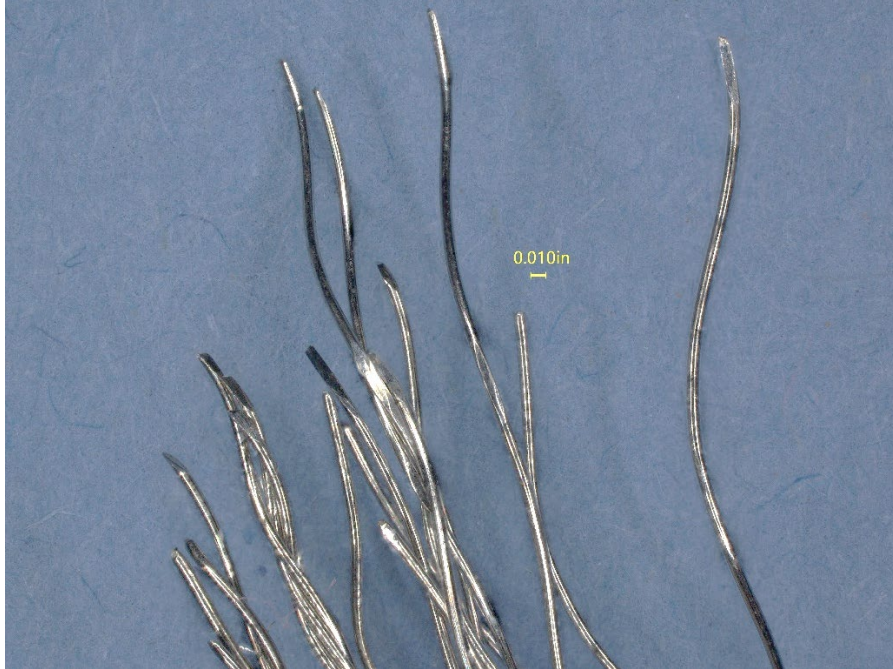
**Figure 3.** Wires exhibiting a mix of overstress and wear fractures in a strand of the "RH aileron AFT wing" cable.

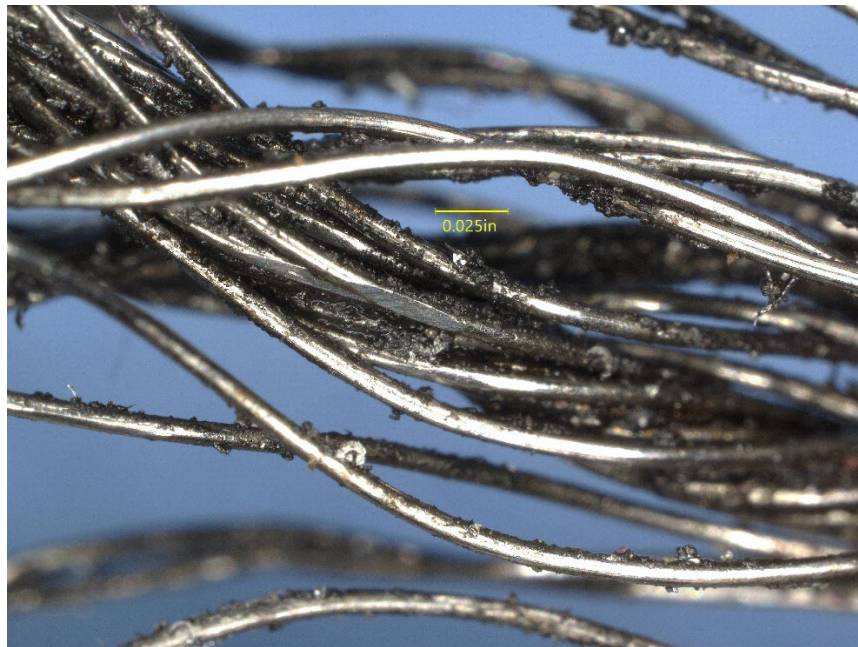
**Figure 4.** Wear spot along length of "RH aileron AFT wing" control cable.

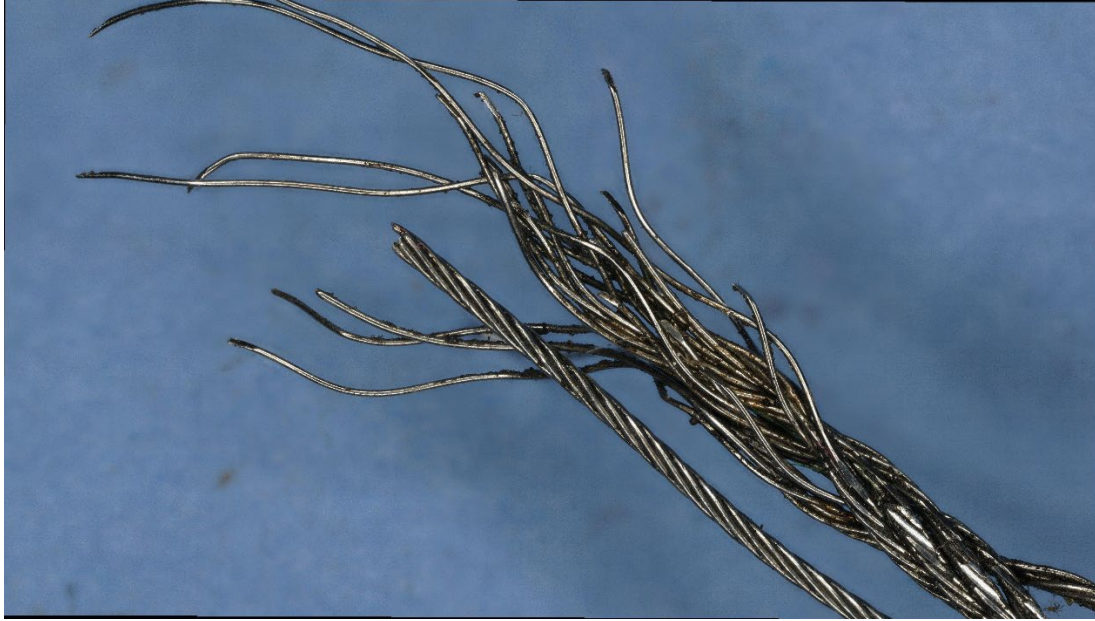
**Figure 5.** Fractured wires from "Trim" control cable exhibiting wear and overstress fractures.

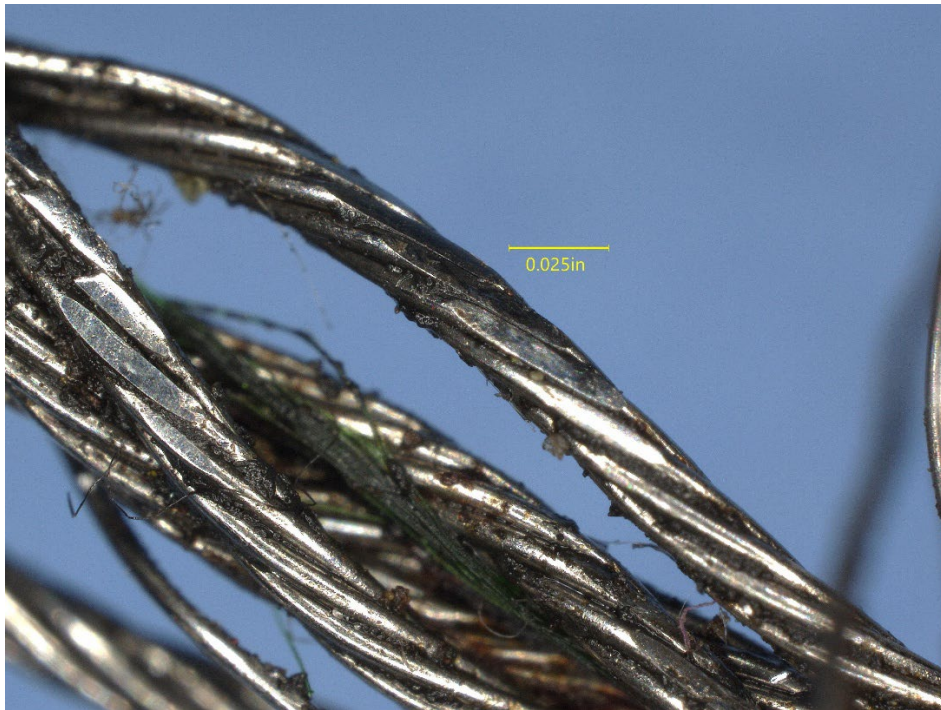
**Figure 6.** Wear spots along the length of "Trim" control cable.

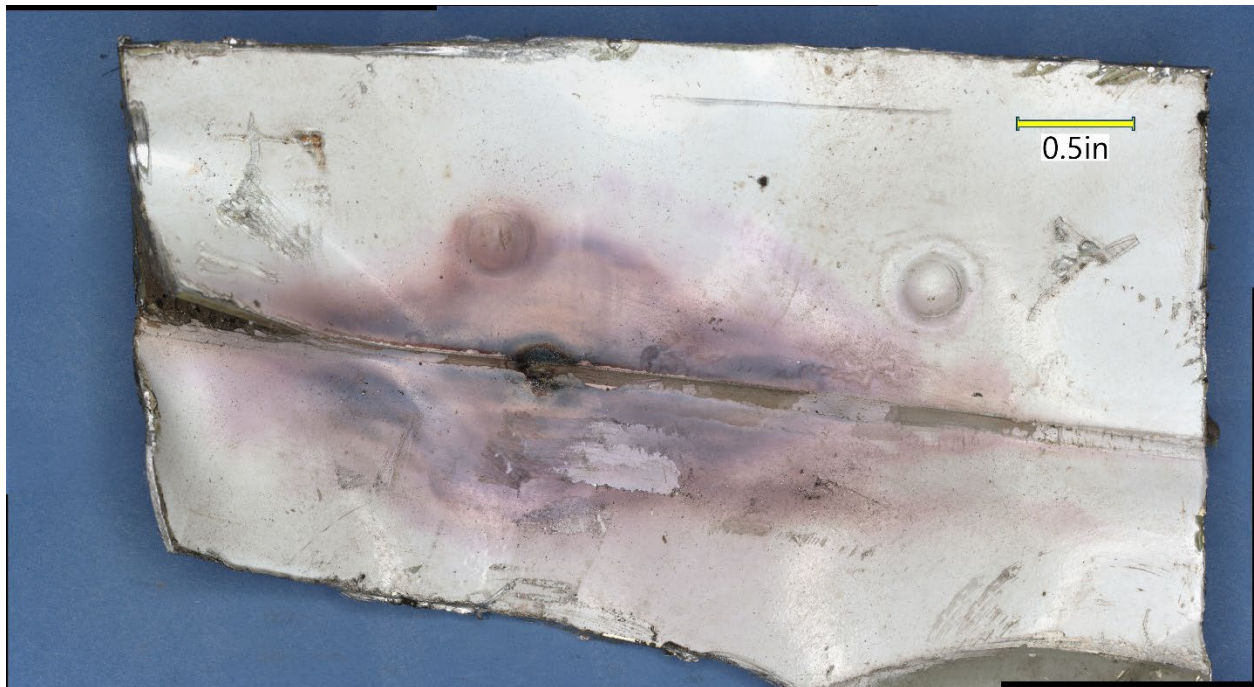
**Figure 7.** Portion of wing skin with discoloration.
