# **Continental Motors**

## **ENGINE EXAMINATION REPORT**

ENGINE MODEL: IO550R

REGISTRATION: N35952

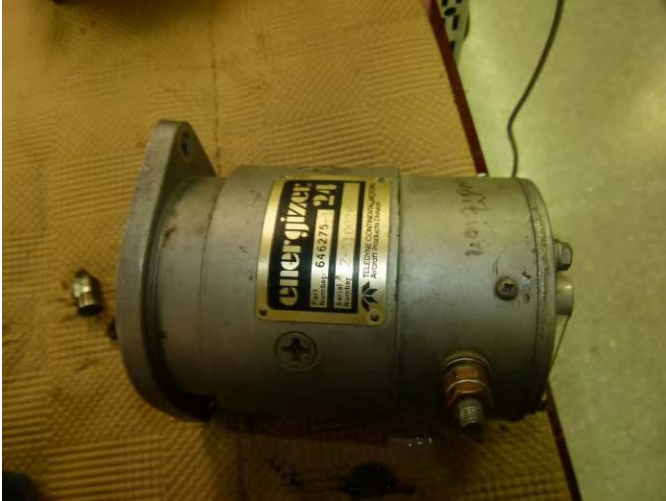
Condition: The starter rotated by hand and was intact and undamaged.

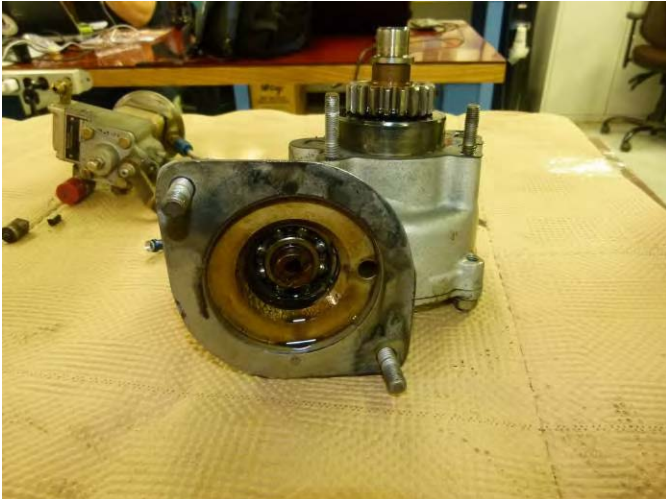
Condition: The starter adapter rotated by hand and was intact and undamaged.

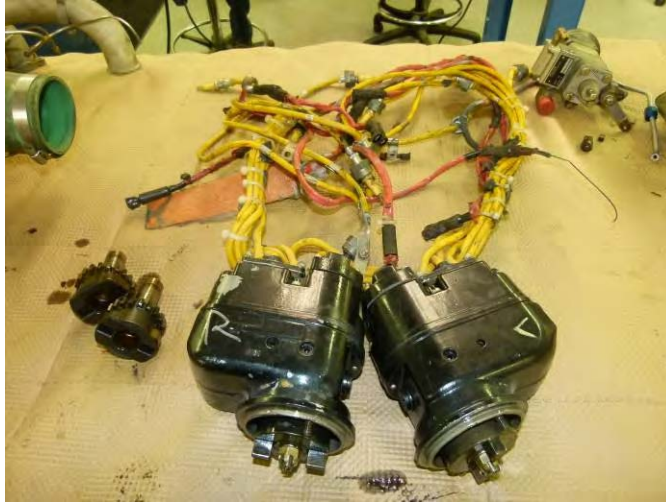
Condition:      All leads were free of frayed or damaged shielding and exhibited normal operating signatures.

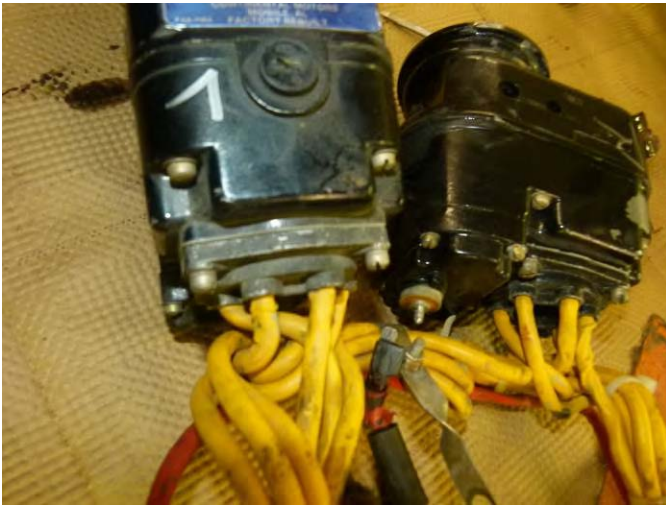
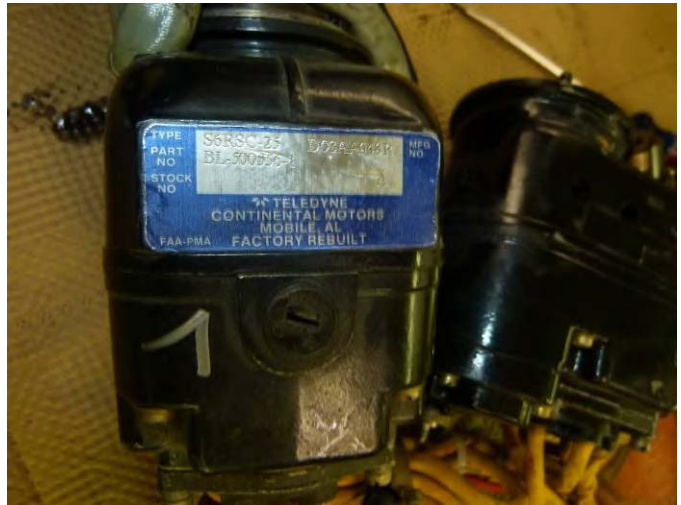
#### L/H Magneto

Condition:      The left-hand magneto turned freely with impulse coupling engagement.

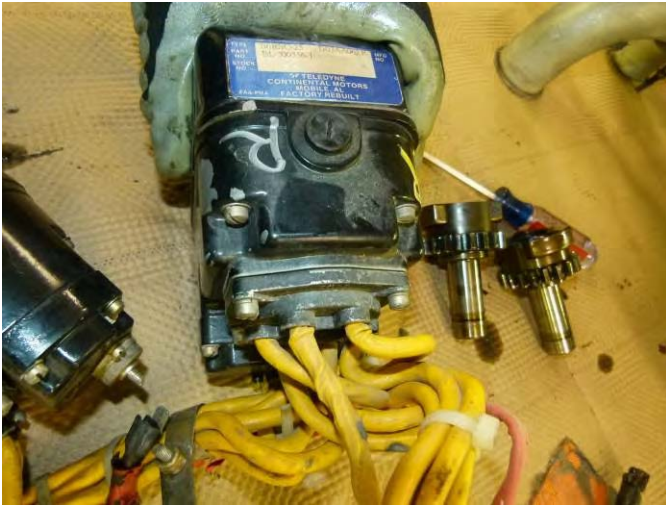
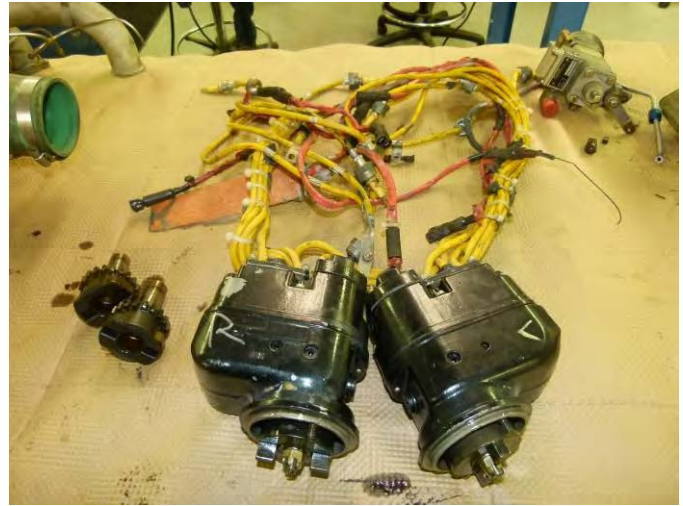
R/H Magneto

Condition: The right-hand magneto turned freely with impulse coupling engagement.

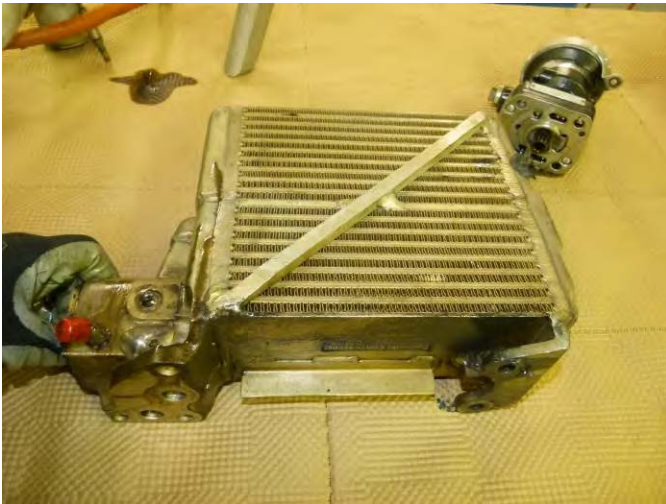
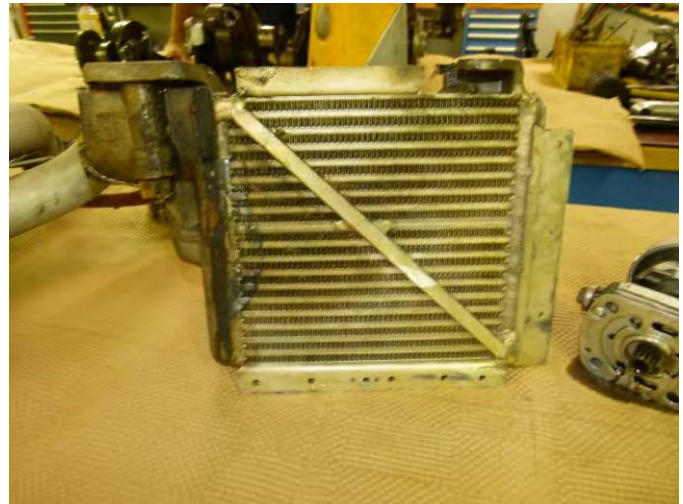
Oil Cooler

Condition: The oil cooler was undamaged and exhibited normal operating signatures.

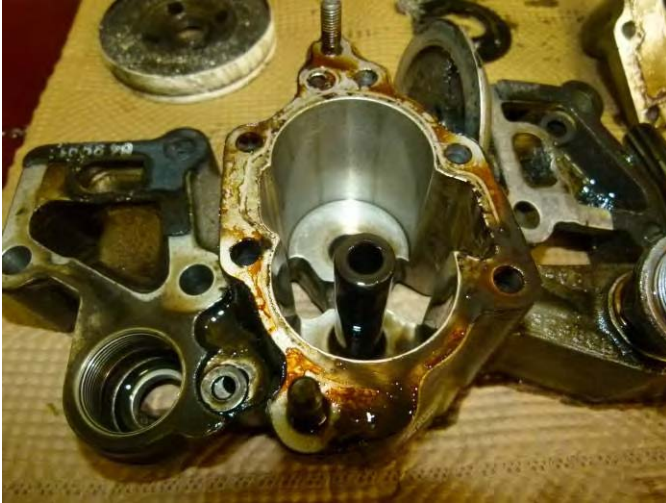
#### Oil Pump

Condition: The oil pump drive was intact. The oil pump cavity contained light scratches and exhibited normal operating signatures. The oil pump gear teeth exhibited normal operating signatures. The oil pressure relief valve and seat contained no obstructions and exhibited signatures of proper seating.

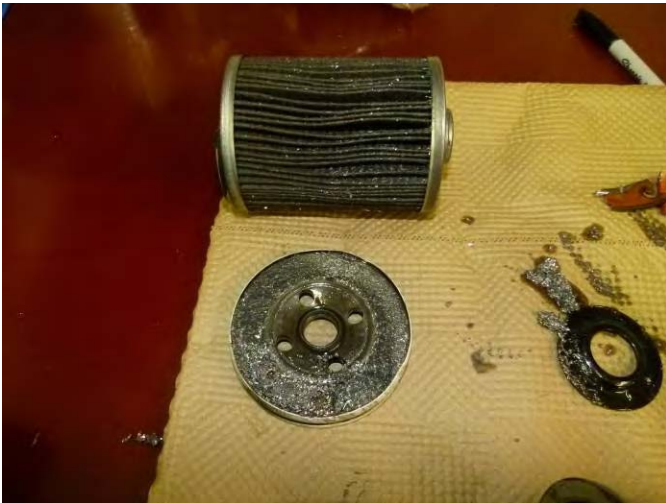
#### Oil Filter

Condition: The oil filter housing was cut open using the cutting tool and the filter element was cut from the canister to allow examination. The oil filter element was examined and contained abundance of flakes and slivers from the damaged internal engine components.

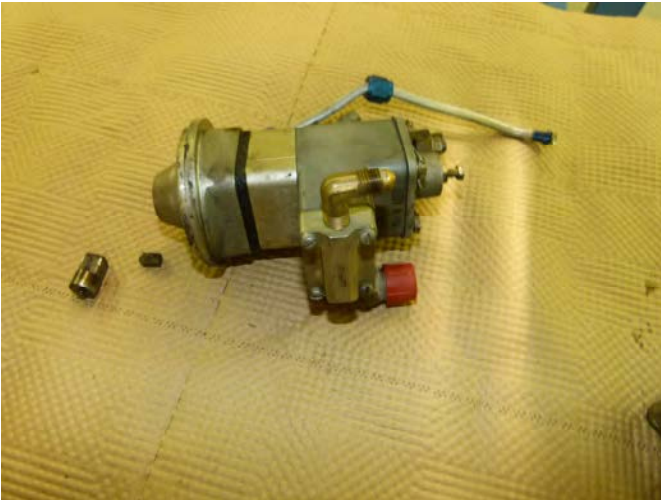
### Fuel Pump

Condition: The fuel pump turned freely and there were no abnormalities present. The fuel pump drive was fractured due to the loss of support at the rear of the crankshaft which the drive coupling is inserted.

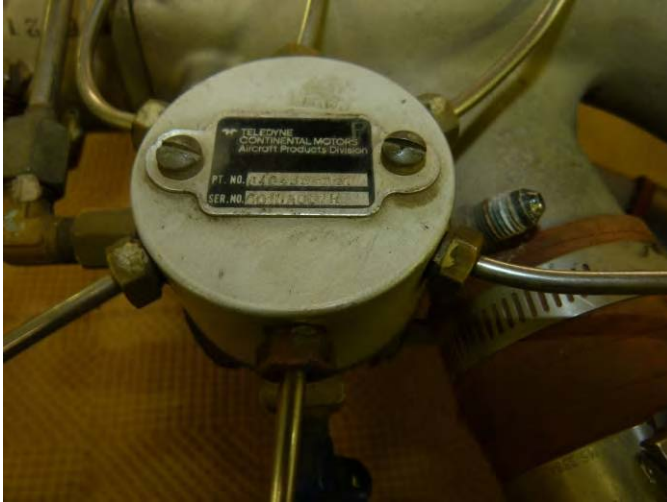
Condition:    The fuel manifold valve exhibited normal operating signatures. There was no indication of leakage observed from the cover vent port. The fuel nozzles were unrestricted and exhibited normal operating signatures. The fuel lines were intact and undamaged.

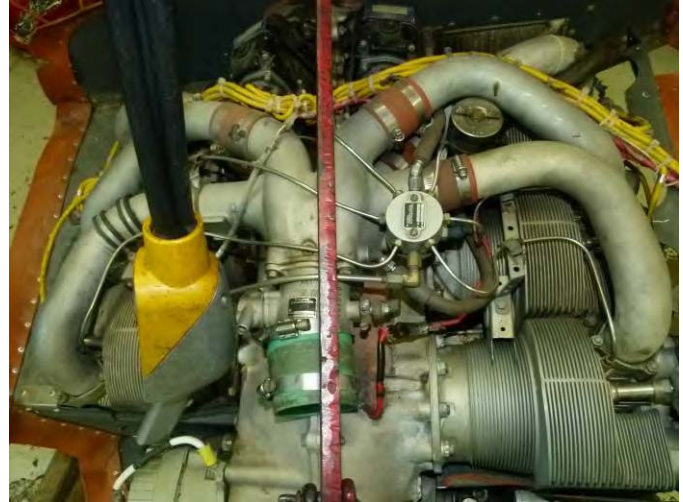
Fuel Manifold Valve    Manufacturer: CMI    Part Number: 646435-3A1    Serial #: B01CA317R

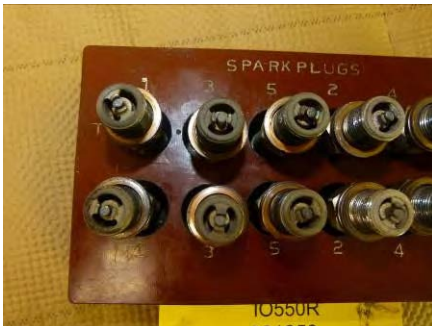
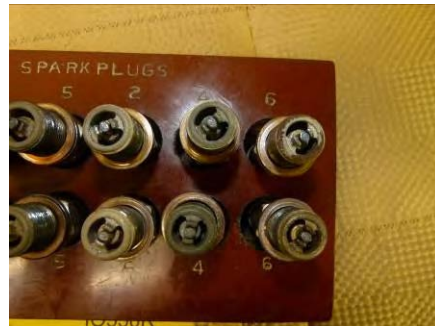
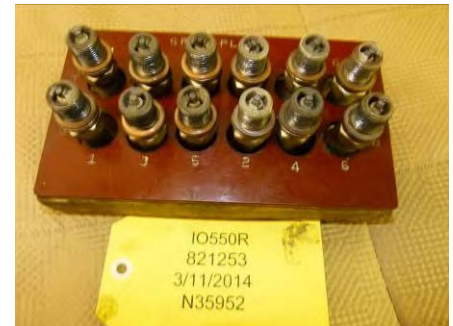
Condition:    The number spark plugs The remaining top and bottom sparkplugs had normal wear signatures in accordance with the Champion aviation check-a-plug comparison chart.

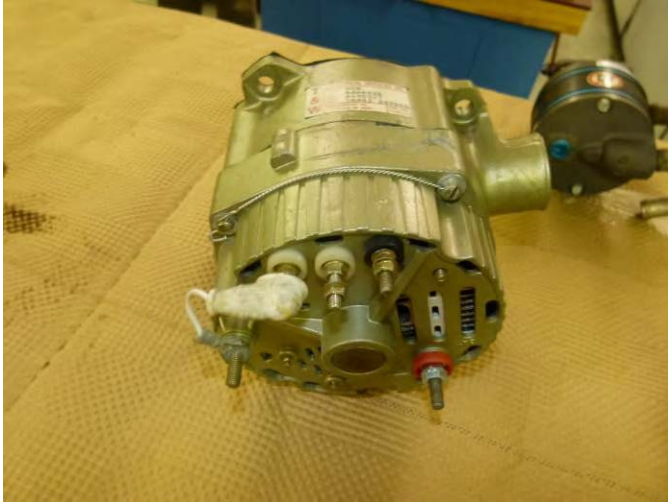
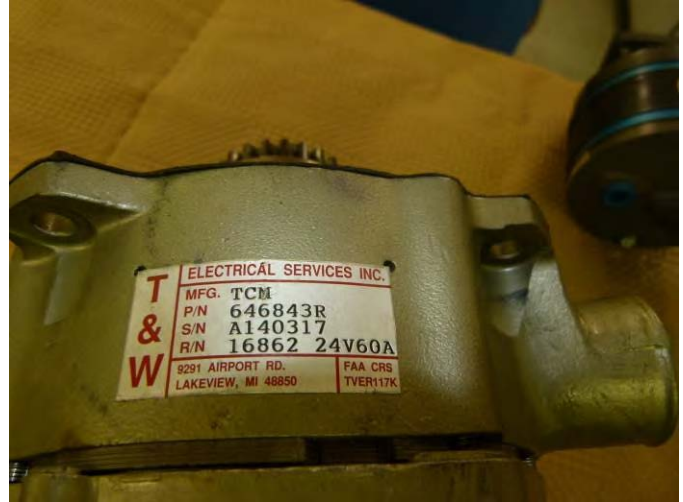
Alternator/Generator    Manufacturer: T&W overhaul    Part Number: 646843    Serial #: A140317

Condition:    The alternator turned through freely and exhibited normal operating signatures. The drive coupling was intact and undamaged.

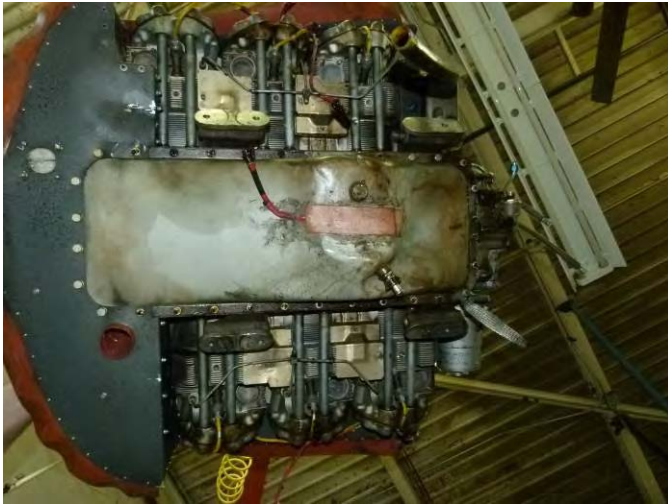
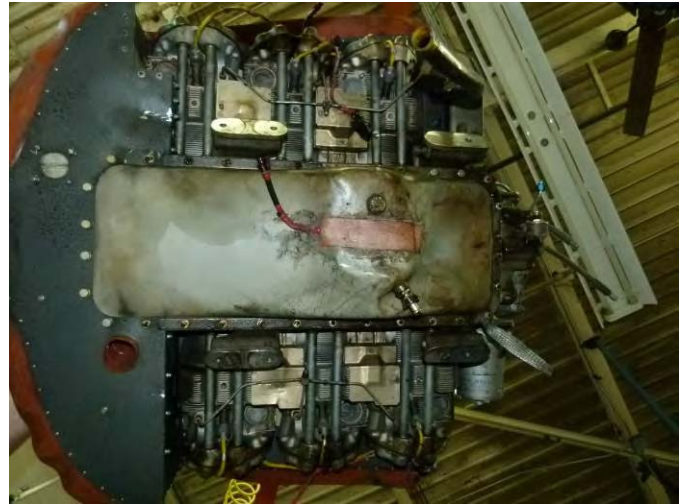
Oil Sump    Condition: The oil sump drain plug was safety wired. The oil sump was undamaged and exhibited normal operating signatures. The oil sump contained residual oil.

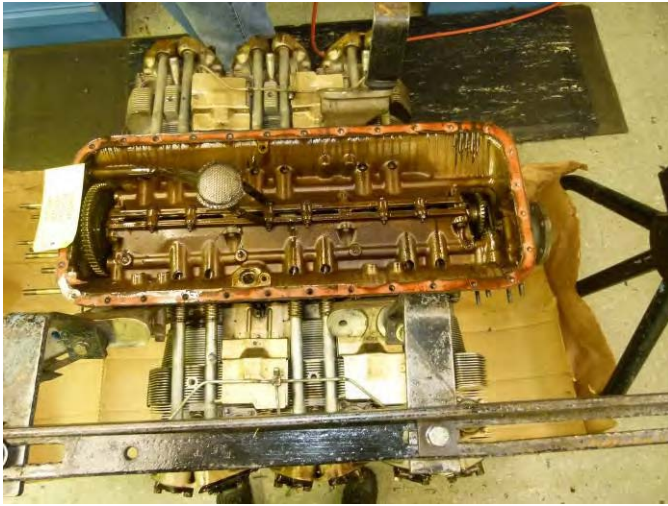
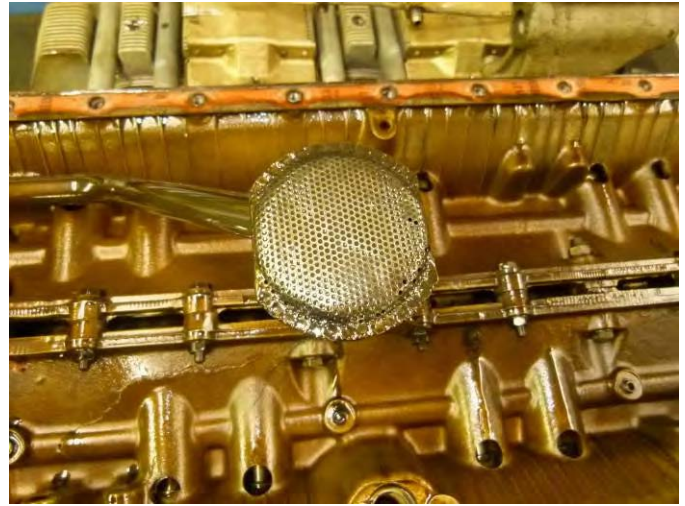
#### Oil Pick-up Tube & Screen

Condition: The oil pick-up tube was undamaged. The oil suction screen was unrestricted.

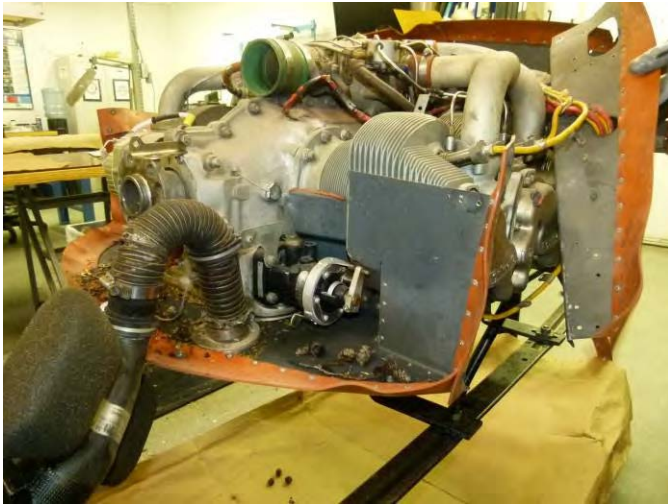
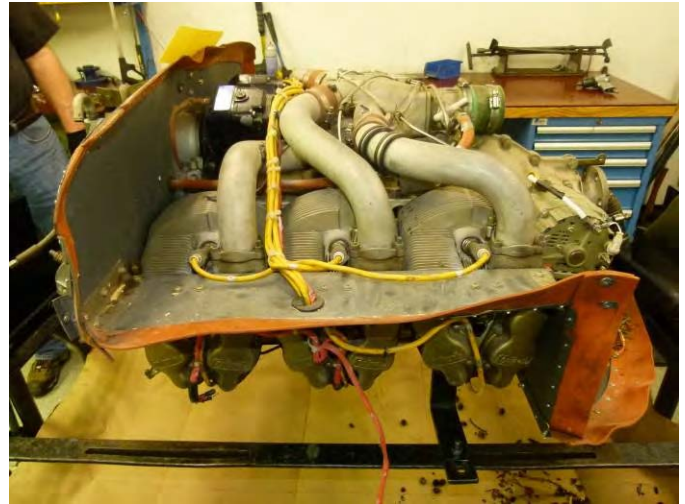
#### Induction System

Condition: The induction risers were undamaged and exhibited normal operating signatures.

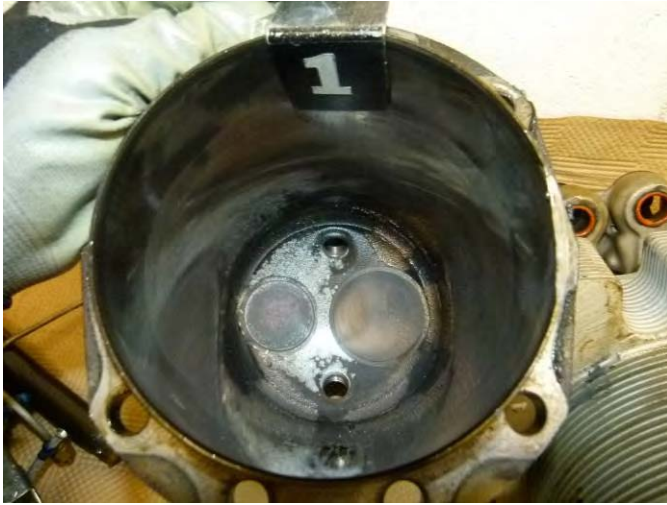
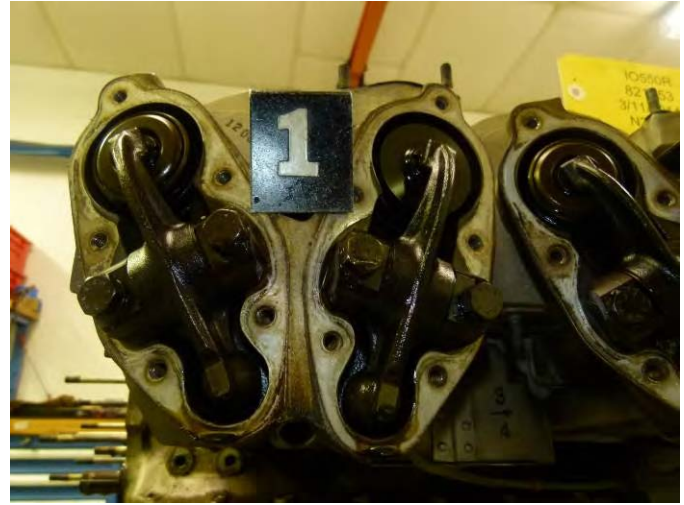
Cylinder #1 Part Number: 654928

Condition: The spot putty was evident on the cylinder hold-down nuts. The cylinder combustion chamber had a normal amount of combustion deposits and the bore condition was free of scoring and undamaged. The cylinder skirt was intact and undamaged and there were no hone marks visible in the cylinder bore ring travel area. The intake and exhaust valve heads exhibited normal deposits and operating signatures. The rocker box area had an oil residue indicating lubrication to the overhead. The cylinder overhead components (valves, rocker arms, guides, springs, retainers and shafts) were lubricated and undamaged.

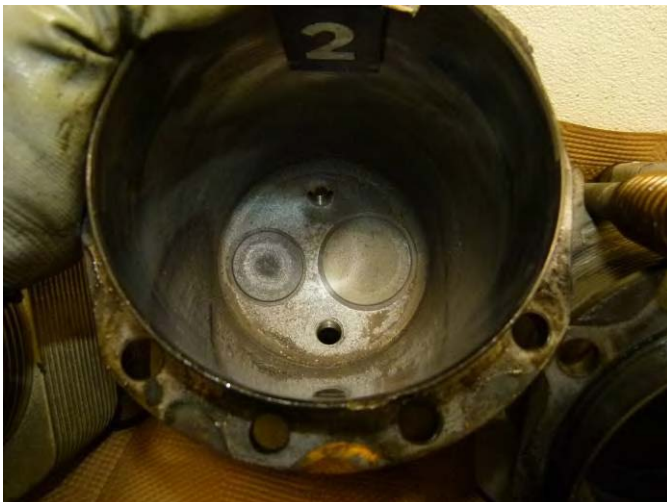
Condition: The spot putty was not evident on the cylinder hold-down nuts. The cylinder combustion chamber had a normal amount of combustion deposits and the bore condition was free of scoring and undamaged. The cylinder skirt was intact and undamaged and there were no hone marks visible in the cylinder bore ring travel area. The intake and exhaust valve heads exhibited normal deposits and operating signatures. The rocker box area had an oil residue indicating lubrication to the overhead. The cylinder overhead components (valves, rocker arms, guides, springs, retainers and shafts) were lubricated and undamaged.

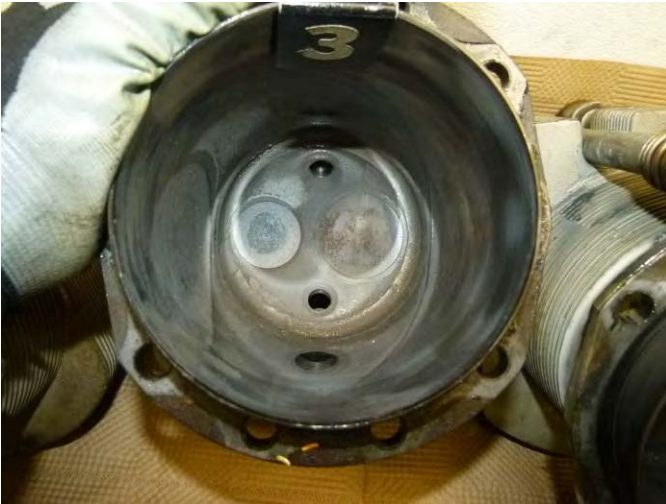
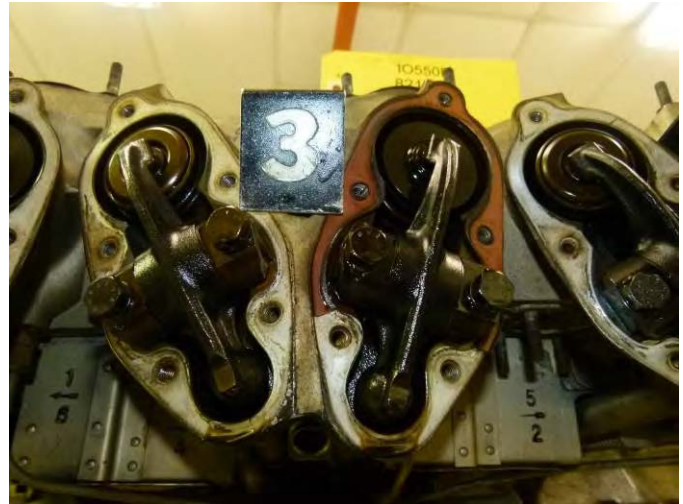
Cylinder #3    Part Number: 654928    Head Date: 3-01    Barrel Surface: Steel  
Serial #: N/A    Work Order Numbers: None

Condition: The spot putty was not evident on the cylinder hold-down nuts. The cylinder combustion chamber had a normal amount of combustion deposits and the bore condition was free of scoring and undamaged. The cylinder skirt was intact and undamaged and there were no hone marks visible in the cylinder bore ring travel area. The intake and exhaust valve heads exhibited normal deposits and operating signatures. The rocker box area had an oil residue indicating lubrication to the overhead. The cylinder overhead components (valves, rocker arms, guides, springs, retainers and shafts) were lubricated and undamaged.

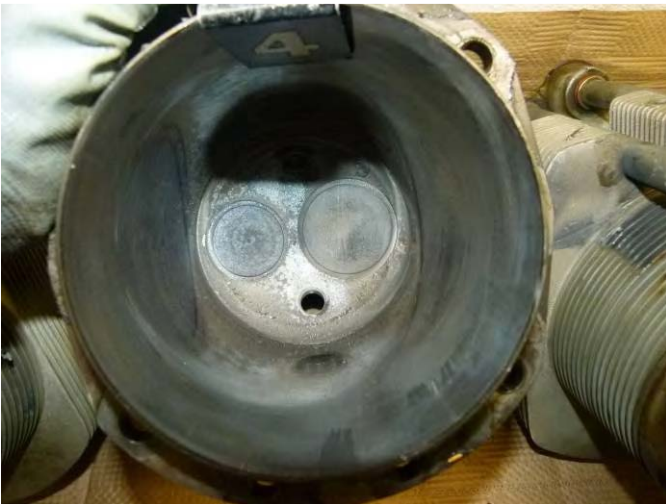
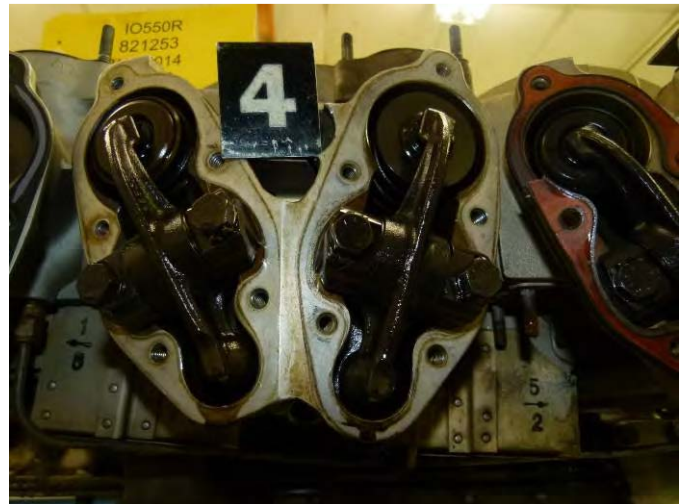
Cylinder #4    Part Number: 654928    Head Date: 3-01    Barrel Surface: Steel  
Serial #: N/A    Work Order Numbers: None

Condition: The spot putty was not evident on the cylinder hold-down nuts. The cylinder combustion chamber had a normal amount of combustion deposits and the bore condition was free of scoring and undamaged. The cylinder skirt was intact and undamaged and there were no hone marks visible in the cylinder bore ring travel area. The intake and exhaust valve heads exhibited normal deposits and operating signatures. The rocker box area had an oil residue indicating lubrication to the overhead. The cylinder overhead components (valves, rocker arms, guides, springs, retainers and shafts) were lubricated and undamaged.

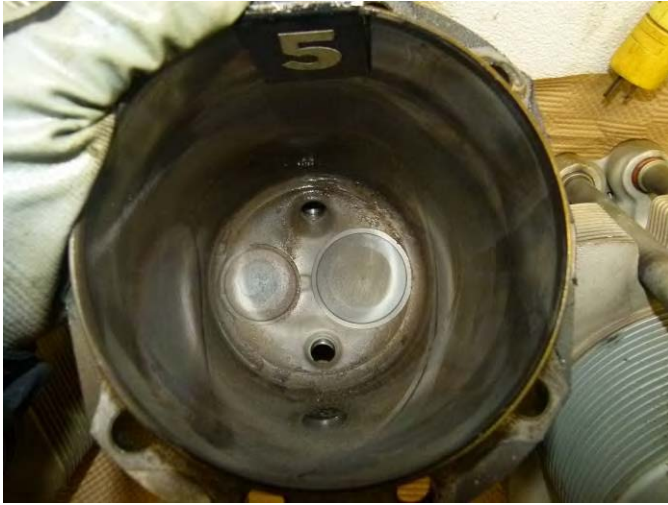
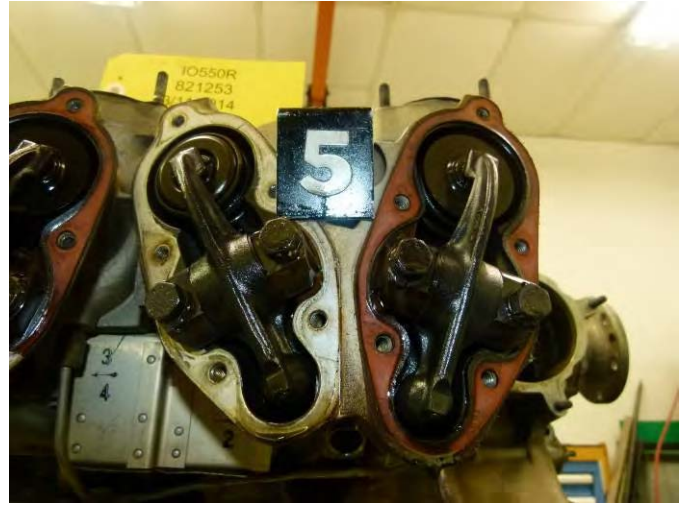
Cylinder #5      Part Number: 654928      Head Date: 3-01      Barrel Surface: Steel

Condition:      The spot putty was evident on the cylinder hold-down nuts. The cylinder combustion chamber had a normal amount of combustion deposits and the bore condition was free of scoring and undamaged. The cylinder skirt was intact and undamaged and there were no hone marks visible in the cylinder bore ring travel area. The intake and exhaust valve heads exhibited normal deposits and operating signatures. The rocker box area had an oil residue indicating lubrication to the overhead. The cylinder overhead components (valves, rocker arms, guides, springs, retainers and shafts) were lubricated and undamaged.

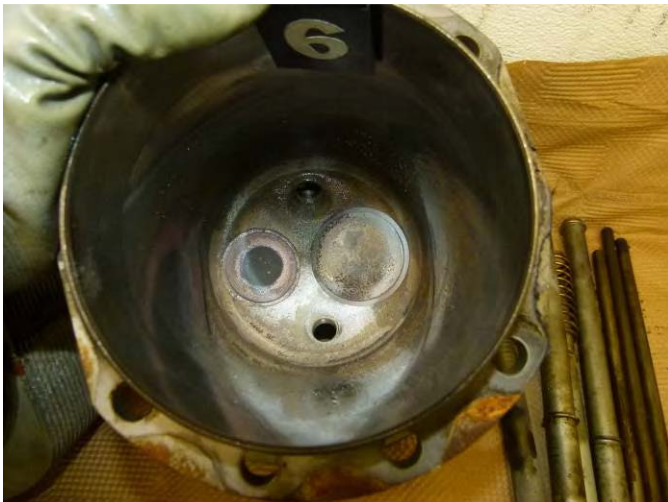
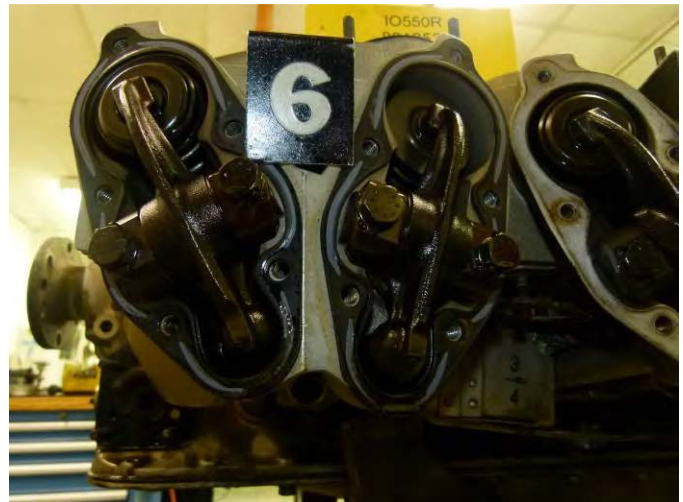
Cylinder #6      Part Number: 655465      Head Date: 7-05      Barrel Surface: Steel

Condition:      The spot putty was not evident on the cylinder hold-down nuts. The cylinder combustion chamber had a normal amount of combustion deposits and the bore condition was free of scoring and undamaged. The cylinder skirt was intact and undamaged and there were no hone marks visible in the cylinder bore ring travel area. The intake and exhaust valve heads exhibited normal deposits and operating signatures. The rocker box area had an oil residue indicating lubrication to the overhead. The cylinder overhead components (valves, rocker arms, guides, springs, retainers and shafts) were lubricated and undamaged.

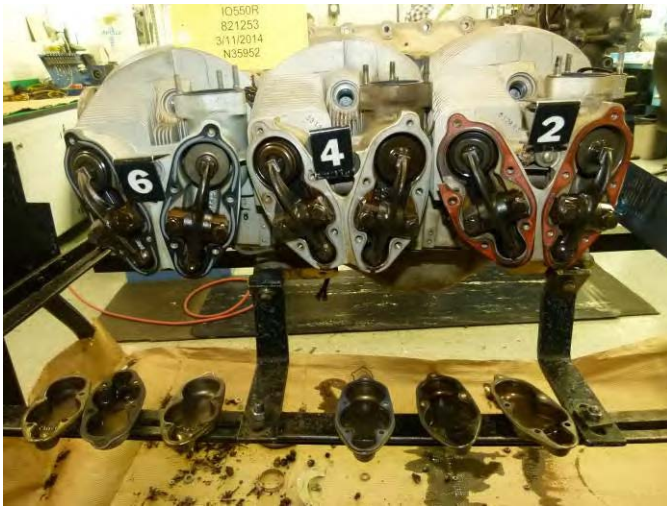
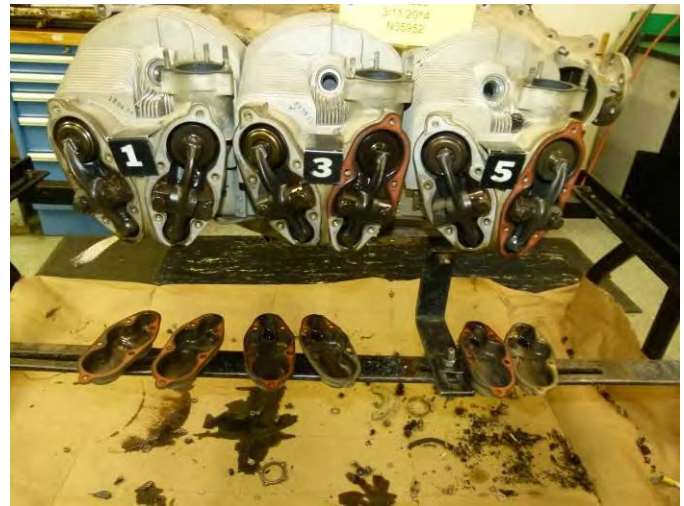
#### Rocker Arm and Shaft

Condition: The intake and exhaust rocker arms and shafts exhibited normal operating signatures.

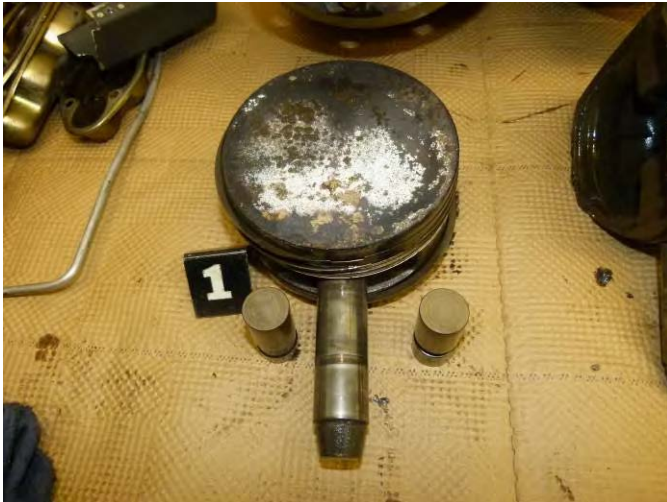
Condition: The piston head exhibited a normal amount of combustion deposits and the piston skirt was free of scoring and damage. The piston rings were intact, free in their grooves, exhibited normal wear and operating signatures. The piston pin and plug assembly was intact and undamaged.

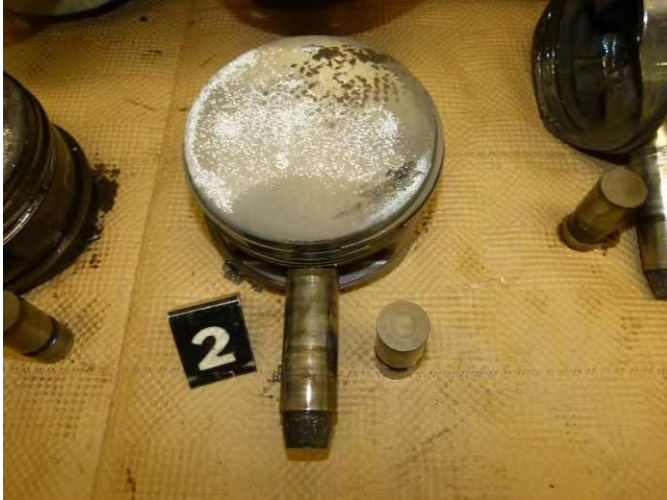
#2 Piston, Rings and Pin      Piston Part Number:    Illegible

Condition:    The piston head exhibited a normal amount of combustion deposits and the piston skirt exhibited scoring and damage. The piston rings were intact, free in their grooves, exhibited normal wear and operating signatures. The piston pin and plug assembly was intact and undamaged.

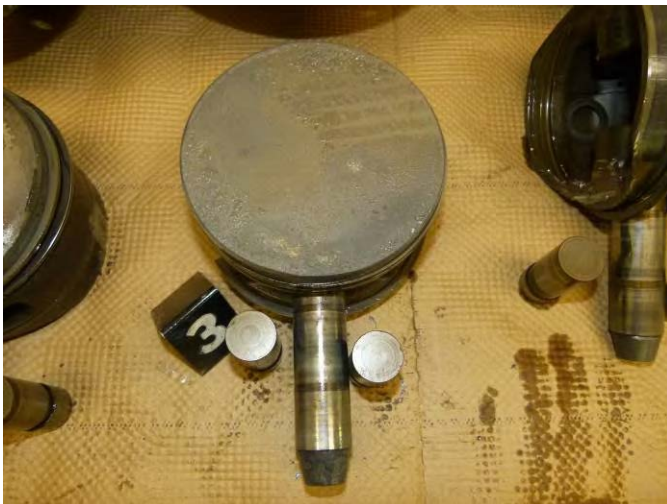
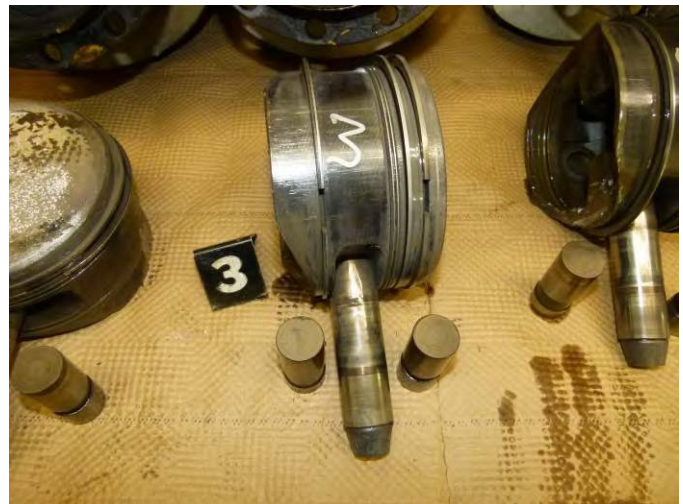
#3 Piston, Rings and Pin      Piston Part Number:    Illegible

Condition:    The piston head exhibited a normal amount of combustion deposits and the piston skirt was free of scoring and damage. The piston rings were intact, free in their grooves, exhibited normal wear and operating signatures. The piston pin and plug assembly was intact and undamaged.

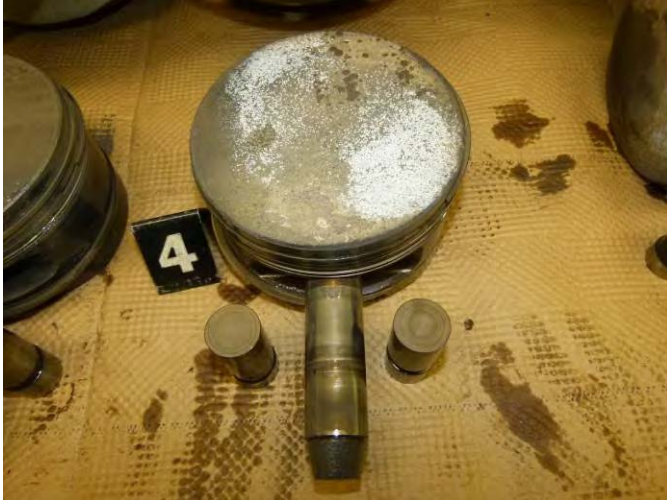
#4 Piston, Rings and Pin      Piston Part Number:      Illegible

Condition:      The piston head exhibited a normal amount of combustion deposits and the piston skirt was free of scoring and damage. The piston rings were intact, free in their grooves, exhibited normal wear and operating signatures. The piston pin and plug assembly was intact and undamaged.

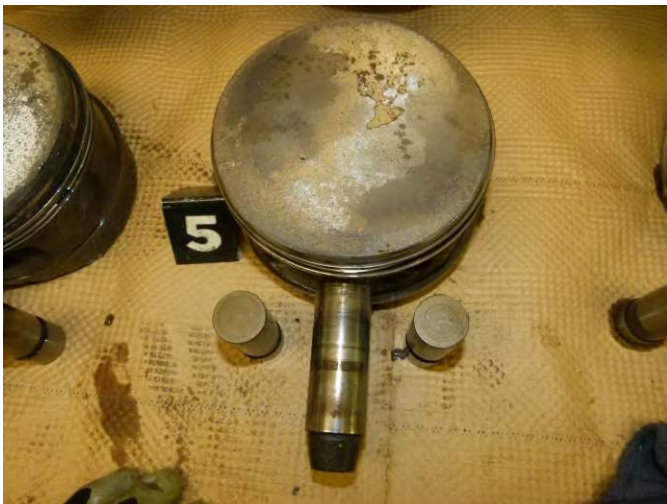
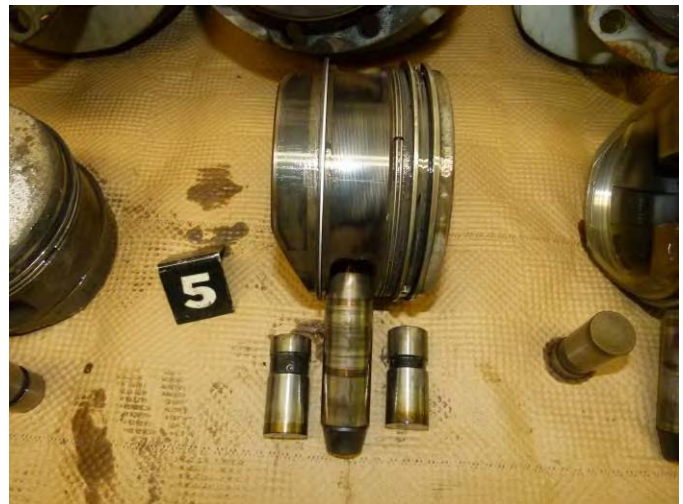
#5 Piston, Rings and Pin      Piston Part Number:      illegible

Condition:      The piston head exhibited a normal amount of combustion deposits and the piston skirt was free of scoring and damage. The piston rings were intact, free in their grooves, exhibited normal wear and operating signatures. The piston pin and plug assembly was intact and undamaged.

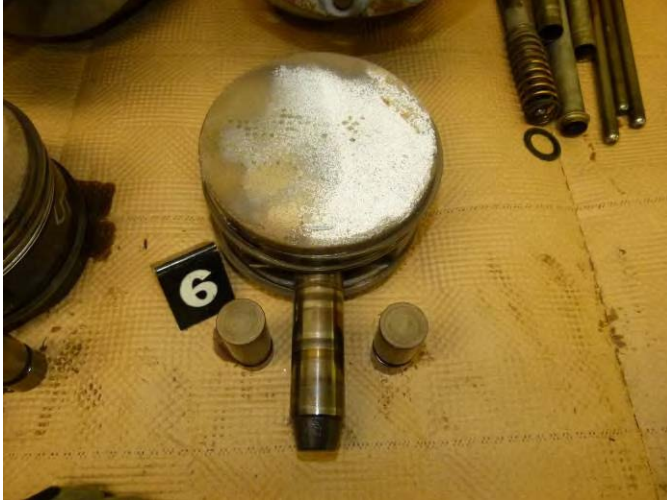
#6 Piston, Rings and Pin      Piston Part Number:      Illegible

Condition:      The piston head exhibited a normal amount of combustion deposits and the piston skirt was free of scoring and damage. The piston rings were intact, free in their grooves, exhibited normal wear and operating signatures. The piston pin and plug assembly was intact and undamaged.

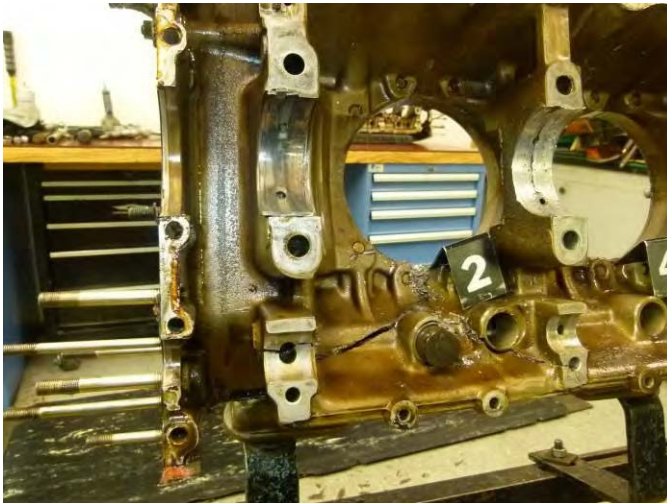
#### #1 Main Bearings

The #1 (rear) crankshaft main bearings exhibited contamination imbedded in the surface layer. The bearings exhibited lock slot elongation in the crank case and bearing shift.

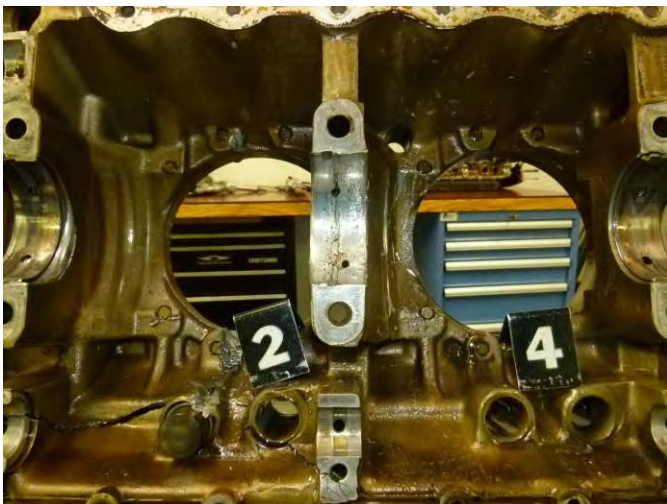
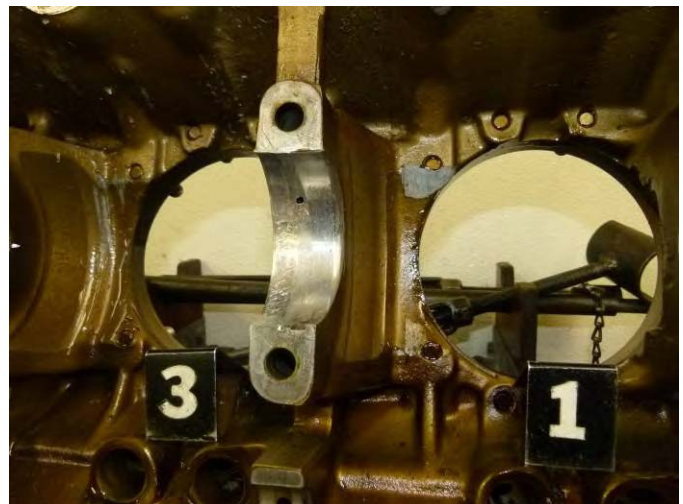
#### #2 Main Bearings

The #2 (intermediate) crankshaft main bearings exhibited lubrication distress and thermal smearing of the surface babbitt down to the copper layer. The bearings were fragmented and extruded from the bearing support. Fragments were recovered from the oil sump.

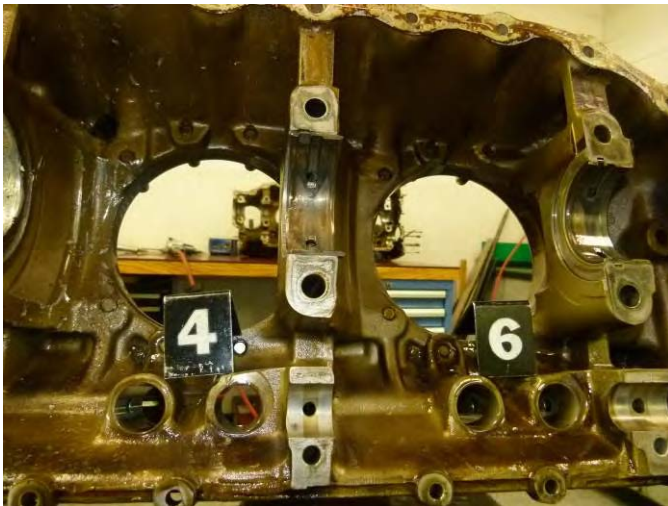
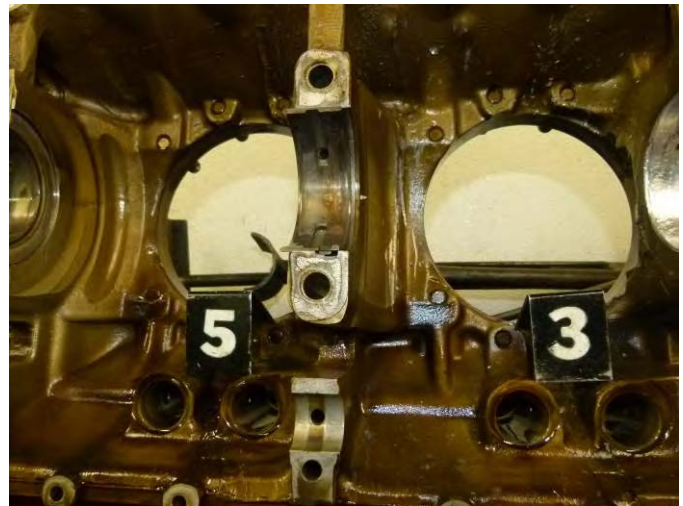
### #3 Main Bearings

The #3 (intermediate) crankshaft main bearings exhibited contamination imbedded in the surface layer. The bearings exhibited lock slot elongation in the crank case and bearing shift.

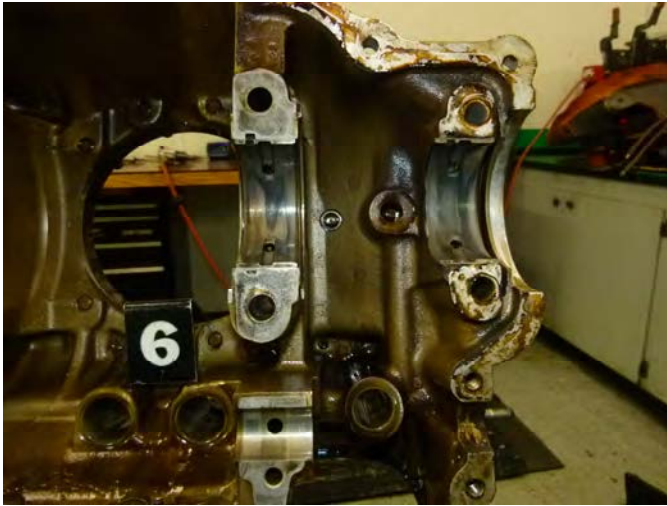
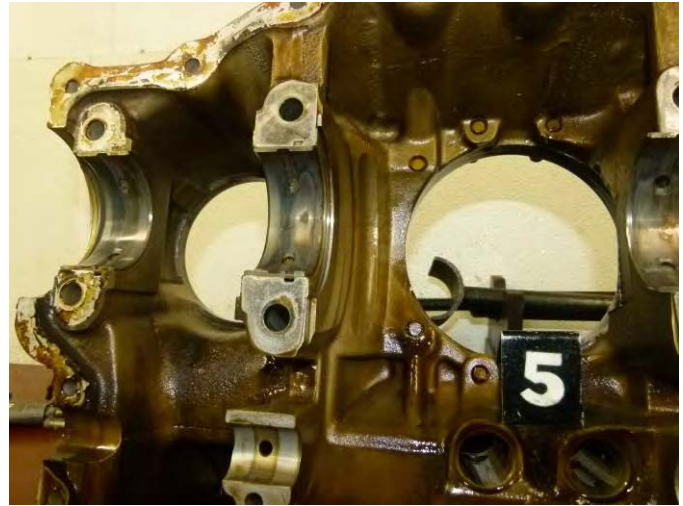
#### #4 Main Bearings

The #4 (intermediate or front) crankshaft main bearings exhibited normal operating and lubrication signatures. The bearings were intact and exhibited an insignificant amount of contamination and hard particle passage. The bearings exhibited contamination imbedded in the surface layer. The bearings exhibited wear down to the copper layer.

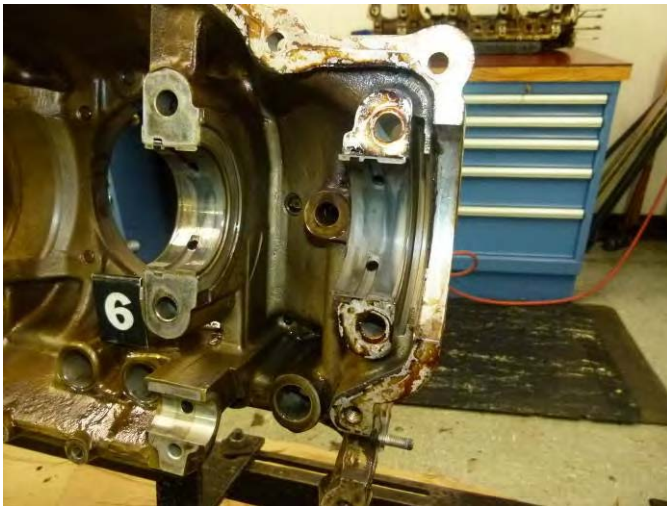
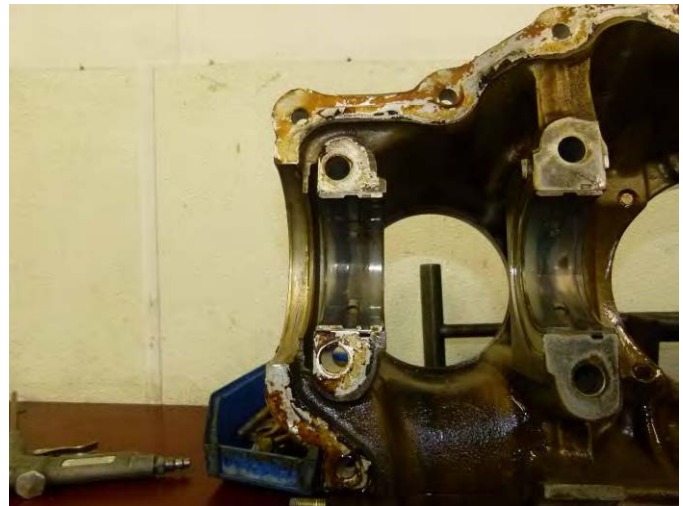
#### #5 Main Bearings

The #5 (front) crankshaft main bearings exhibited normal operating and lubrication signatures. The bearings were intact and exhibited an insignificant amount of contamination and hard particle passage. The bearings exhibited contamination imbedded in the surface layer. The bearings exhibited wear down to the copper layer.

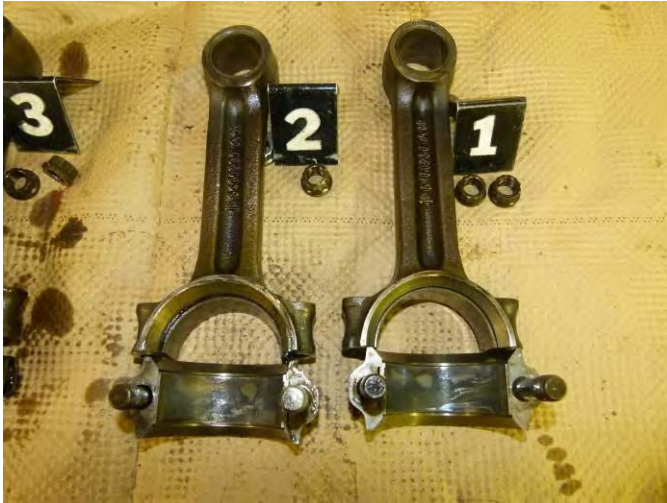
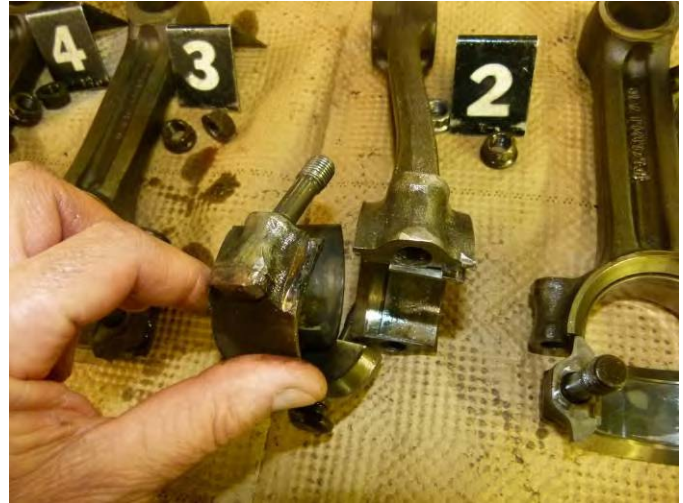
#### #1 & 2 Connecting Rod Bearings

Condition: The number one connecting rod assembly was intact and undamaged. The connecting rod nuts and bolts were intact and secure. The connecting rod bushing exhibited normal operating and lubrication signatures. The number two connecting rod assembly was intact and exhibited mechanical damage on the rod cap and was bent along the I-beam section of the rod. The connecting rod nuts and bolts were intact and secure. The connecting rod bushing exhibited normal operating and lubrication signatures.

Condition: The connecting rod bearing exhibited lubrication distress and thermal smearing of the surface babbit, exposing the copper layer.

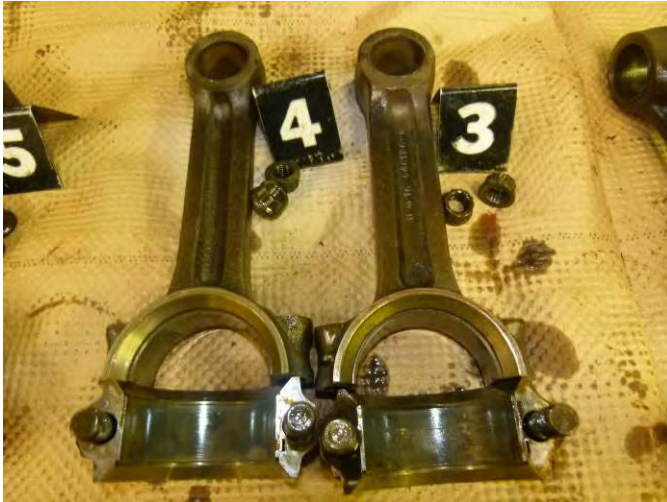
Condition: The connecting rod bearing exhibited normal operating and lubrication signatures. The connecting rod bearings were intact and exhibited an insignificant amount of contamination and hard particle passage. There were no signs of lubrication distress.

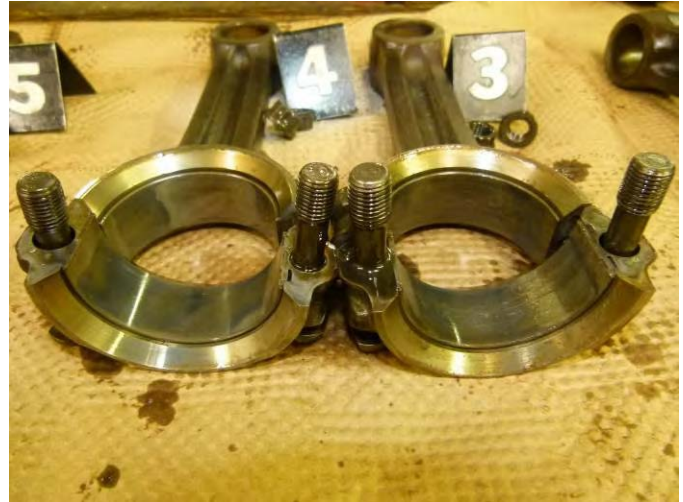
### #3 & 4 Connecting Rod Bearings

Condition: The connecting rod assembly was intact and undamaged. The connecting rod nuts and bolts were intact and secure. The connecting rod bushing exhibited normal operating and lubrication signatures.

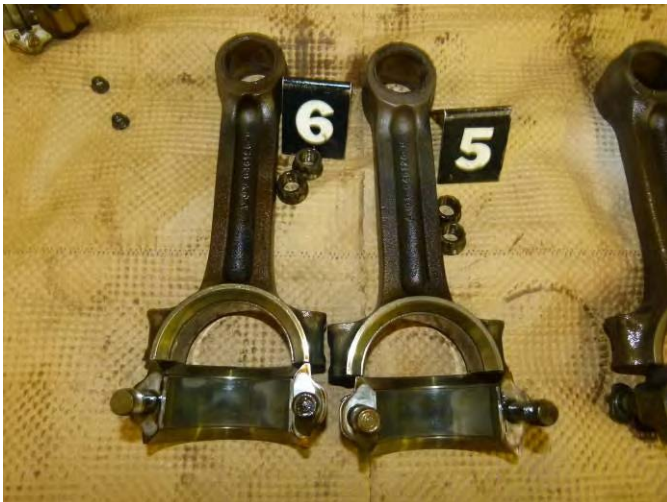
### #5 & 6 Connecting Rod

Condition: The connecting rod bearing exhibited normal operating and lubrication signatures. The connecting rod bearings were intact and exhibited an insignificant amount of contamination and hard particle passage. There were no signs of lubrication distress.
