# **Continental Motors**

## **ENGINE EXAMINATION REPORT**

ENGINE MODEL: IO550R

REGISTRATION: N35952

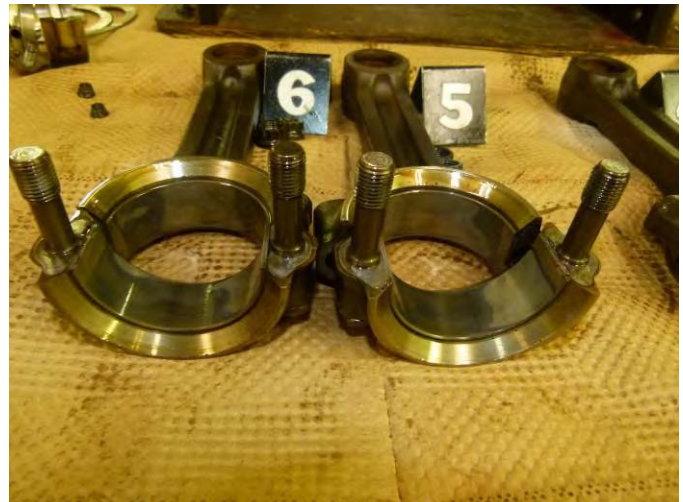
### #5 & 6 Connecting Rod Bearings

Condition: The connecting rod assembly was intact and undamaged. The connecting rod nuts and bolts were intact and secure. The connecting rod bushing exhibited normal operating and lubrication signatures.

Condition: The connecting rod bearing exhibited normal operating and lubrication signatures. The connecting rod bearings were intact and exhibited an insignificant amount of contamination and hard particle passage. There were no signs of lubrication distress.

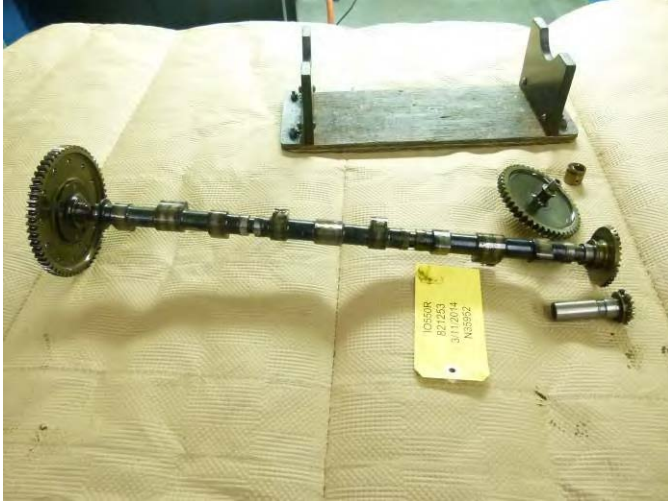
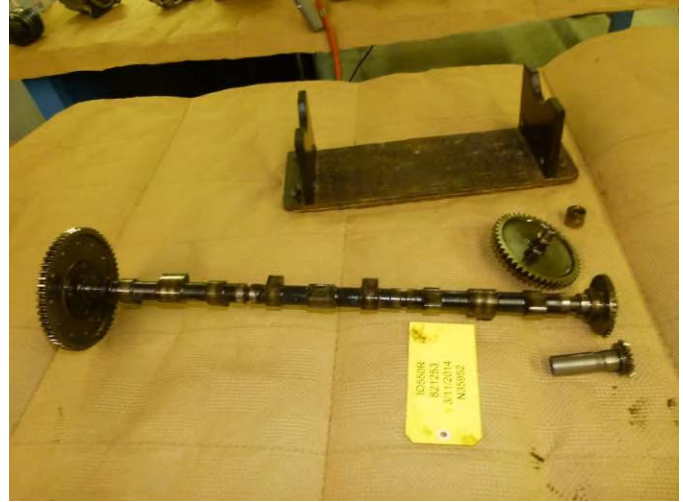
Camshaft Part number: 655008

Condition: The camshaft lobes exhibited normal operating signatures. The camshaft cluster gear was intact and exhibited normal operating signatures. The gear bolts were tight and safety wired and the gear teeth were undamaged.

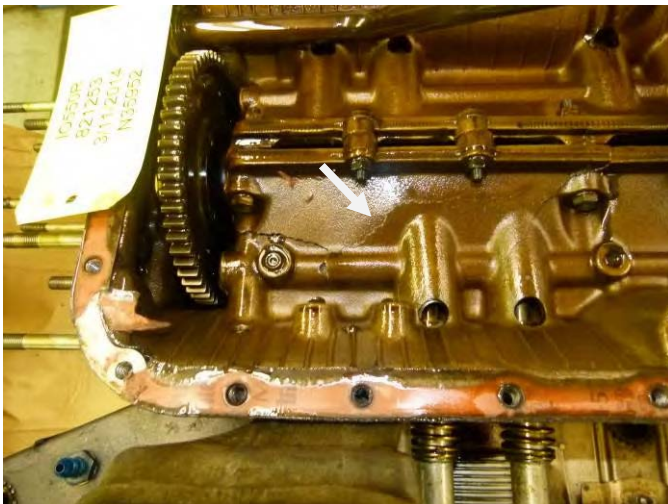
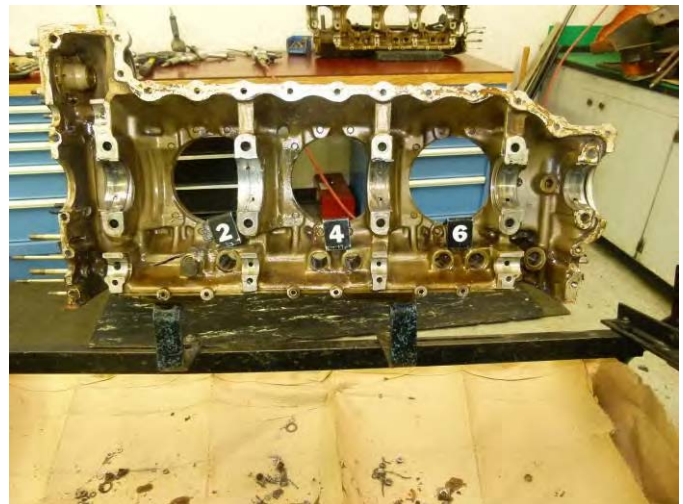
Crankcase Casting Number 1-3-5 Side: 646201 2-4-6 Side: 646200 Serial number: A159003RPL

Condition: The crankcase exhibited minimal exterior damage. The cylinder bays were intact and undamaged. The oil galleries and passages in the left and right crankcase halves were intact, clear and unrestricted. The number one, two and three main bearing support exhibited lock slot elongation and bearing shift signatures. The number one, two and three main bearing parting surfaces exhibited rough surface and fretting. The number two main bearing support exhibited bearing rotation signatures. The number two bearing was fragmented and found in the oil sump. The lower rear section of the crankcase (below the fracture area of the crankshaft) exhibited mechanical damage from the internal rotating components of the engine.

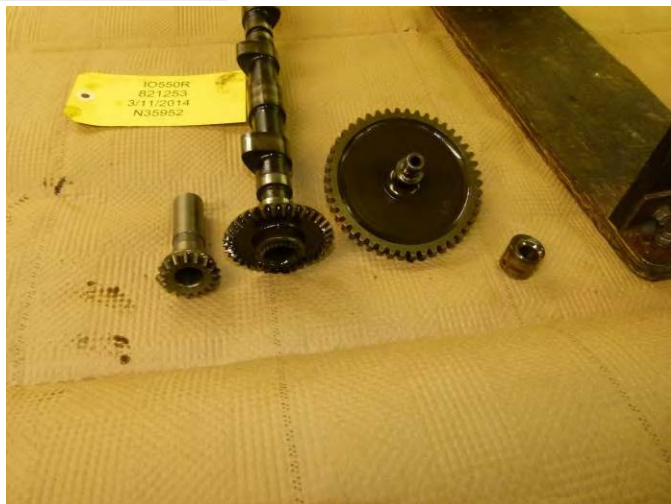
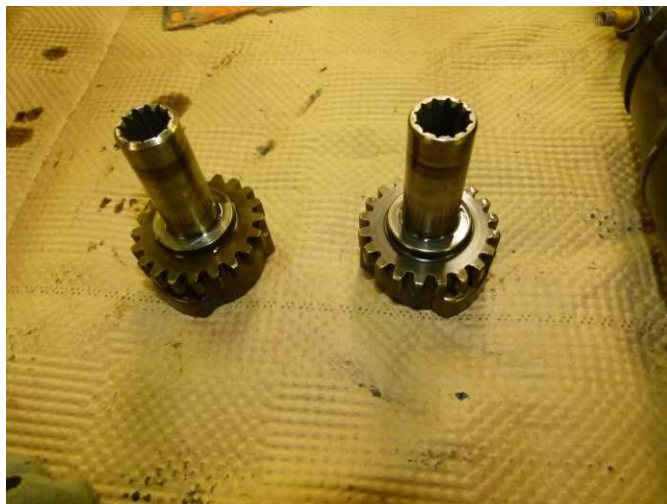
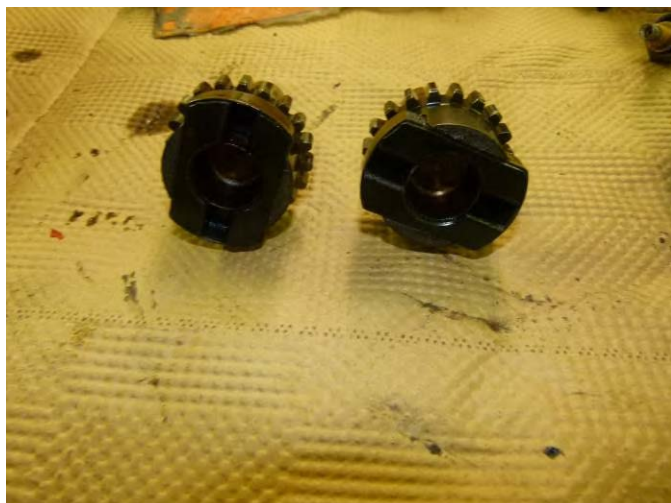
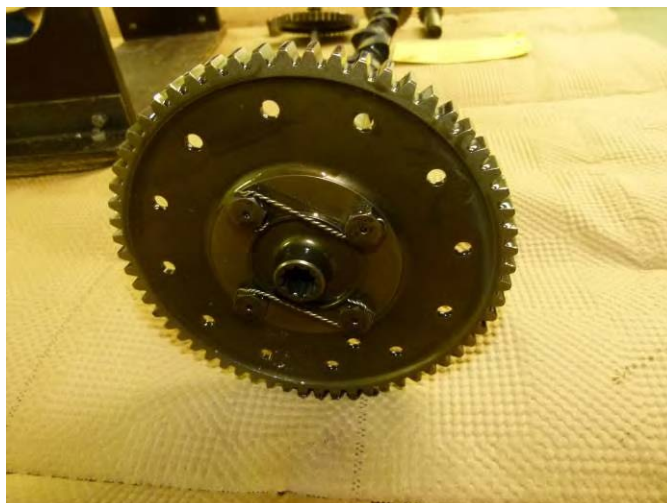
#### Accessory Gears

Condition: The accessory gears had continuity. The teeth were undamaged and exhibited normal operating signatures.

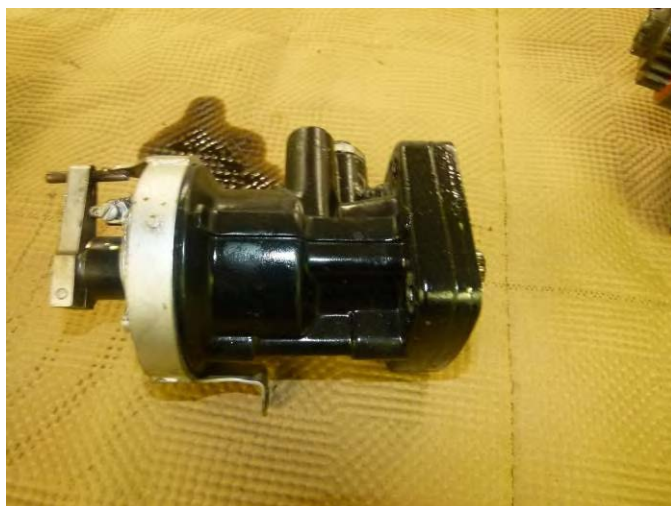
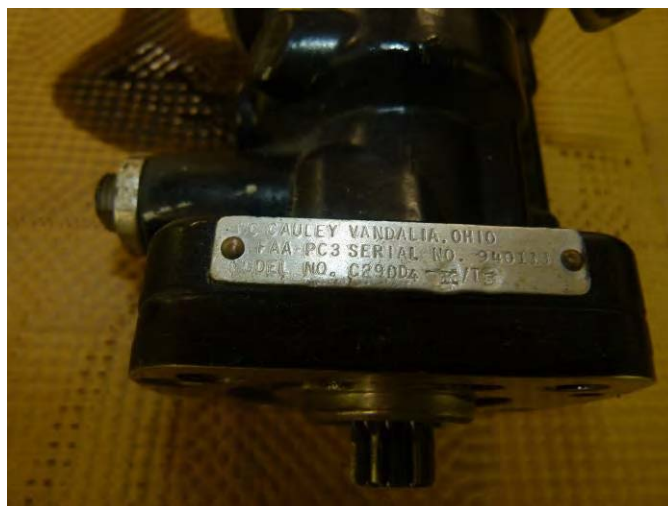
Propeller Governor    Part number: C290D4??/T3

Condition:    The propeller governor could be rotated by hand, was intact and undamaged.

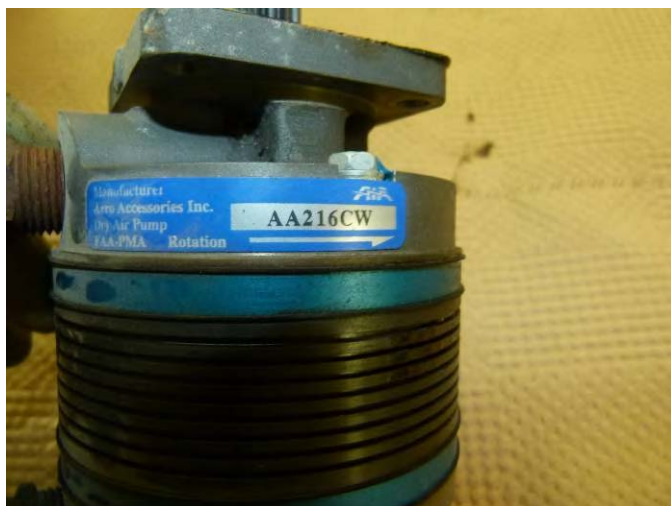
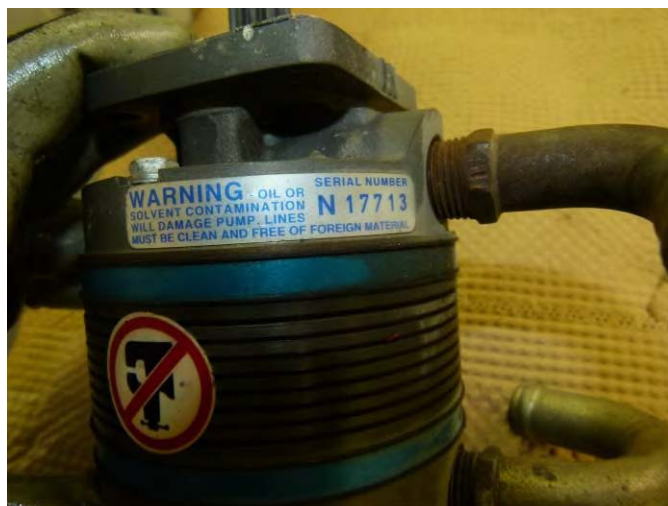
Vacuum Pump    Part number: AA216CW

Condition:    The vacuum pump could be rotated by hand, was intact and undamaged.
