## **NATIONAL TRANSPORTATION SAFETY BOARD**

### **Group Chairman's Weather Study Report**

# **METEOROLOGY**

ANC16FA017

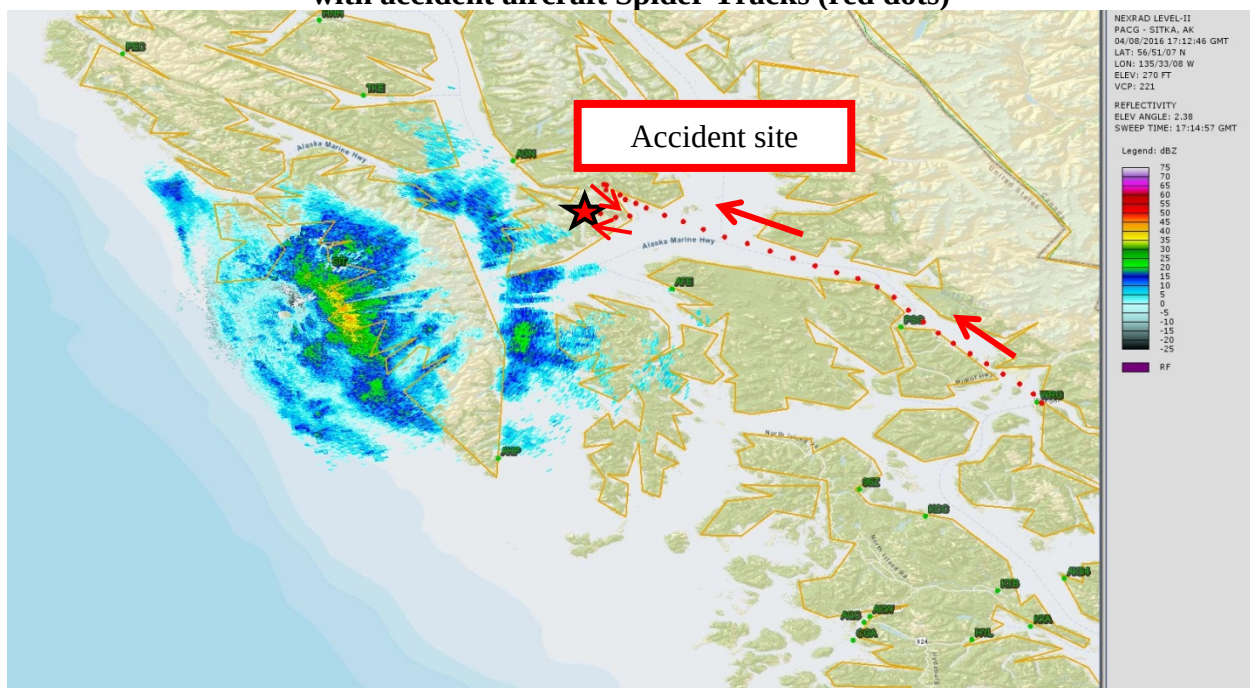
**Figure 9 – PACG WSR-88D reflectivity for the 2.4° elevation scan initiated at 0915 AKDT with accident aircraft Spider Tracks (red dots)**

Based on the beam heights, the 2.4° elevation scan depicted the conditions between 12,310 feet and 17,230 feet msl over the accident site and these are the closest altitudes<sup>16</sup> to the accident flight level without the radar beam being blocked by terrain. Reviewing the weather radar data information to the east of PACG, the 0.5° and 1.4° radar beam was blocked by terrain and therefore indicated no precipitation targets above the accident site. The 2.4° elevation scan was the closest scan to the ground not blocked by terrain indicative of precipitation targets near the accident site.

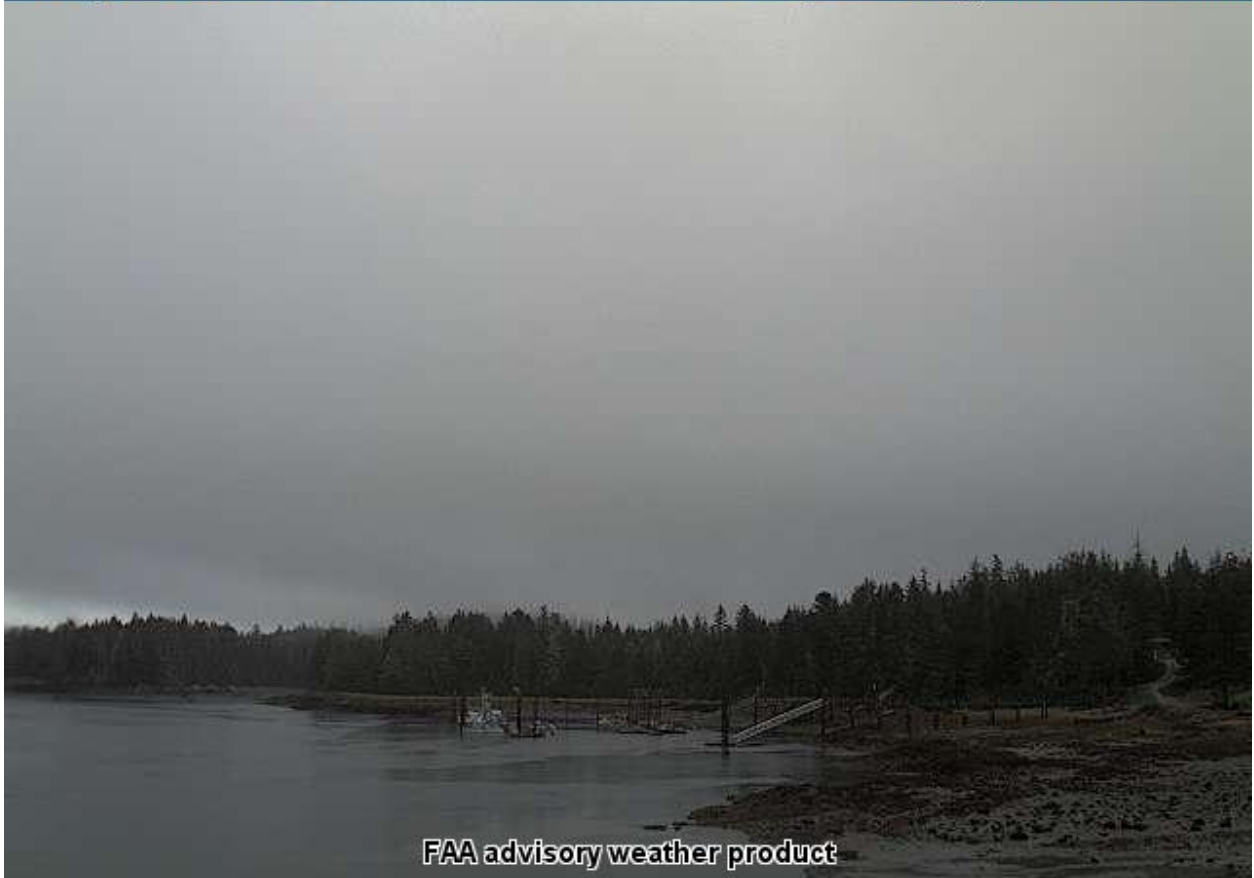
**Figure 12 – FAA weather camera from Angoon southeast looking view from 0855 AKDT**

Images from the FAA's Aviation Weather Cameras are shown in figures 10 through 27 along with attachments 4 through 6 providing images of the weather conditions surrounding the accident site at the accident time. The weather camera from Angoon, 17 miles northwest of the accident site, showed the weather conditions surrounding the accident time with the southeast facing camera images provided in figures 10 through 15 with times from 0855 AKDT through 0925 AKDT. On the southeast facing camera the horizontal visibility conditions were less than 7.5 miles with ceilings under 2,950 feet msl from 0855 through 0925 AKDT with mountain obscuration conditions present the entire time to the southeast of Angoon in the direction of the accident site. The broken ceiling conditions at 500 feet agl reported by PAGN at 0856 AKDT (section 3.0) were present to the southeast of PAGN, and the cloud layer was stratiform in nature with the stratiform conditions spread to the southeast. The northwest facing weather camera from Cape Fanshaw (figures 16 through 21) indicated a similar stratiform nature to the lowest cloud layer with ceiling conditions below 1,650 feet msl between 0850 and 0920 AKDT (figures 18 through 21). In addition, the northwest facing weather camera from Cape Fanshaw indicated an additional lower cloud layer, below the stratiform cloud ceiling layer around 1,500 feet msl, which ran along the mountainous terrain in Pybus Bay. The west facing weather camera from Cape Fanshaw (figures 22 through 27), indicated several different layers of stratiform clouds looking west-southwestward down Frederick Sound towards Baranof Island between 0856 and 0926 AKDT. The least amount of cloud cover was directly down the middle of Frederick Sound with mountain obscuration conditions present on both Admiralty Island and Kupreanof Island.

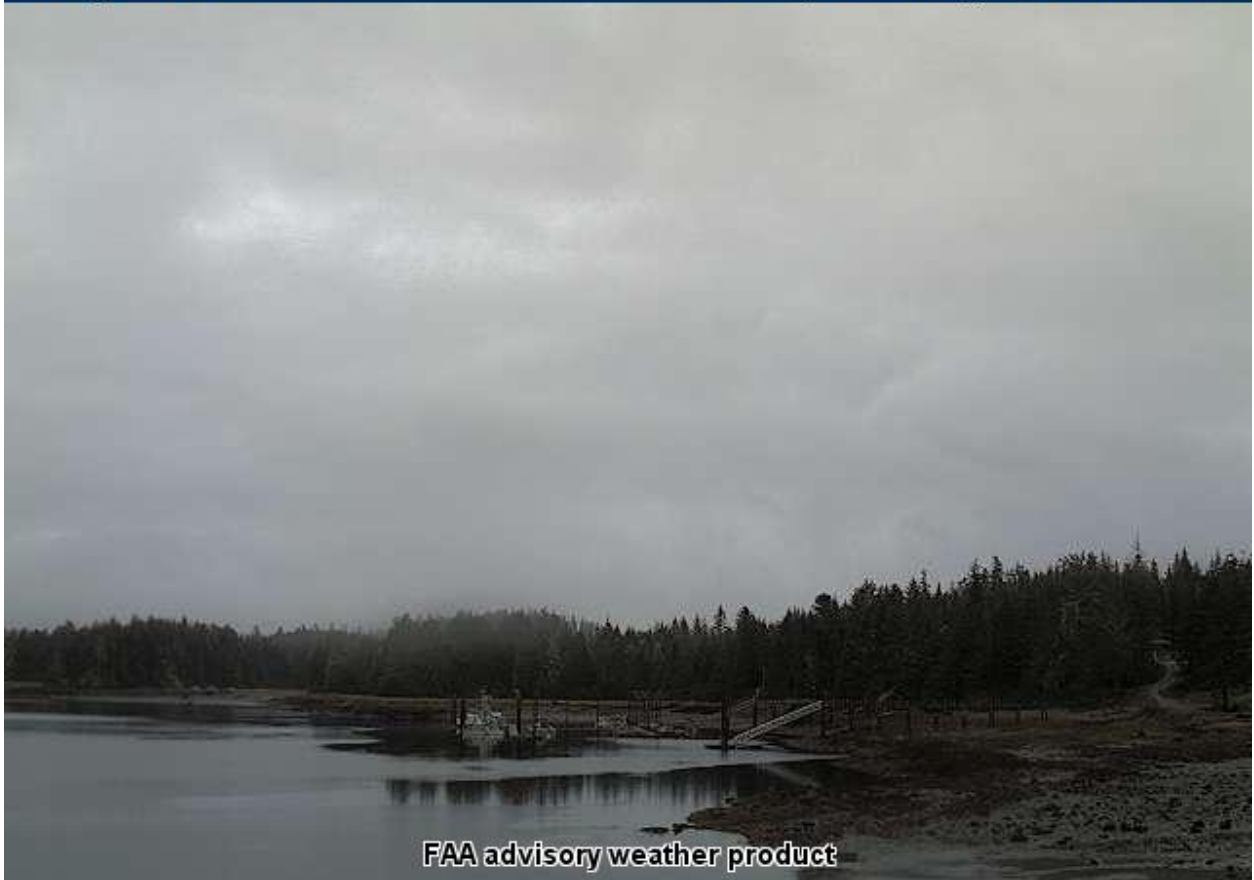
**Figure 13 – FAA weather camera from Angoon southeast looking view from 0905 AKDT**

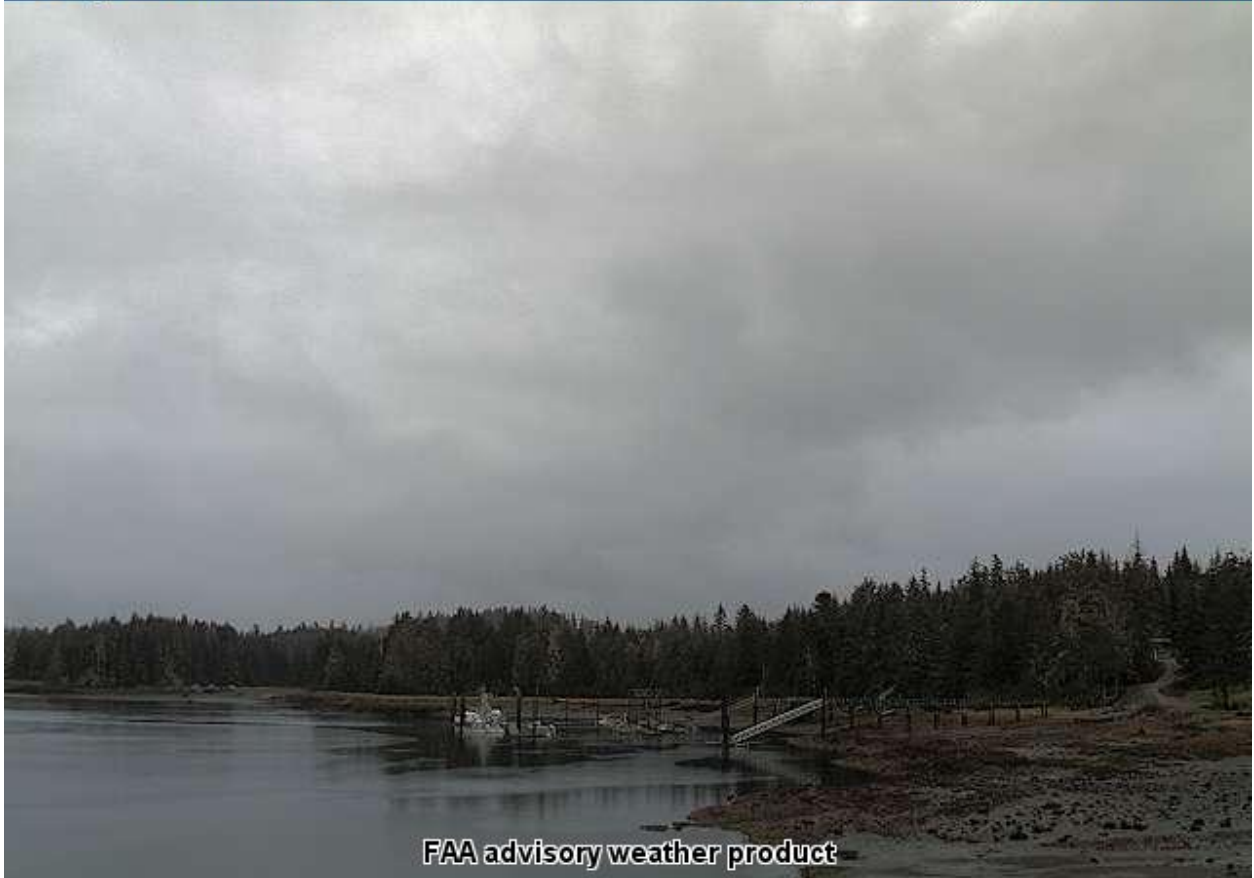
**Figure 14 – FAA weather camera from Angoon southeast looking view from 0915 AKDT**

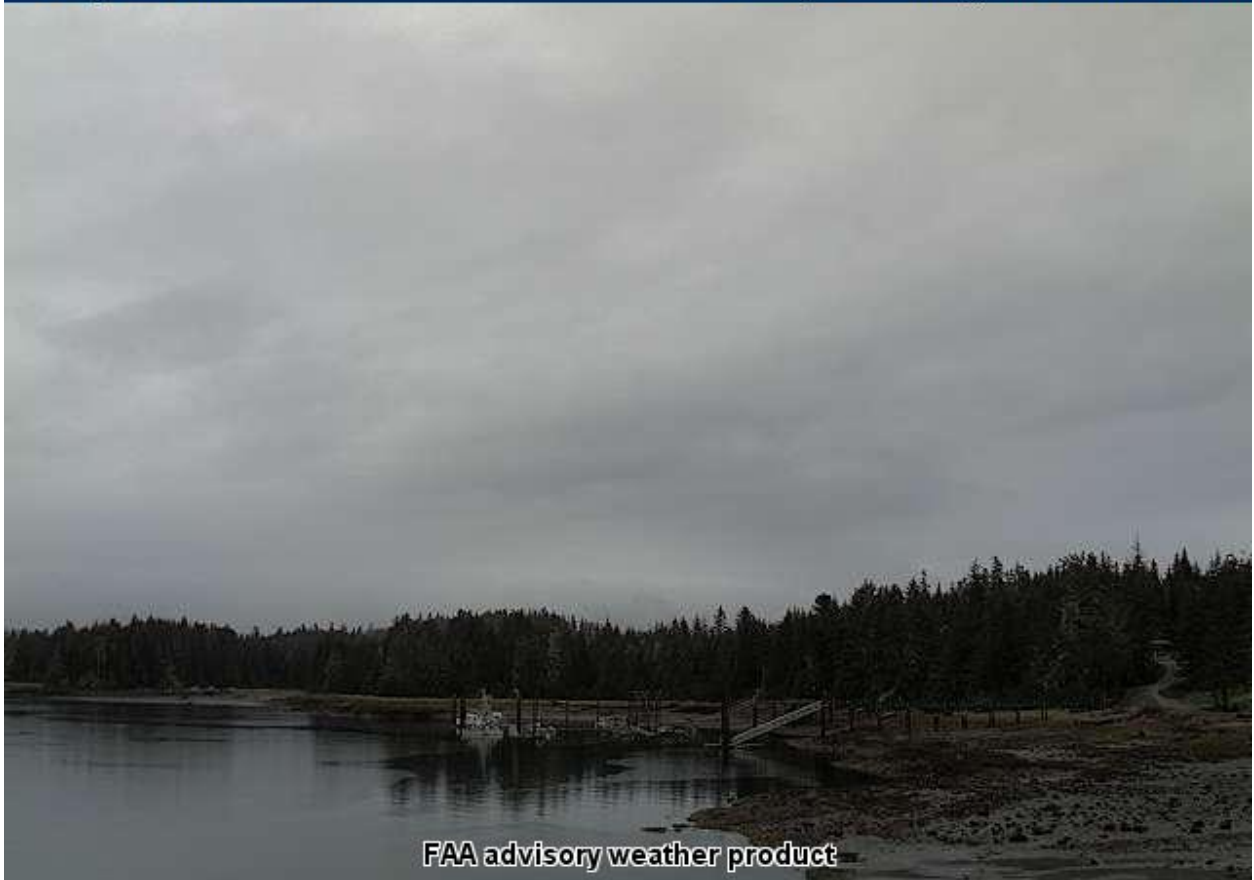
**Figure 15 – FAA weather camera from Angoon southeast looking view from 0925 AKDT**

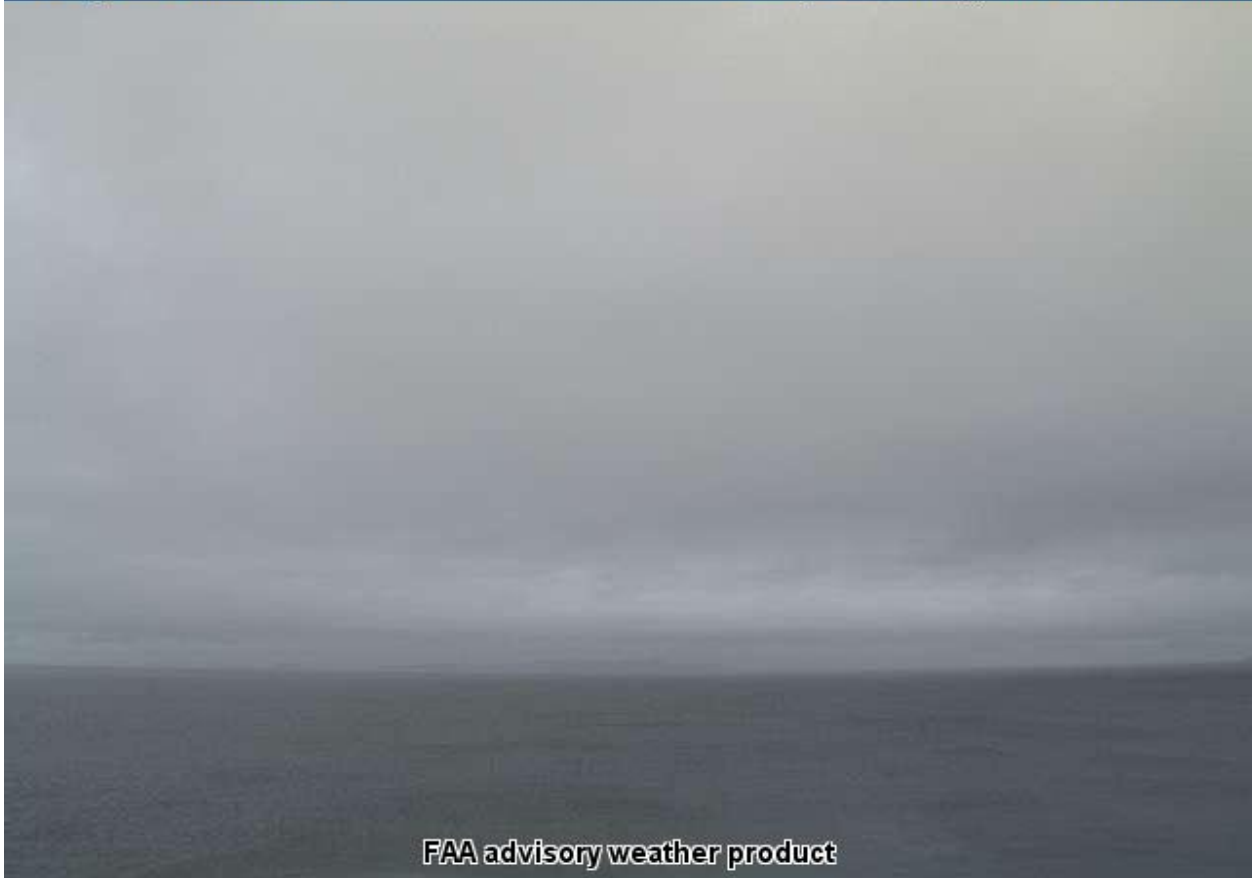
**Figure 18 – FAA weather camera from Cape Fanshaw northwest looking view from 0850 AKDT**

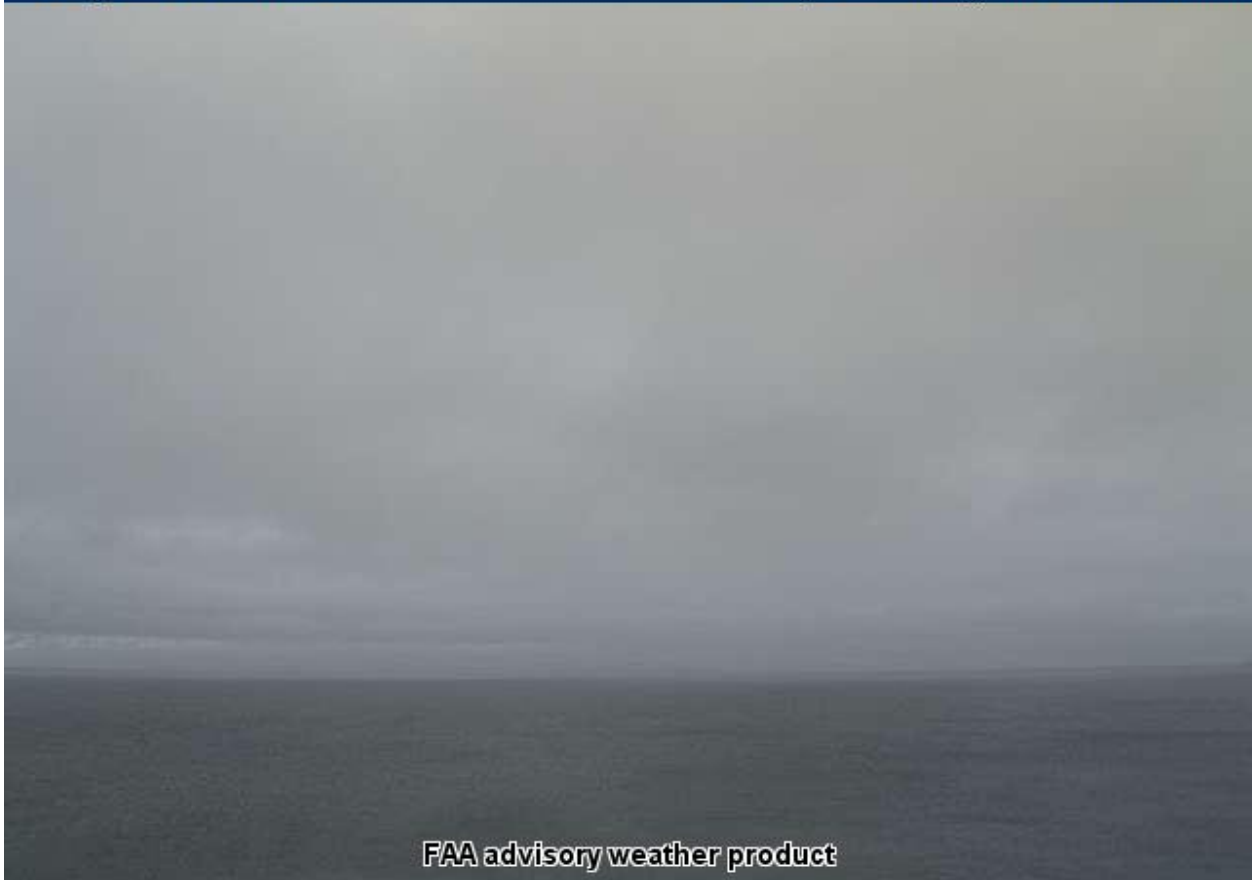
**Figure 19 – FAA weather camera from Cape Fanshaw northwest looking view from 0900 AKDT**

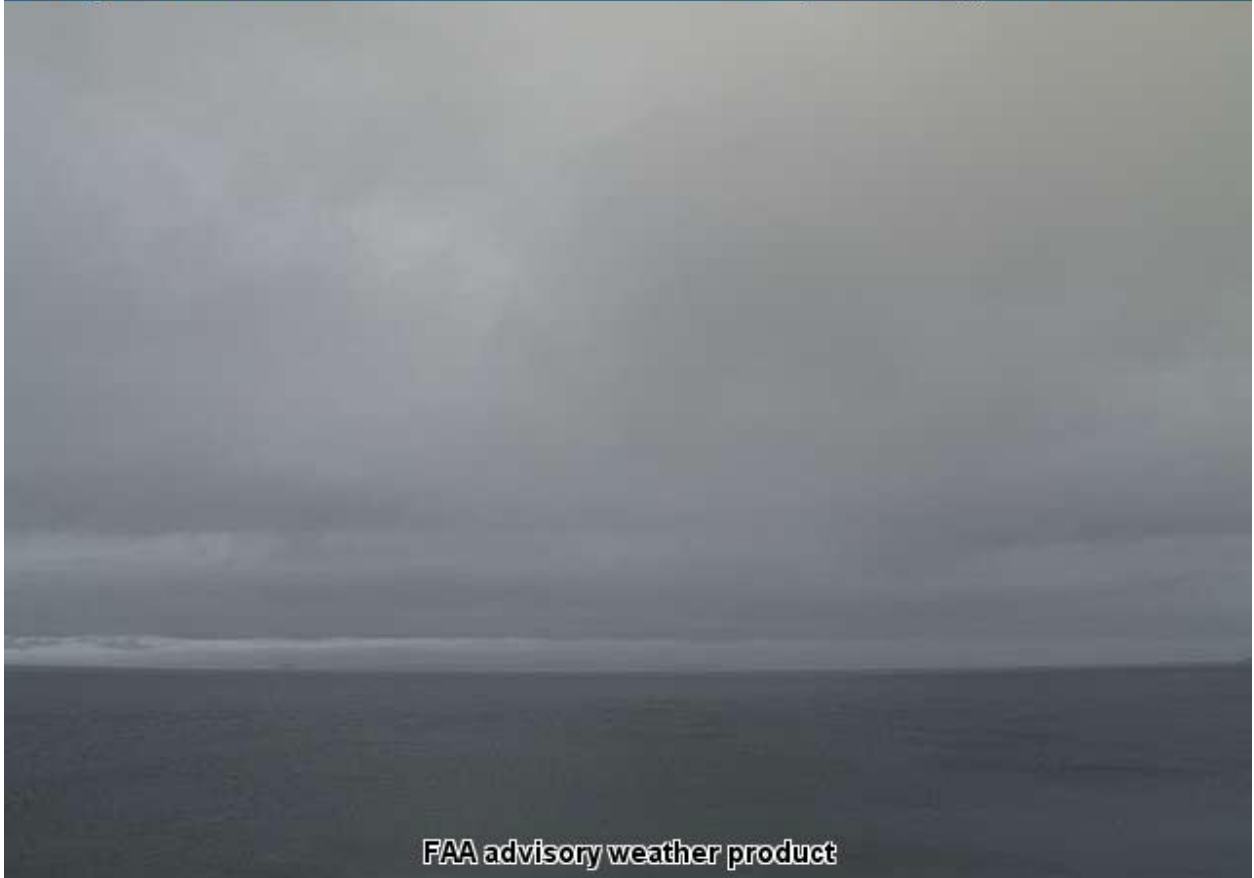
**Figure 20 – FAA weather camera from Cape Fanshaw northwest looking view from 0910 AKDT**

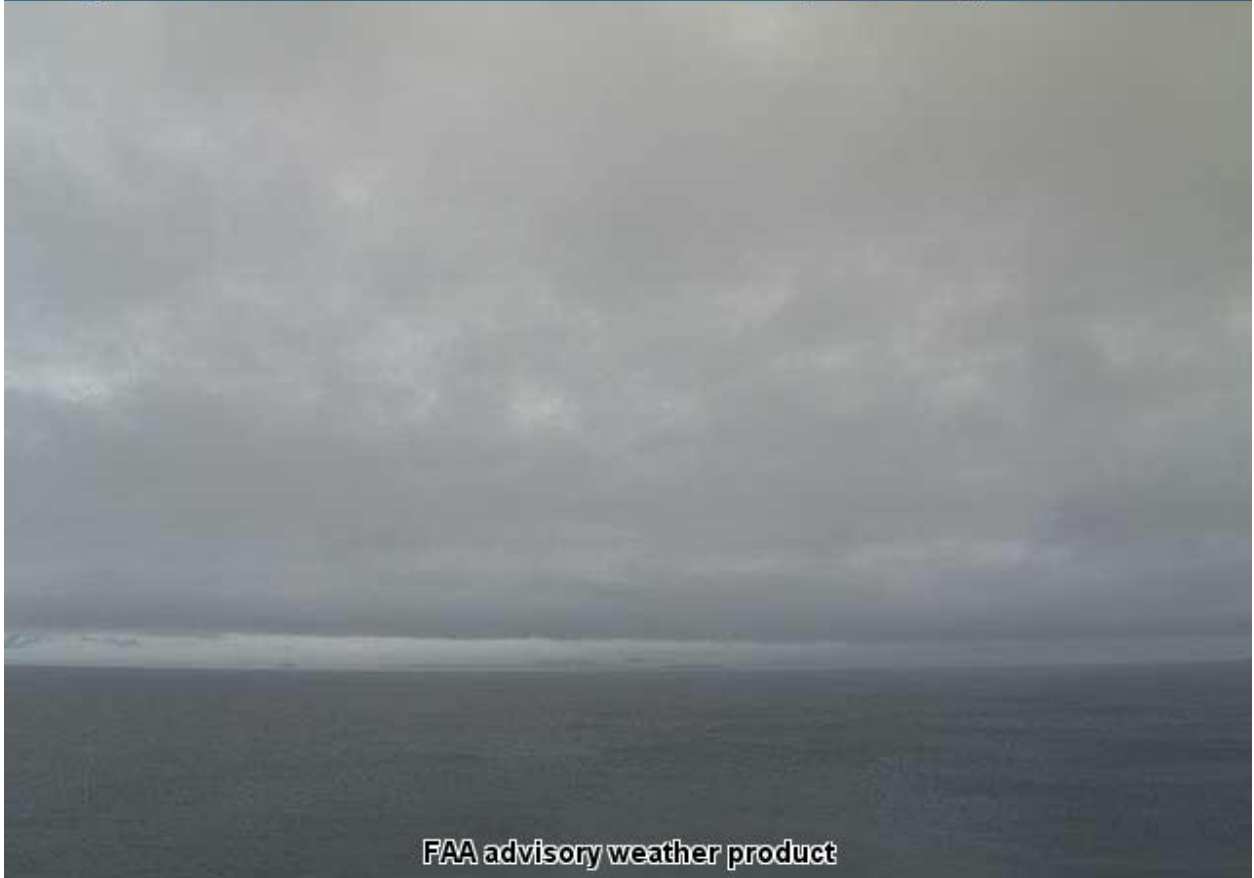
**Figure 21 – FAA weather camera from Cape Fanshaw northwest looking view from 0920 AKDT**

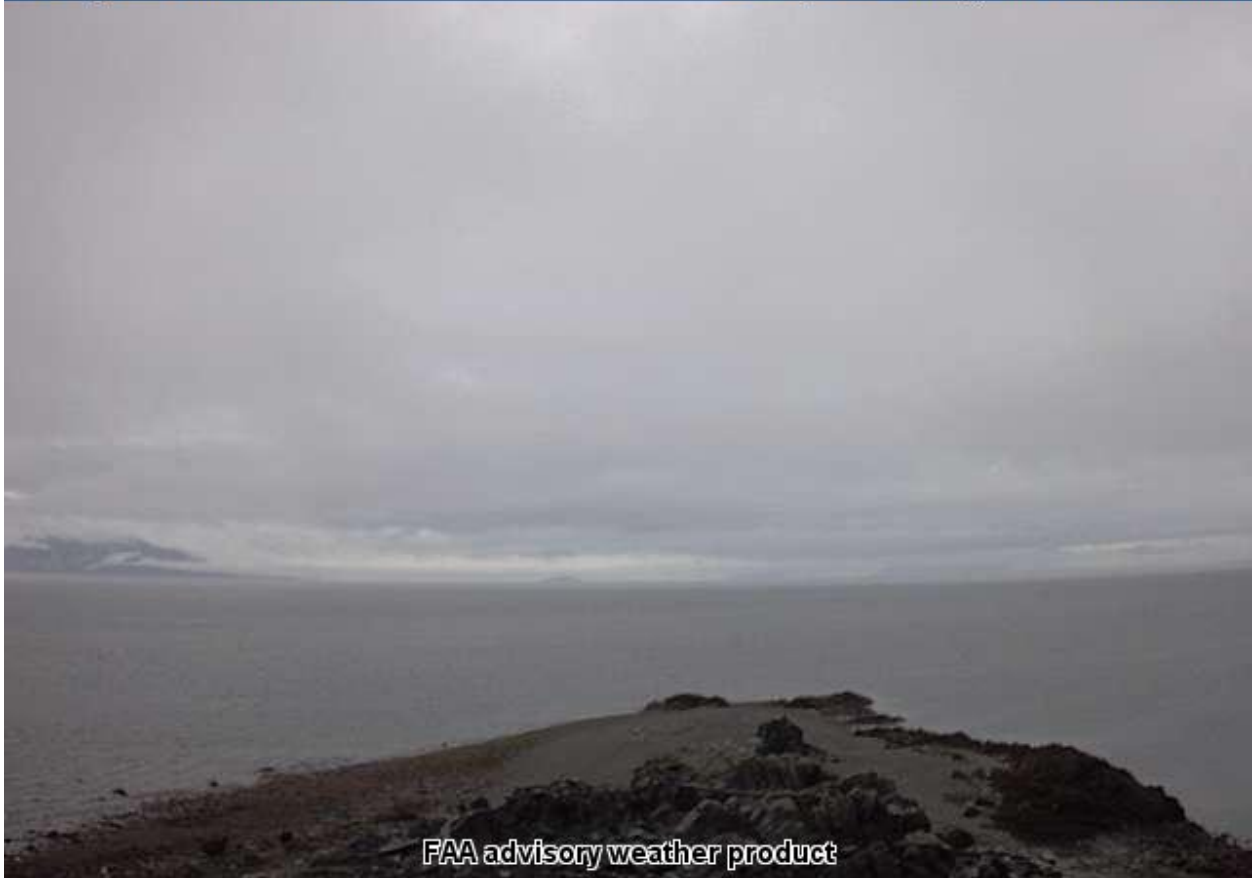
**Figure 24 – FAA weather camera from Cape Fanshaw west looking view from 0856 AKDT**

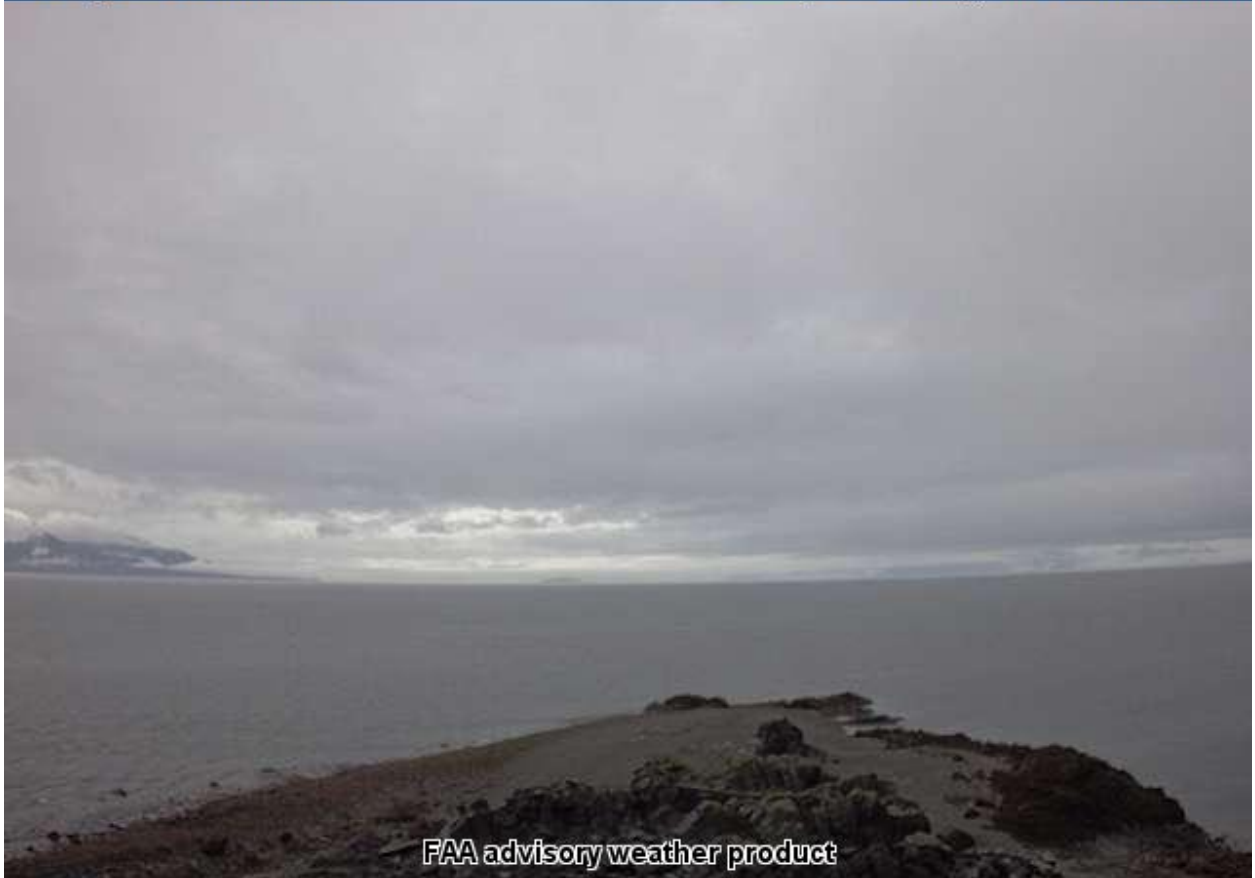
**Figure 25 – FAA weather camera from Cape Fanshaw west looking view from 0906 AKDT**

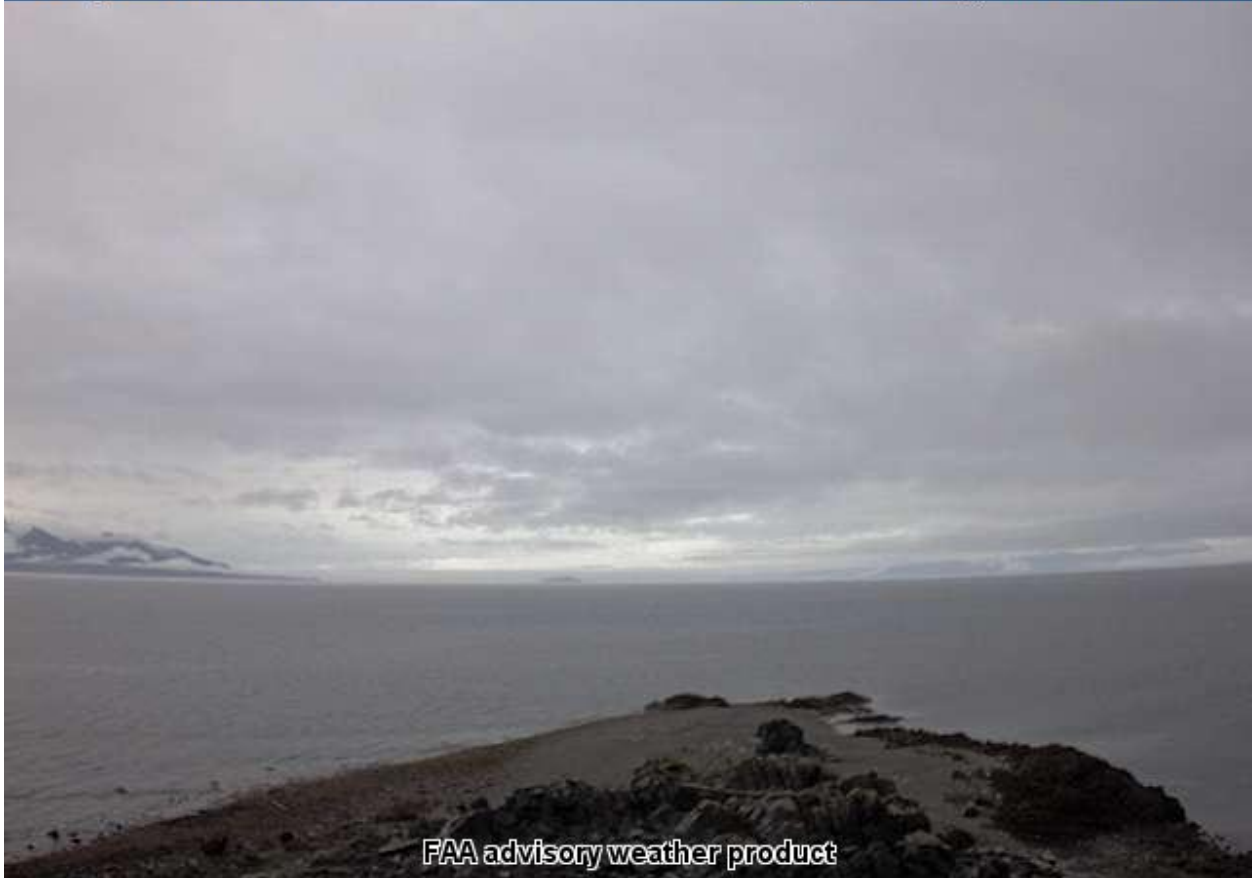
**Figure 26 – FAA weather camera from Cape Fanshaw west looking view from 0916 AKDT**

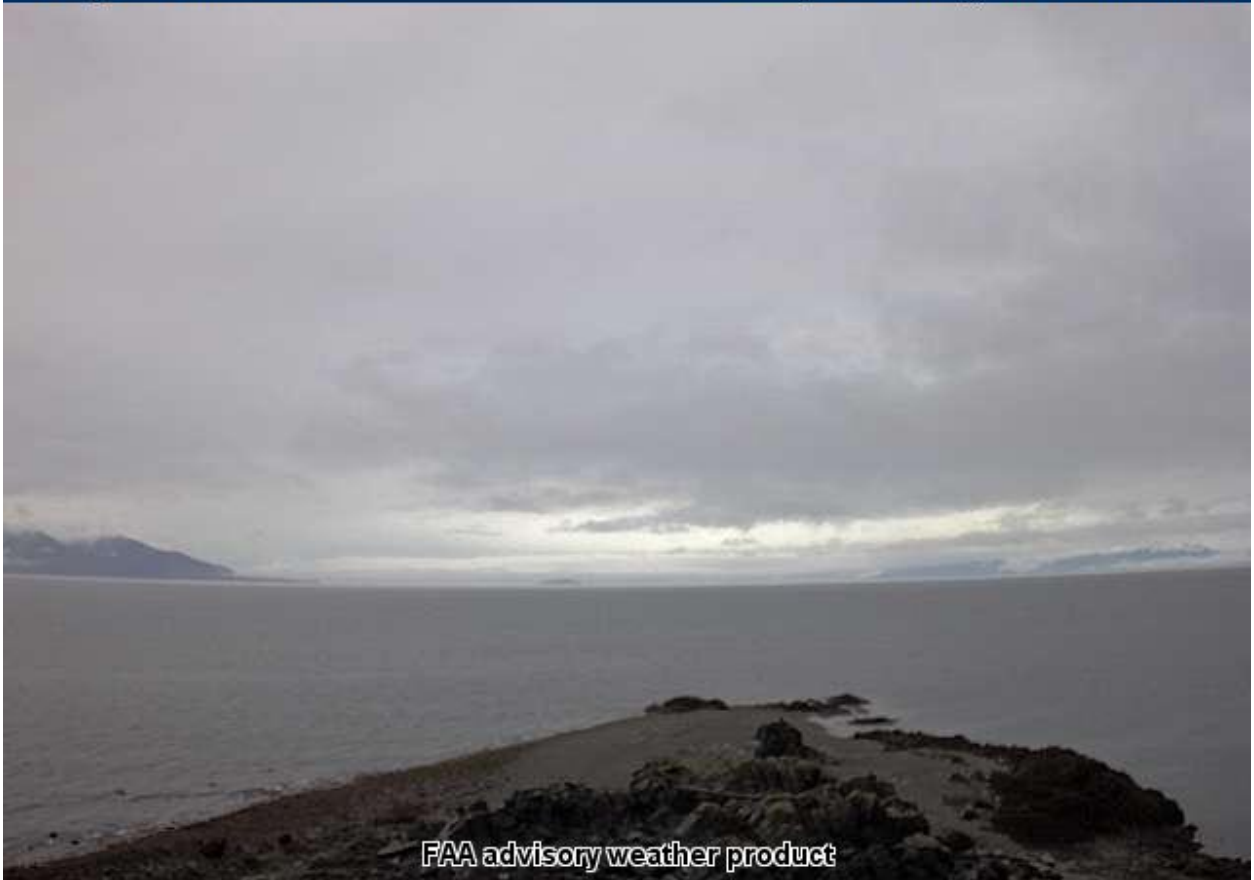
**Figure 27 – FAA weather camera from Cape Fanshaw west looking view from 0926 AKDT**
