## **NATIONAL TRANSPORTATION SAFETY BOARD**

**WEATHER STUDY**

**ANC17FA004**

Location: Port Alsworth, Alaska  
Date: October 28, 2016  
Time: 1828 Alaska daylight time (0228 UTC<sup>1</sup> on October 29, 2016)  
Airplane: Fairchild Heli-Porter Pilatus PC-6; Registration: N5308F

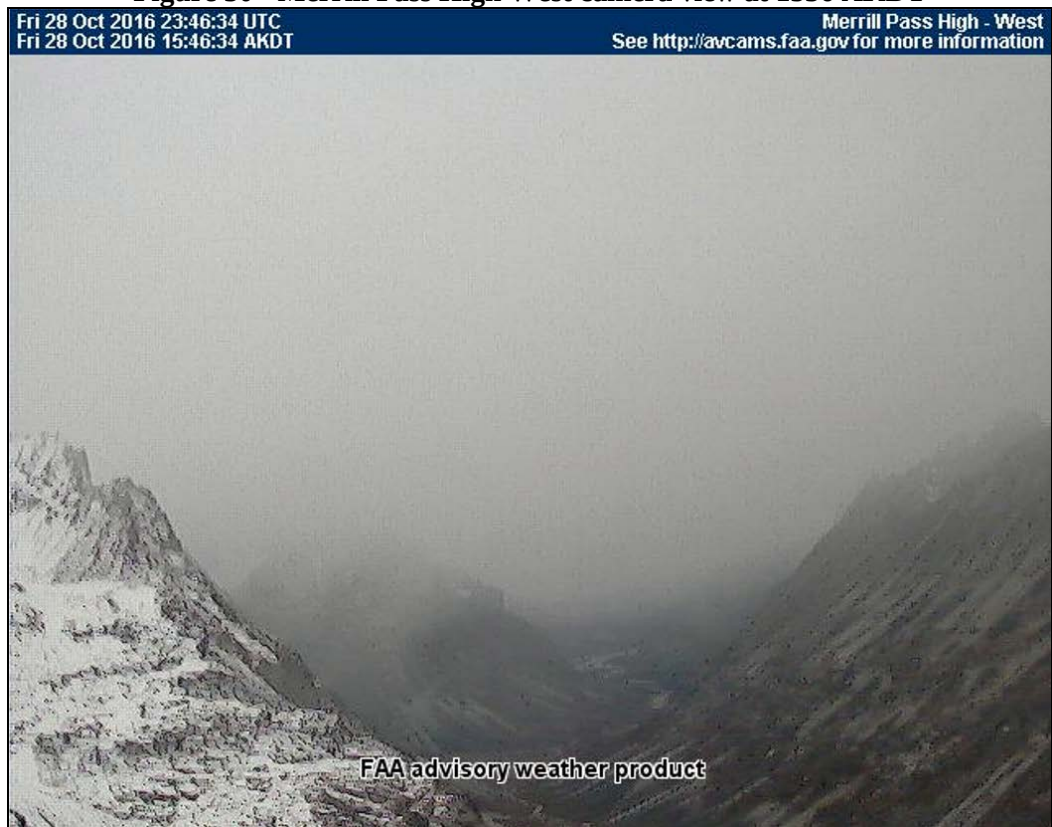
**Figure 31 - Merrill Pass High West camera view at 1546 AKDT**

Figure 30 is the Merrill Pass High West camera view at 1536 AKDT with overcast sky cover and visibility at less than 6 miles, with the distant mountains already hidden from view in precipitation and/or clouds and the higher peaks beginning to be obscured in clouds. Figure 31 is the image at 1546 AKDT continuing to show decreasing sky cover and visibility to less than 4 miles as the closest mountain tops used for reference begin to be obscured in the clouds.

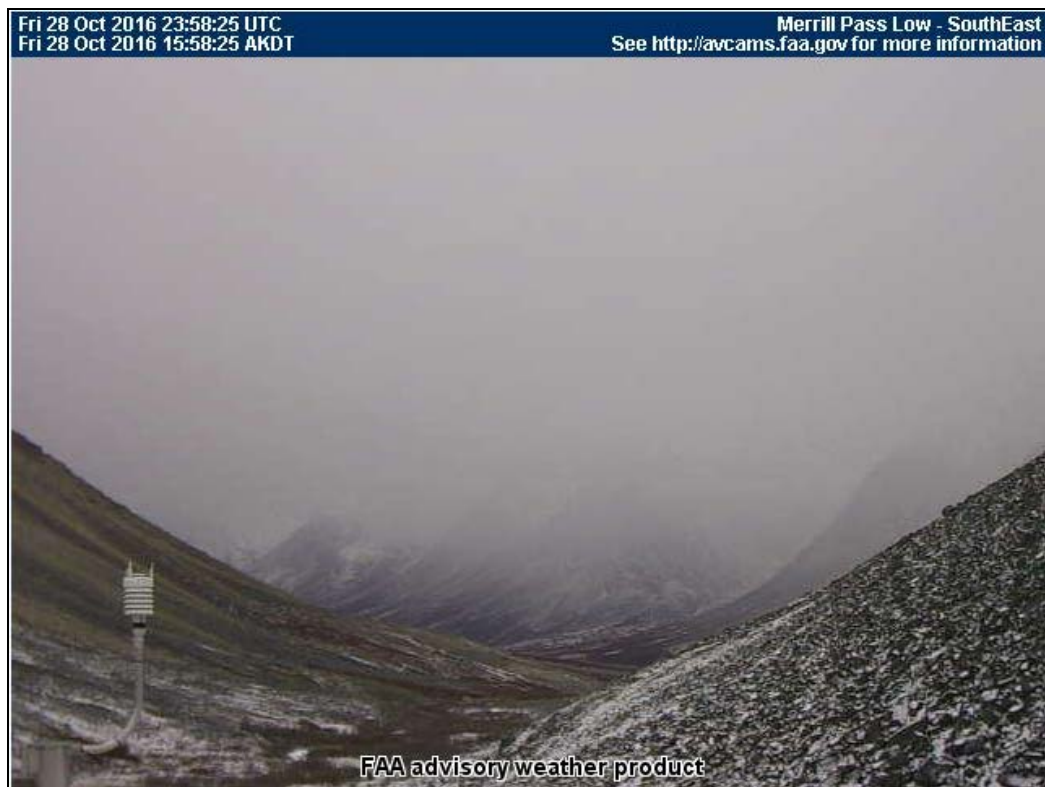
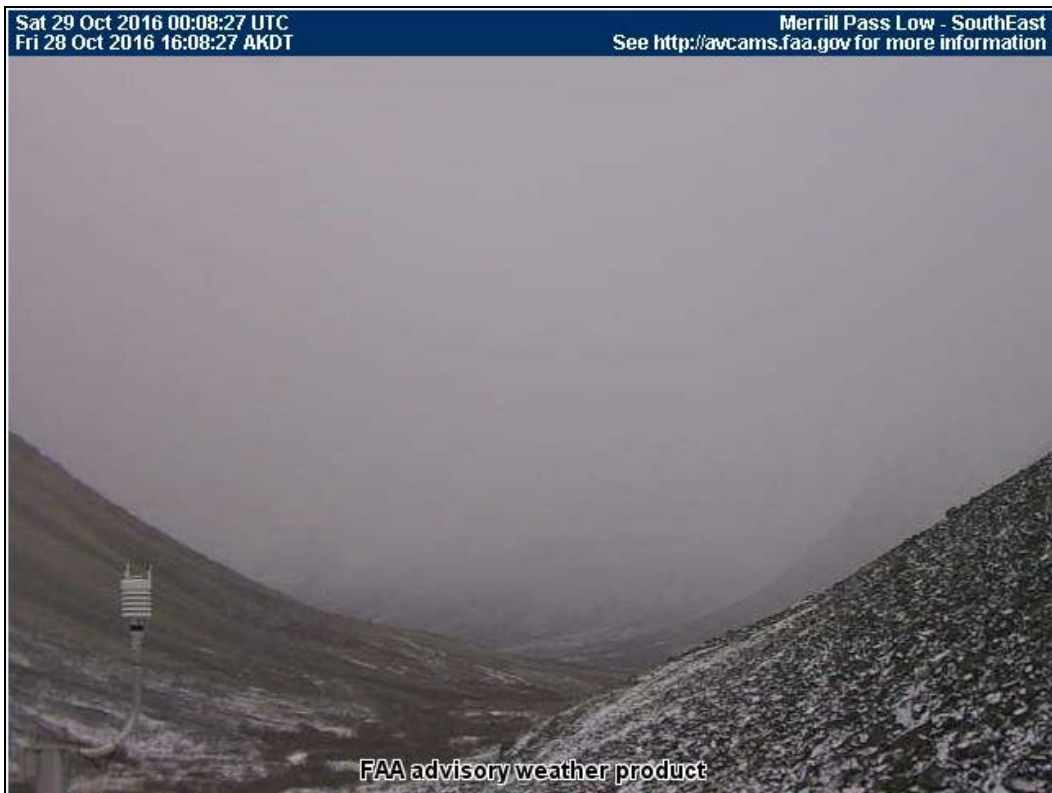
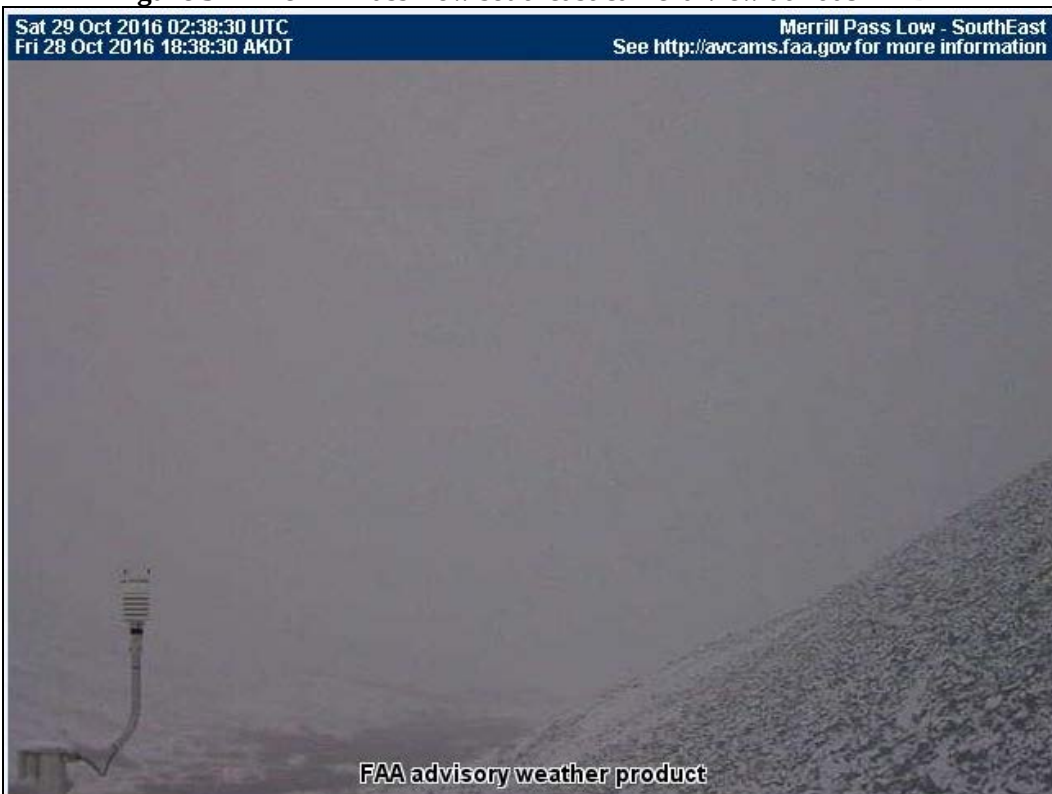
Figure 35 is the Merrill Pass Low southeast camera view reference showing multiple peaks in the vicinity for visibility references on a clear day, followed by figures 36 through 38 with images surrounding the time of the accident at 1558, 1608, and 1838 AKDT. The images show initial overcast skies with the highest peaks above 5,400 feet already obscured by the clouds and with visibility beginning to restricted and rapidly lowering with time by 1608 AKDT, and completely obscured with visibility less than ½ mile at the time of the accident. The images also suggest that snow was falling during the period with the terrain being covered in snow by the time of the accident.

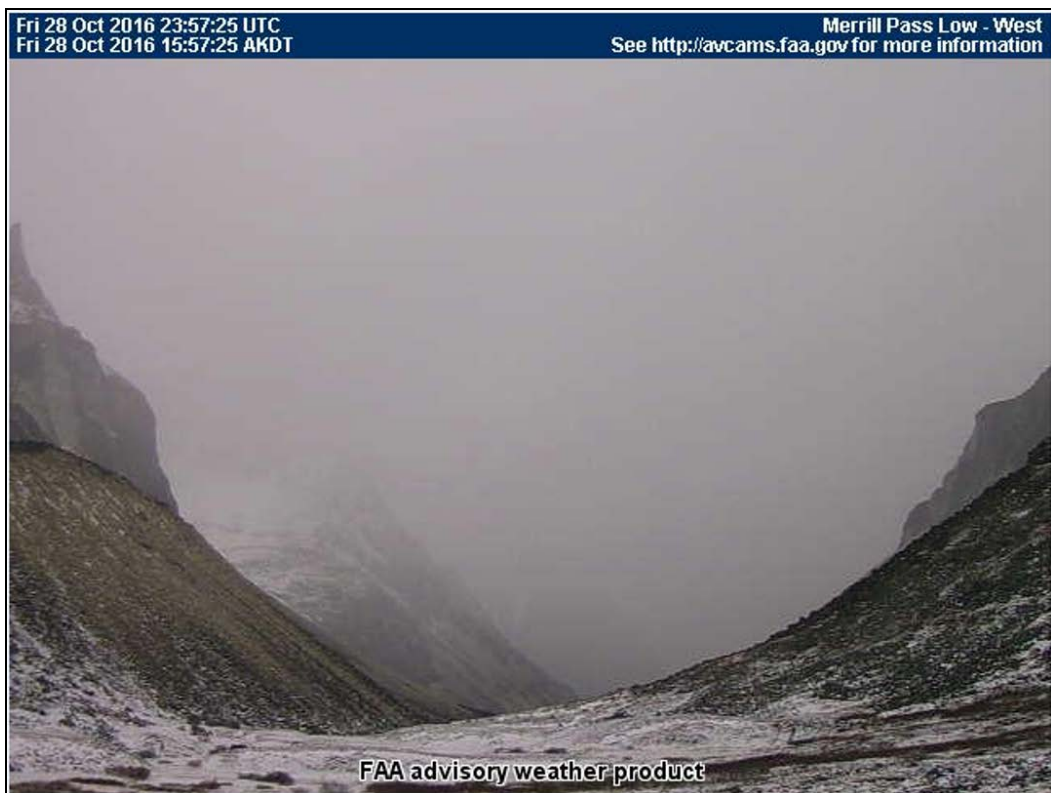
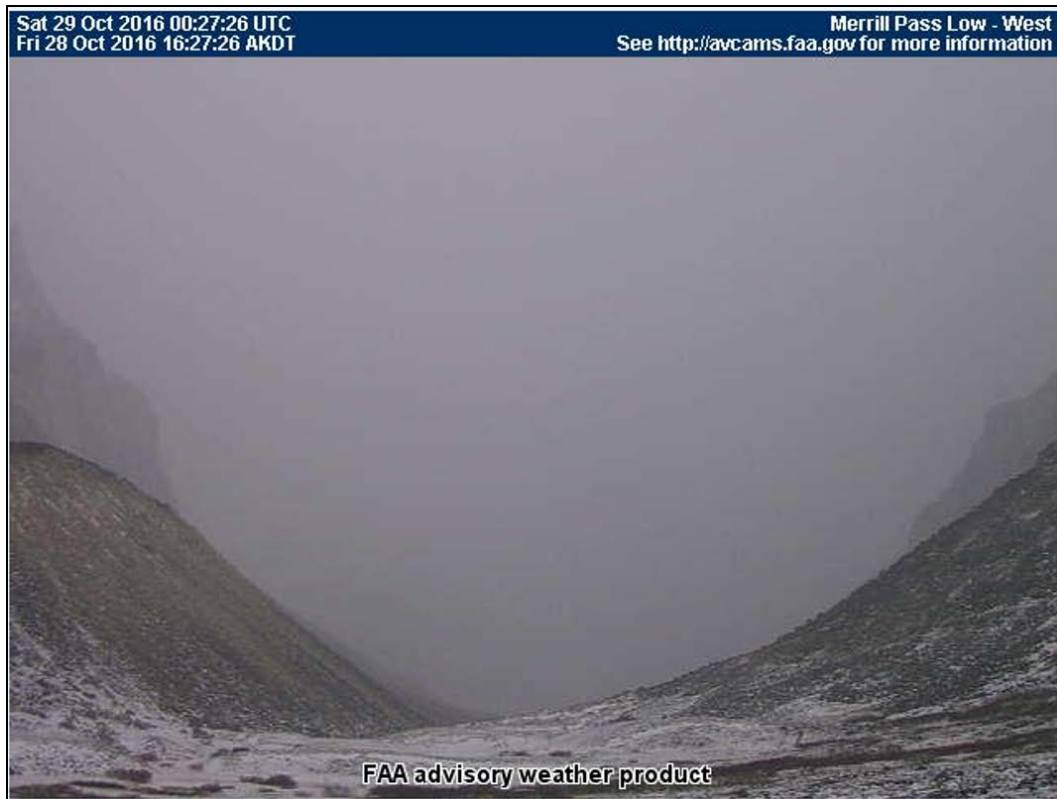
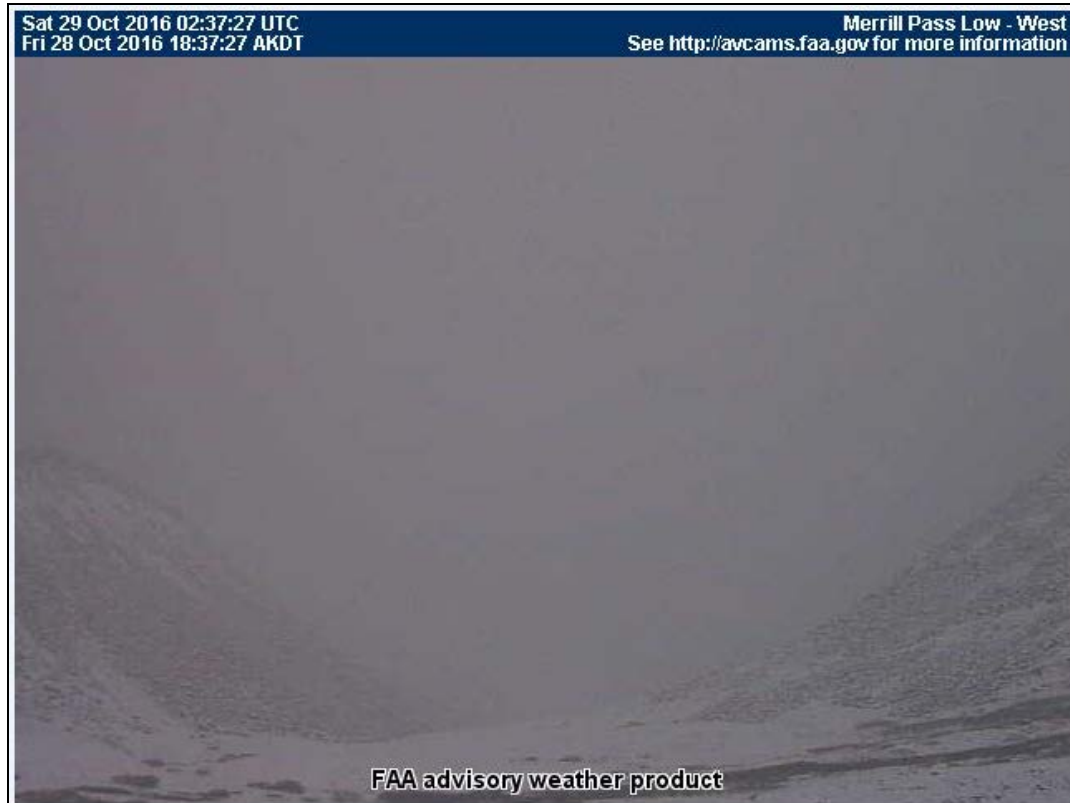
Figure 39 is the Merrill Pass Low west camera view reference on a clear day showing the high peaks and visibility references on a clear day, follow figures 40 through 43 with images at 1537, 1557, 1627, and 1837 AKDT and shows similar rapidly deteriorating conditions surrounding the period with snow.

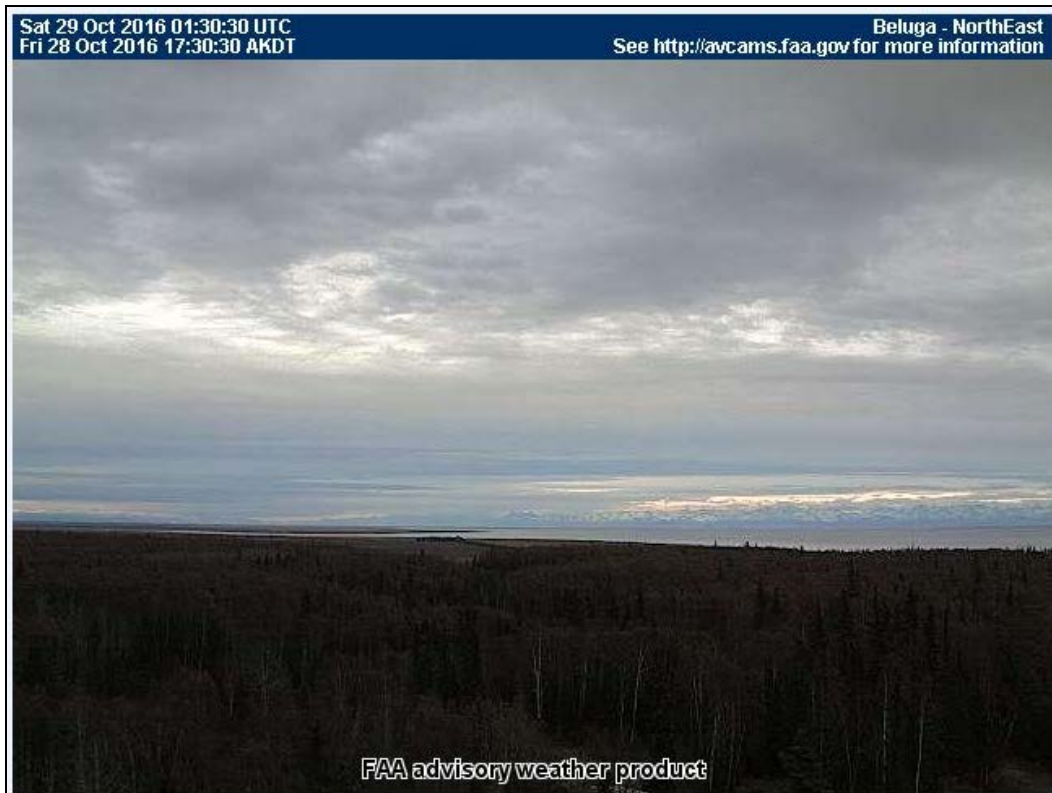
The first camera along the route was Beluga (BLG) located at 61°11'7.775" north latitude and 151° 2'4.438" west longitude, at an elevation of 75 feet. The Beluga northeast or 062° camera view on a clear day is included as figure 44, followed by figure 45 which is the image on the day of the accident at 1730 AKDT when the accident airplane overflew the location at an altitude of approximately 4,800 feet. The image depicted a broken layer of altostratus type clouds with unrestricted visibility under the cloud layer with Cook Inlet and the snowcapped mountains observed on the horizon.

Figure 45 - Beluga northeast camera view at 1730 AKDT when accident airplane overflow the area

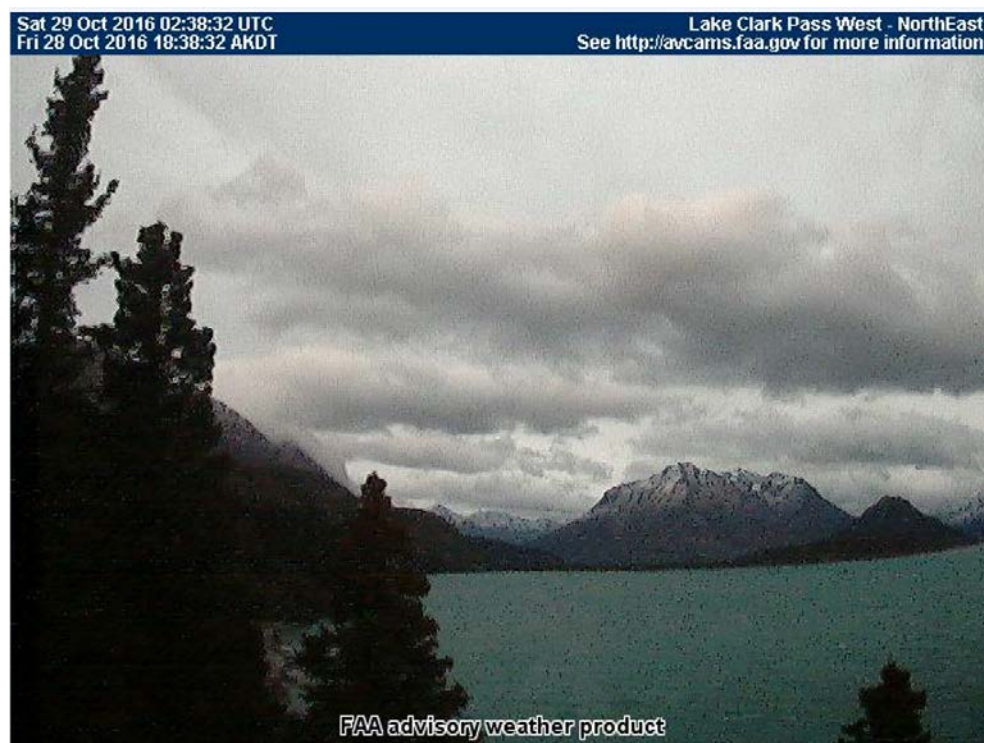
Figure 59 - Lake Clark Pass West northeast camera view at 1838 AKDT

Lake Clark Pass West (QLW) was located near the northeast tip of the Lake Clark at coordinates 60° 22'25.32" N latitude and 153° 53'24" W longitude, at an elevation of 261 feet. The accident site was located approximately 45 miles north-northeast or 017° from the camera. Figures 58 and 59 are the lake Clark Pass West northeast or 033° camera view on a clear day and at 1838 AKDT or the approximate time of the accident, with clouds above the higher elevation and visibility unrestricted below the clouds. The animation of the images (attachment 6) shows the trees swaying in relatively strong easterly winds with white caps on Lake Clark during the period. The band of clouds also show little motion with time and show signs of orographic clouds associated with mountain wave activity.
