# NATIONAL TRANSPORTATION SAFETY BOARD

## Electronic Devices

**Specialist's Factual Report**  
**By Christopher Babcock**

Location: Lake Clark National Park, Alaska  
Date: October 28, 2016  
Aircraft: Pilatus PC-6  
Registration: N5308F  
Operator: Private  
NTSB Number: ANC17FA004

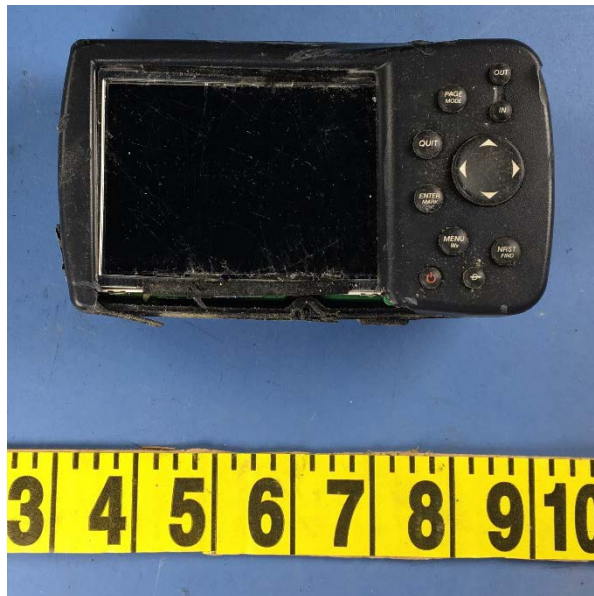
Upon arrival at the laboratory, mechanical damage was noted on the device (Figure 1). Data recovery was attempted by connecting the device to a computer running manufacturer software, but the device was not recognized by the computer.

**Figure 1.** Photo of damaged Garmin GPSMAP 396, as received.

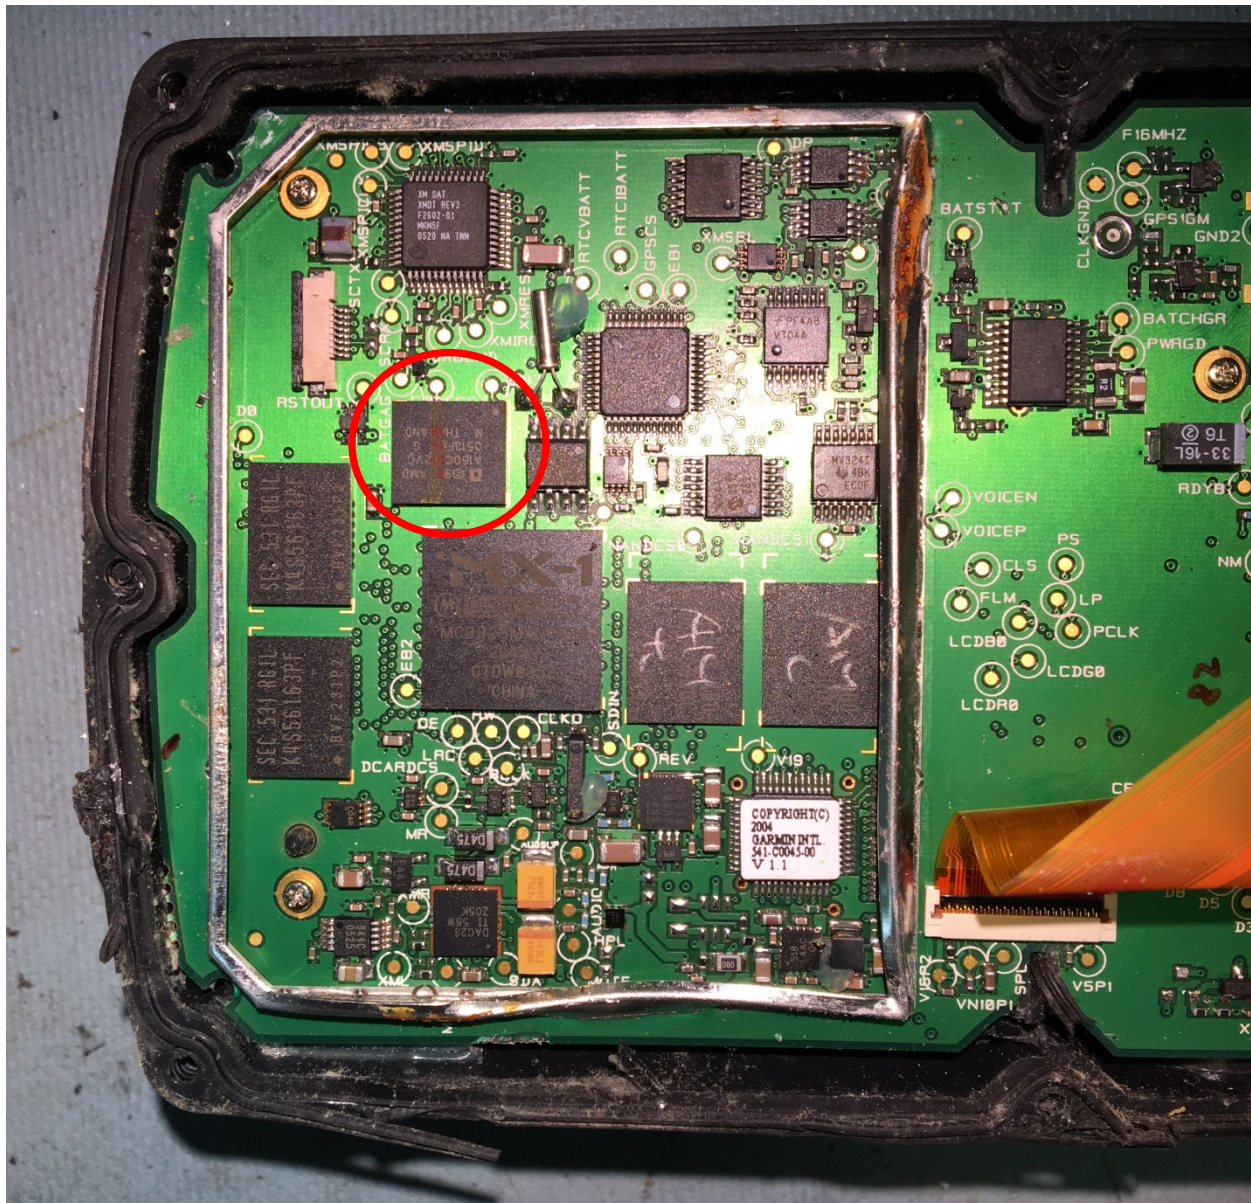
The flash memory chip containing the non-volatile (NVM) memory was removed and imaged using a chip reader (Figure 2).<sup>1</sup> Examination of the image file revealed 33 power cycles of the GPS between September 25, 2015, and October 24, 2016. Several power cycles contained only a few points of ground operation. The last flight recorded was April

**Figure 2.** Chip containing NVM (circled in red).

9, 2016. Seventeen flights were recorded between Anchorage and an airstrip northeast of Port Alsworth Airport.

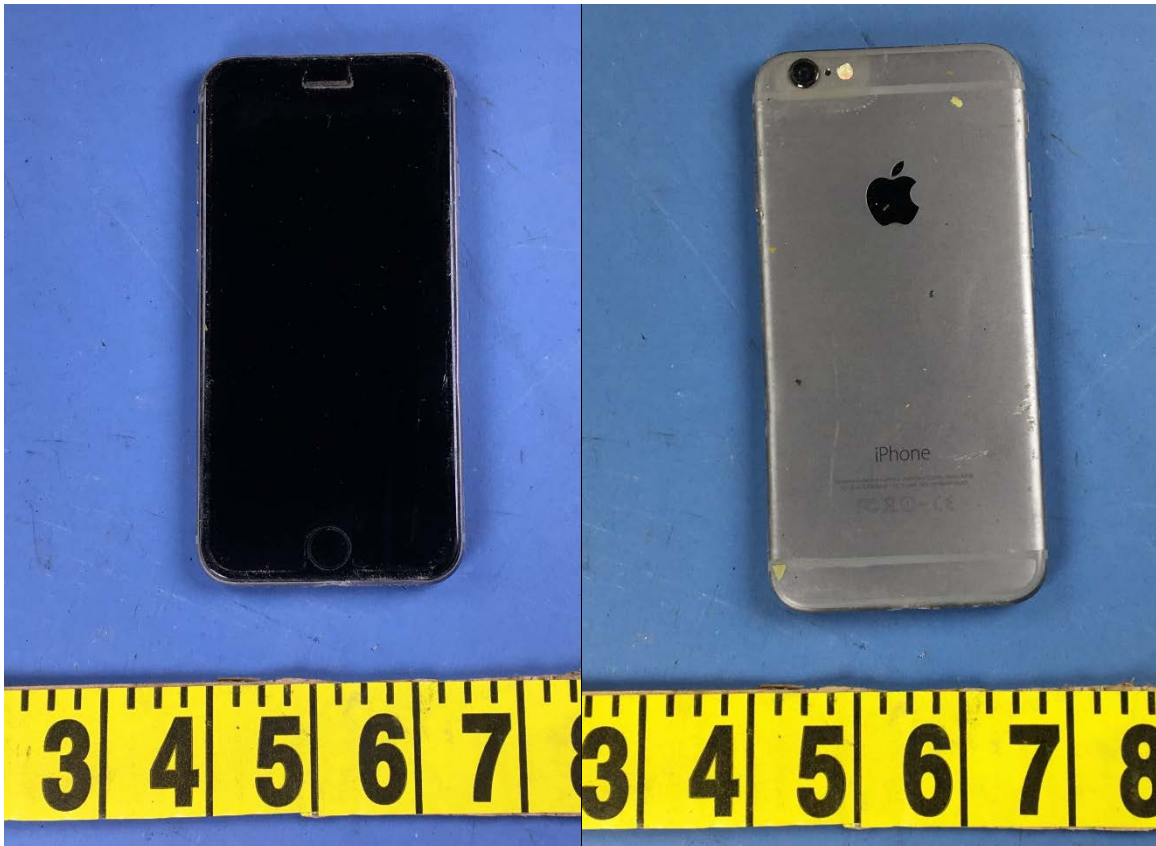
Upon arrival at the laboratory, mechanical damage was observed on the device, however it was able to power on (Figure 3). The device was locked with a passcode. In consultation with the investigator in charge, no further attempts were made to access the device.

**Figure 3.** Front and rear of the iPhone, as received.
