# NATIONAL TRANSPORTATION SAFETY BOARD

## Global Positioning System Device

### Specialist's Factual Report

Location: Fairbanks, Alaska  
Date: December 7, 2016  
Aircraft: Bellanca Citabria 7GCBC  
Registration: N88452  
Operator: Private  
NTSB Number: ANC17FA009

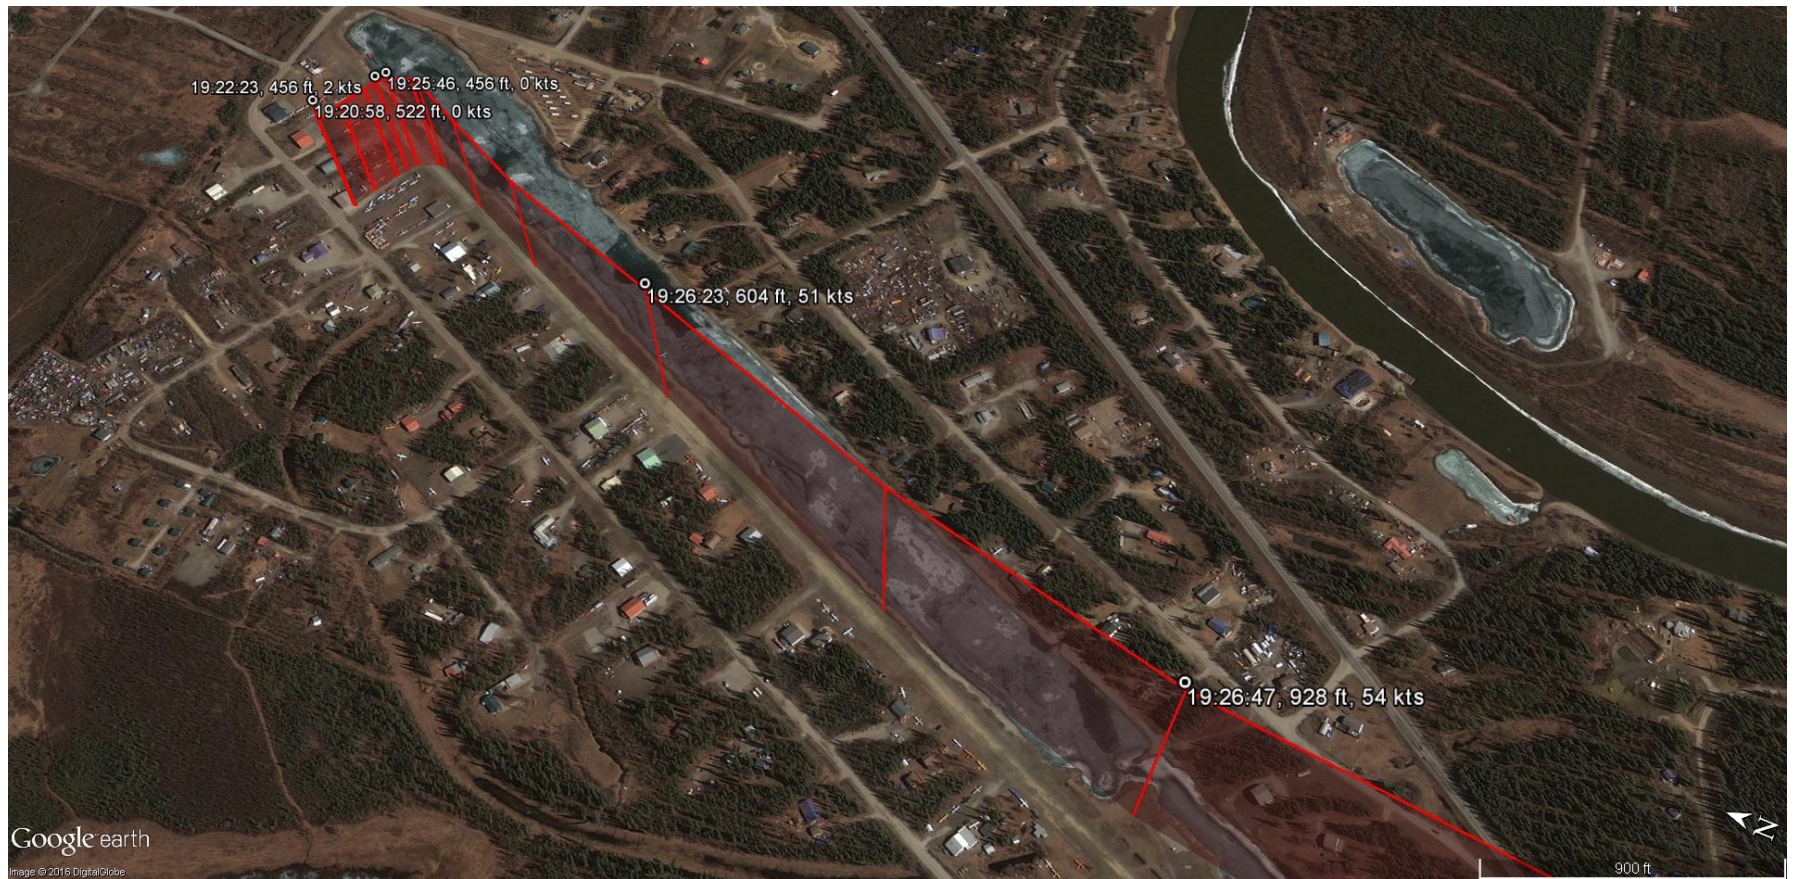
Figures 1 through 7 show Google Earth overlays of the accident flight with different areas of focus. In figure 3, the overlay is displaced above the ground when the aircraft is on the ground; this may happen for a number of reasons, including Earth model discrepancies, or GPS vertical accuracy.

**Figure 3. Start of accident flight recording.**

- The recording began at the Chena Marina Airport at 19:20:58 UTC. From about 19:22:23 UTC to 19:25:46 UTC, the aircraft was stationary near the north side of the runway. By 19:26:23 UTC, the aircraft had begun its takeoff.
- Between 19:33 UTC and 19:37 UTC, the aircraft performed three, 360 degree turns at about 1,500 feet over the Tanana Flats, and then continued southbound.
- At about 19:40:11 UTC, the aircraft started a left turn towards the southeast at a groundspeed of about 75 knots.
- Between 19:41:03 UTC and 19:42:28 UTC, the recorded GPS altitude decreased from 1,532 feet to 1,417 feet, with a groundspeed of about 75 knots.
- Between 19:42:28 UTC and 19:43:28 UTC, the recorded GPS altitude decreased from 1,417 feet to 981 feet, and the groundspeed decreased to 26 knots. Due to the straight path during this period, the derived groundspeeds are relatively accurate.

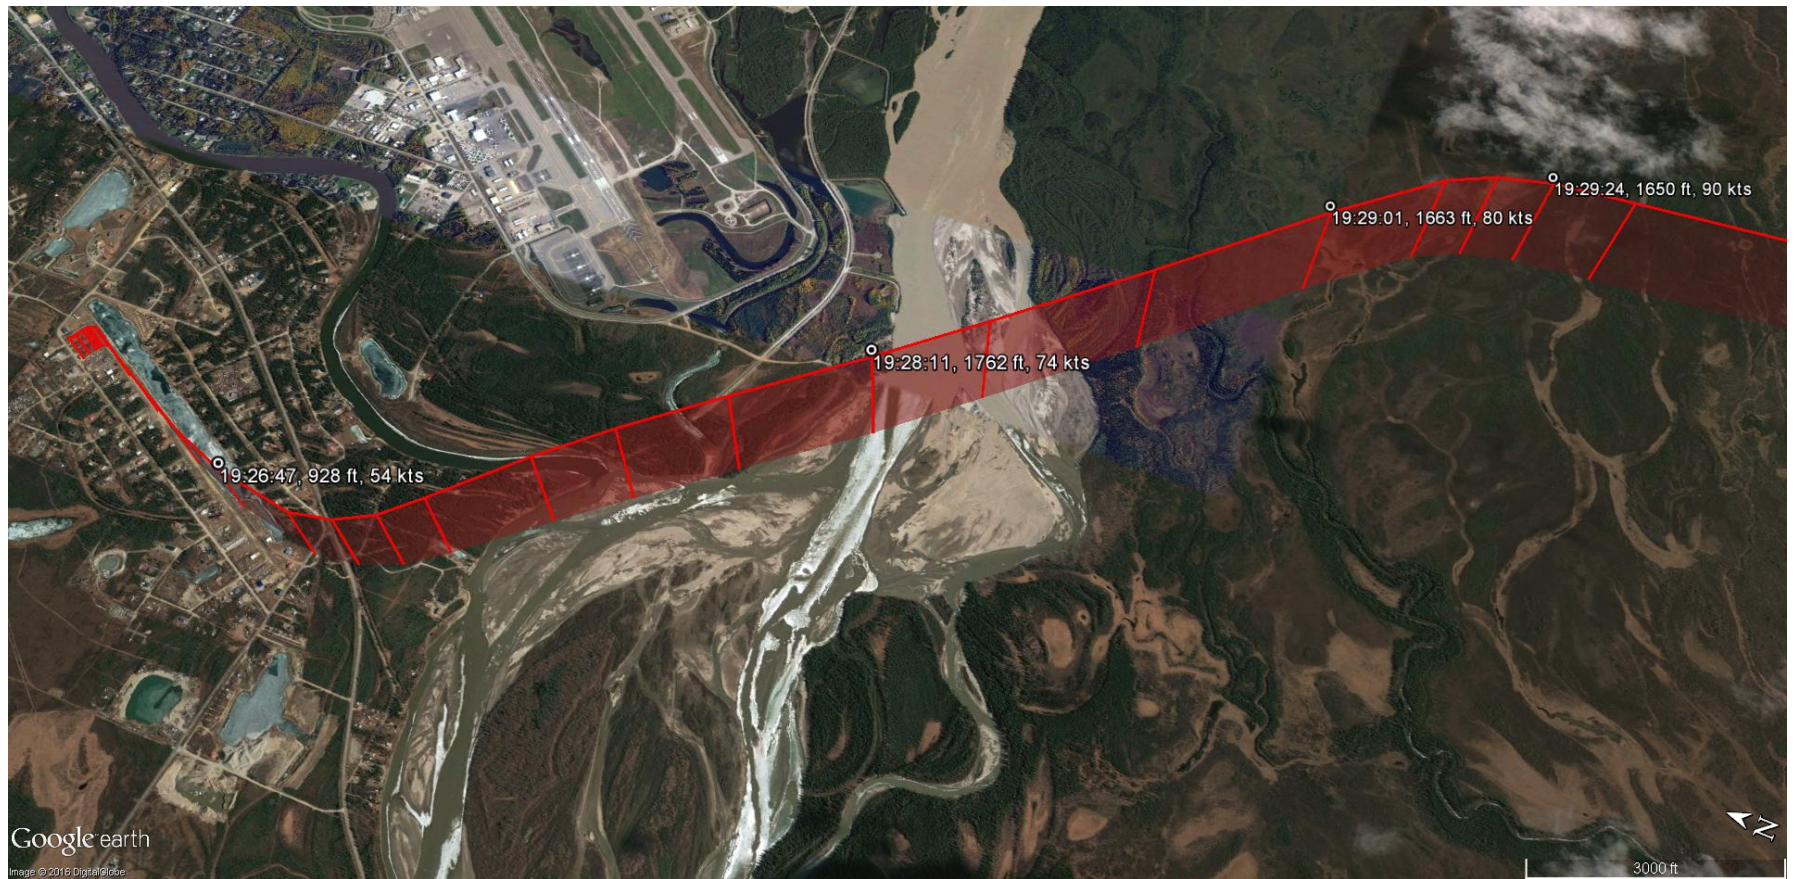
Figure 4. Initial departure path of accident flight.

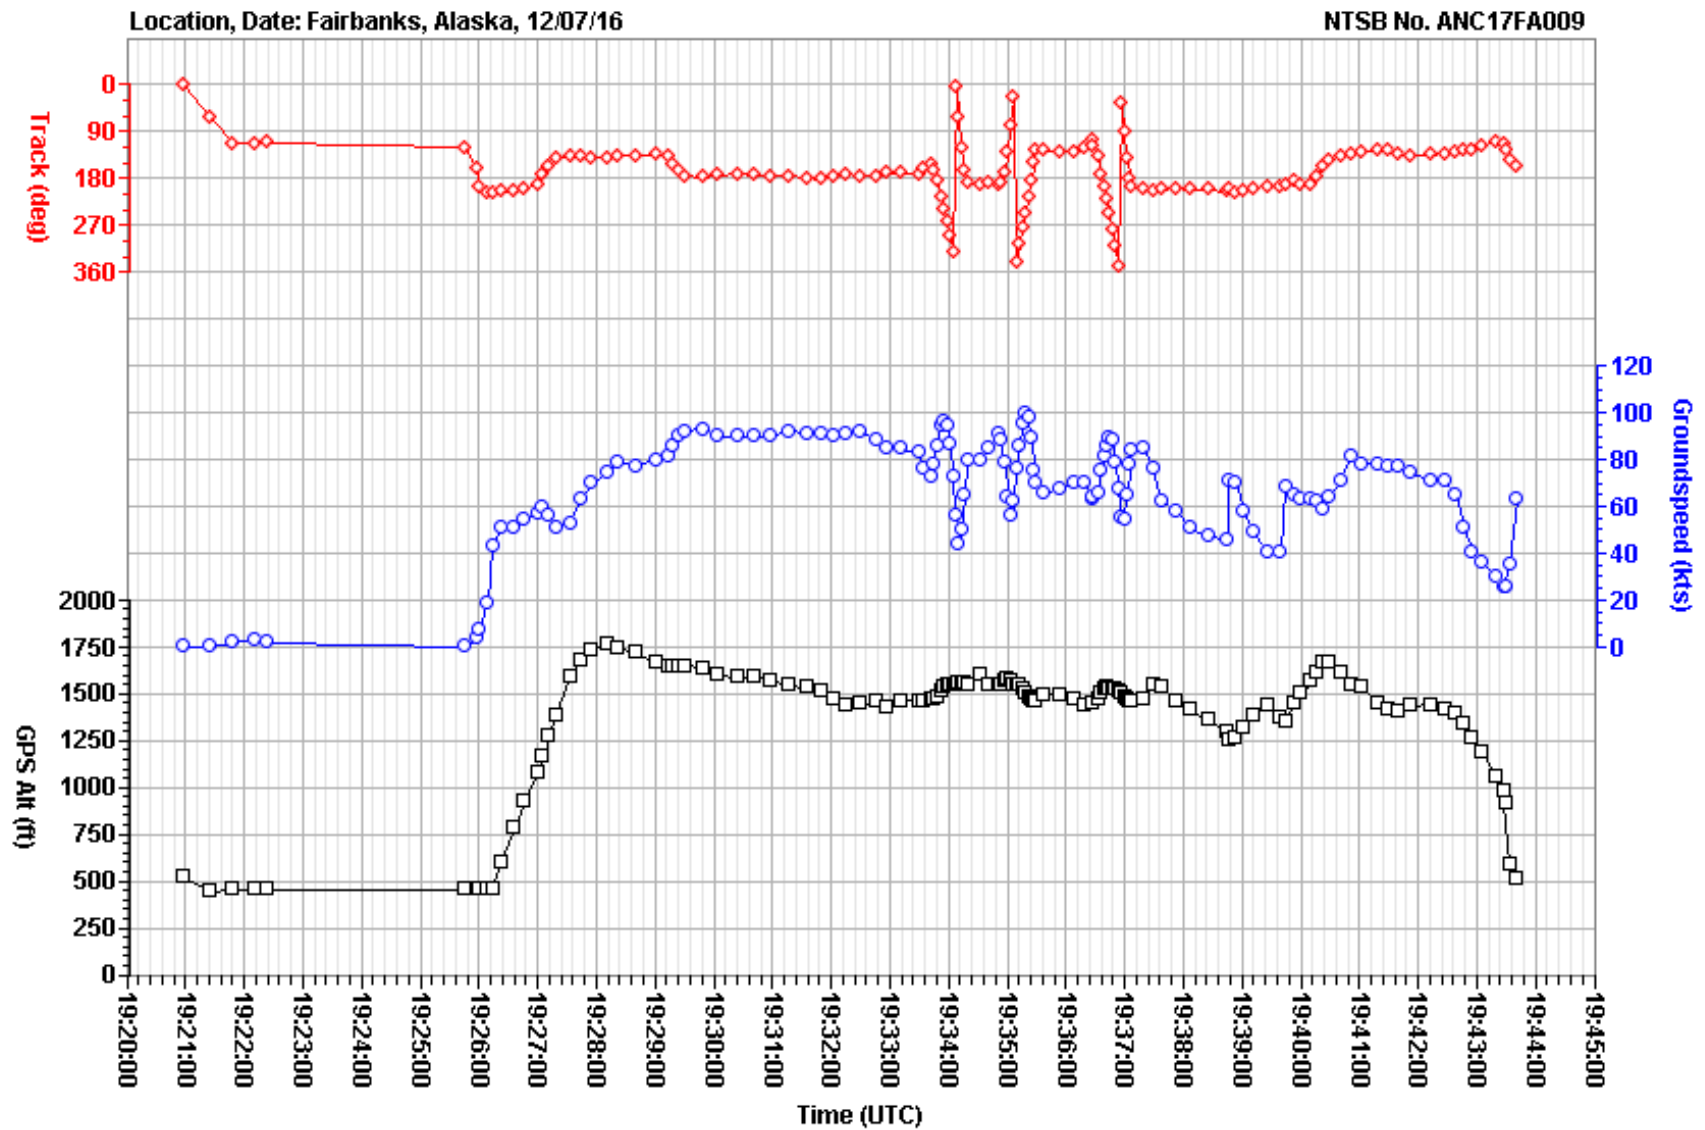
Figure 8 plots the true track, derived groundspeed, and GPS altitude for the accident flight. The increase in derived groundspeed at the last datapoint may be inaccurate due to the sampling rate and other unknown dynamics.

Figure 8. Plot of track, groundspeed, and altitude.
