## **NATIONAL TRANSPORTATION SAFETY BOARD**

### **Weather Study**

# **METEOROLOGY**

ANC17FA010

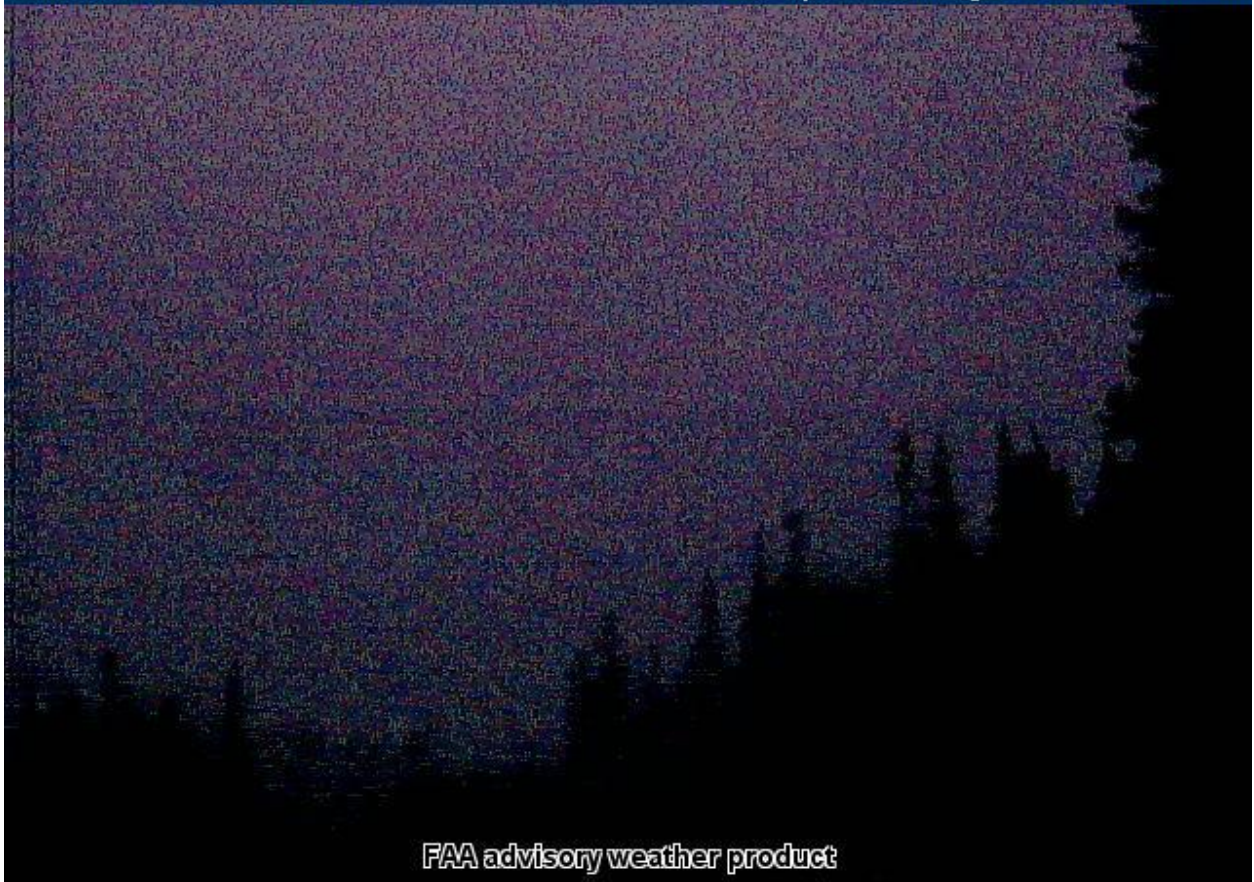
Images from the FAA’s Aviation Weather Cameras are shown in figures 13 through 28 along with attachments 3 and 4 providing images of the weather conditions surrounding the accident site at the accident time. The weather cameras (figure 13 and 19) from Lake Clark Pass West, located 8 miles east-northeast of the accident site (figure 14), showed the weather conditions surrounding the accident time with the south facing camera images provided in figures 15 through 18 with times from 0931 AKST through 1001 AKST. On the south facing camera images depicted a complete surface based obscuration with visibilities less than 3 miles with an indefinite ceiling from 0931 through 1001 AKST. The images further suggest complete mountain obscuration conditions prevailed during the entire time with fog (figures 15 through 18).

**Figure 15 – FAA weather camera from Lake Clark Pass West south looking view from 0931 AKST**

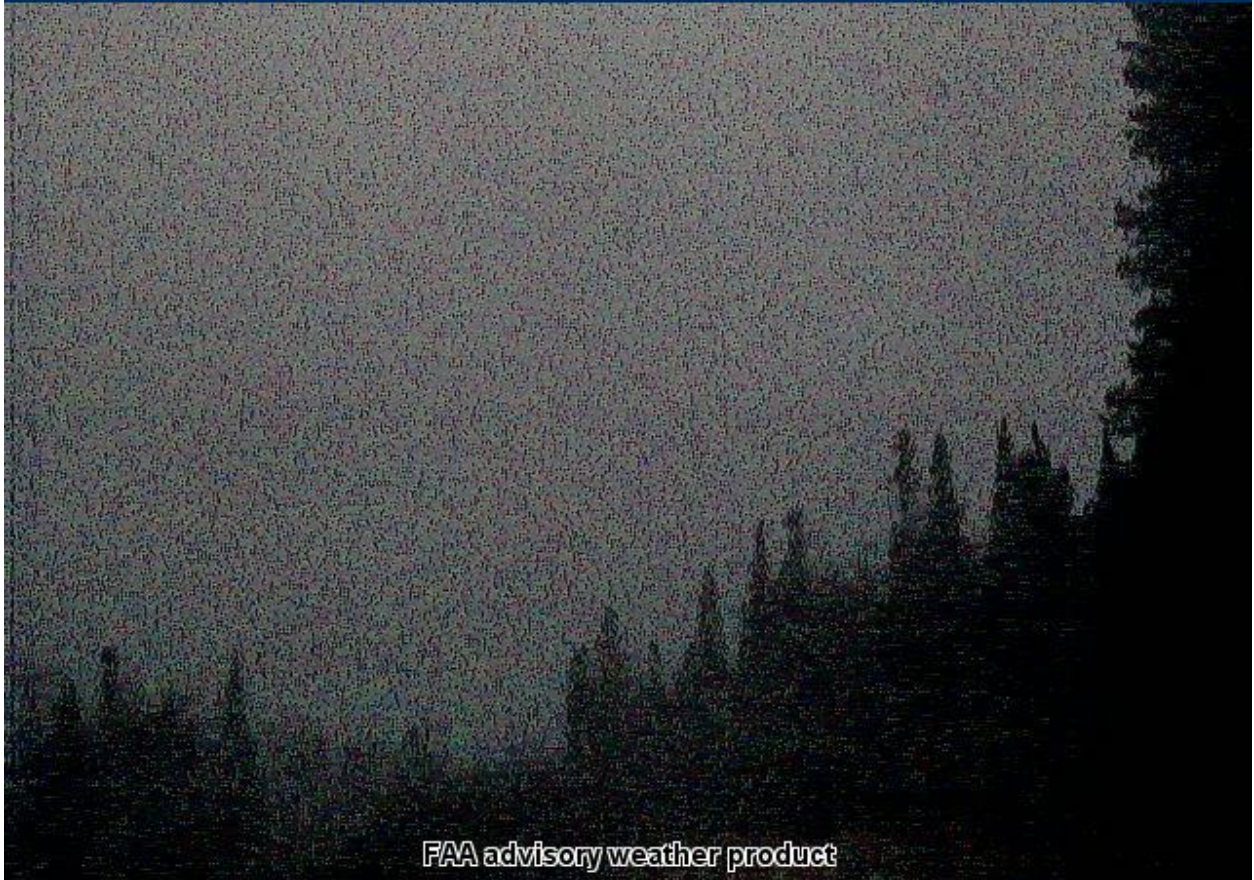
**Figure 16 – FAA weather camera from Lake Clark Pass West south looking view from 0941  
AKST**

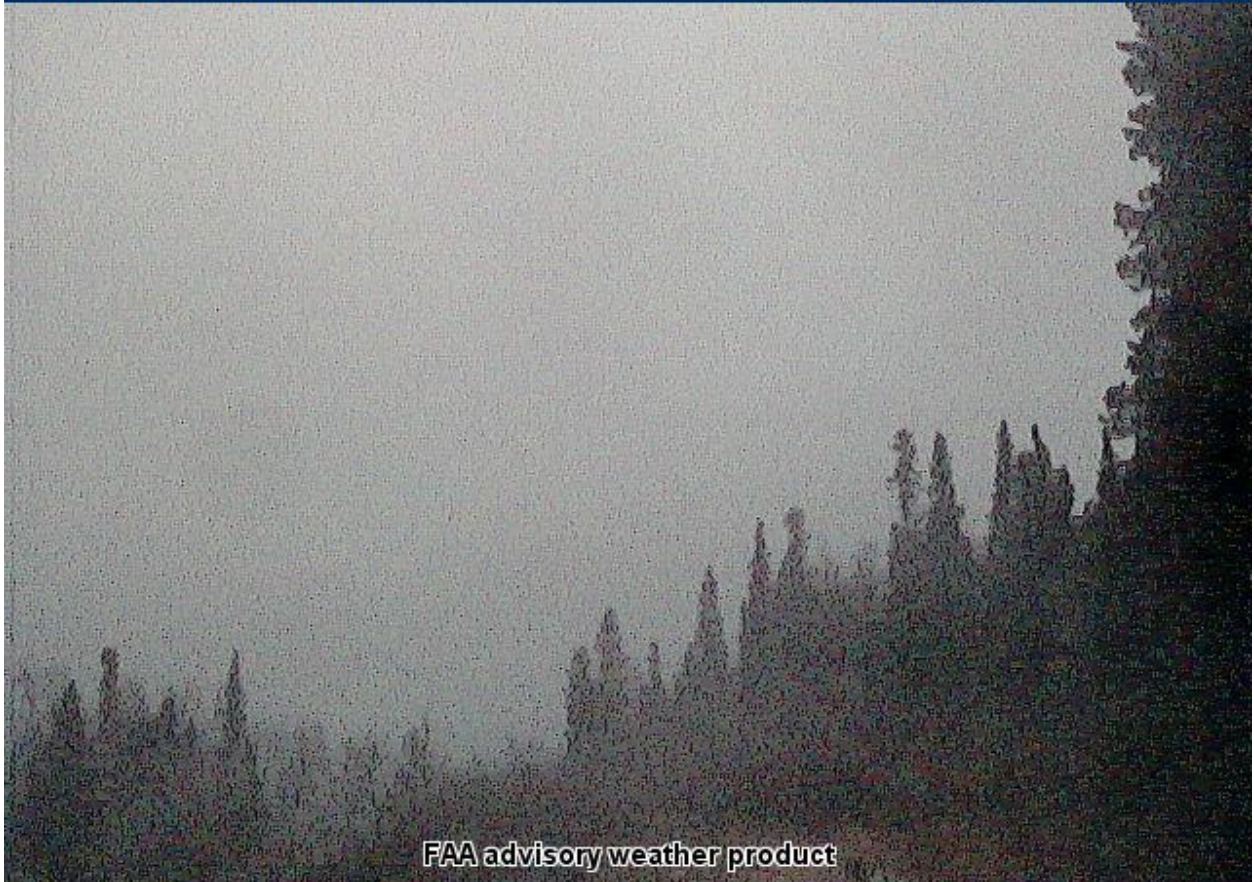
**Figure 17 – FAA weather camera from Lake Clark Pass West south looking view from 0951 AKST**

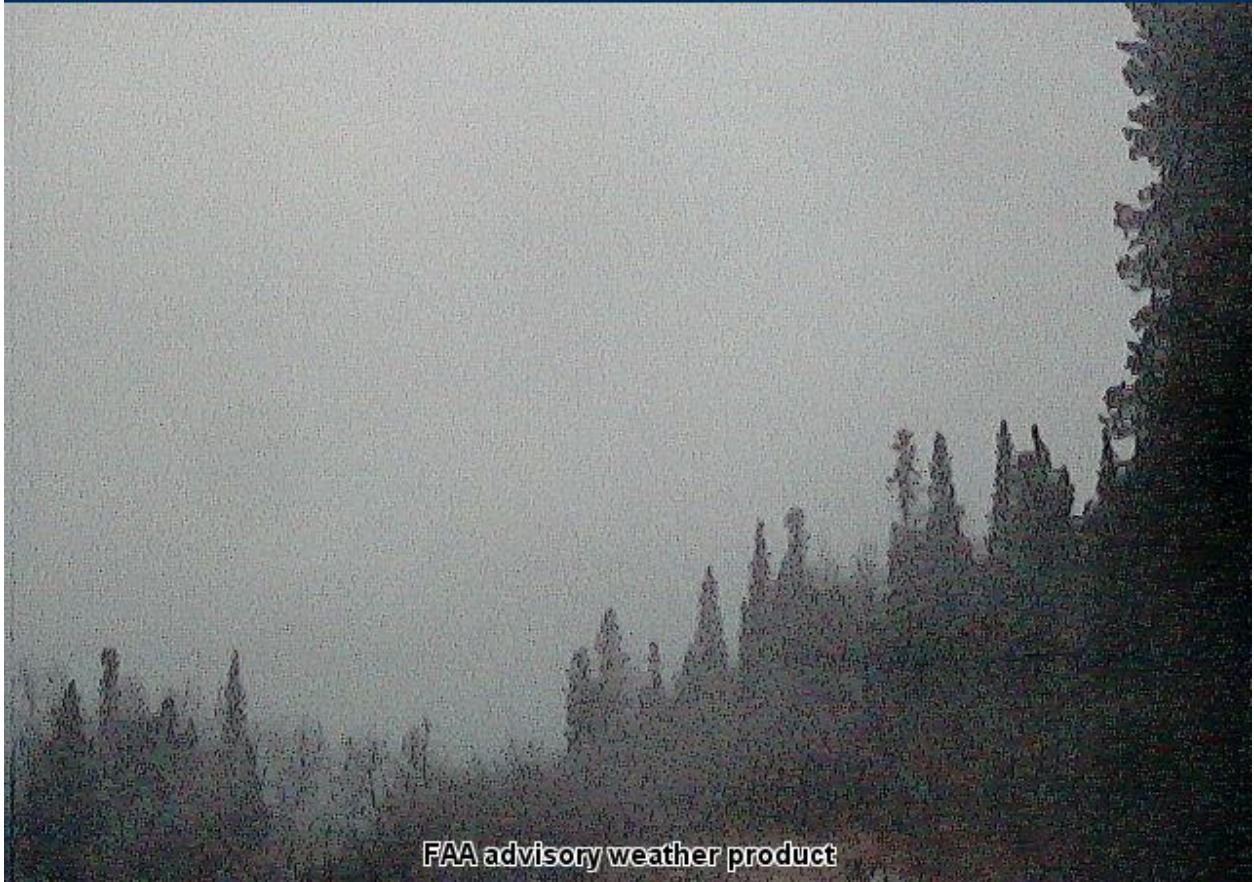
**Figure 18 – FAA weather camera from Lake Clark Pass West south looking view from 1001  
AKST**

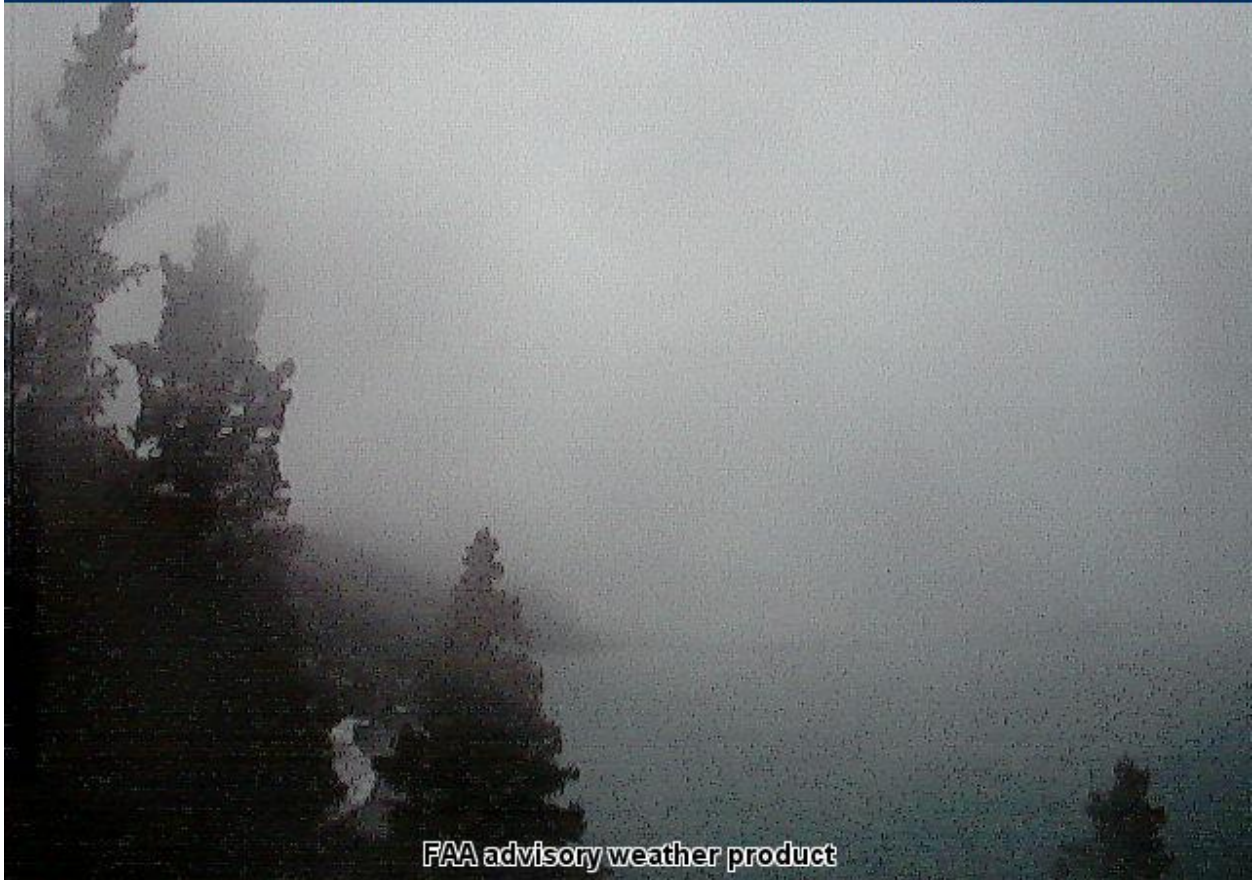
The northeast facing weather camera from Lake Clark Pass West (figures 19 through 22) indicated a similar obscuration conditions as the southward facing camera with visibilities under a mile between 0928 and 0948 AKST (figures 20 through 22). In addition, the northeast facing weather camera indicated ceiling heights less than 100 feet or near the top of the trees directed next to the camera site.

**Figure 21 – FAA weather camera from Lake Clark Pass West northeast looking view from 0938 AKST**

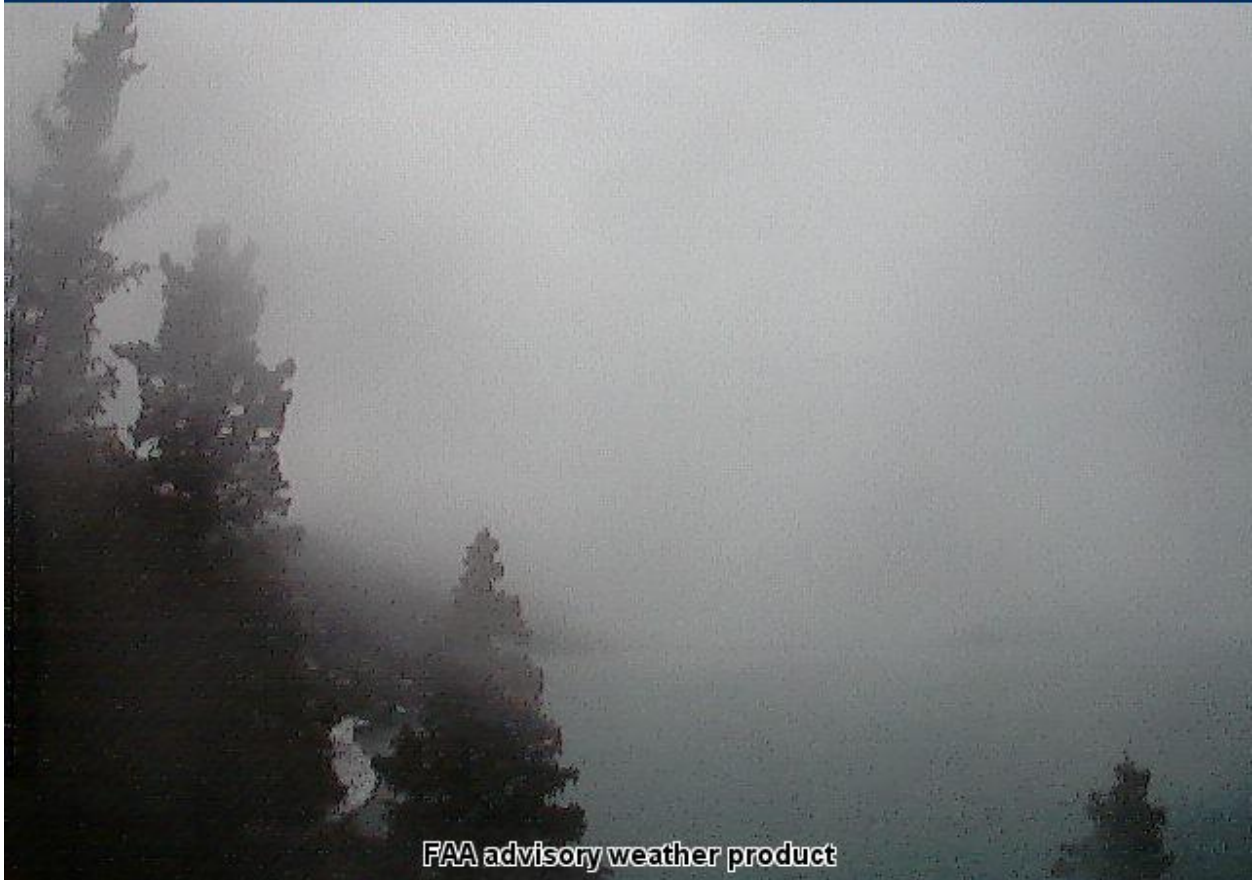
**Figure 22 – FAA weather camera from Lake Clark Pass West northeast looking view from 0948 AKST**

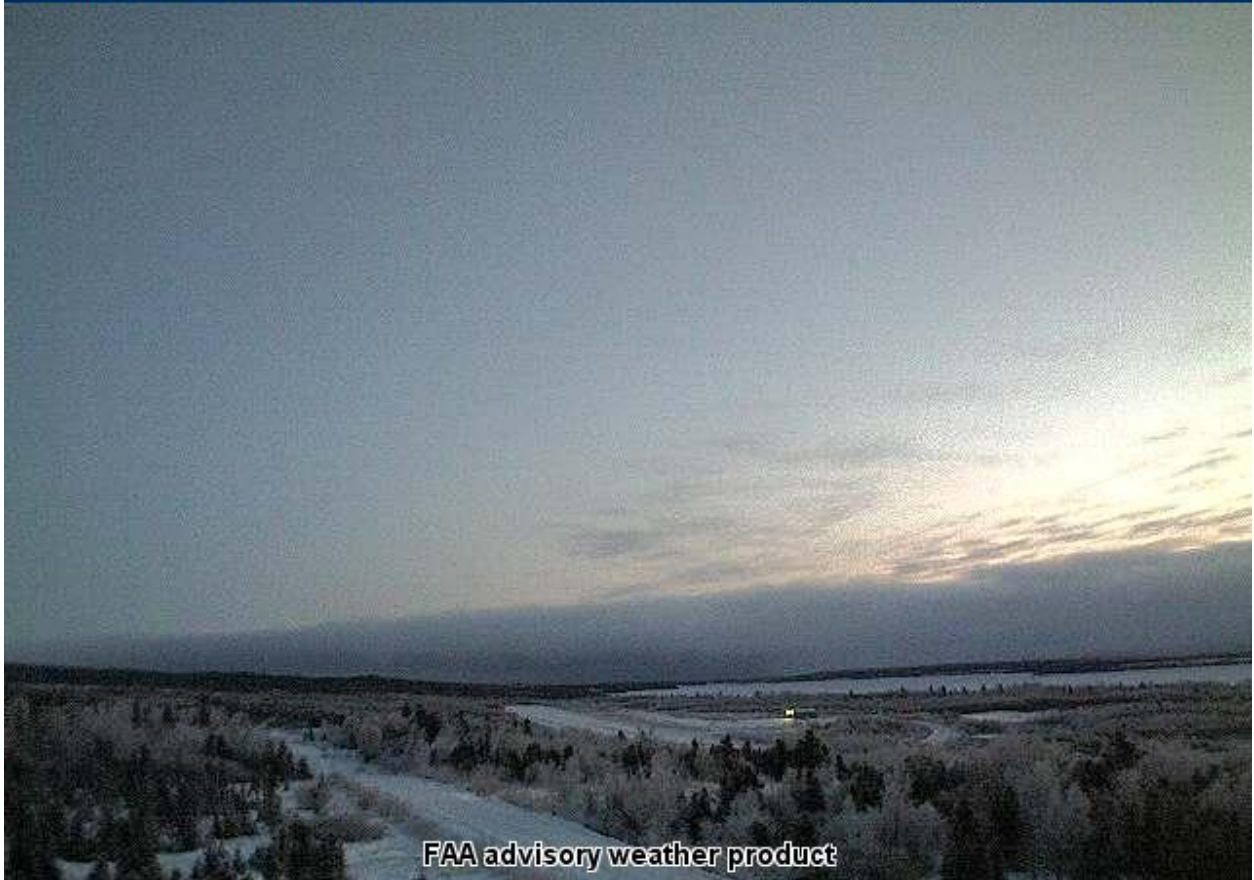
The Nondalton cameras were located 29 miles southwest of the accident site (figure 23). On the northeast facing weather camera from Nondalton (figures 24 through 28), an area of low stratus clouds is seen in the direction of Port Alsworth and the accident site between 0917 and 0947 AKST. The cloud ceilings were below 2,150 feet msl with visibilities to the northeast of the Nondalton camera less than 8.5 miles. The low clouds moved across the Nondalton camera site by 1047 AKST (attachment 4).

**Figure 25 – FAA weather camera from Nondalton northeast looking view from 0917 AKST**

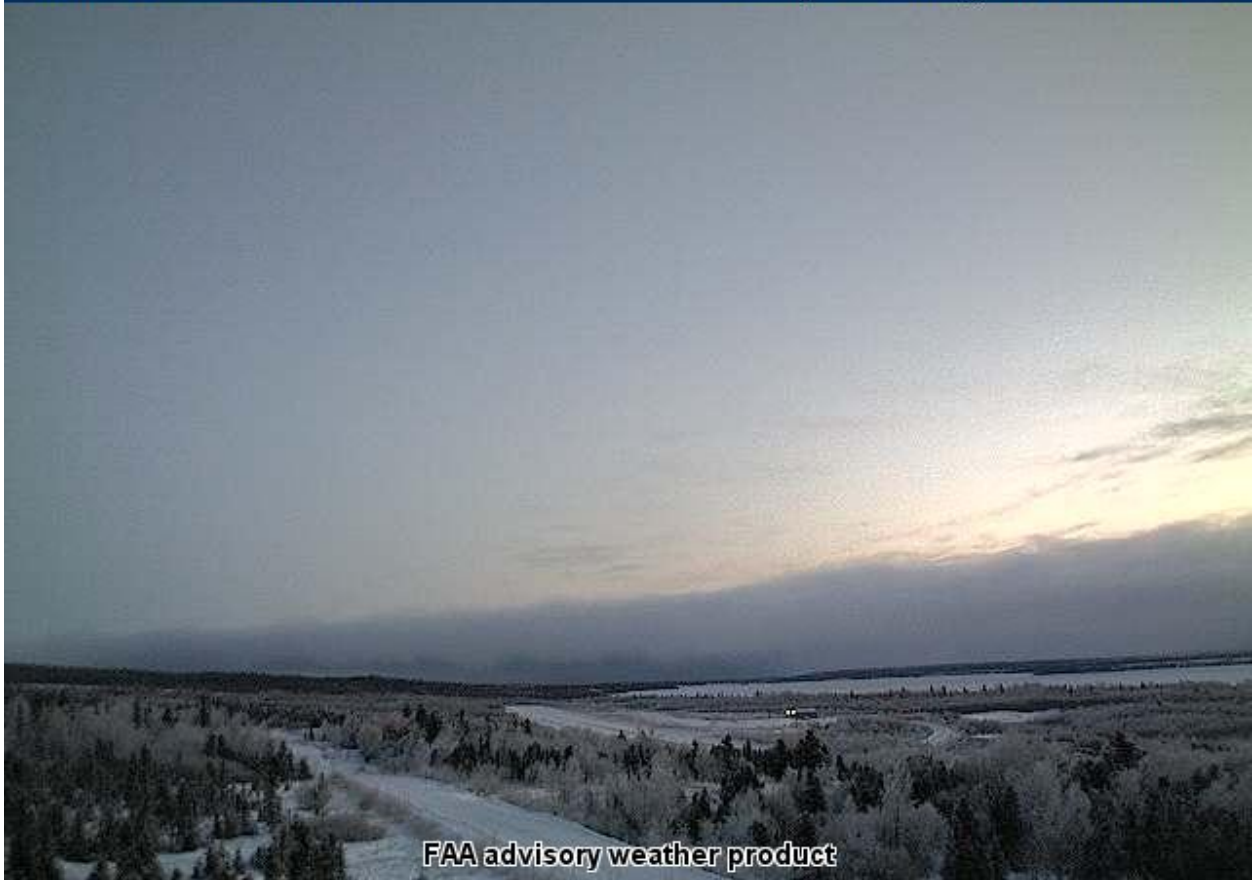
**Figure 26 – FAA weather camera from Nondalton northeast looking view from 0927 AKST**

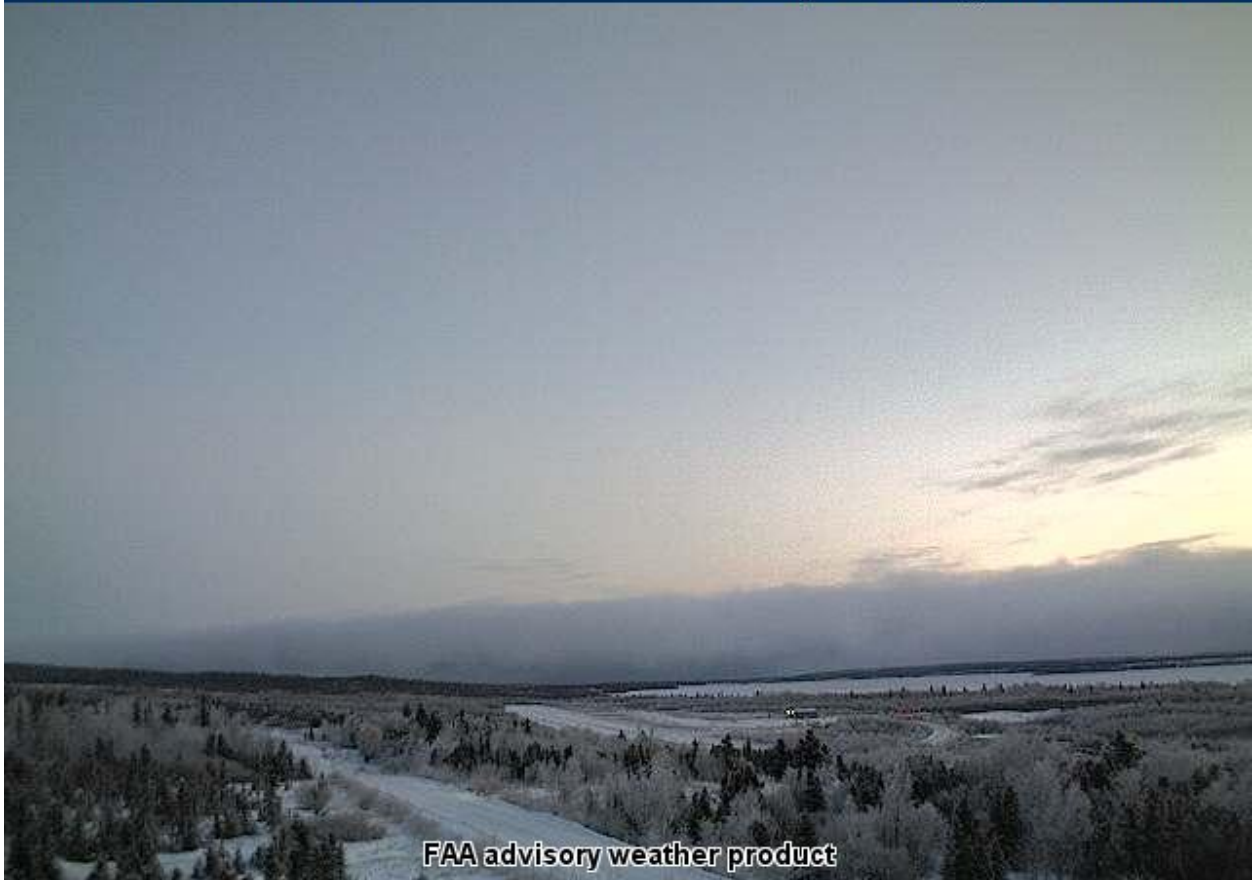
**Figure 27 – FAA weather camera from Nondalton northeast looking view from 0937 AKST**

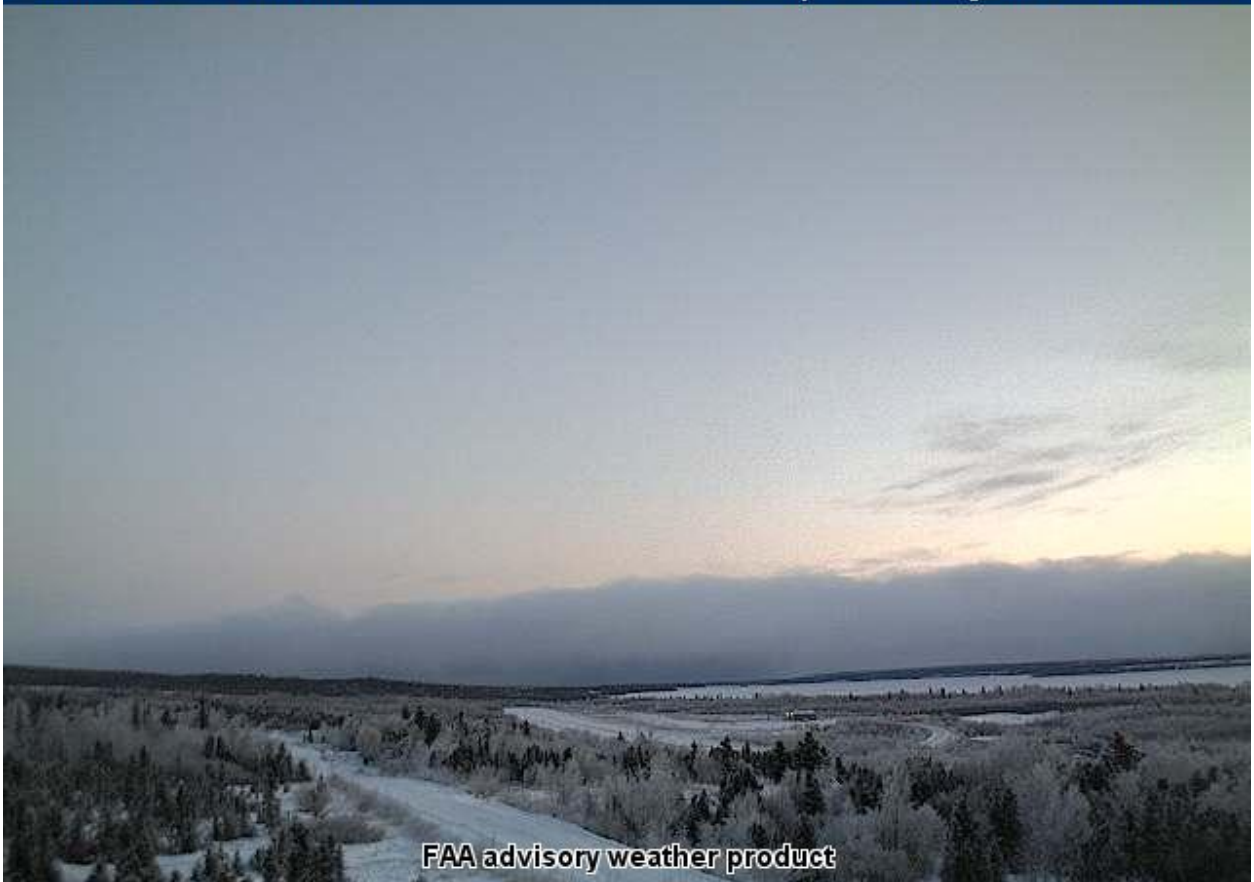
**Figure 28 – FAA weather camera from Nondalton northeast looking view from 0947 AKST**
