## **NATIONAL TRANSPORTATION SAFETY BOARD**

### **Weather Study**

ANC17FA021

Location: Near Chignik Lake, Alaska  
Date: May 1, 2017  
Time: 1350 Alaska daylight time  
2150 Coordinated Universal Time (UTC)  
Airplane: Cessna 208B, N803TH

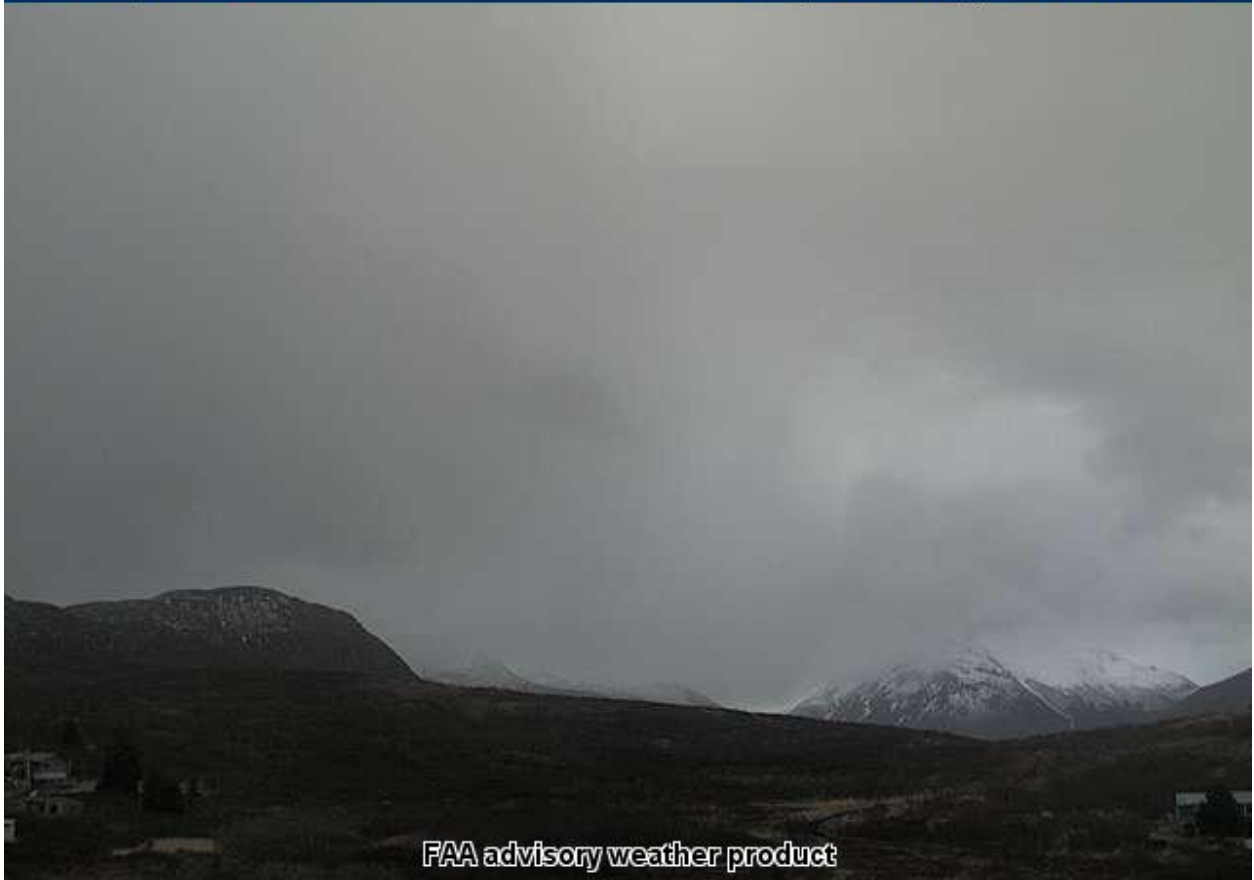
Images from the FAA’s Aviation Weather Cameras are shown in figures 15 through 24 along with attachment 3 providing images of the weather conditions surrounding the accident site at the accident time. Figure 25 indicates the web camera locations included in attachment 3. The weather cameras (figures 15 through 20) from Chignik Lake, located 7 miles north-northeast of the accident site at an elevation of 45 ft (figure 16), showed the weather conditions surrounding the accident time with the south facing camera images provided in figures 17 through 20 with times from 1337 AKDT through 1407 AKDT. On the south facing camera images depicted ceilings below 2,700 ft msl, but above 900 ft msl with forward visibilities towards the accident site between 1.5 and 5 miles from the web camera location. The images further suggest complete mountain obscuration conditions prevailed with likely rain showers activity (figures 17 through 20).

**Figure 17 – FAA weather camera from Chignik Lake south view from 1337 AKDT**

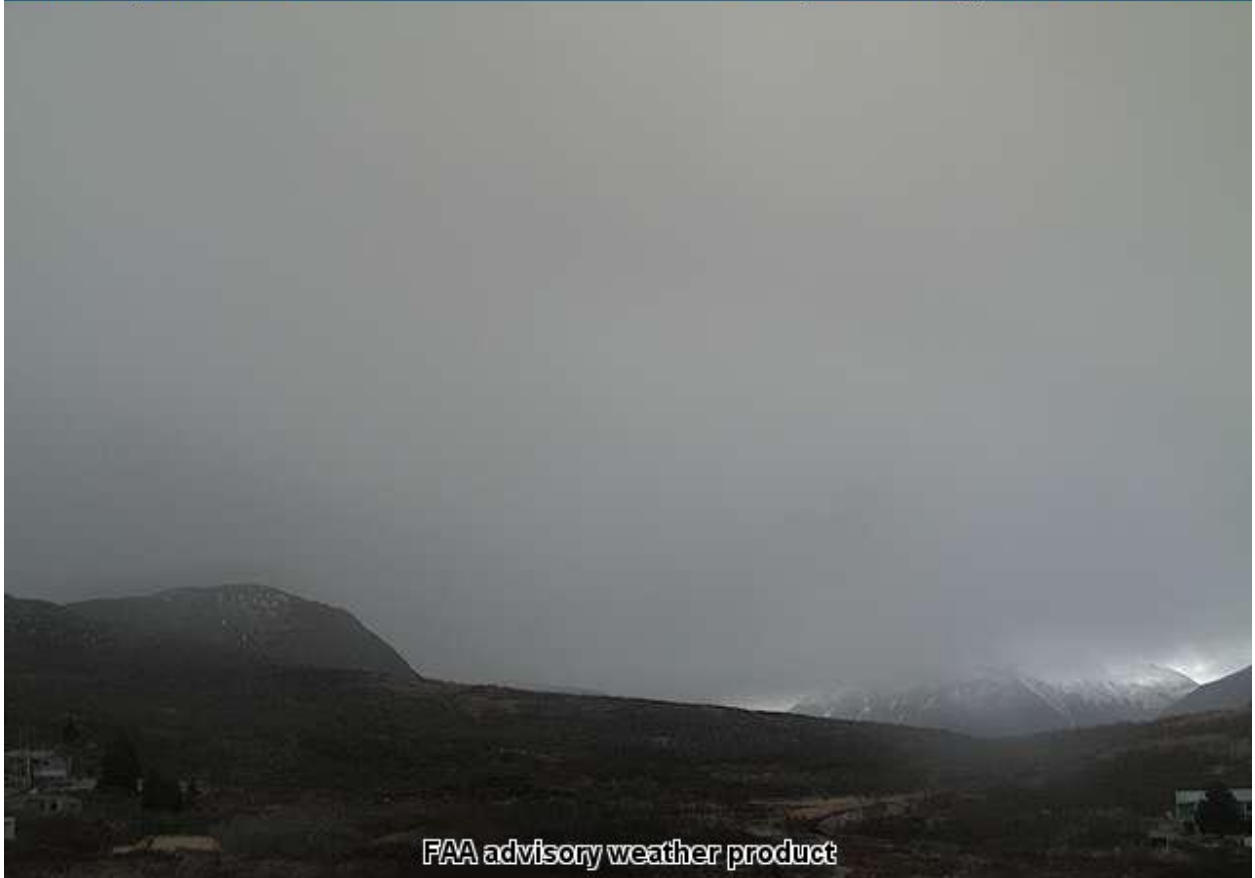
**Figure 18 – FAA weather camera from Chignik Lake south view from 1347 AKDT**

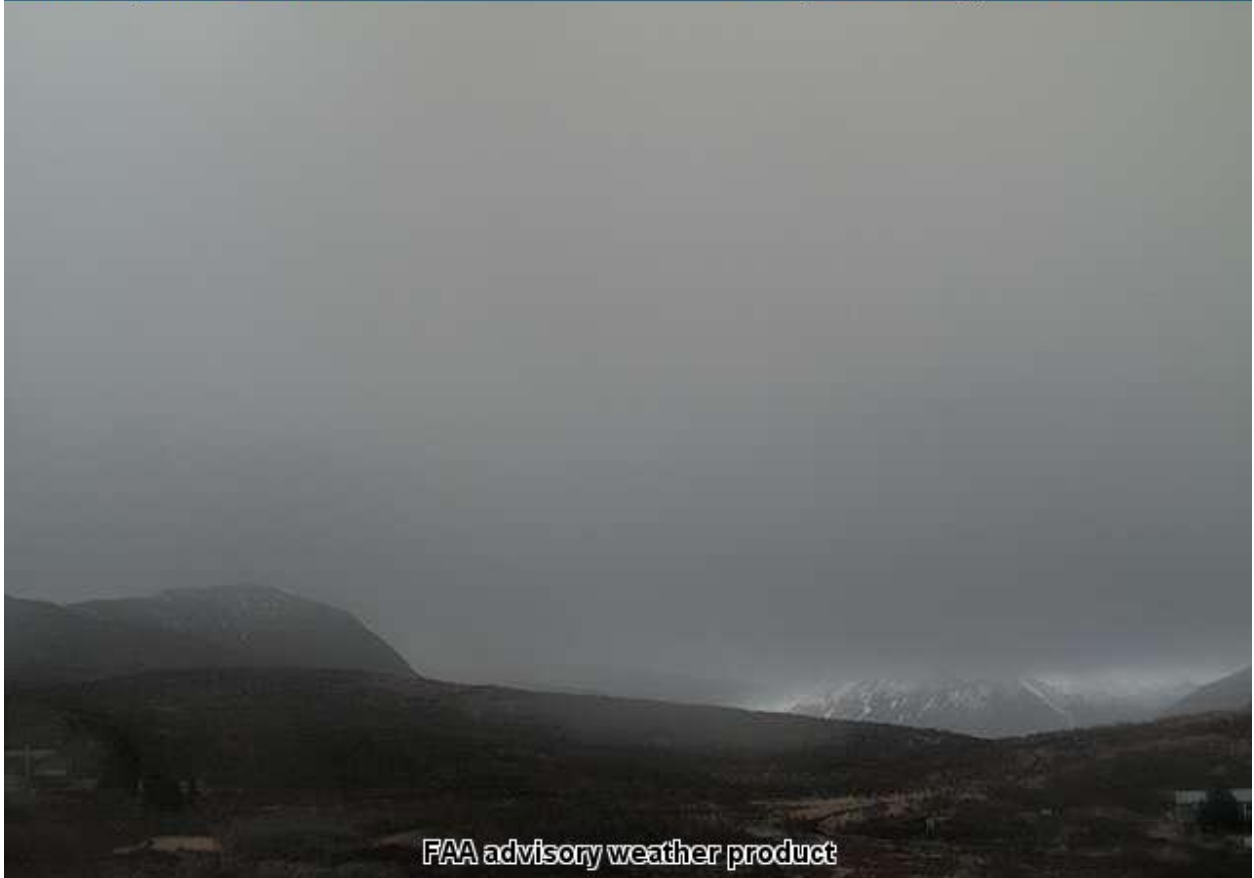
**Figure 19 – FAA weather camera from Chignik Lake south view from 1357 AKDT**

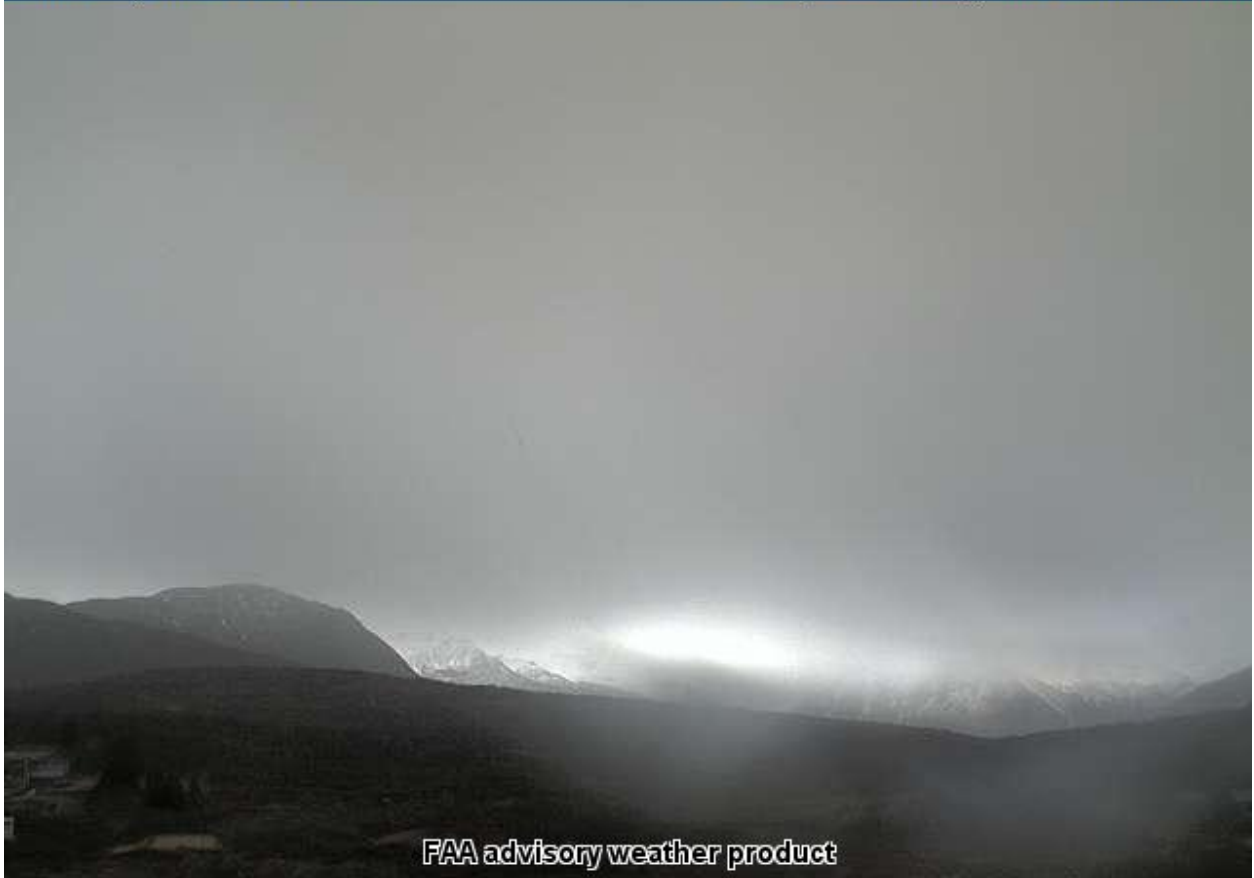
**Figure 20 – FAA weather camera from Chignik Lake south view from 1407 AKDT**

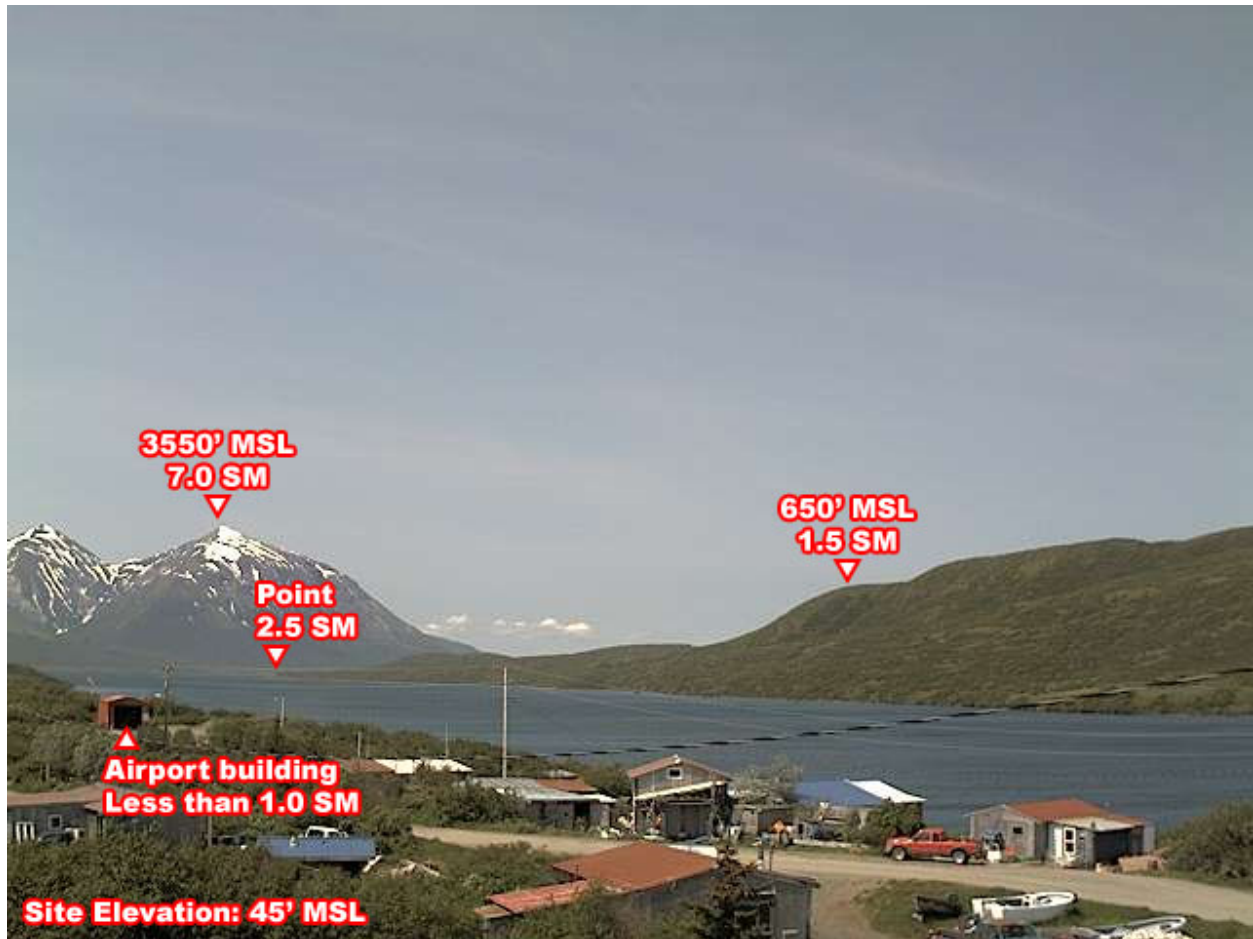
Figure 21 – FAA weather camera from Chignik Lake northwest view from a standard clear sky weather day

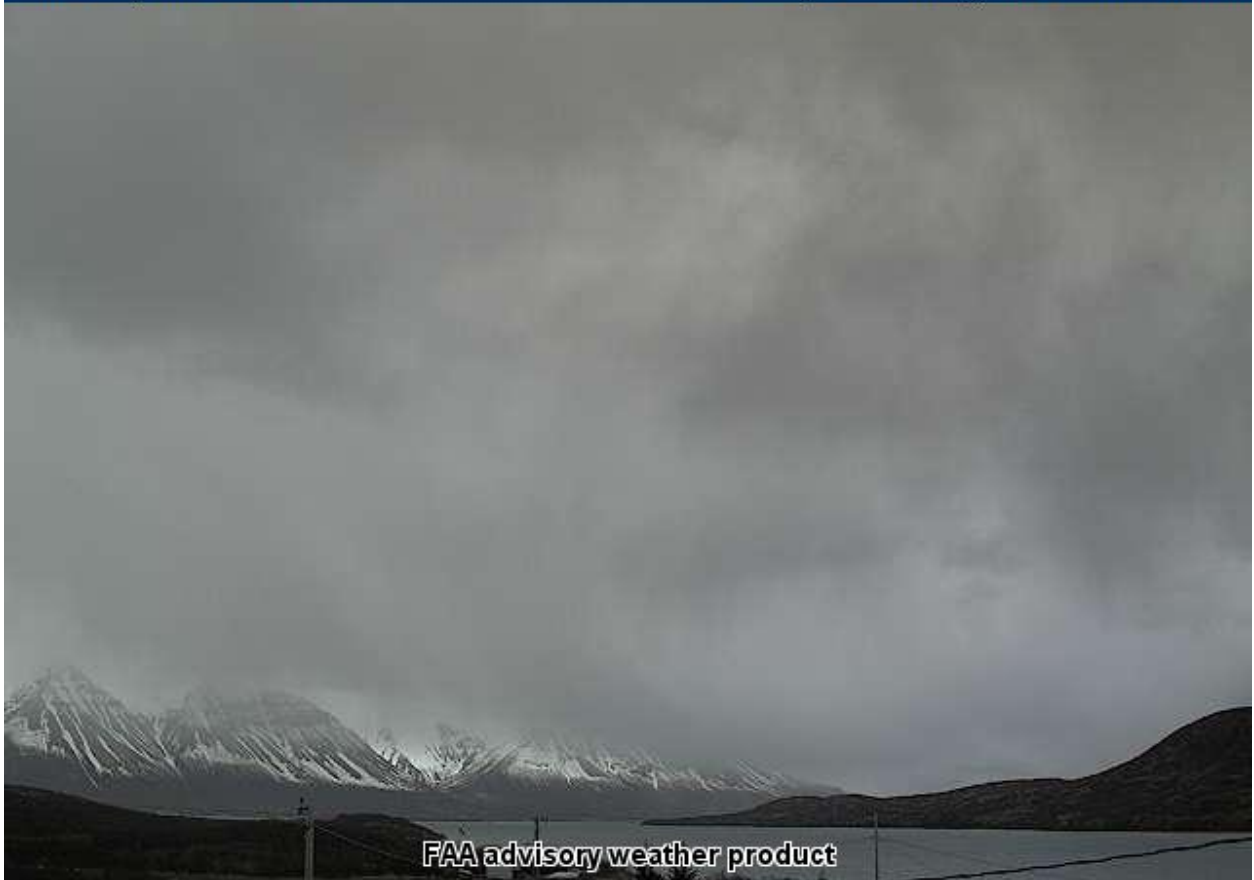
The northwest facing weather camera from Chignik Lake (figures 21 through 24) indicated a similar mountain obscuration condition as the southward facing camera with visibilities between 7 and 2.5 miles underneath the clouds, and precipitation and cloud ceilings between 3,550 and 650 ft msl between 1346 and 1406 AKDT (figures 22 through 24).

**Figure 22 – FAA weather camera from Chignik Lake northwest view from 1346 AKDT**

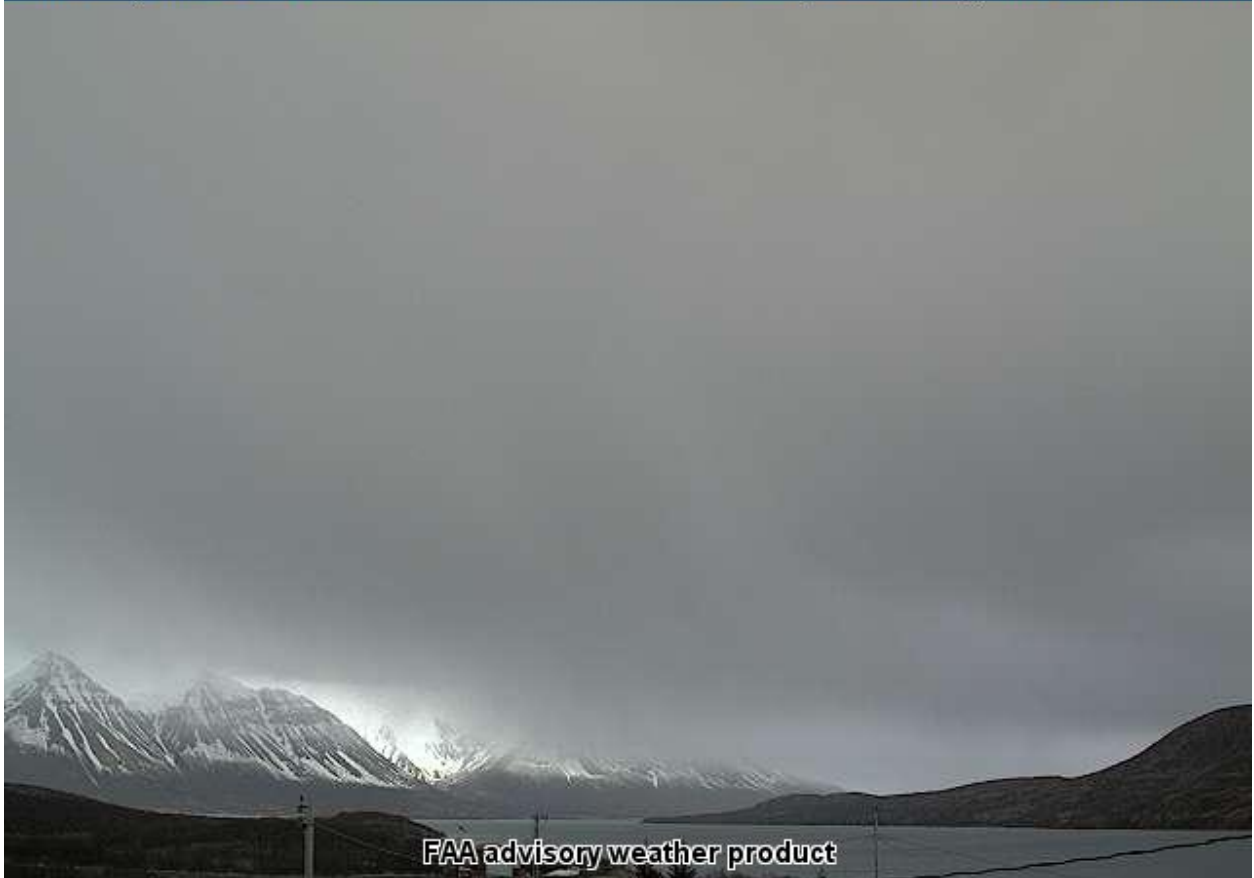
**Figure 23 – FAA weather camera from Chignik Lake northwest view from 1356 AKDT**

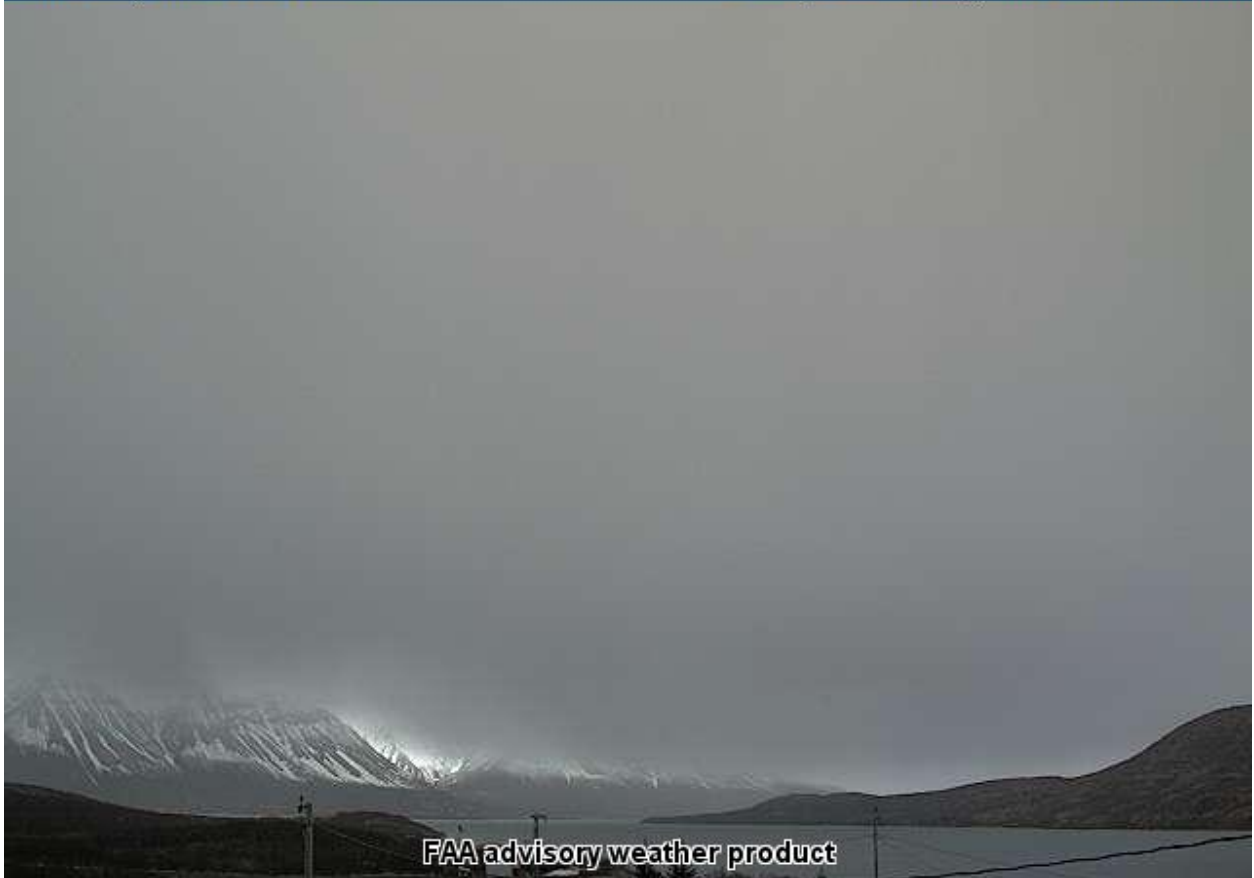
**Figure 24 – FAA weather camera from Chignik Lake northwest view from 1406 AKDT**
