## **NATIONAL TRANSPORTATION SAFETY BOARD**

### **Weather Study**

ANC17FA039

Location: Near Port Alsworth, Alaska  
Date: July 27, 2017  
Time: 0923 Alaska daylight time  
1723 Coordinated Universal Time (UTC)  
Airplane: Cessna U206G, registration: N1749R

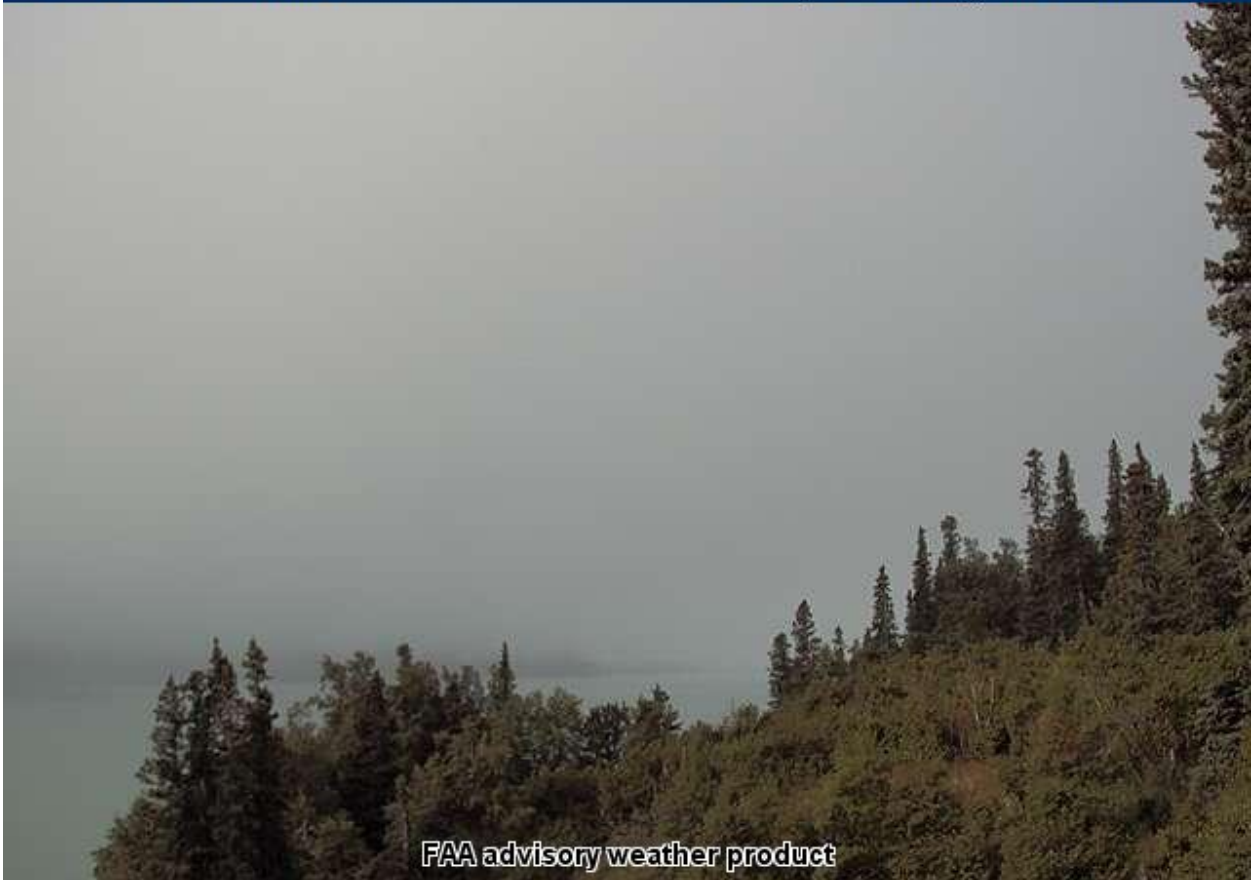
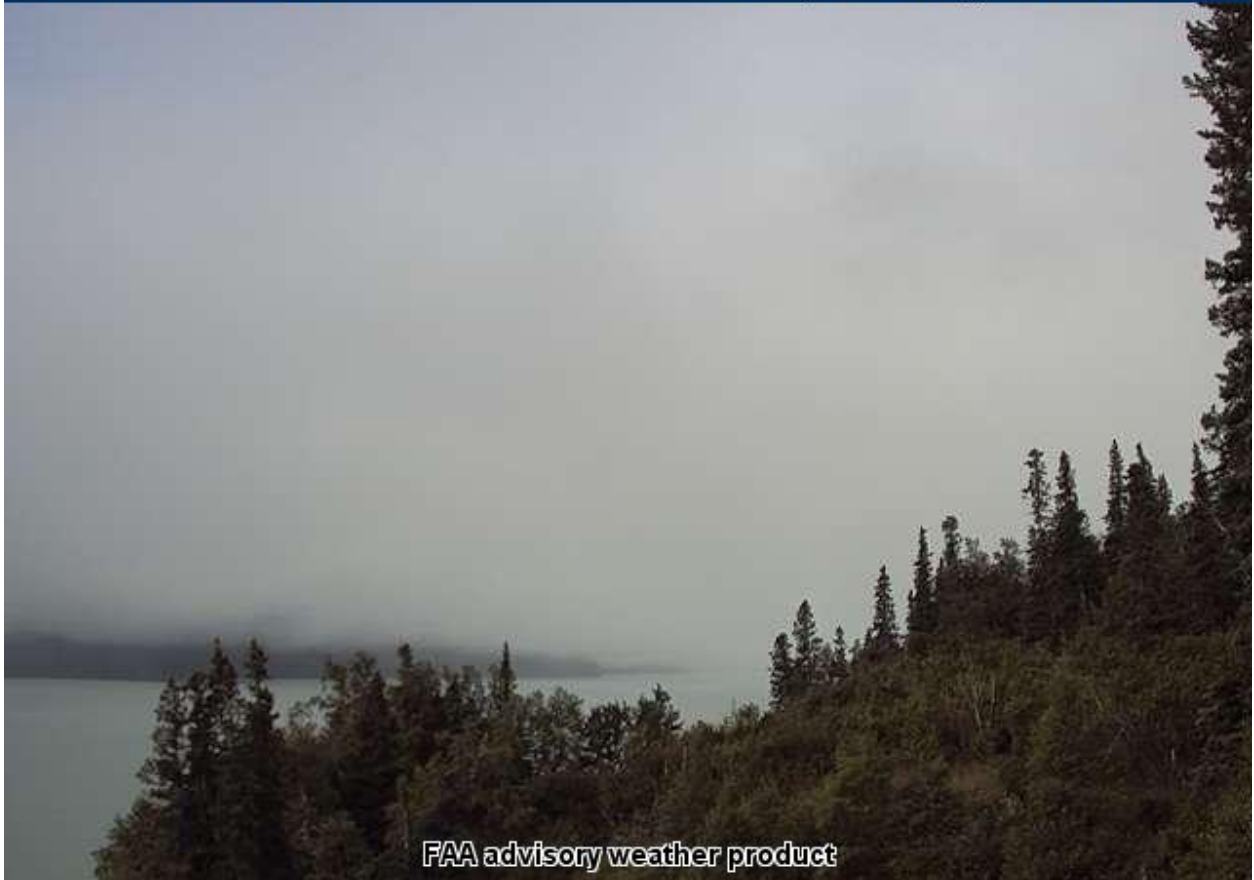
Images from the FAA's Aviation Weather Cameras are shown in figures 14 through 25 along with attachment 3 providing images of the weather conditions surrounding the accident site at the accident time. Figure 13 indicates the web camera locations included in attachment 3. The weather cameras (figures 14 through 20) from Lake Clark Pass West, located 10 miles east of the accident site at an elevation of 261 ft (figure 15), showed the weather conditions surrounding the accident time with the southwest facing camera images provided in figures 16 and 17 with times at 0919 AKDT and 0929 AKDT. The southwest facing camera images depicted ceilings below 3,800 ft msl with visibilities less than 3 miles below the cloud layer. The images suggest complete mountain obscuration conditions prevailed.

**Figure 16 – FAA weather camera from Lake Clark Pass West southwest view from 0919 AKDT**

**Figure 17 – FAA weather camera from Lake Clark Pass West southwest view from 0929 AKDT**

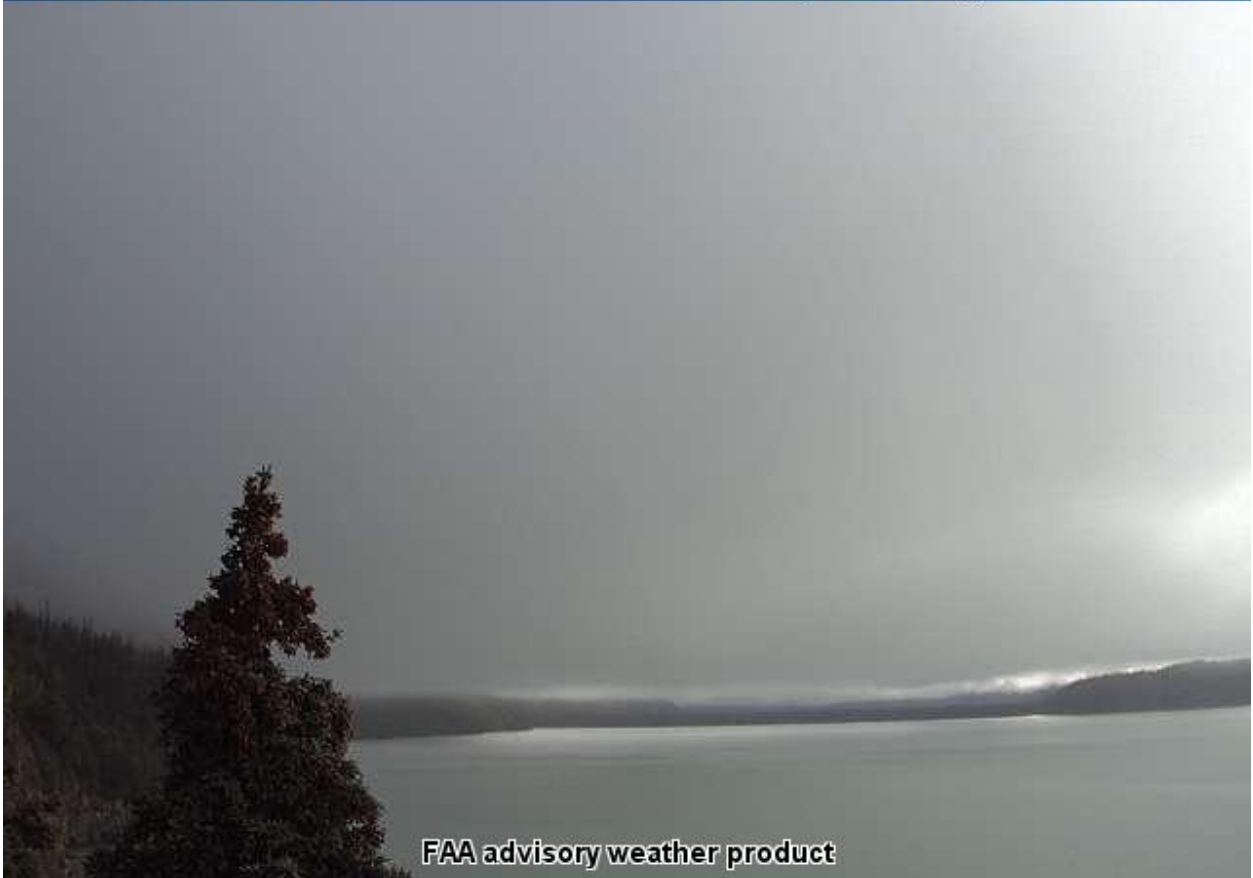
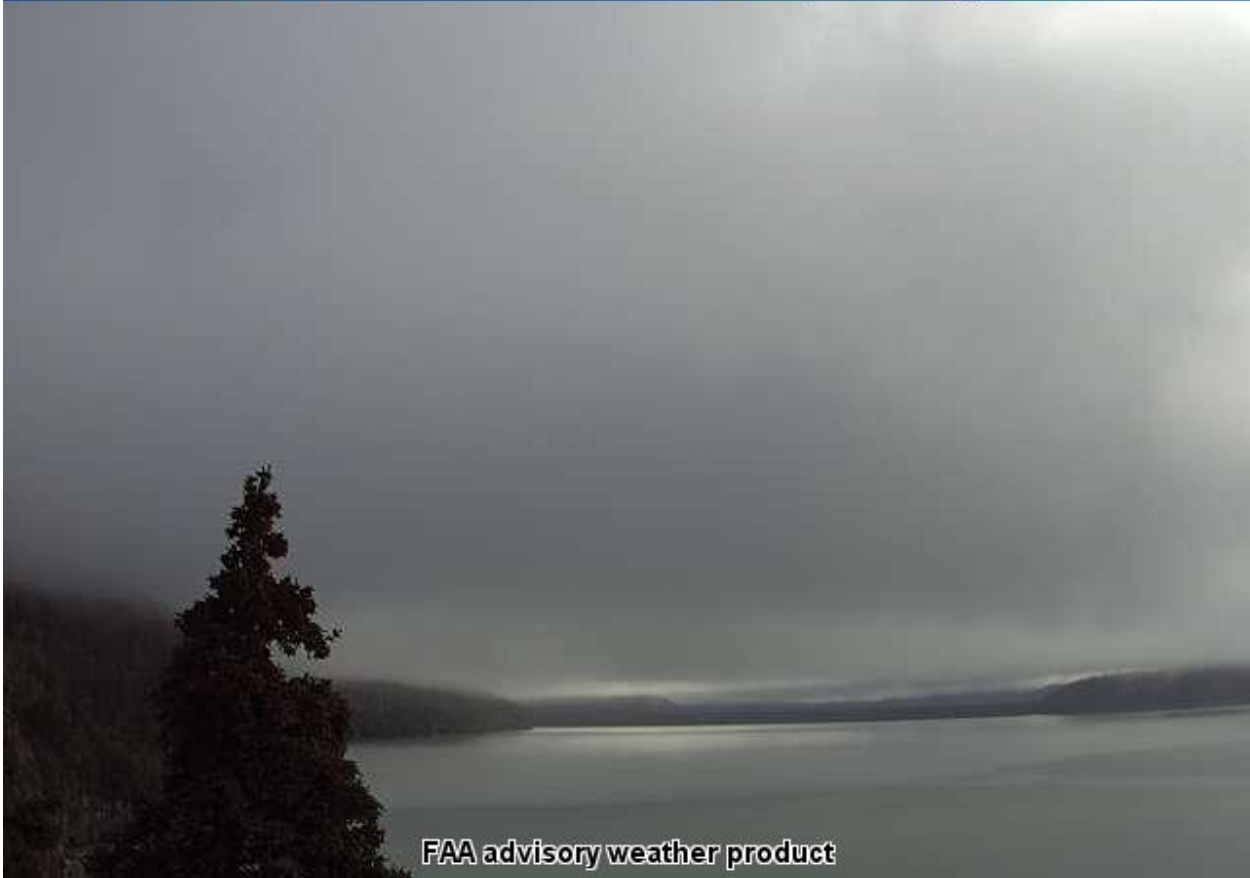
The northeast facing weather camera from Lake Clark Pass West (figures 18 through 20) indicated complete mountain obscuration conditions, similar to the southwest facing camera, with visibilities between 1 and 7.5 miles underneath the overcast cloud layer with all the higher terrain references obscured by the clouds at 0922 and 0932 AKDT (figures 19 and 20).

**Figure 19 – FAA weather camera from Lake Clark Pass West northeast view from 0922  
AKDT**

**Figure 20 – FAA weather camera from Lake Clark Pass West northeast view from 0932  
AKDT**

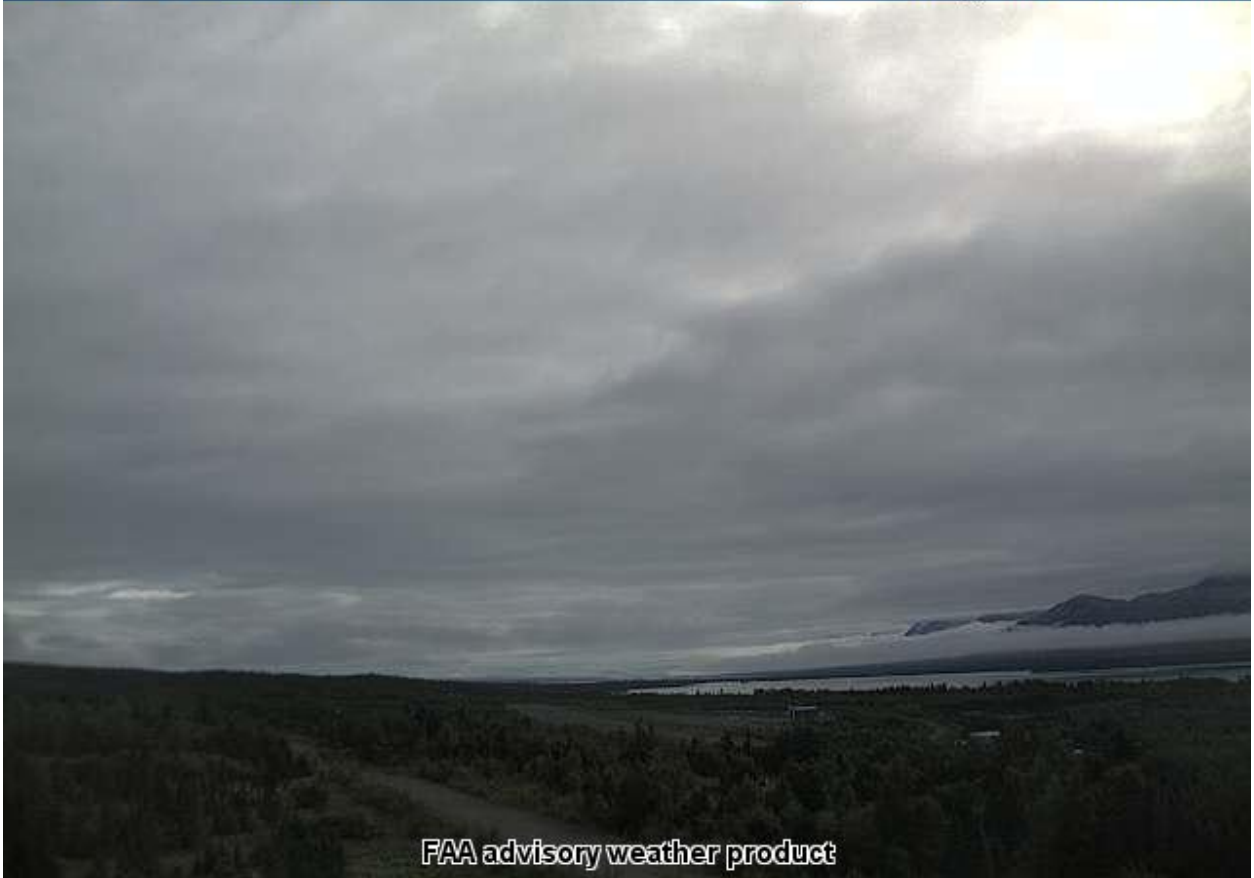
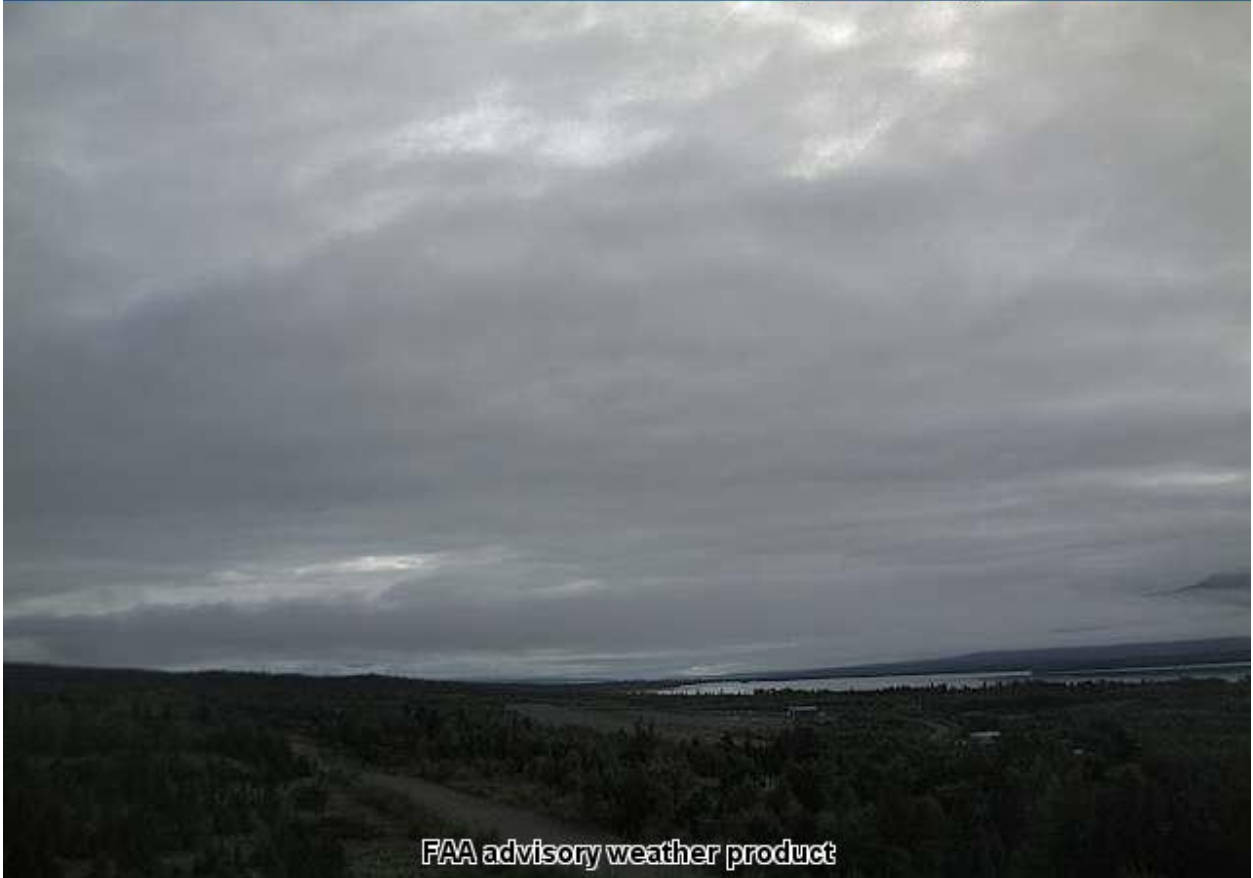
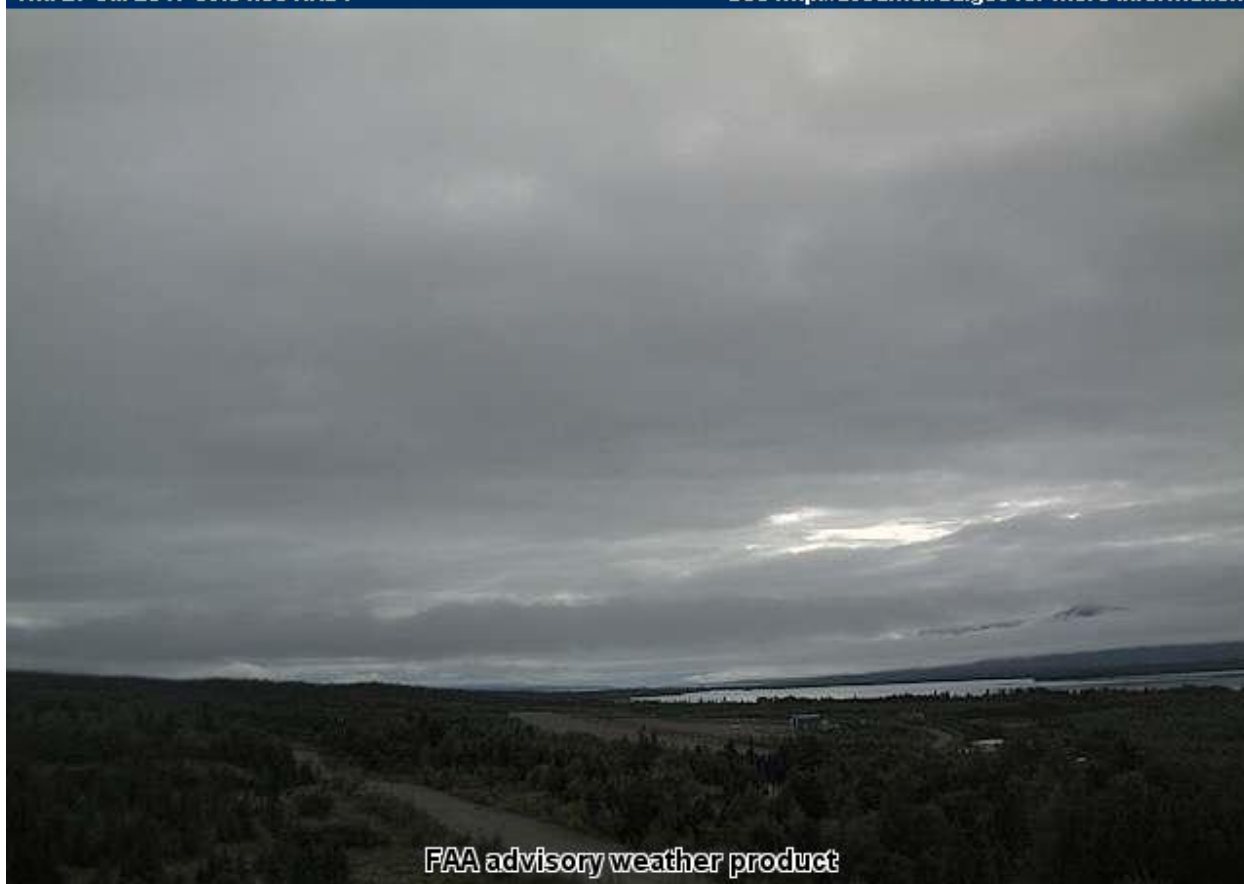
The northeast facing weather camera from Nondalton (figures 21 through 25) indicated complete mountain obscuration conditions with visibilities under 8 miles underneath the clouds and cloud ceilings below 2,150 ft msl between 0912 and 0932 AKDT (figures 23 and 25). The northeast facing weather camera from Nondalton also observed several different cloud layers as reported in sections 2.0 and 14.0.

**Figure 23 – FAA weather camera from Nondalton northeast view from 0912 AKDT**

**Figure 24 – FAA weather camera from Nondalton northeast view from 0922 AKDT**

**Figure 25 – FAA weather camera from Nondalton northeast view from 0932 AKDT**
