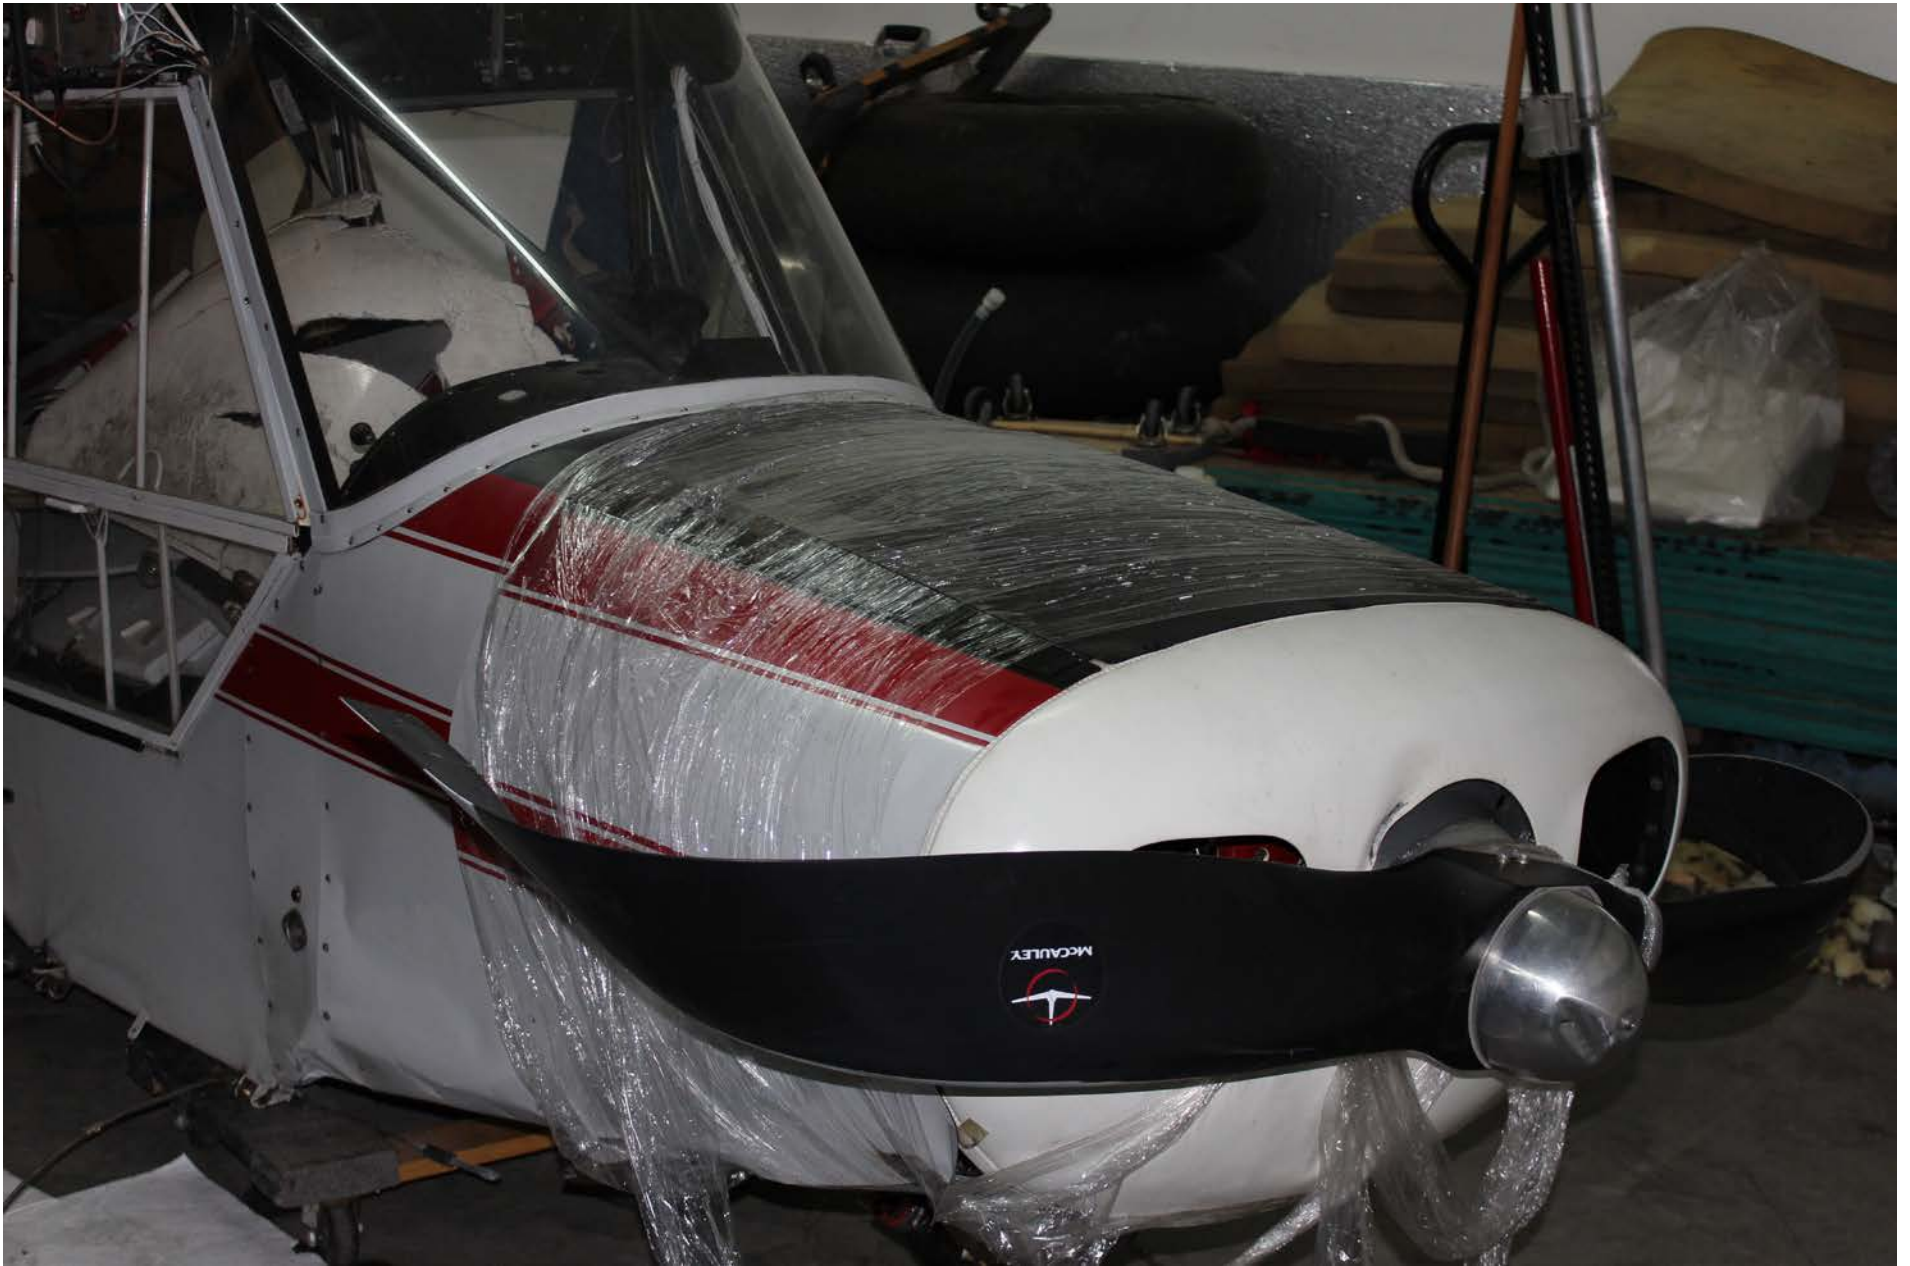
**Photo 1 – Accident airplane at wreckage layout.**

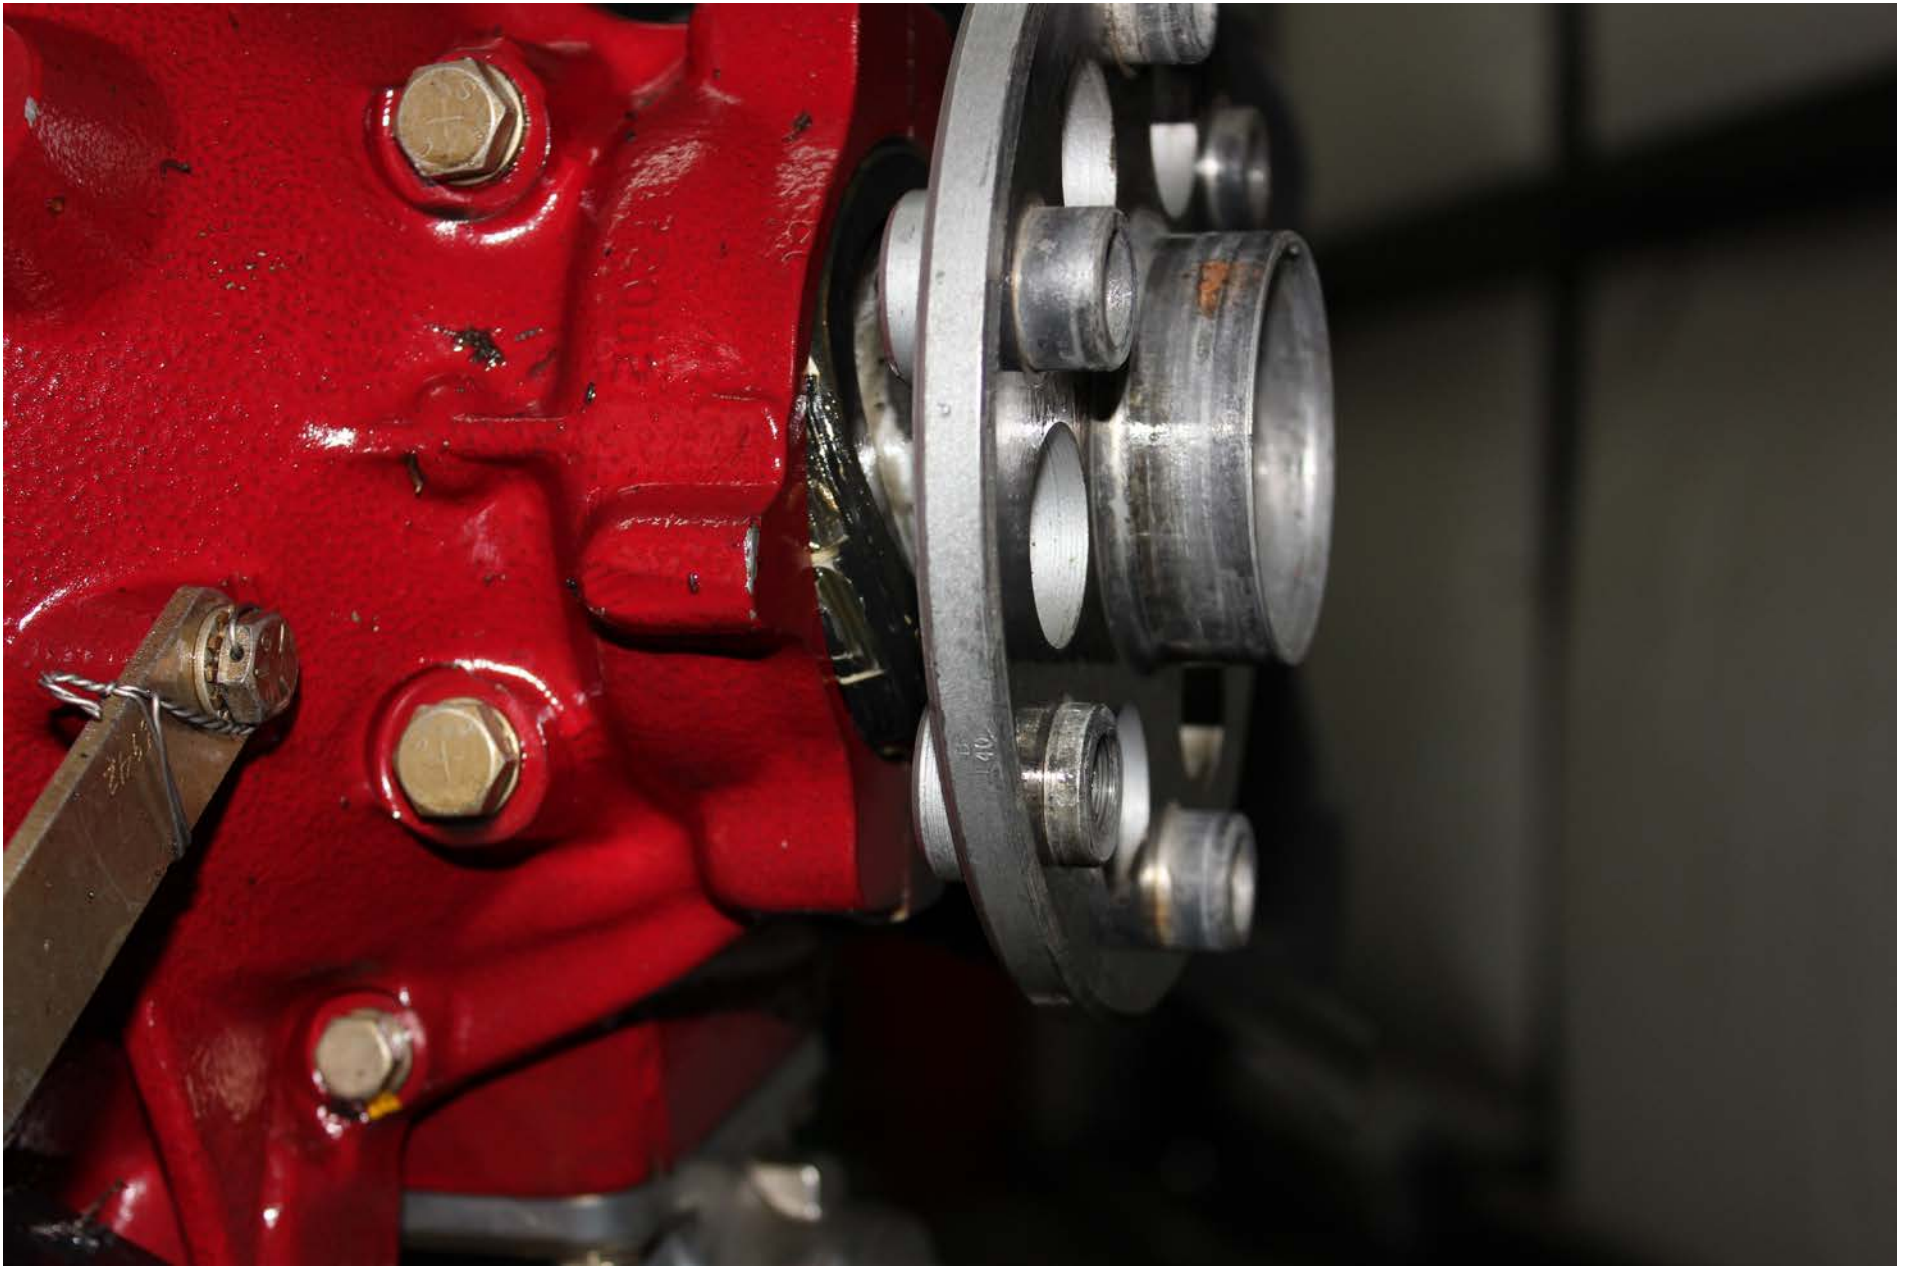
**Photo 2 – Displaced crankshaft oil seal.**

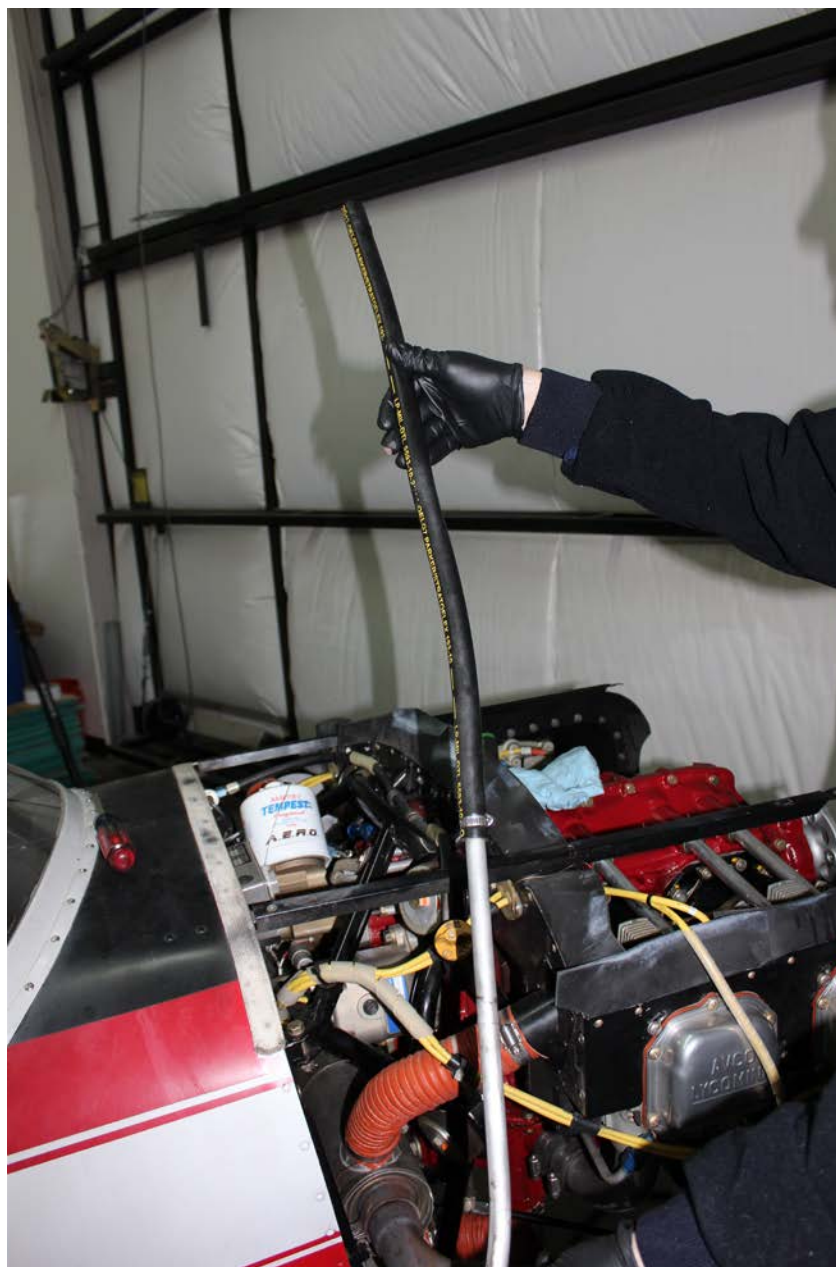
**Photo 3 – Engine breather tube.**
