## **NATIONAL TRANSPORTATION SAFETY BOARD**

### **Weather Study**

# **METEOROLOGY**

ANC18FA003

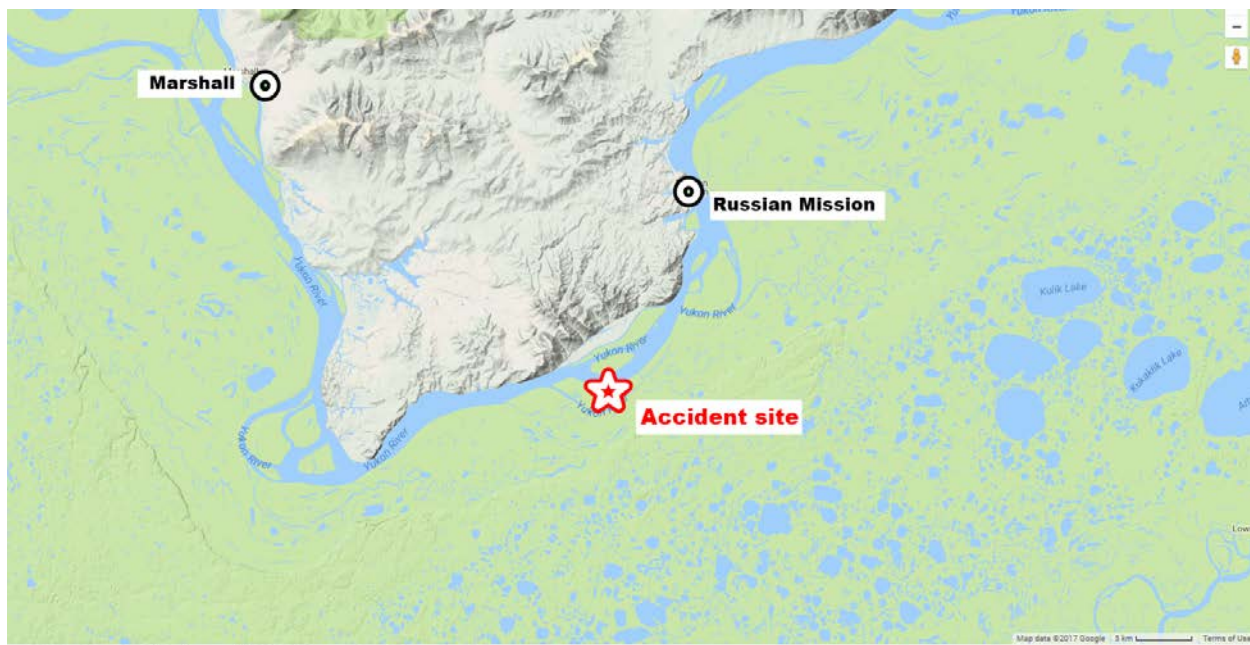
Figure 17 – Map of the closest FAA weather camera sites and the accident site

Images from the FAA's Aviation Weather Cameras are shown in figures 17 through 30 along with attachment 2 providing images of the weather conditions surrounding the accident site at the accident time. Figure 17 indicates the web camera locations included in attachment 2. The weather cameras (figures 18 through 26) from Russian Mission, located 9 miles north-northeast of the accident site at an elevation of 49 ft (figure 18), showed the weather conditions surrounding the accident time with the south and southwest facing camera images provided in figures 19 through 26 with times at 1419, 1420, 1429, 1430, 1439, and 1440 AKDT. The camera images depicted rain shower conditions with the rain showers moving across the area with lower ceiling and visibility conditions within the rain showers beyond the visibility reference point. The Russian Mission south facing camera also indicated a lower bank of clouds towards the Yukon River, the accident site, and along the intended route towards PABE (figures 20 through 22 and attachment 2).

Attachment 2 – FAA’s Aviation Web Camera images from web cameras (locations seen in figure 17) surrounding the accident site

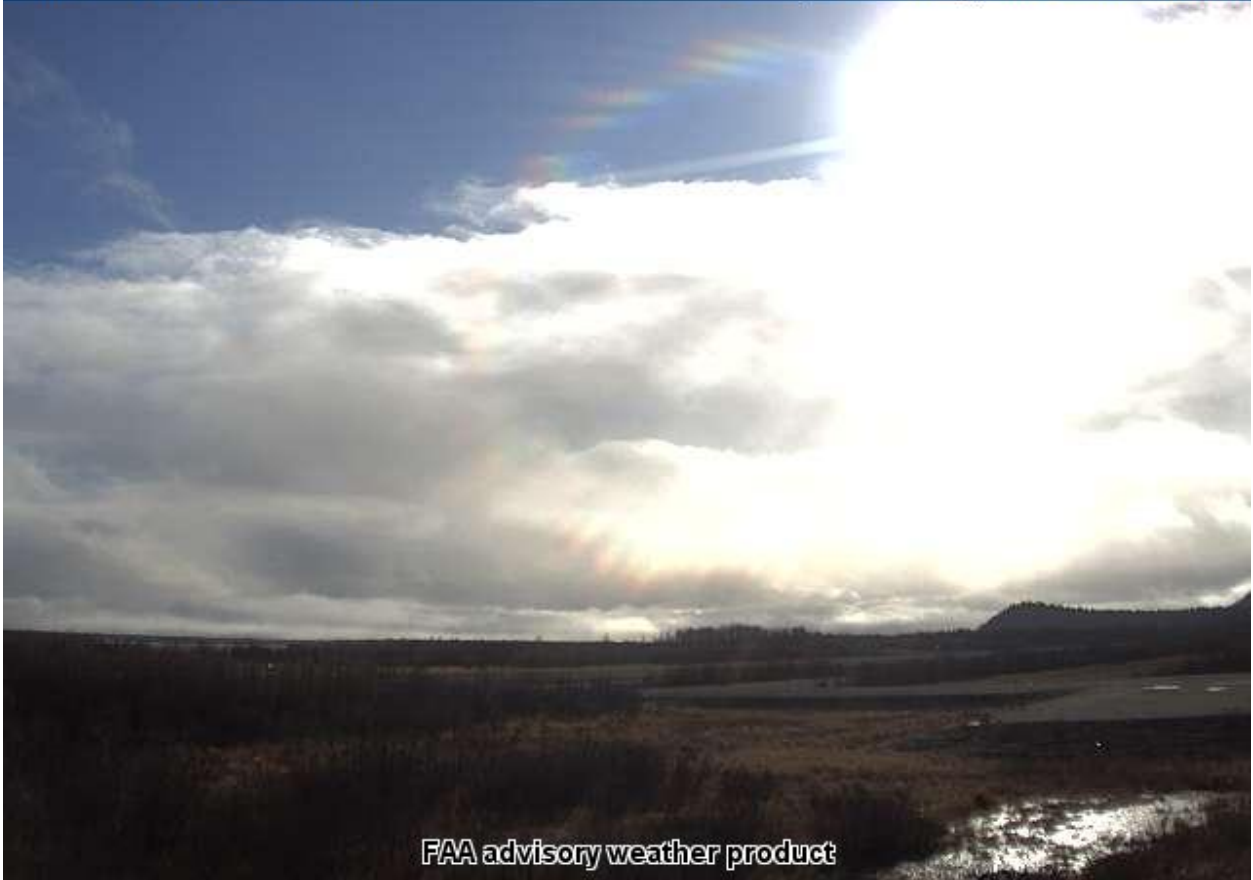
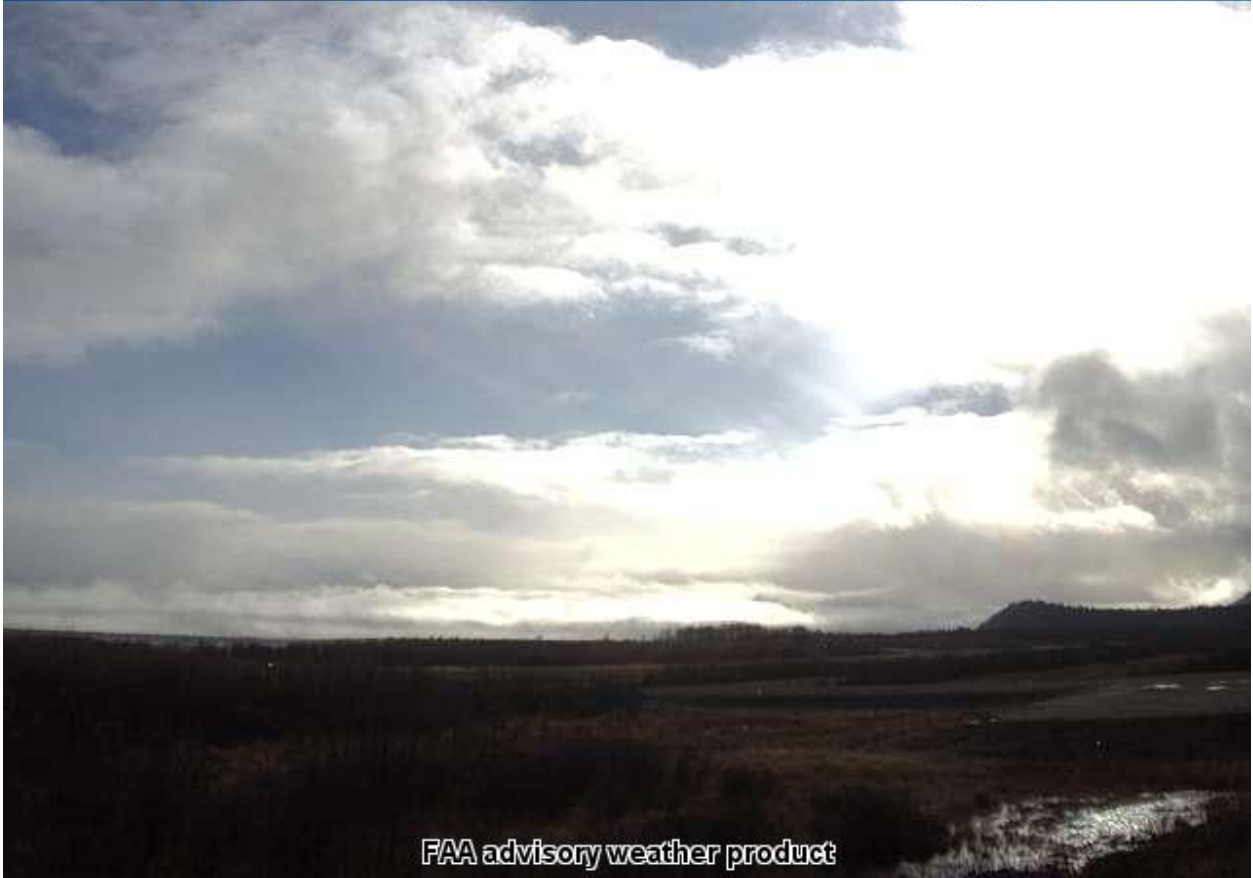
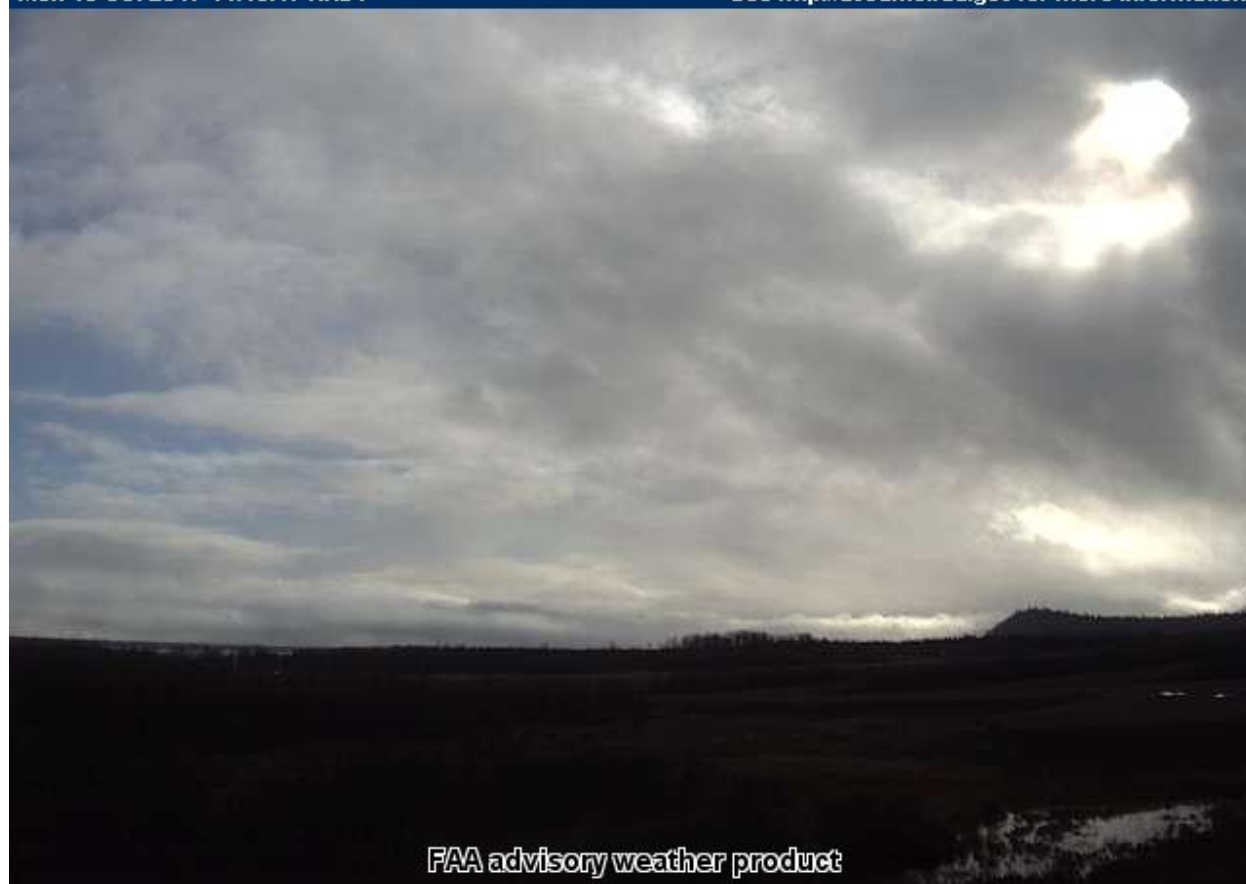
**Figure 20 – FAA weather camera from Russian Mission south view from 1420 AKDT**

**Figure 21 – FAA weather camera from Russian Mission south view from 1430 AKDT**

**Figure 22 – FAA weather camera from Russian Mission south view from 1440 AKDT**

The weather camera observations, surface observations (section 2.0), and weather radar data (section 5.4), indicated the accident airplane likely encountered rain shower activity and reduced ceiling and visibility conditions at the accident time.

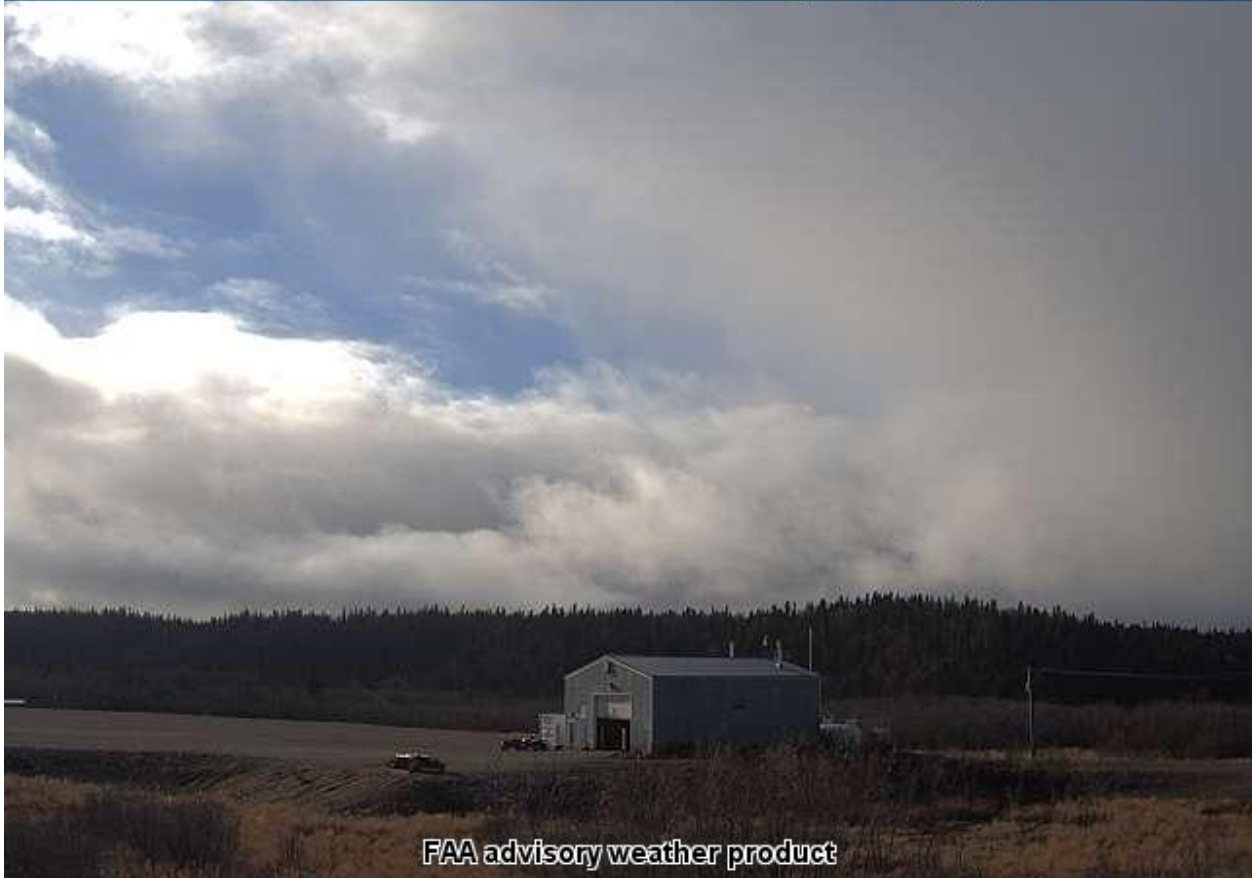
Russian Mission - SouthWest  
See <http://avcams.faa.gov> for more information

**Figure 24 – FAA weather camera from Russian Mission southwest view from 1419 AKDT**

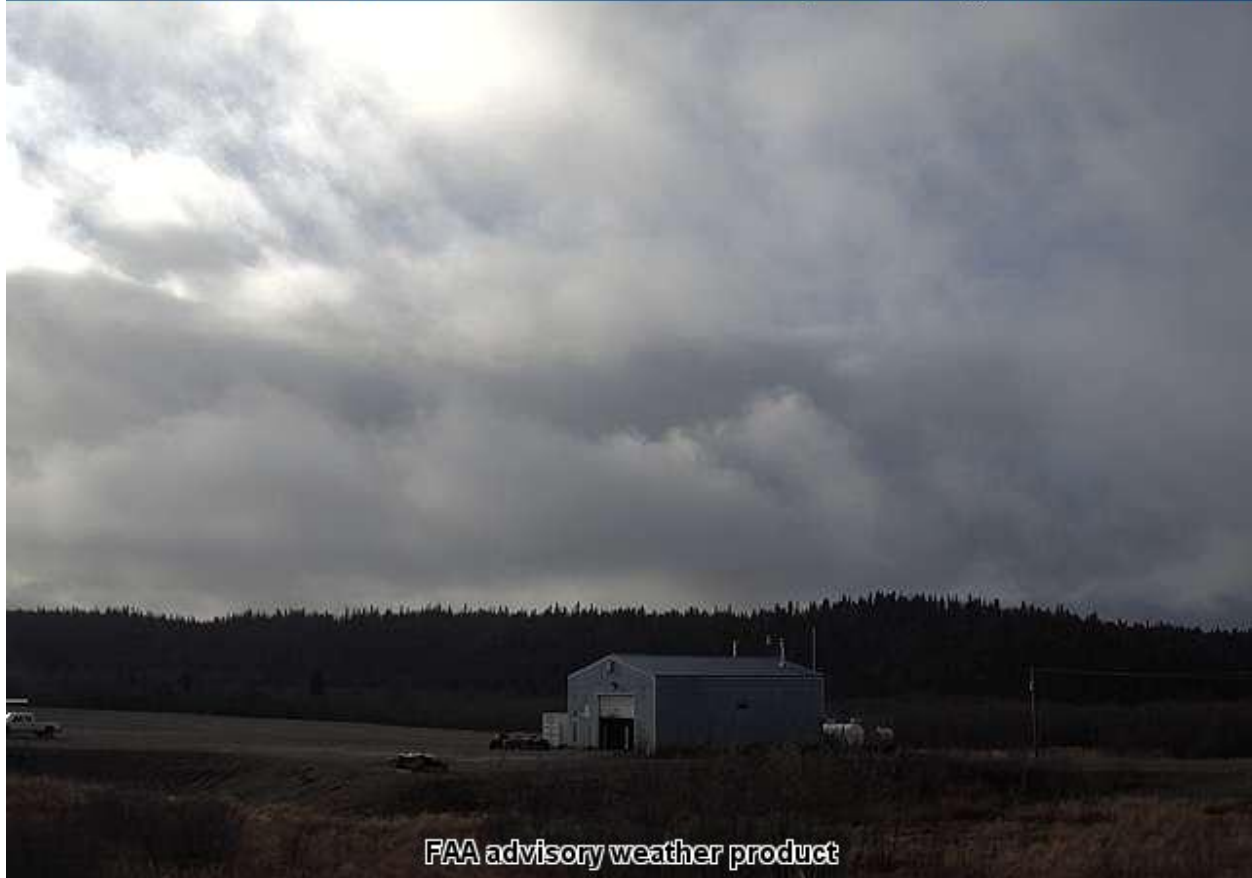
Russian Mission - SouthWest  
See <http://avcams.faa.gov> for more information

**Figure 25 – FAA weather camera from Russian Mission southwest view from 1429 AKDT**

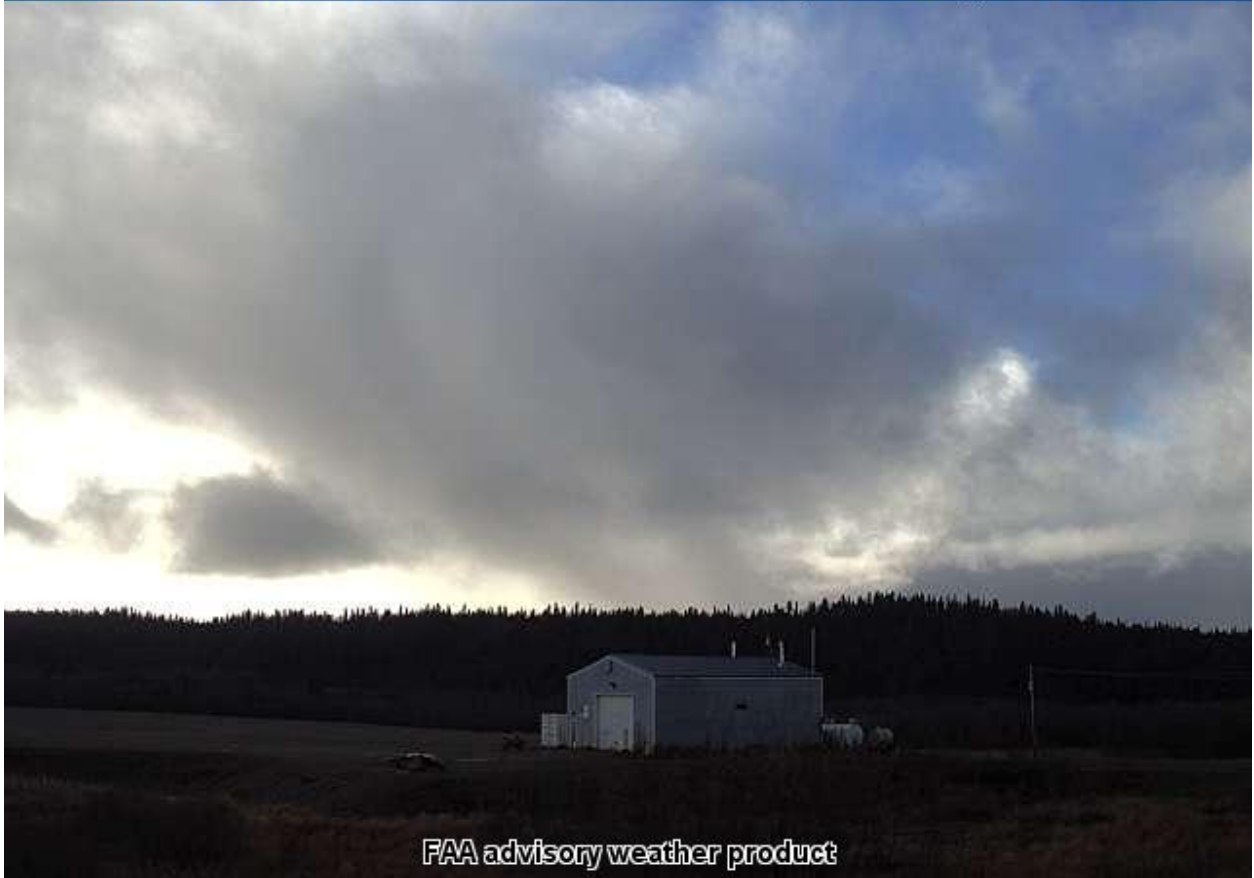
Russian Mission - SouthWest  
See <http://avcams.faa.gov> for more information

**Figure 26 – FAA weather camera from Russian Mission southwest view from 1439 AKDT**

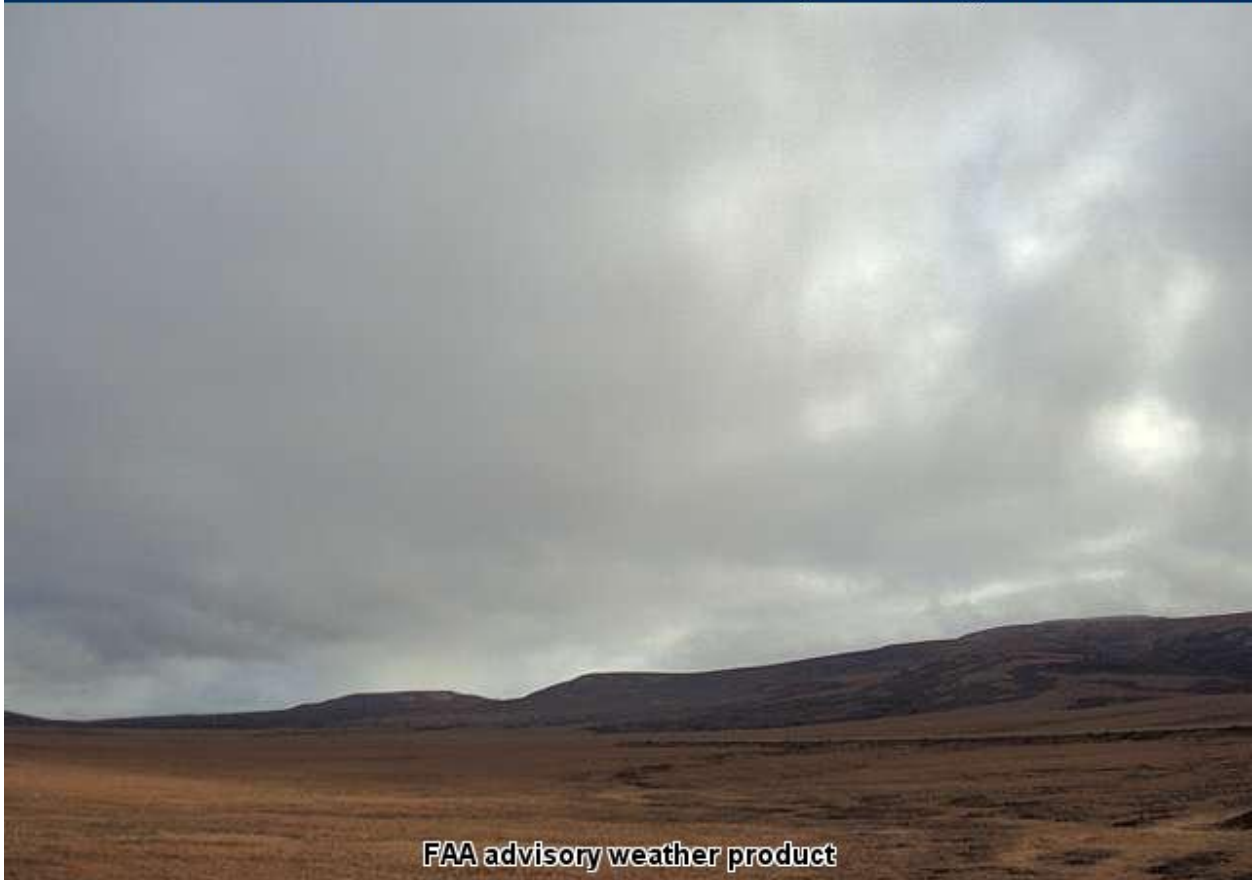
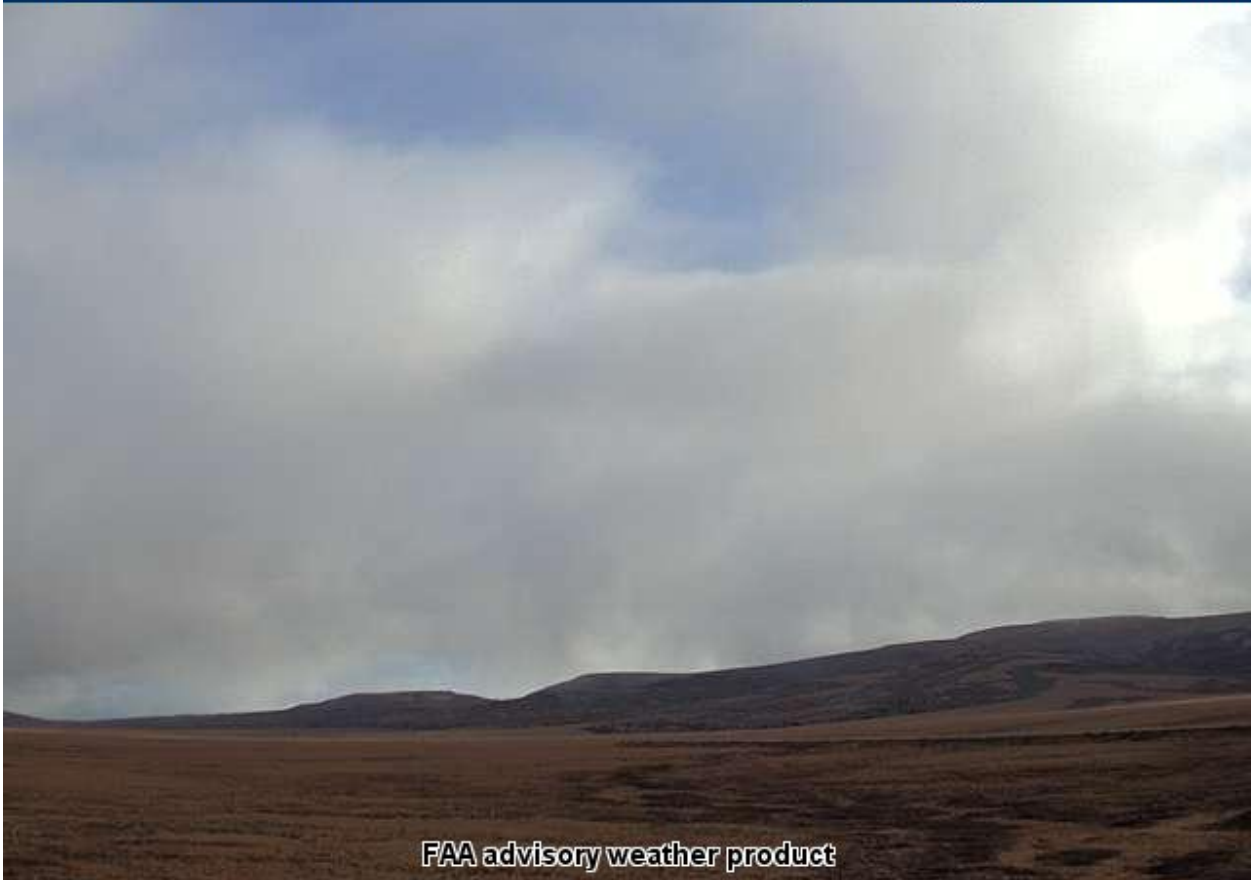
The weather cameras (figures 27 through 30) from Marshall, located 22 miles northwest of the accident site at an elevation of 49 ft, showed the weather conditions surrounding the accident time with the east facing camera images provided in figures 28 through 30 with times at 1426 and 1436 AKDT. The east facing camera images from Marshall also depicted rain shower conditions with the rain showers moving across the area with lower ceiling and visibility conditions within the rain showers, again beyond the visibility reference points.

**Figure 29 – FAA weather camera from Marshall east view from 1426 AKDT**

**Figure 30 – FAA weather camera from Marshall east view from 1436 AKDT**
