**Photo 1 –N1203A PA-18 wreckage on June 12, 2018 in the Katlian River.**

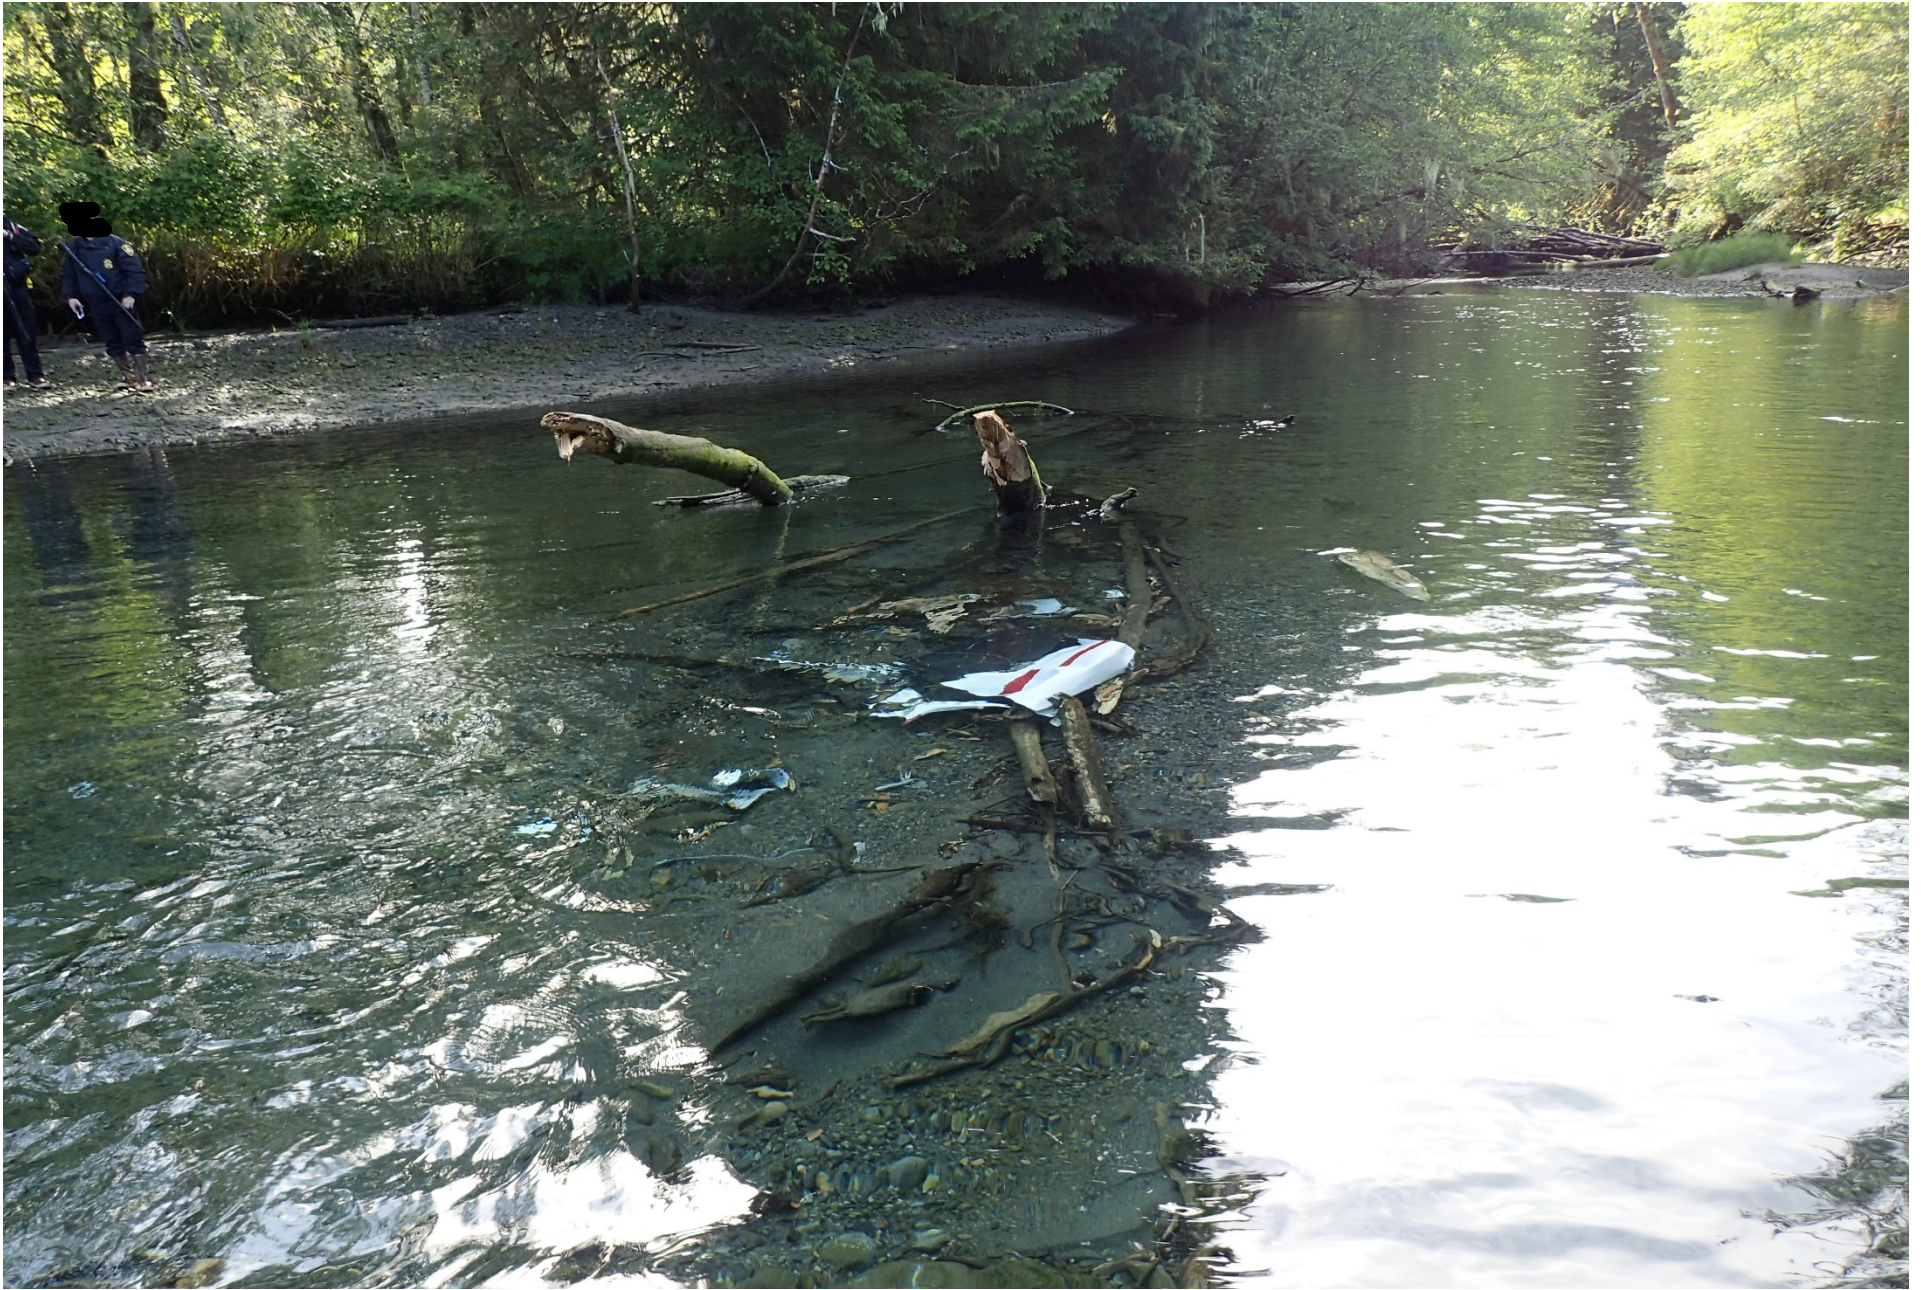
**Photo 2 - Initial impact river bottom depression with debris and cut tree trunk sections.**

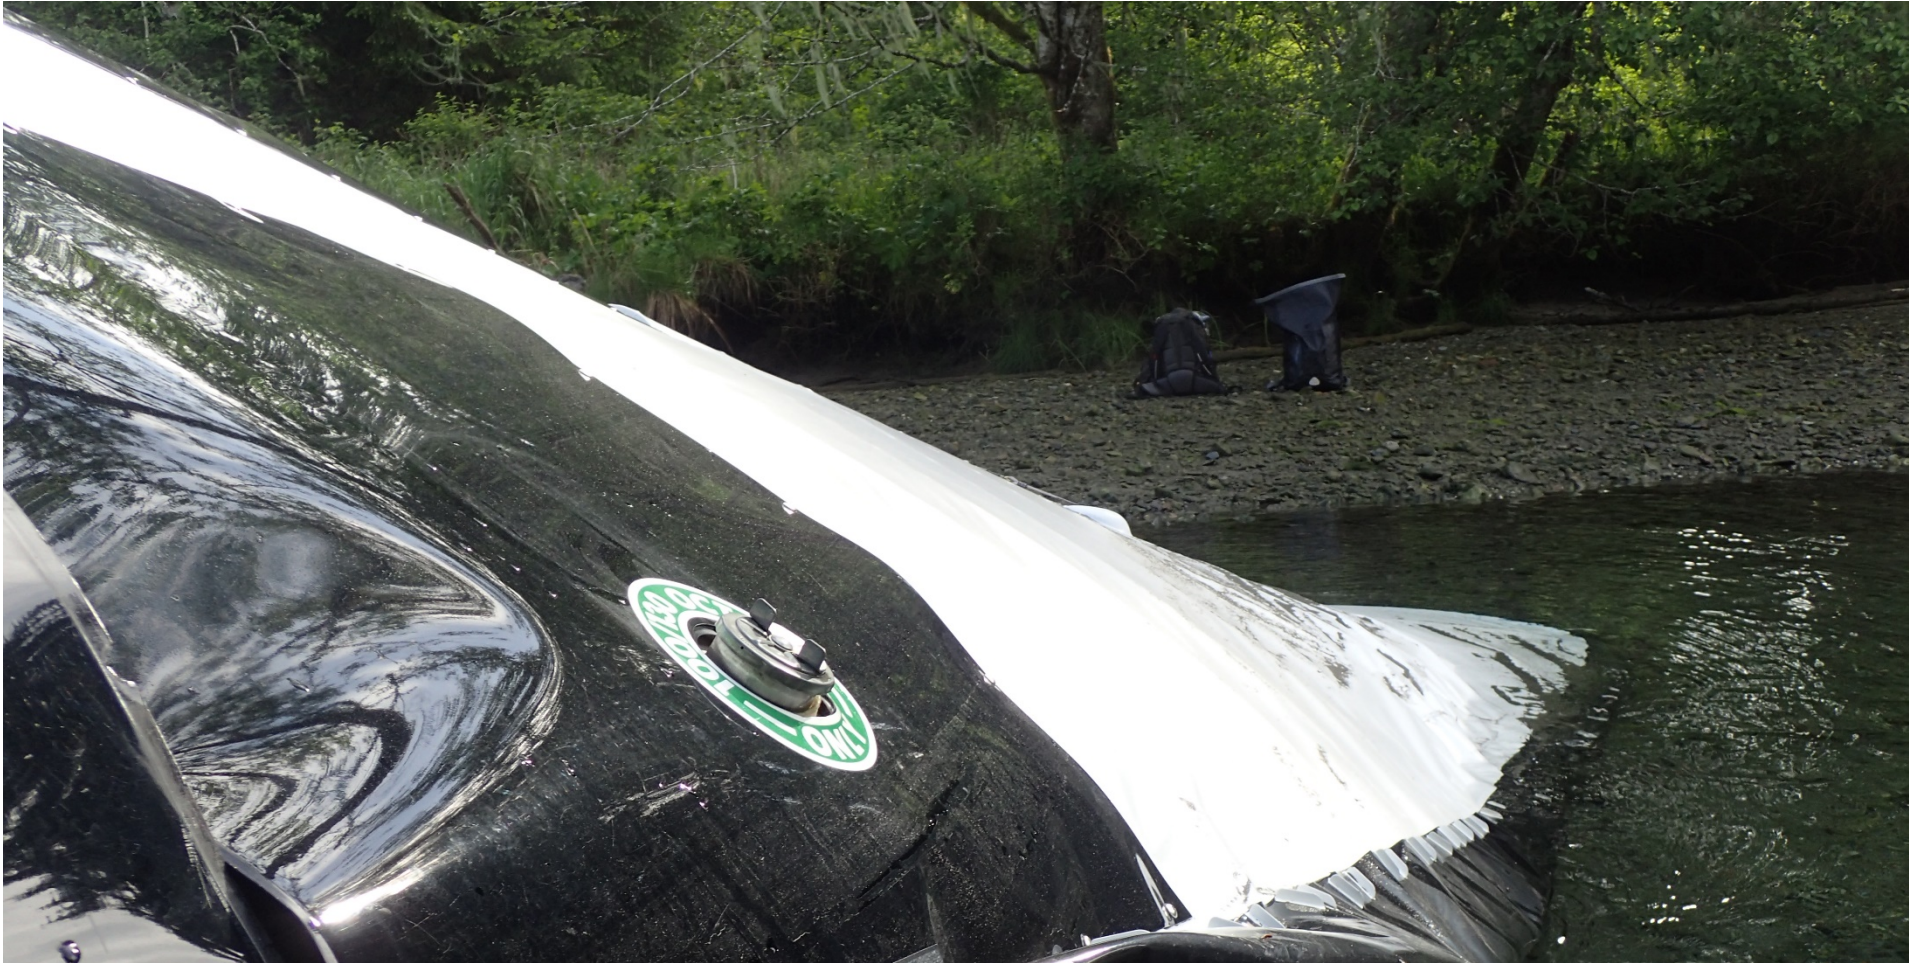
**Photo 3 - Left wing.**

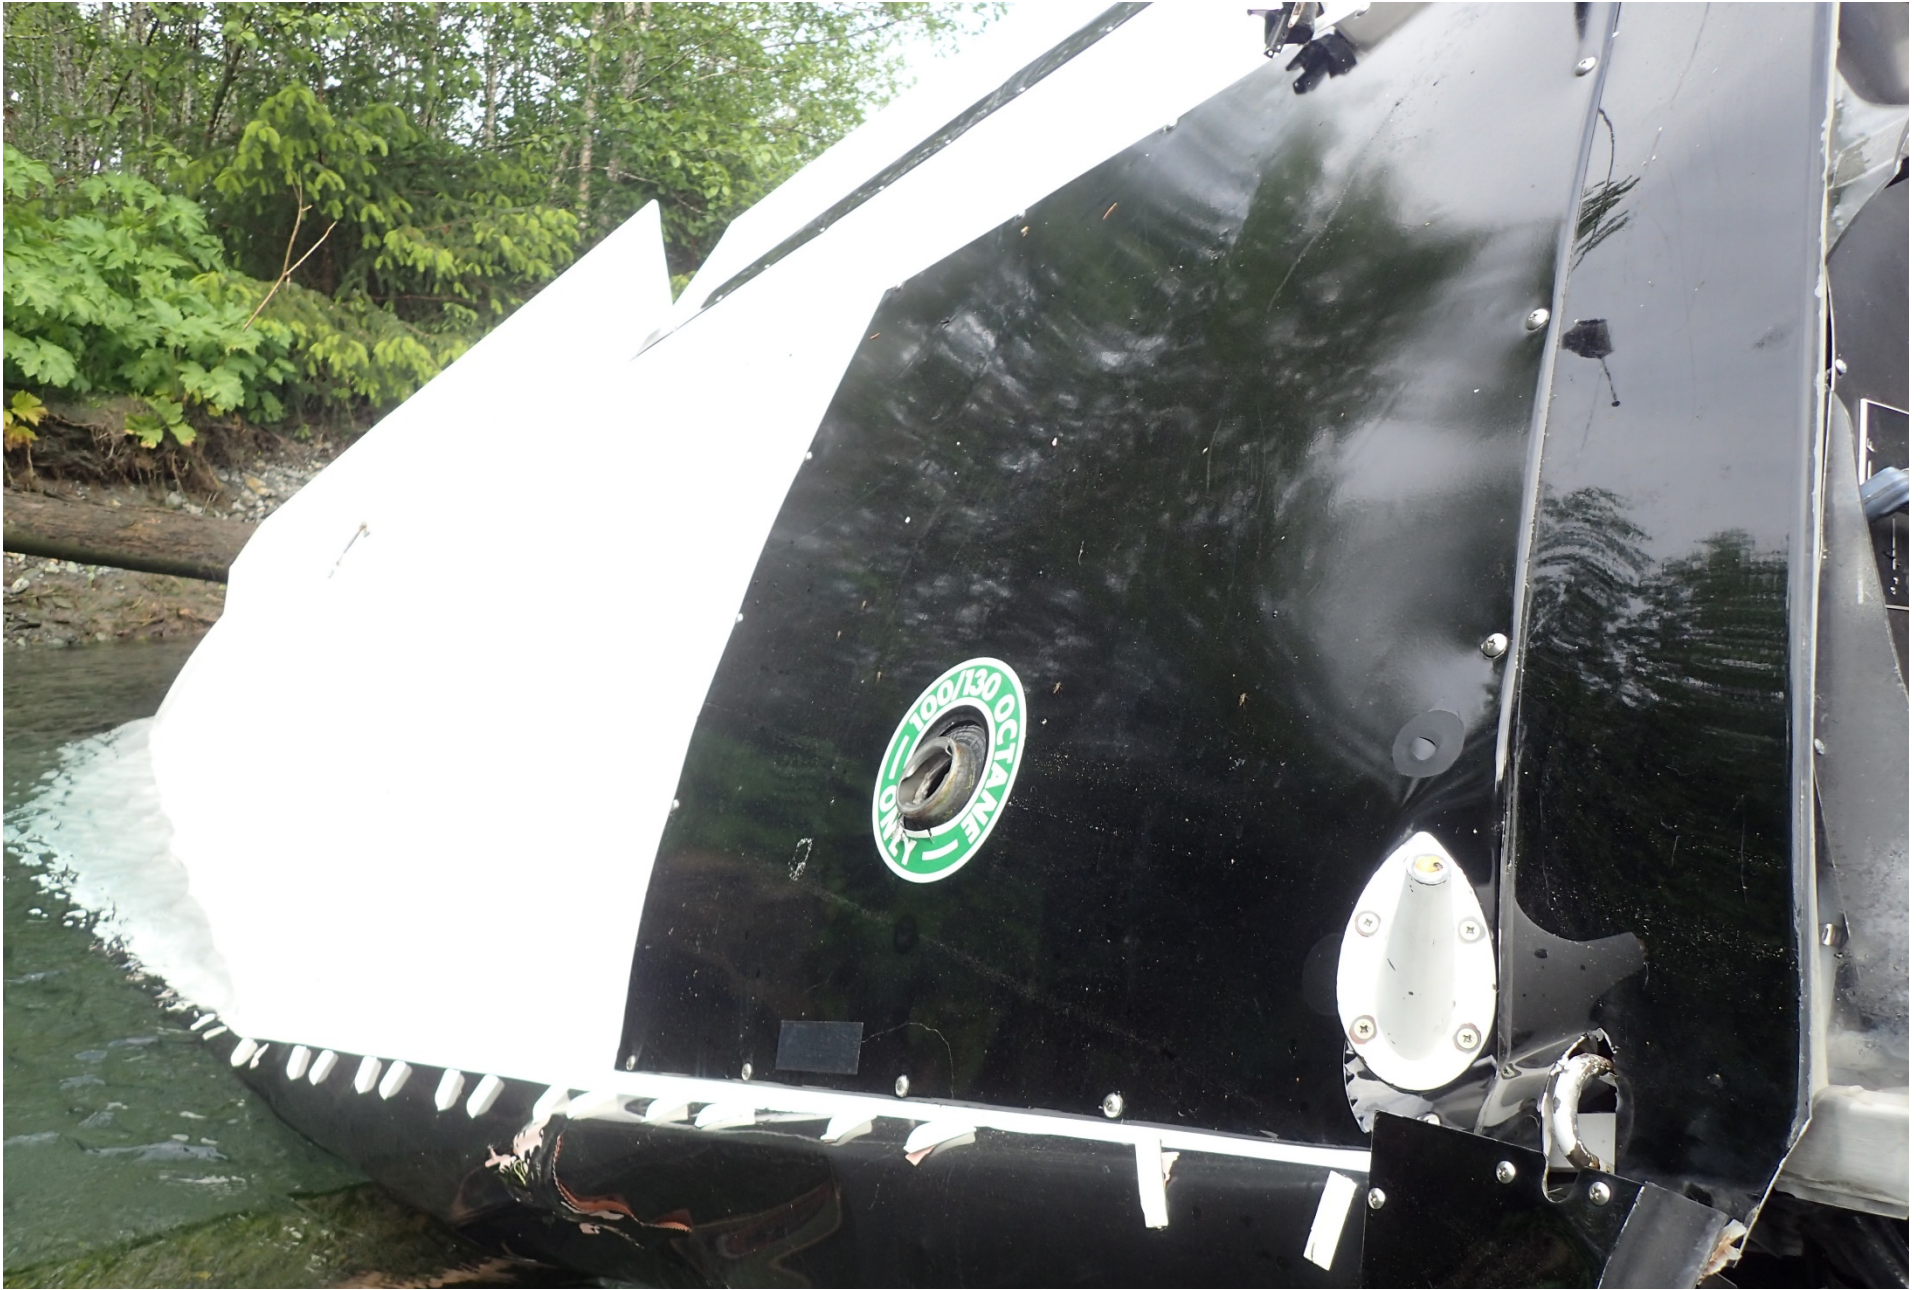
**Photo 4 - Right wing with missing fuel tank cap.**

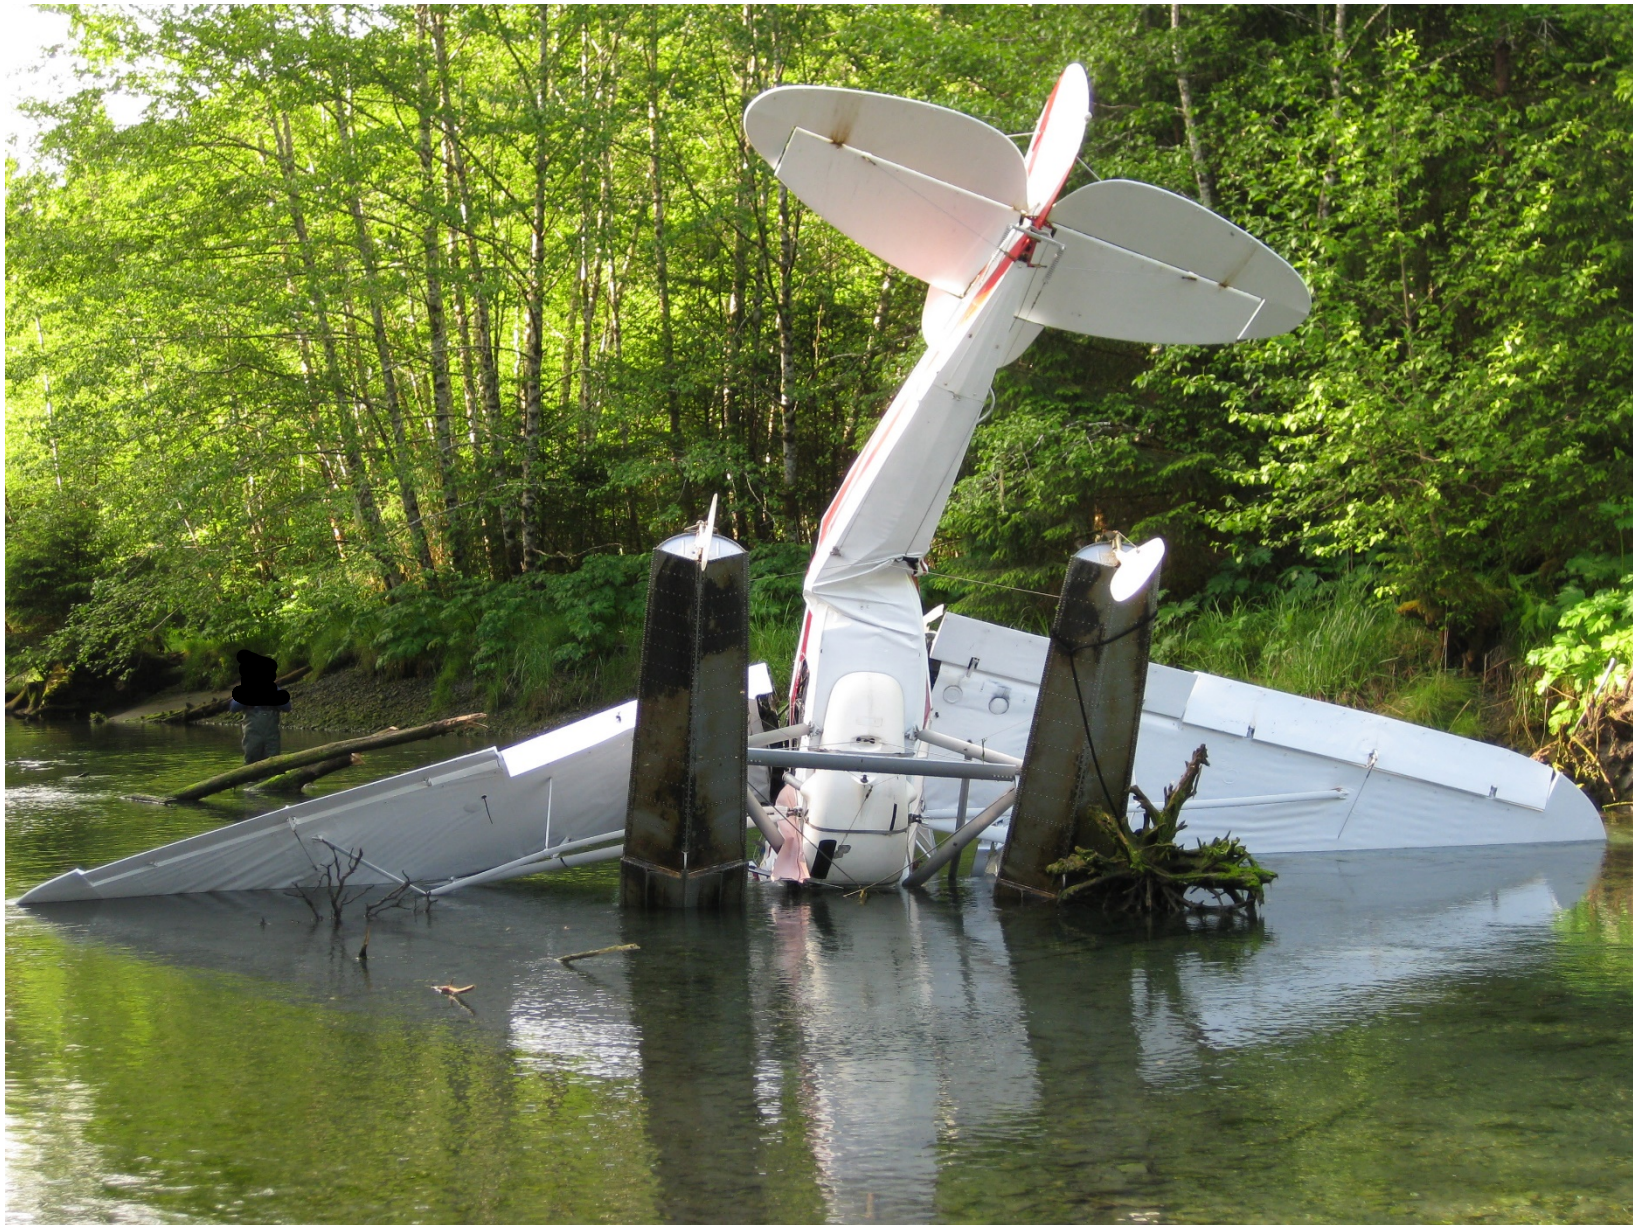
**Photo 5 - Rear view of wreckage exhibiting right twist and displacement in aft fuselage.**

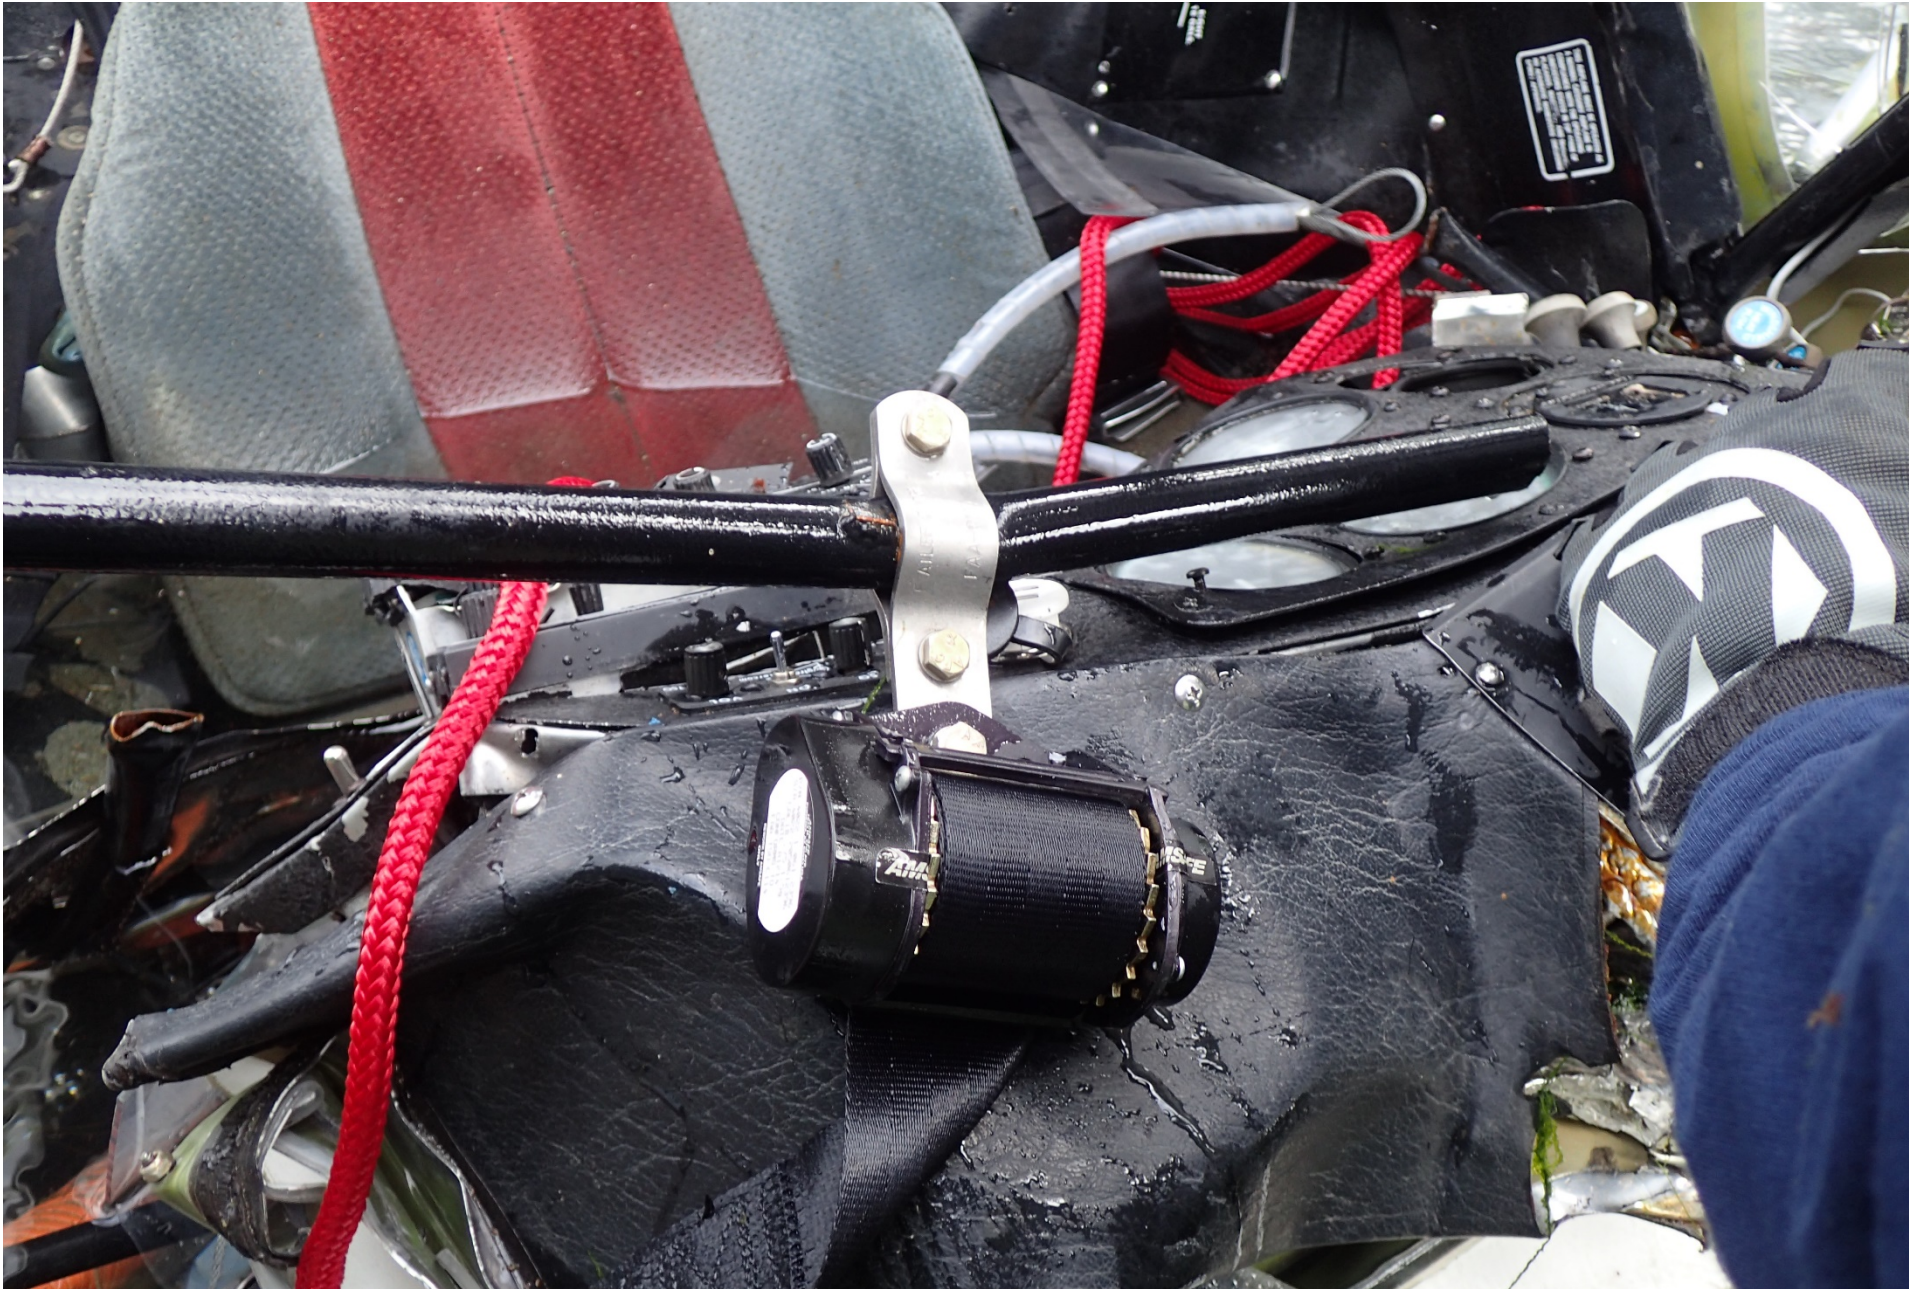
**Photo 6 - Front seat (pilot's) shoulder harness inertia reel mounted on cut tube.**

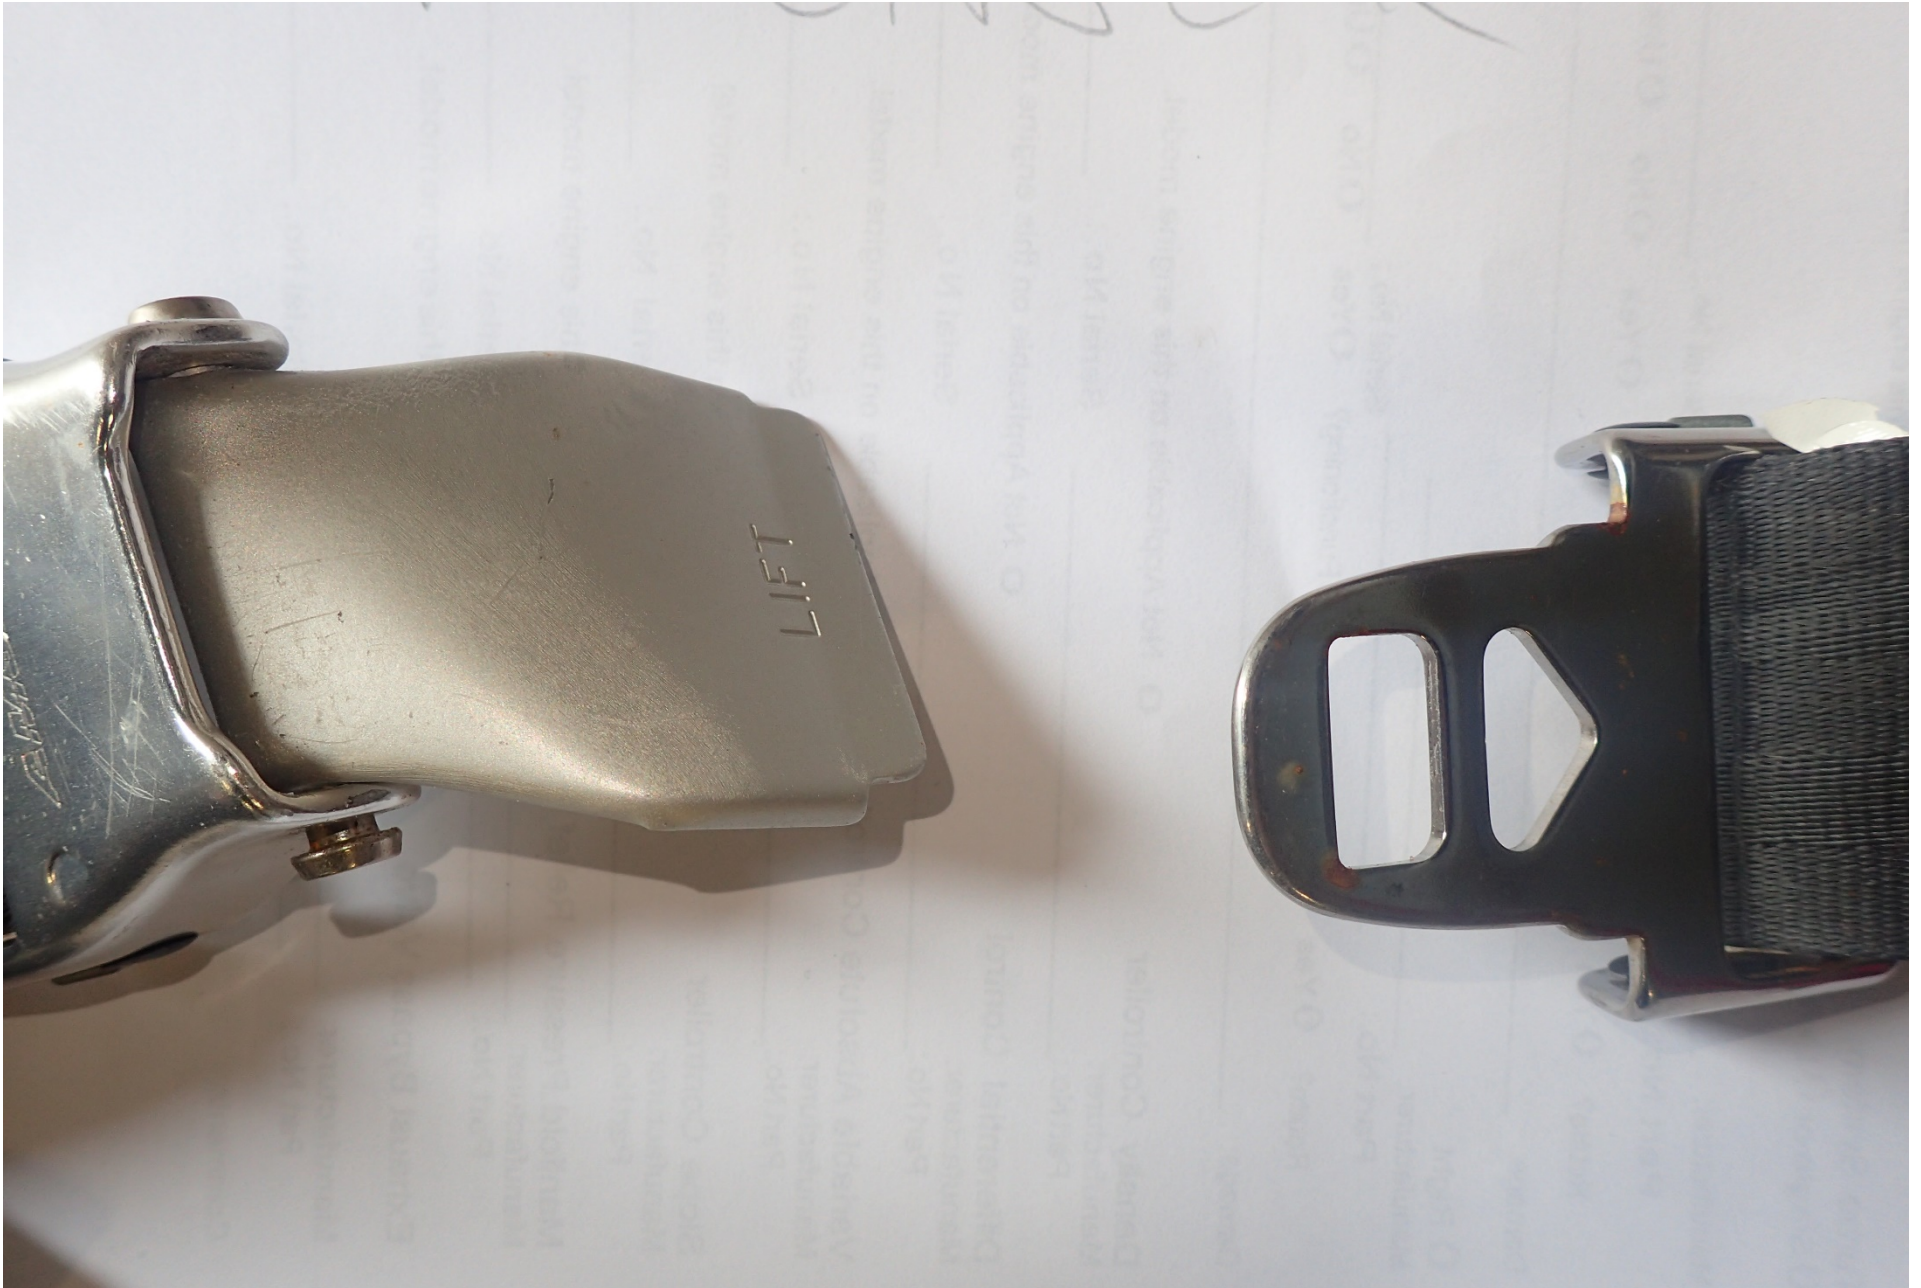
**Photo 7 - Rear seat (passenger's) lap belt buckle exhibiting deformation.**

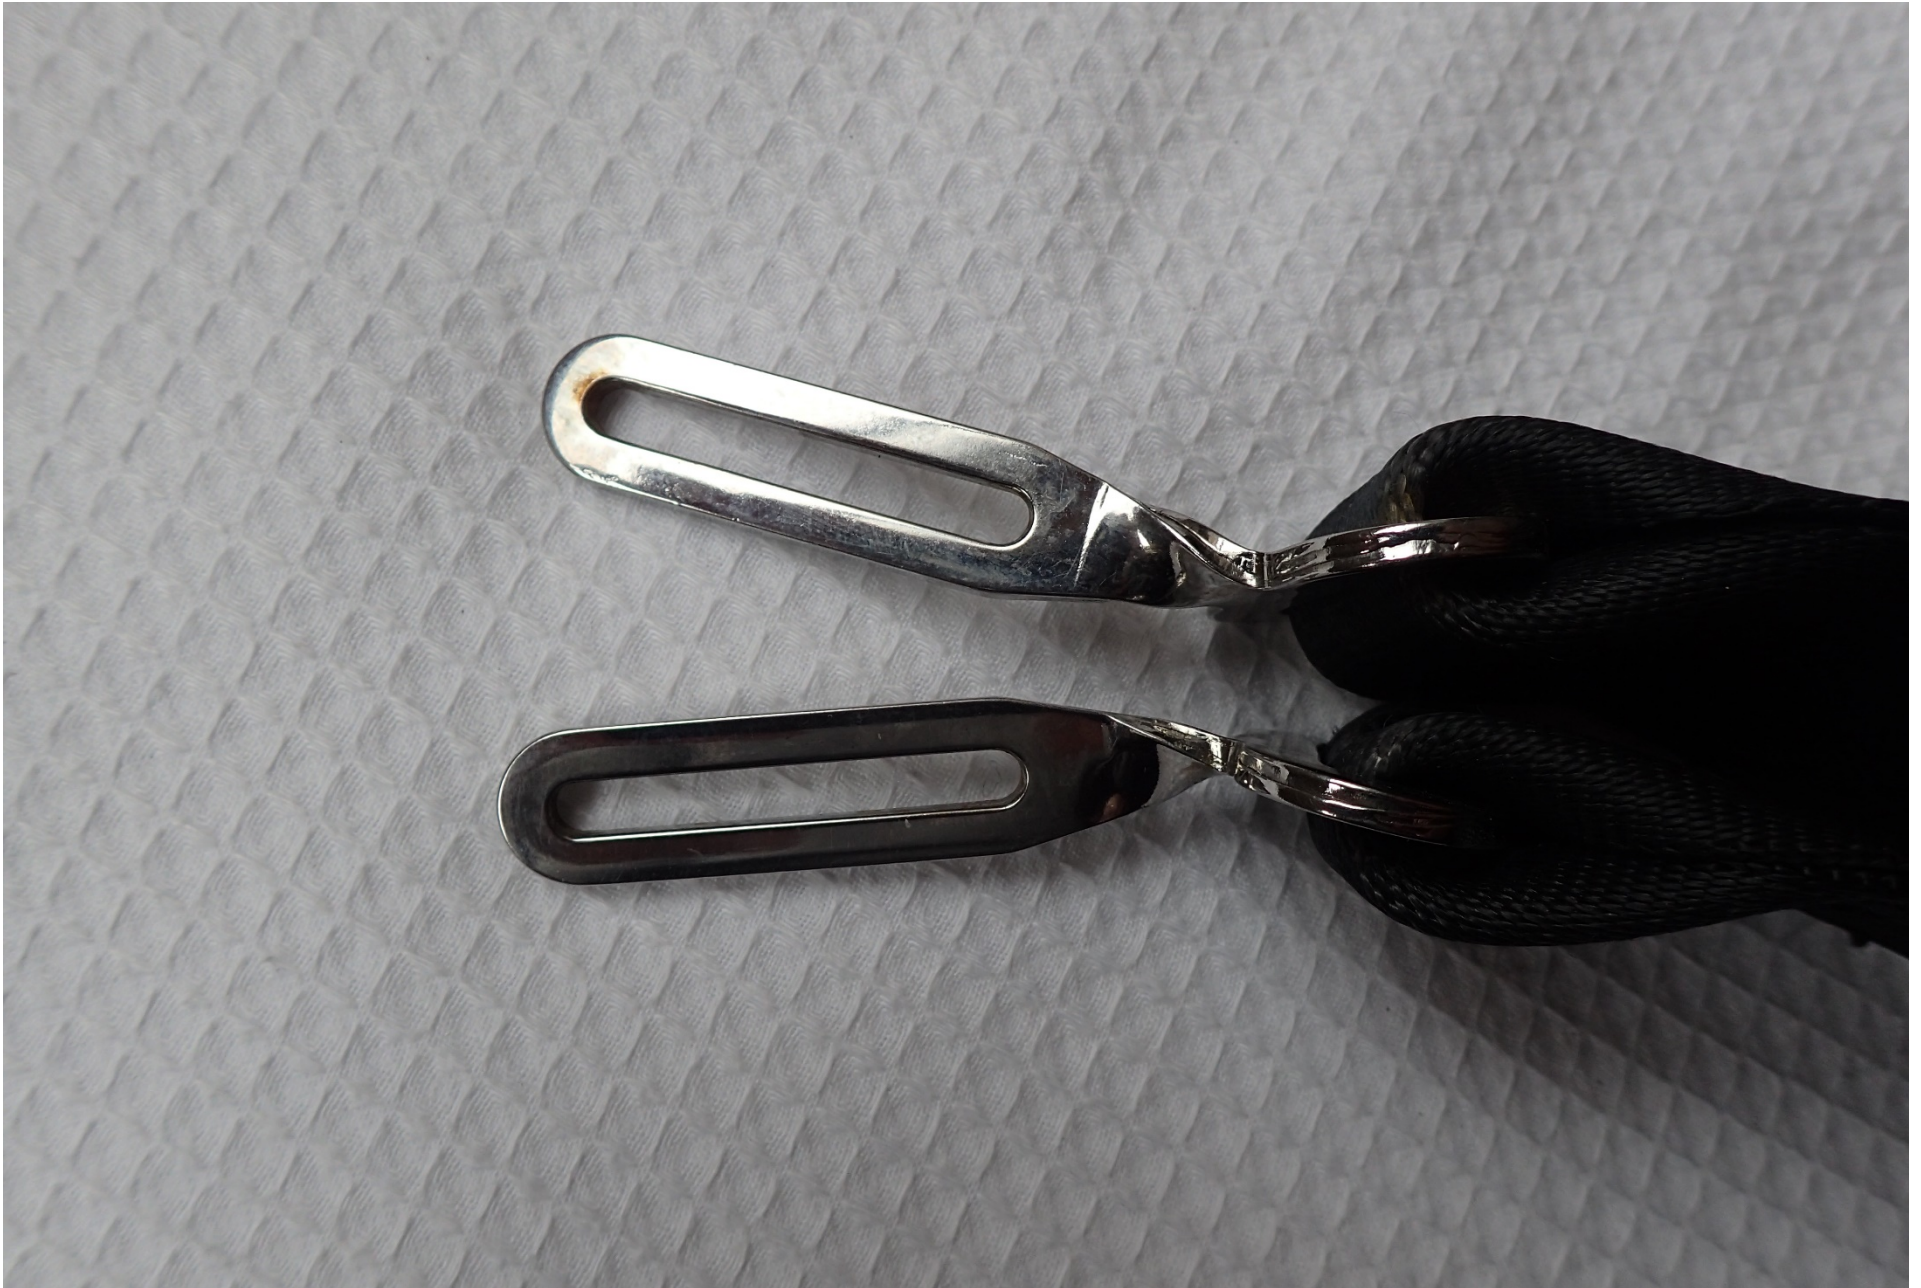
**Photo 8 - Rear seat shoulder harness connectors.**

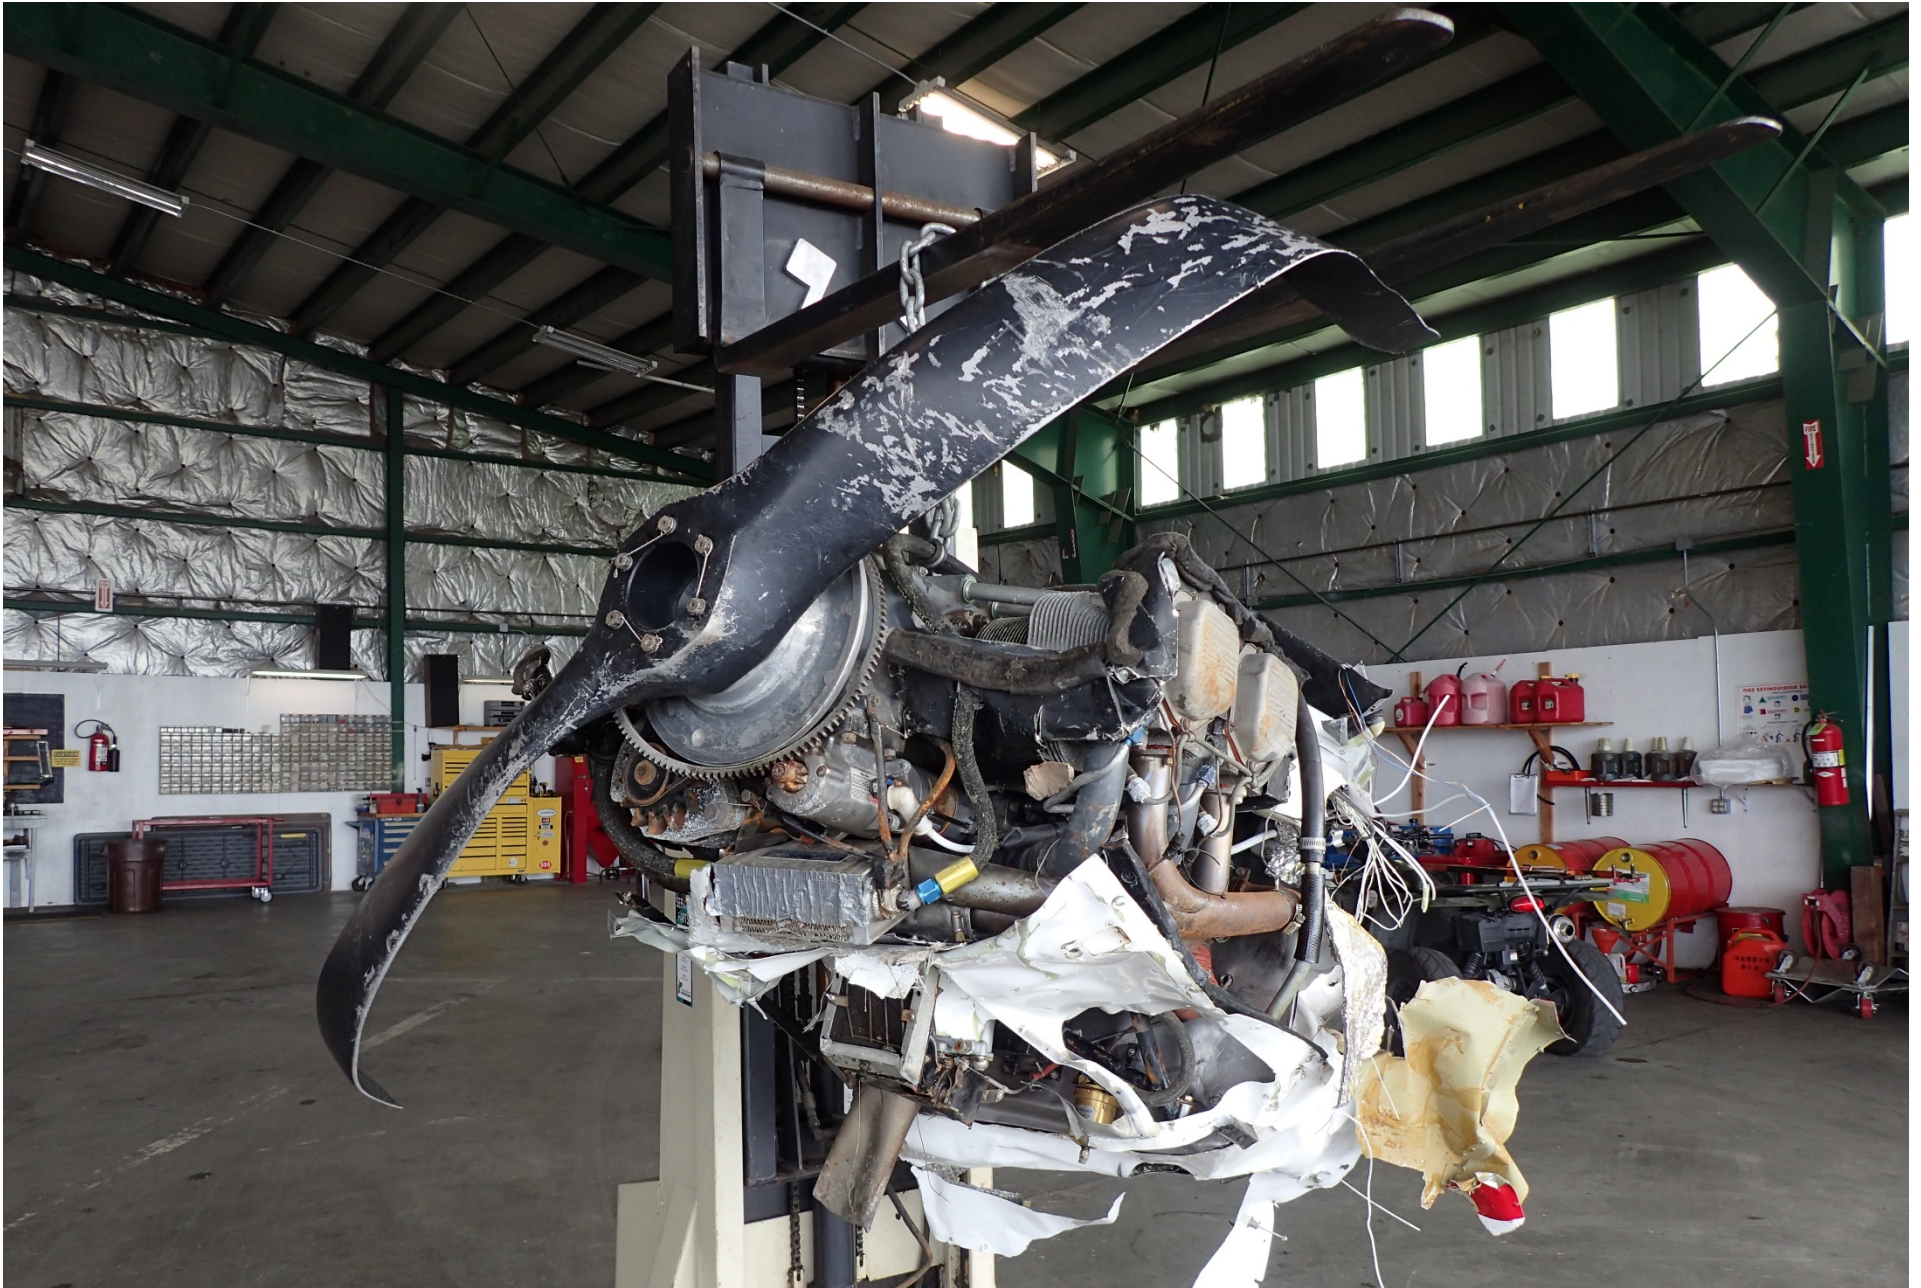
**Photo 9 - Propeller and engine during detailed examination.**
