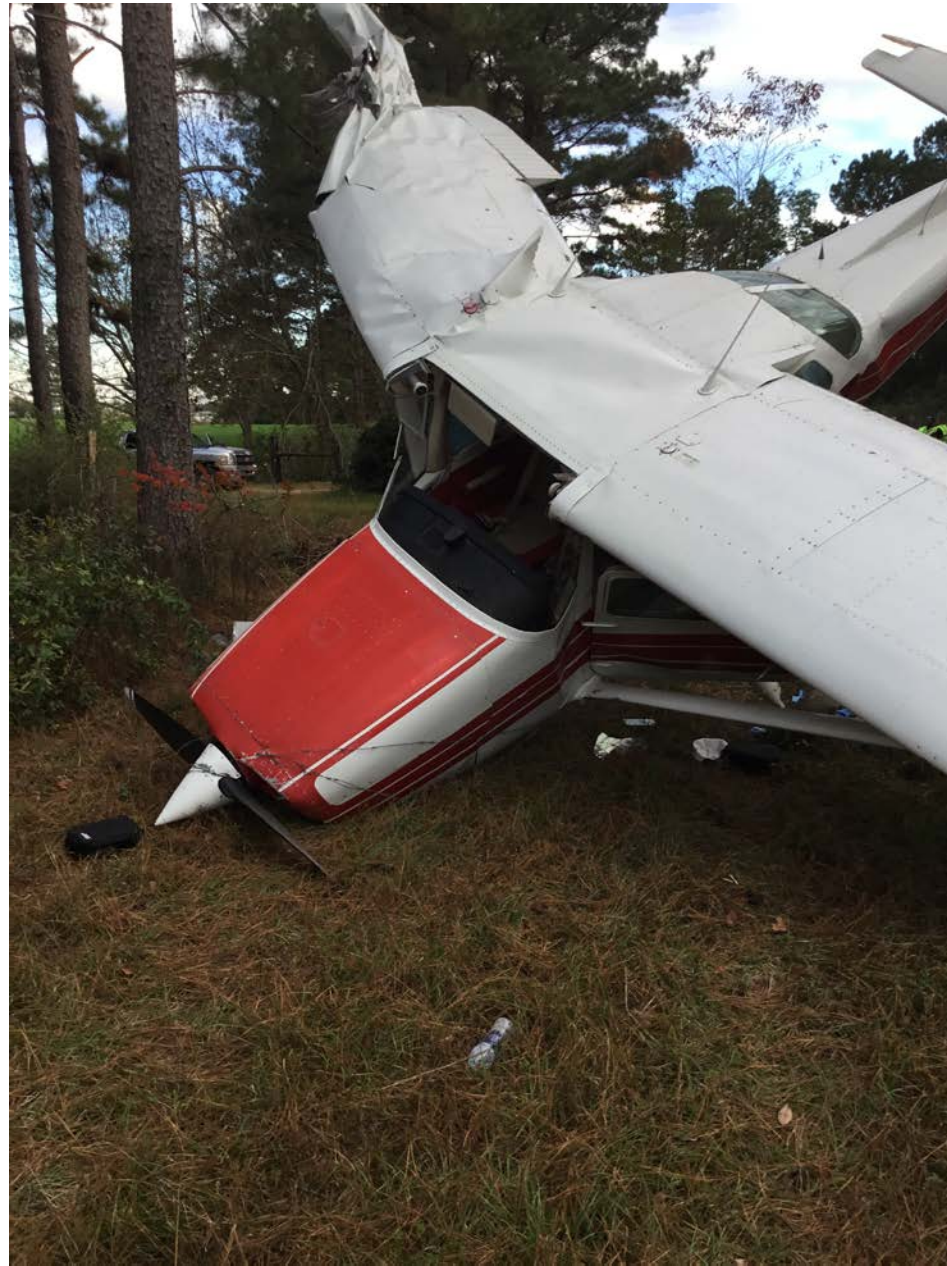
**Photo 1 – Front view of the airplane nose down (courtesy of the pilot).**

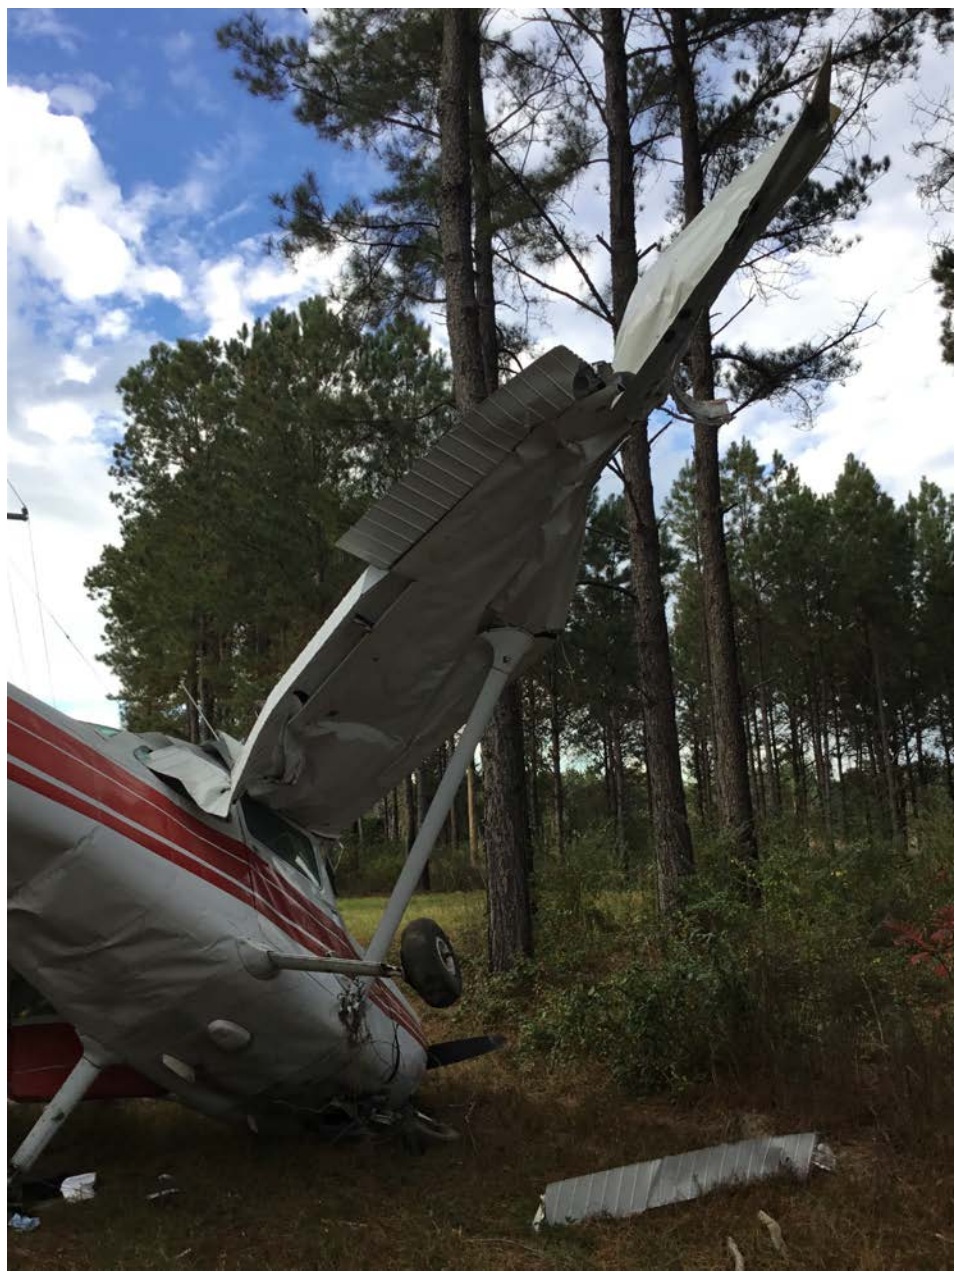
**Photo 2 – Rear view of the airplane nose down (courtesy of the pilot).**

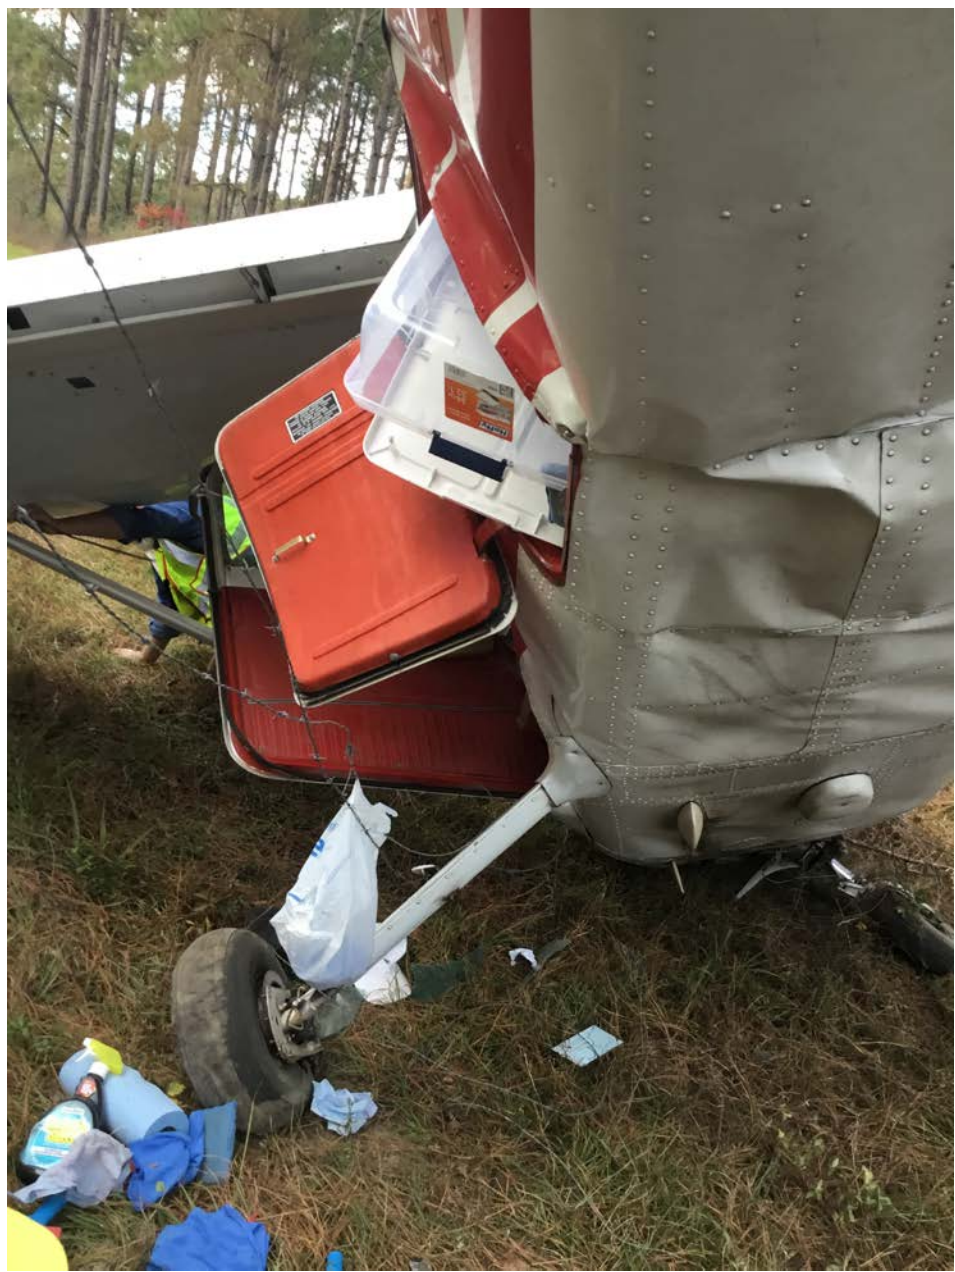
**Photo 3 – Rear view of the underside of the airplane (courtesy of the pilot)**

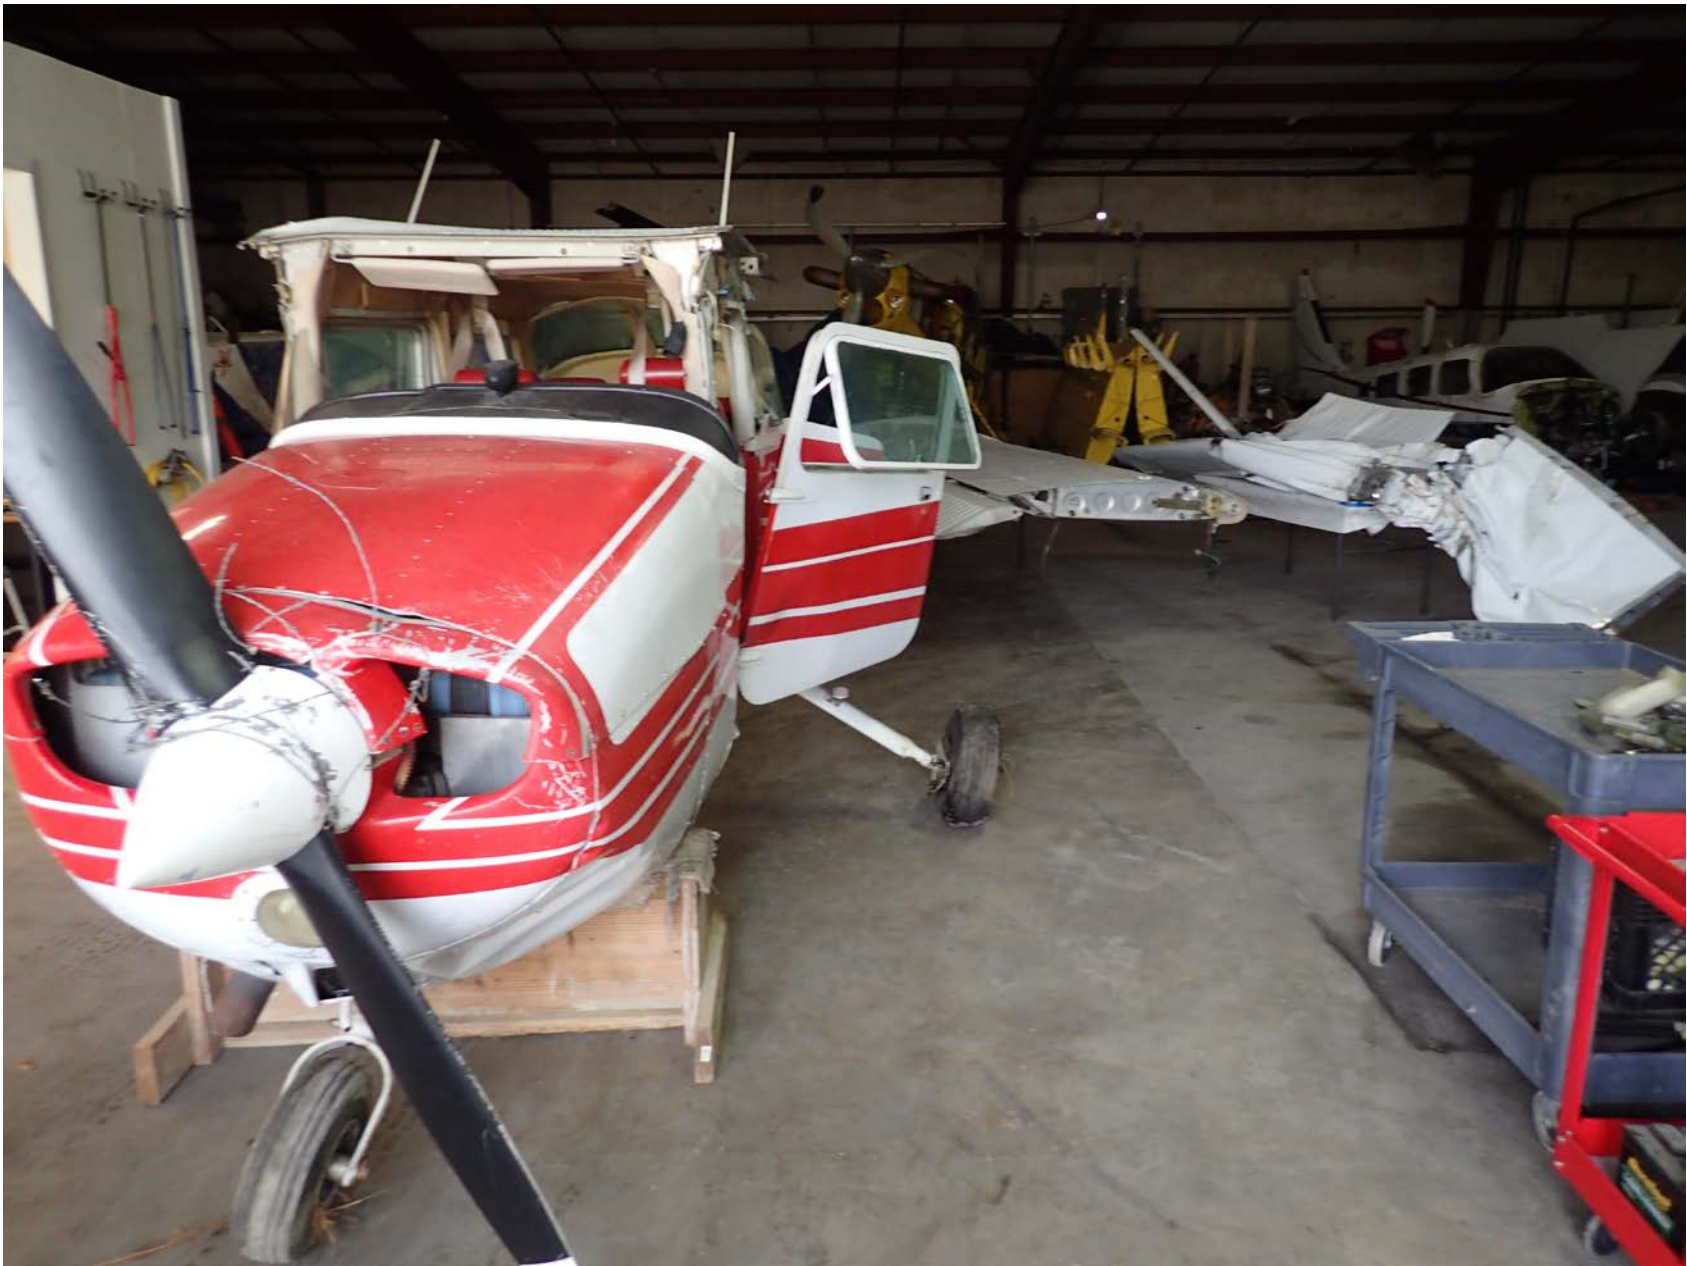
**Photo 4 – View of the fuselage and both wings after the recovery.**

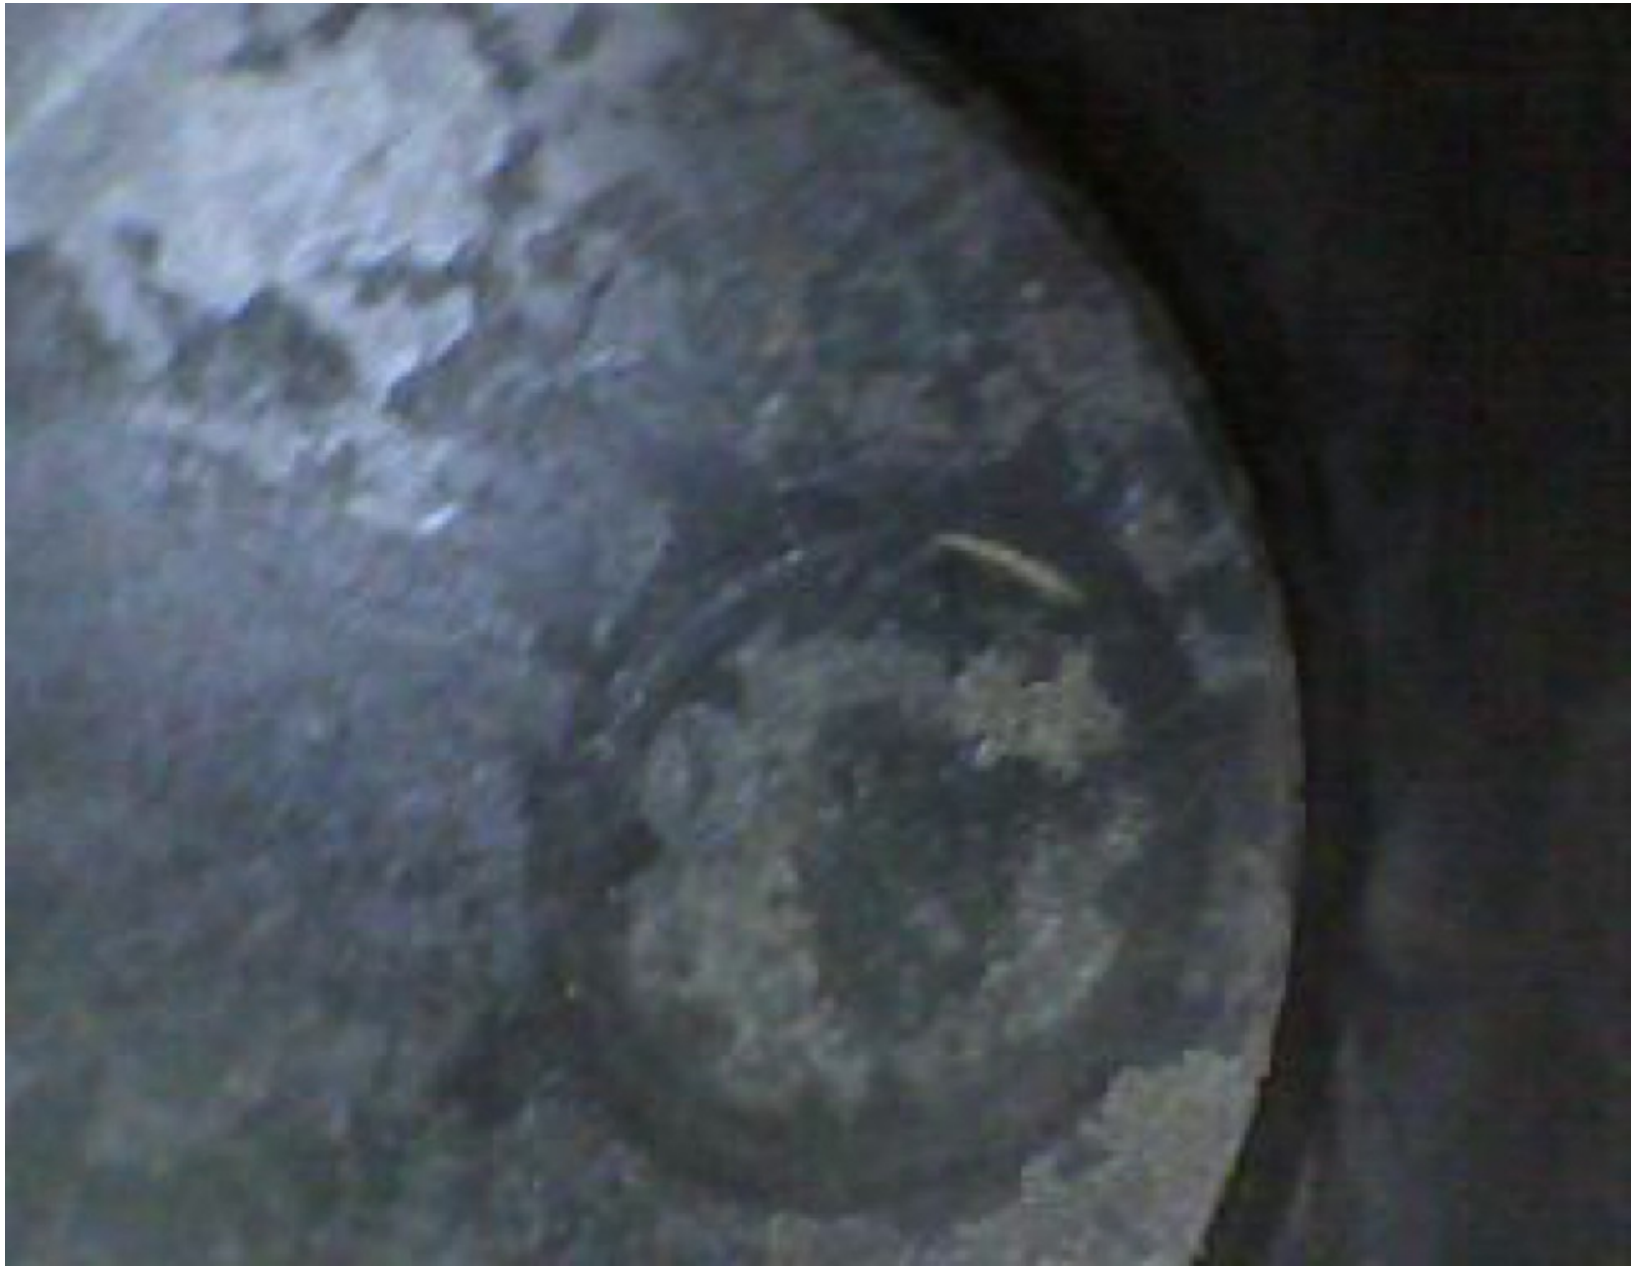
**Photo 5 – Borescope image of the number 3 piston impact marks from the exhaust valve.**

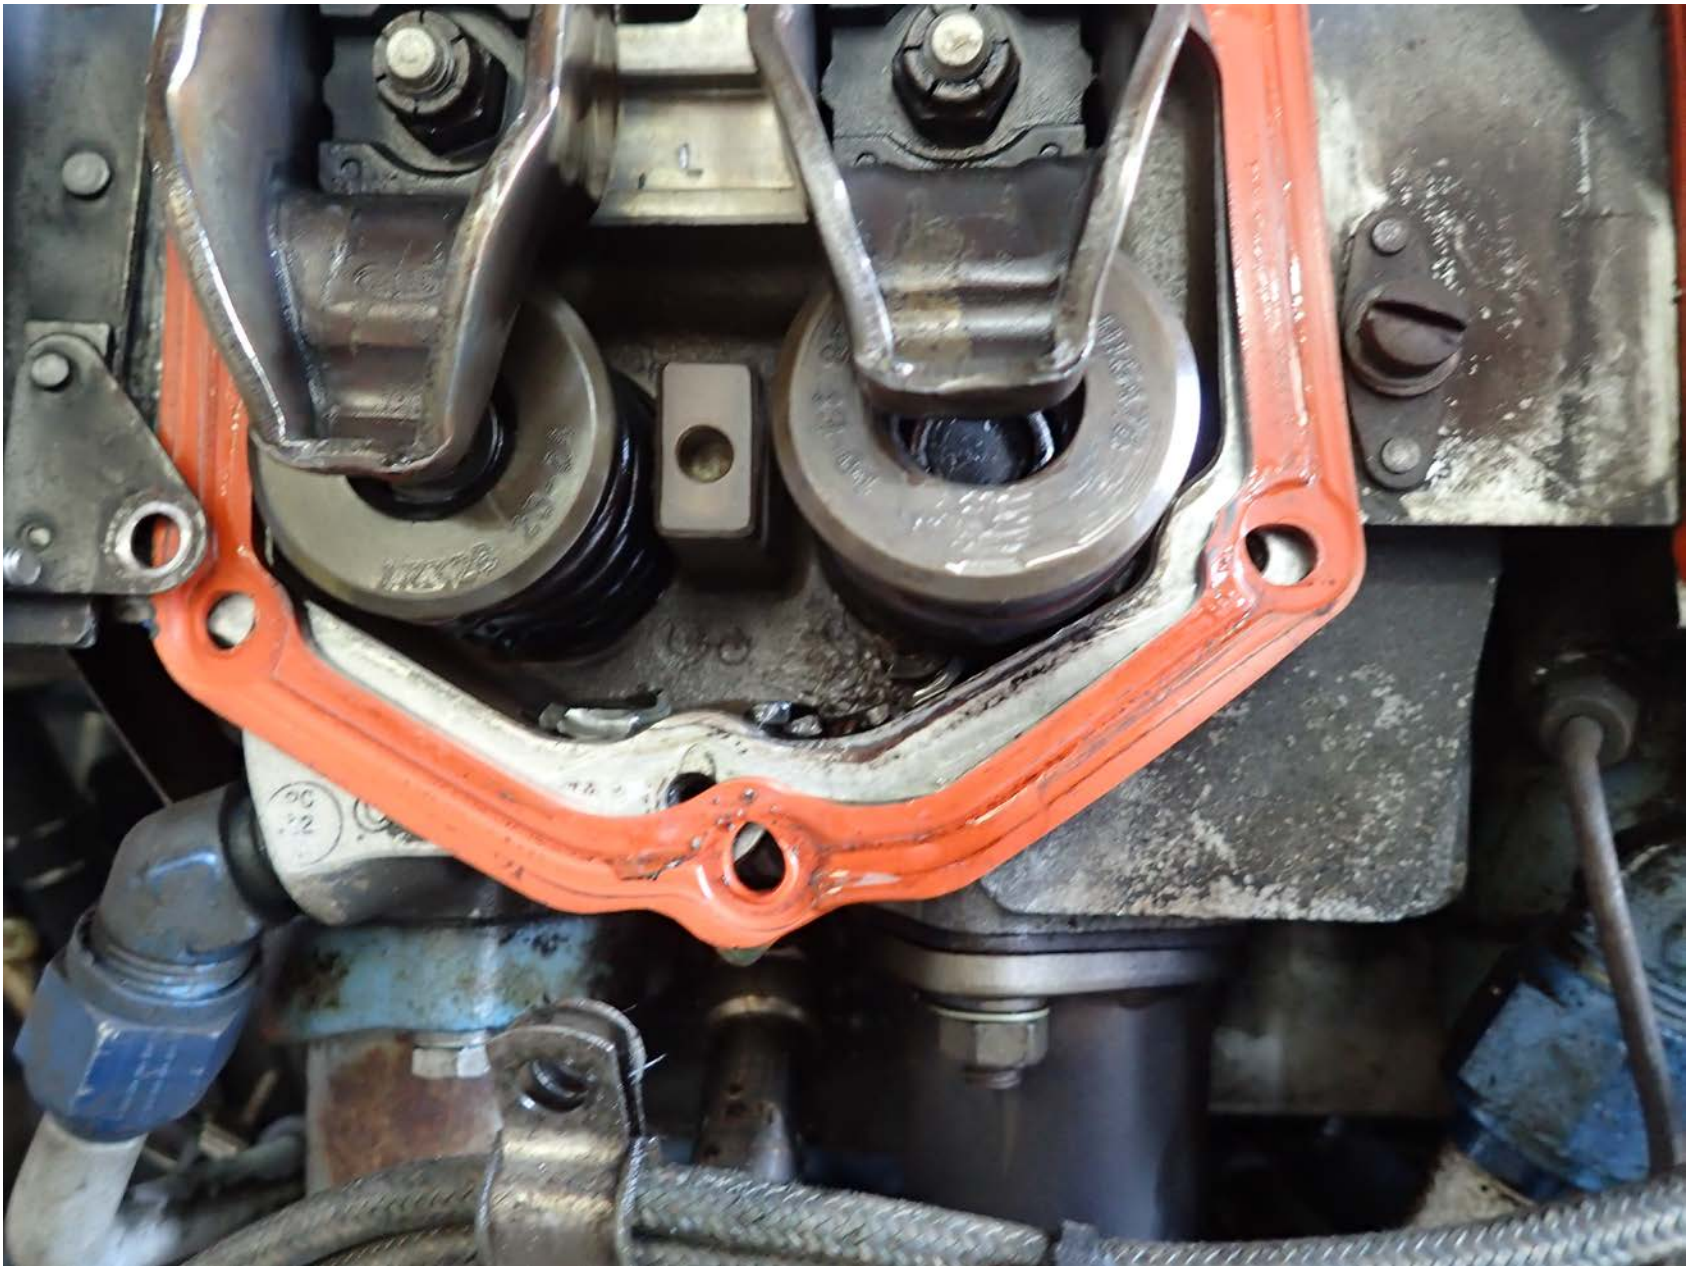
**Photo 6 – View of the fractured valve key (exhaust) and valve stem cap (exhaust) pieces at the bottom of the rocker area of the cylinder head.**

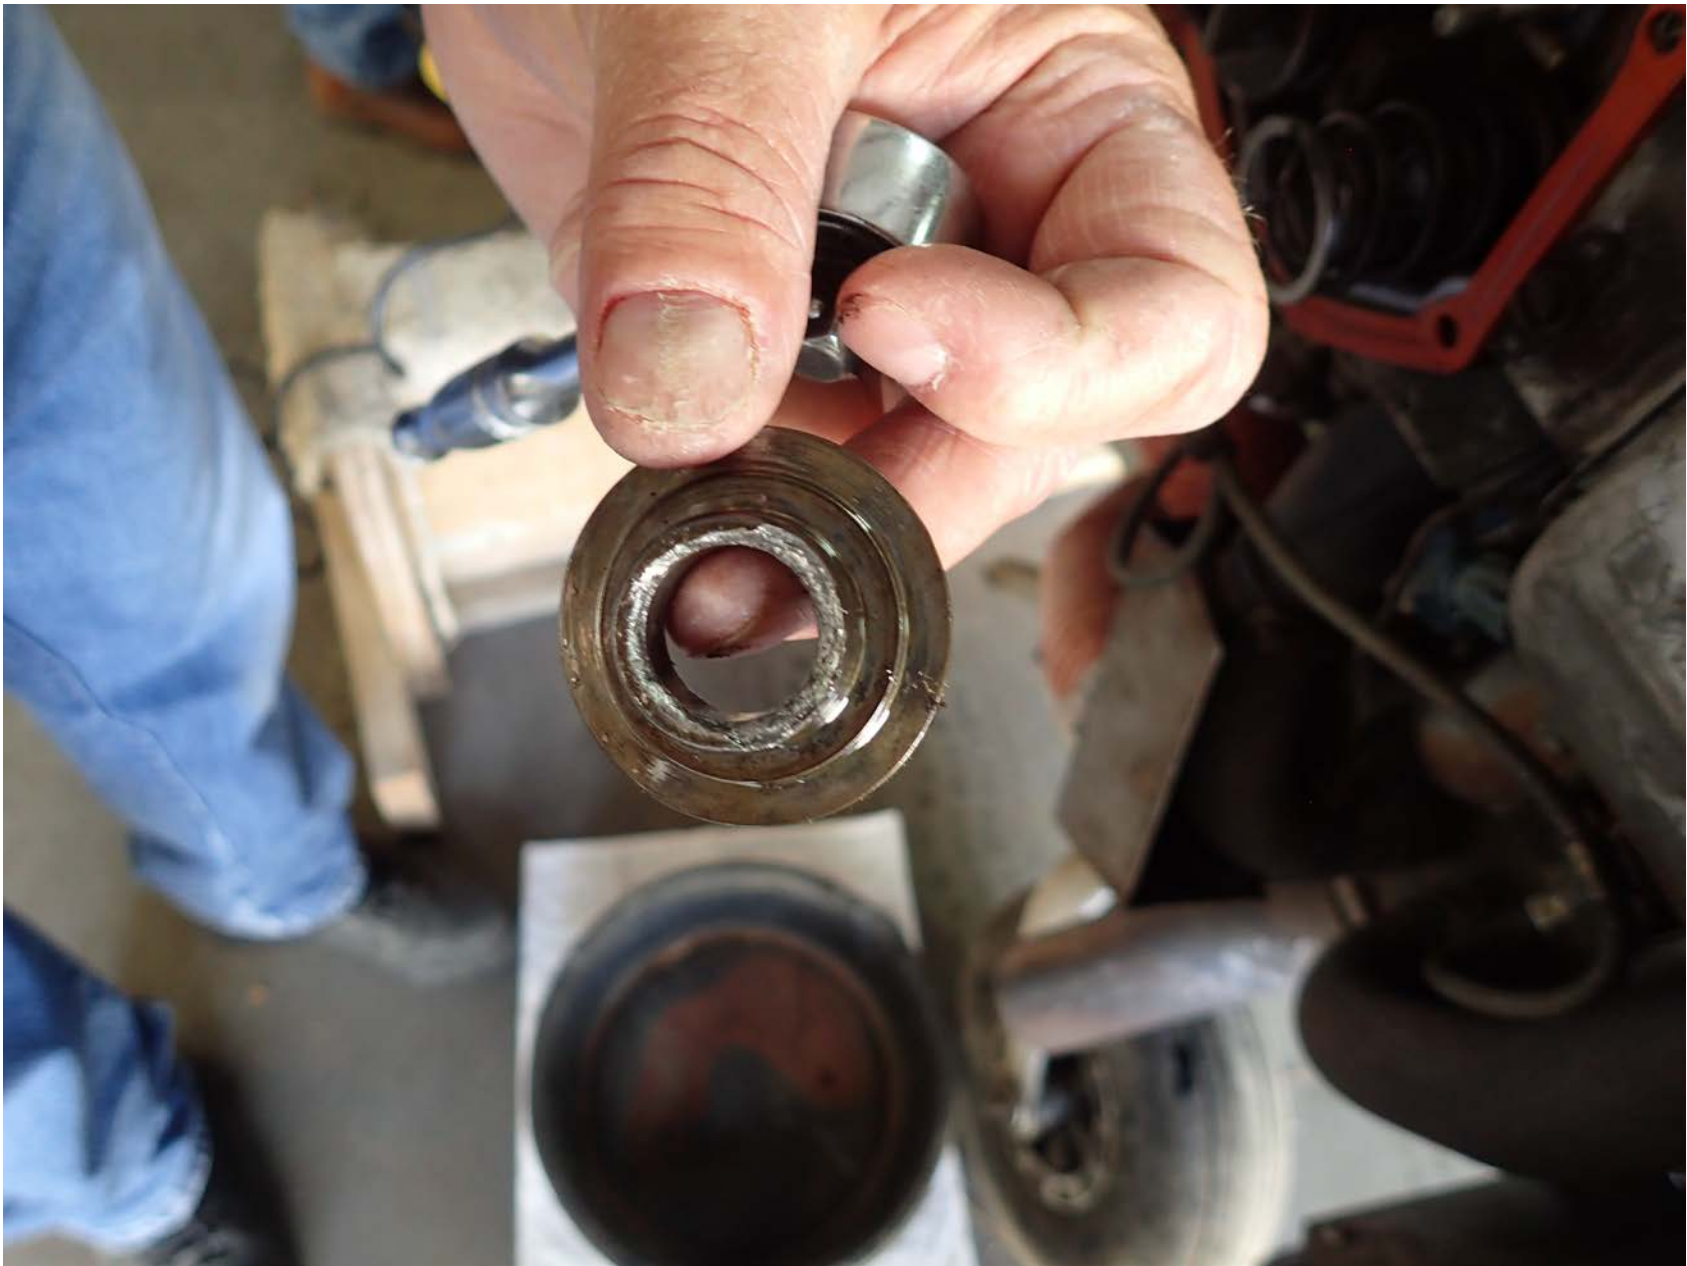
**Photo 7 – View of the damaged number 3 valve spring seat (upper exhaust).**

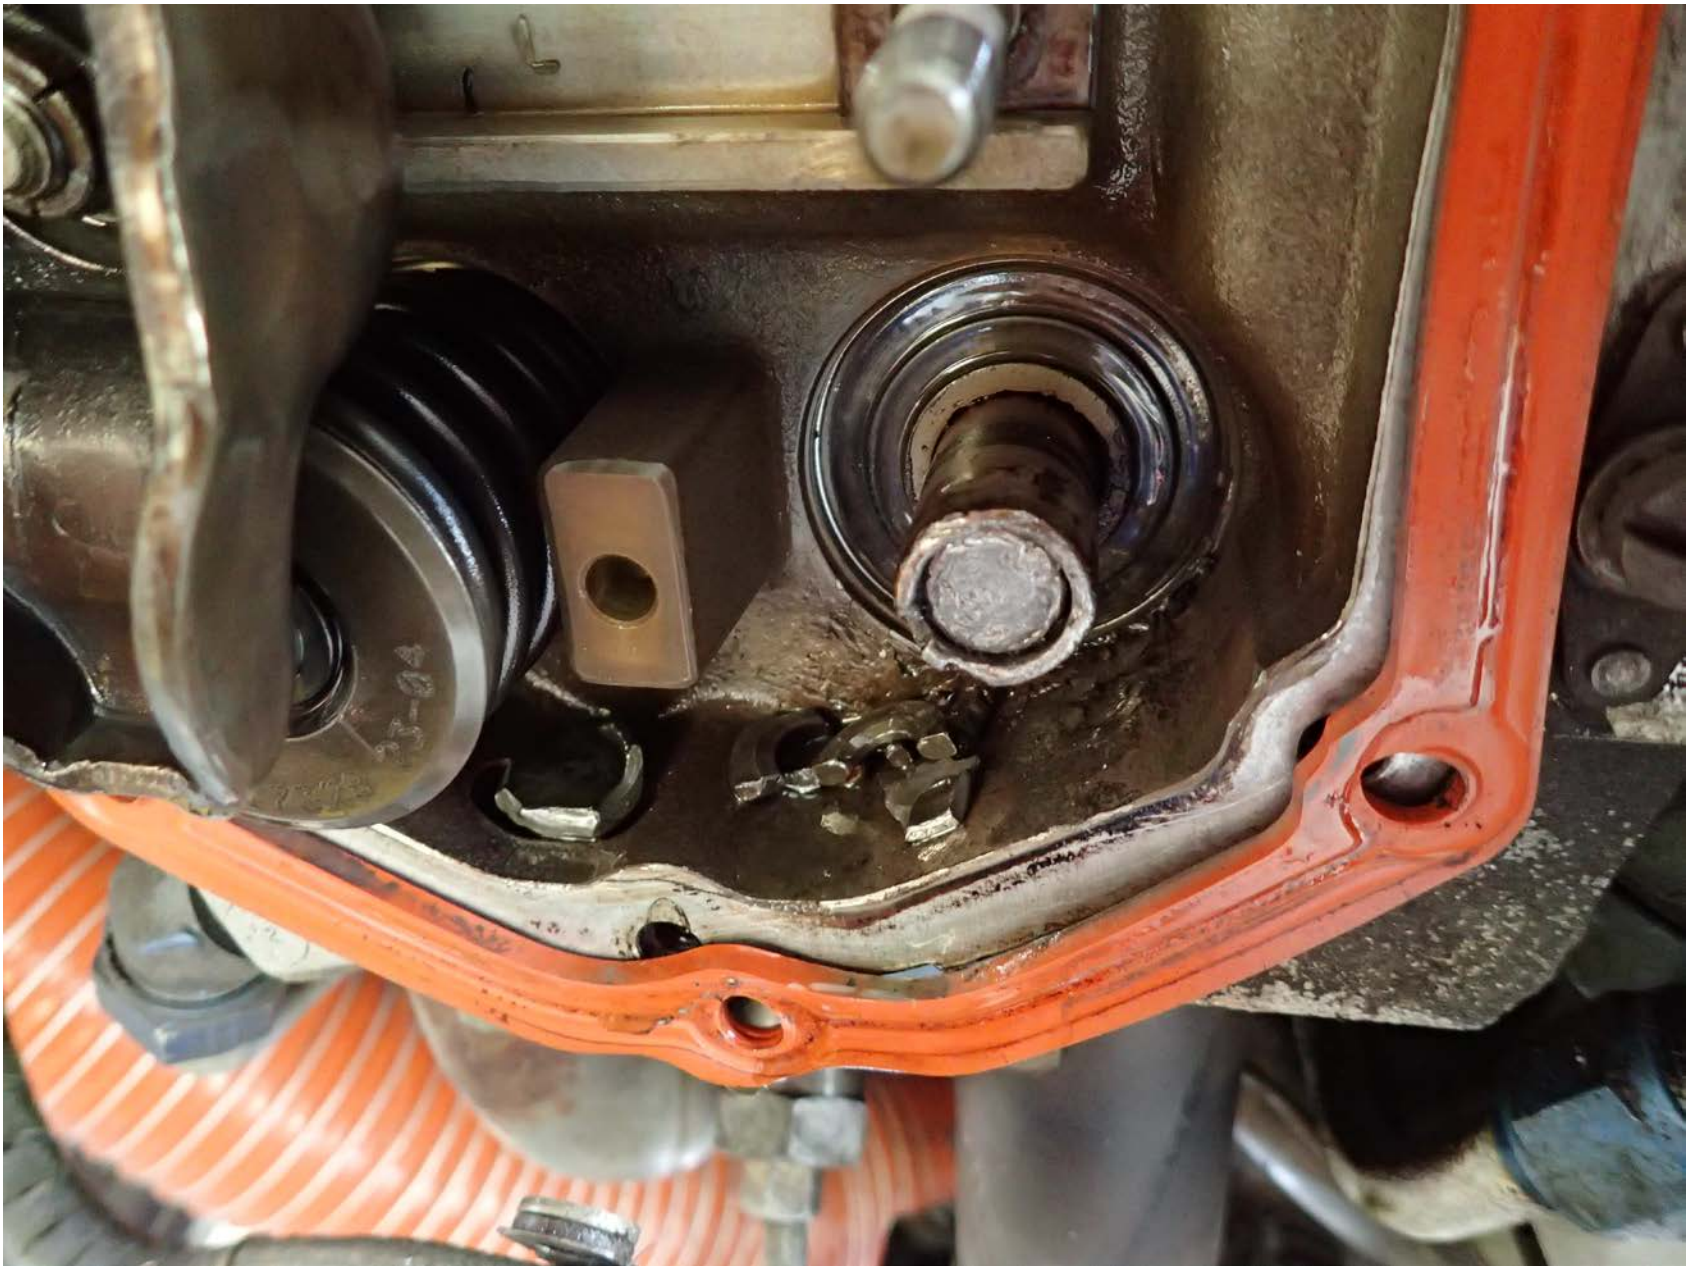
**Photo 8 – View of the fractured valve key (exhaust) and valve stem cap (exhaust) pieces at the bottom of the rocker area of the cylinder head.**

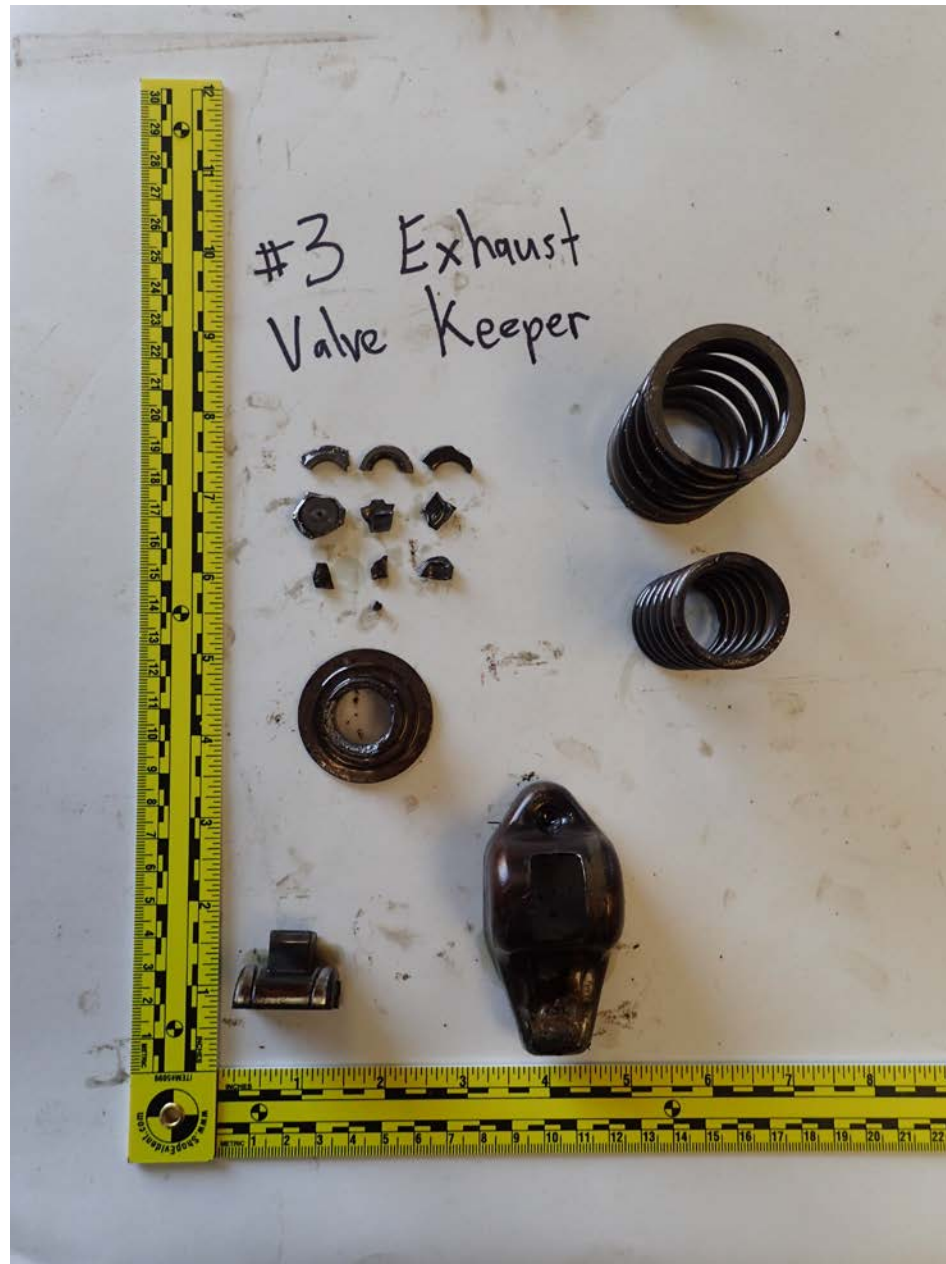
**Photo 9 – View of the fractured valve key (exhaust), fractured valve stem cap (exhaust), and damaged valve spring seat (upper exhaust).**

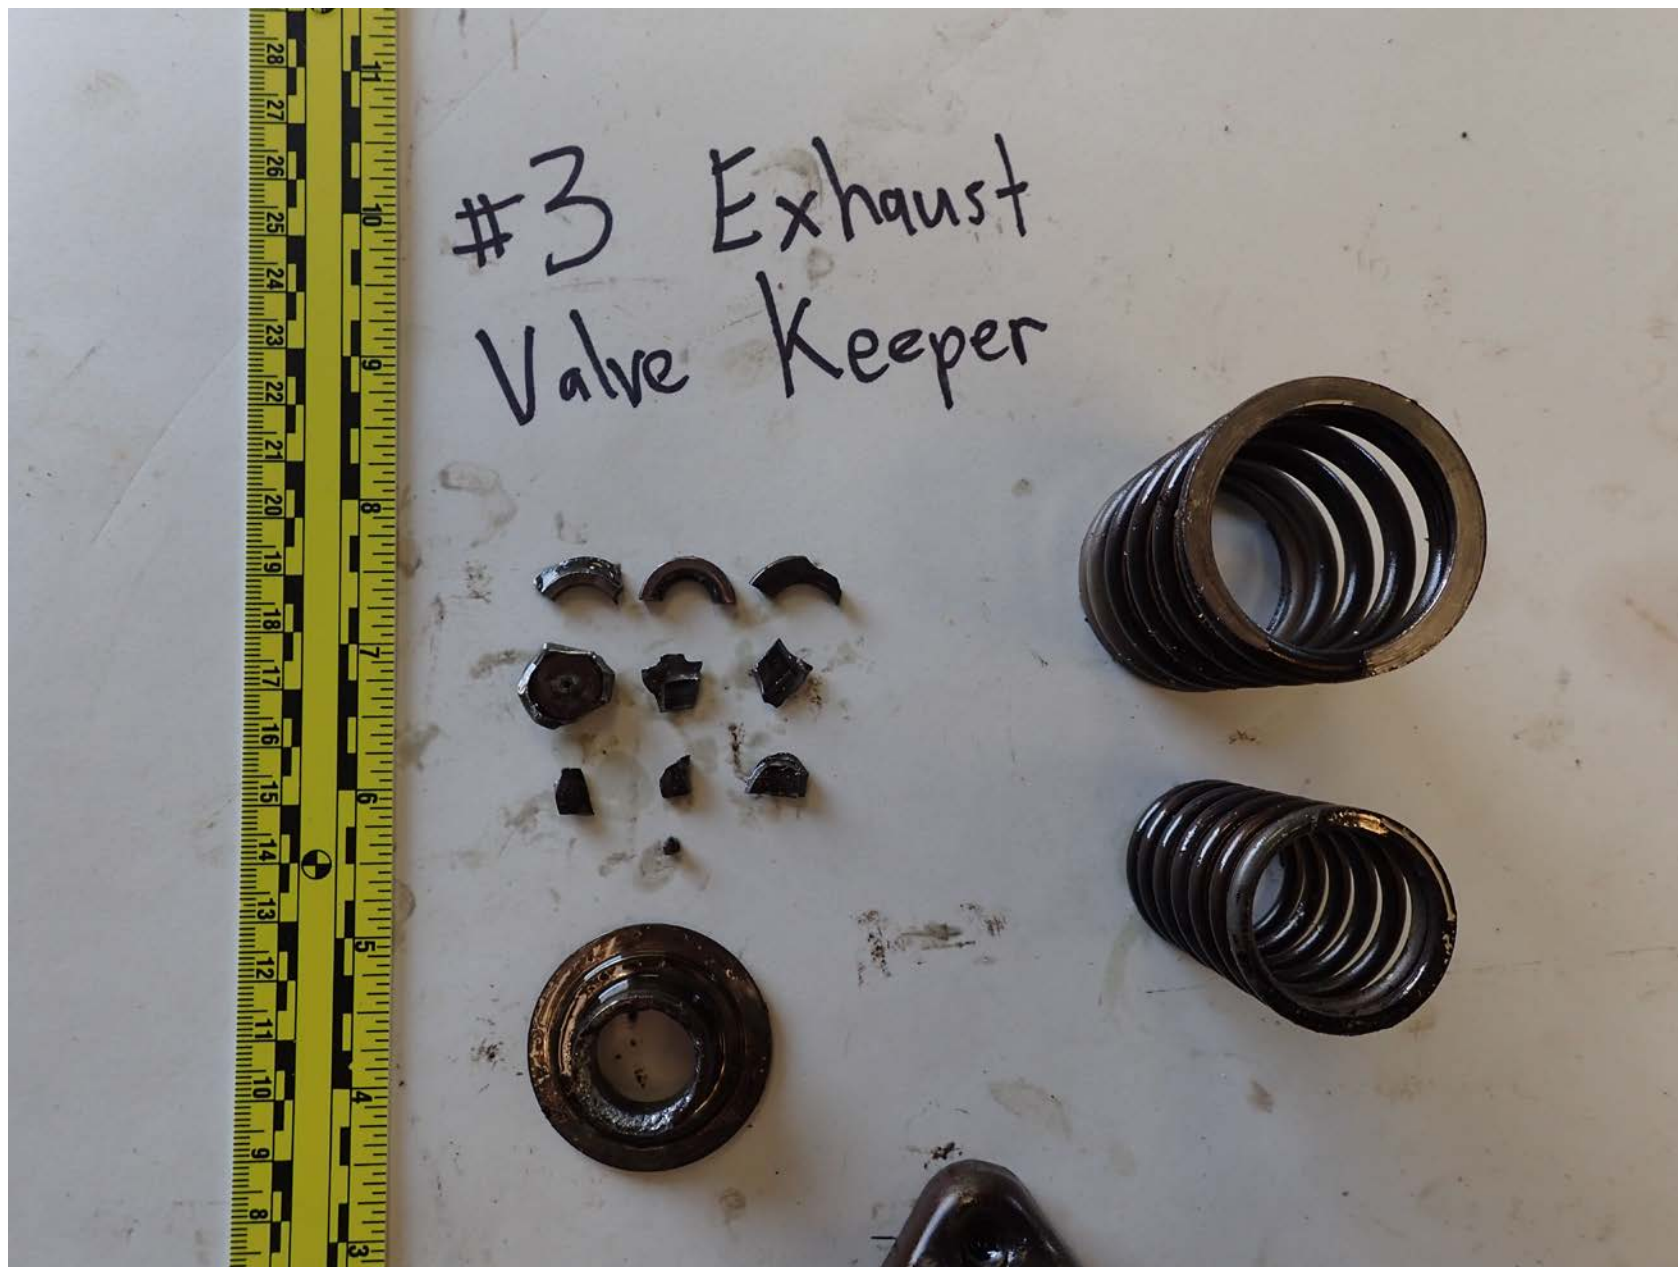
**Photo 10 – View of the fractured valve key (exhaust), fractured valve stem cap (exhaust), and damaged valve spring seat (upper exhaust).**
