# **NATIONAL TRANSPORTATION SAFETY BOARD**

## **Aircraft Performance ADS-B and EGPWS Study**

Aircraft: Cessna 208B, registration N814GV

NTSB#: ANC18LA031

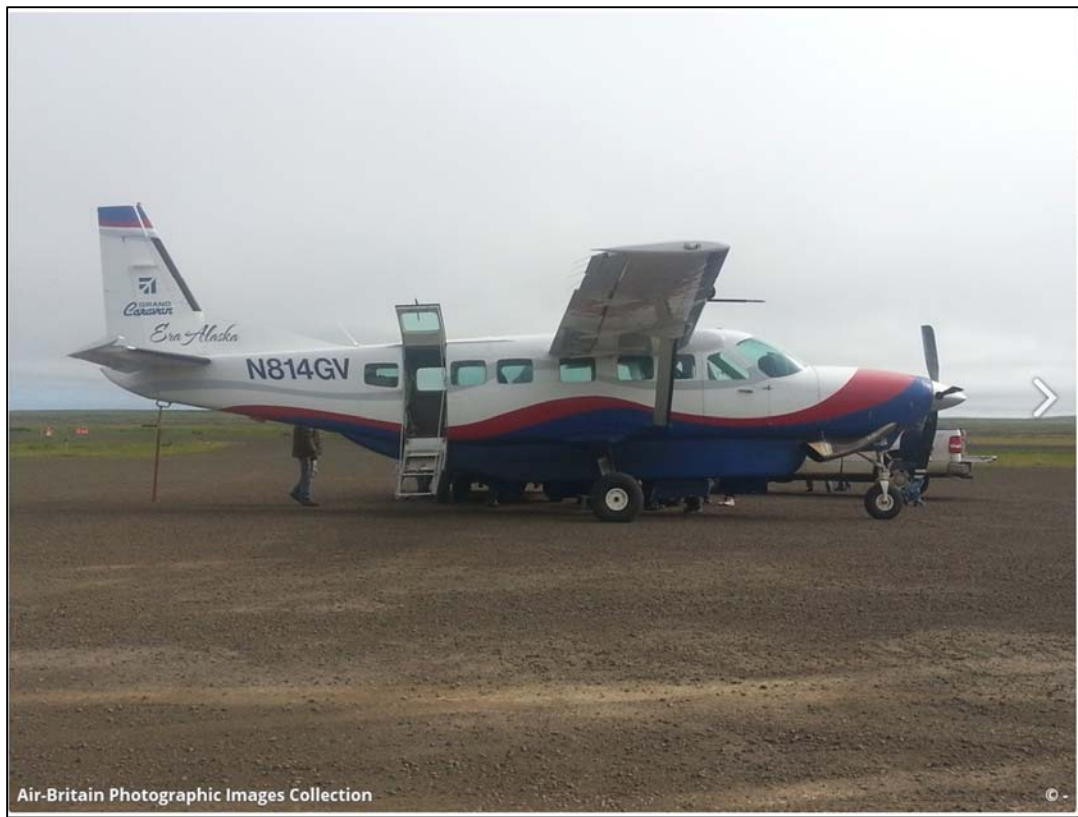
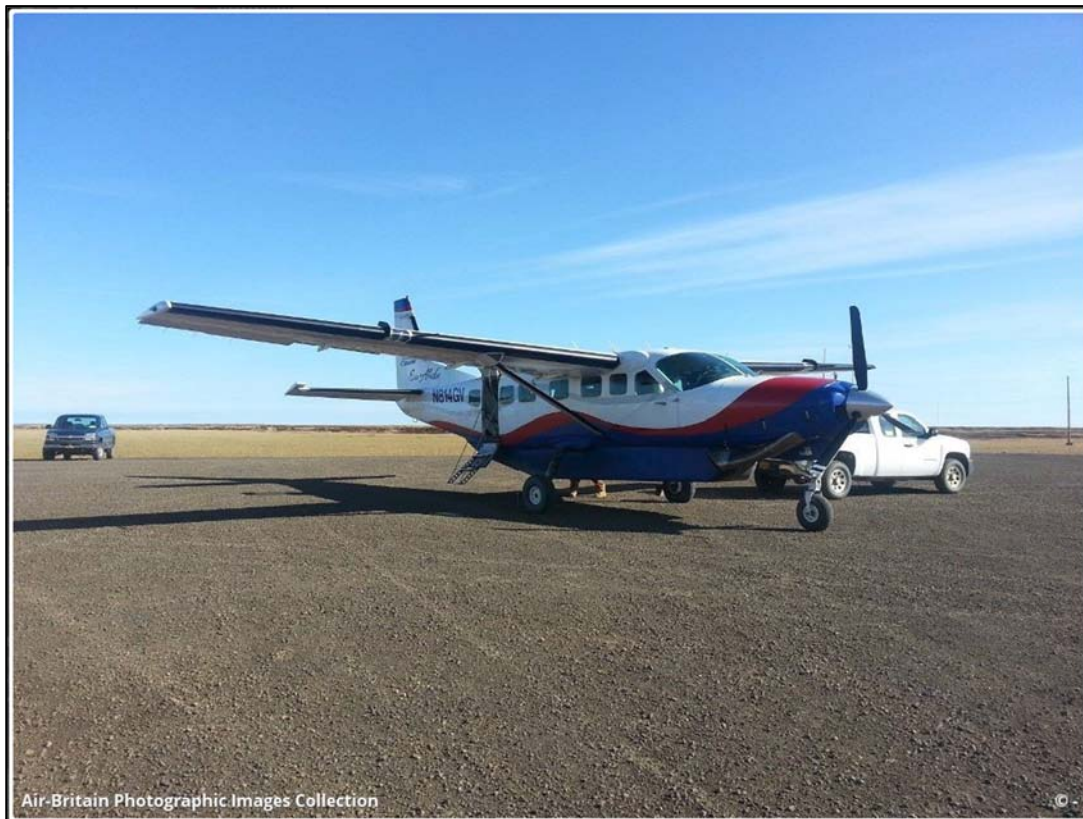
**Figure 1.** Pre-accident photographs of N814GV (© Air-Britain Photographic Images Collection).

Figure 1 presents pre-accident photographs of N814GV. Figure 2 presents three-view diagrams of the C208B, taken from Reference 2. Table 1 provides some dimensions of the airplane, as well as the estimated weight of N814GV at the time of the accident (7,487 lb., which is rounded up to 7,500 lb. for the performance analyses described in this *Study*).

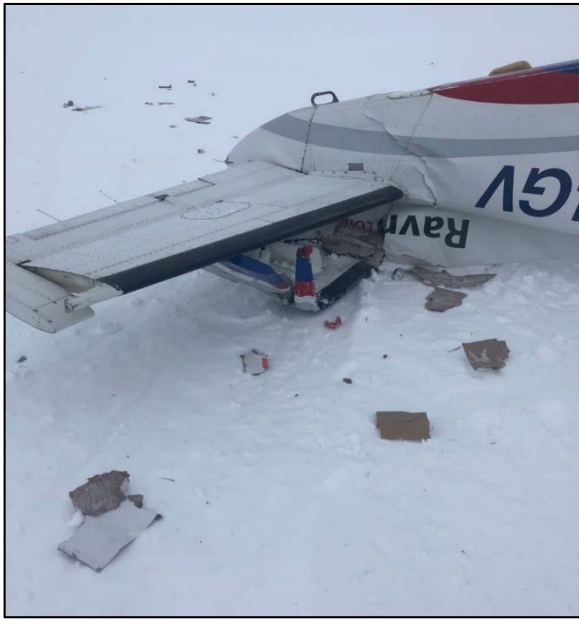
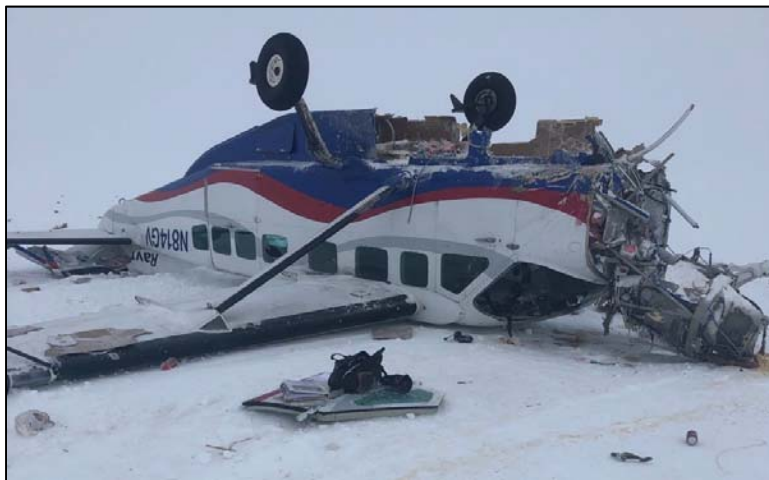
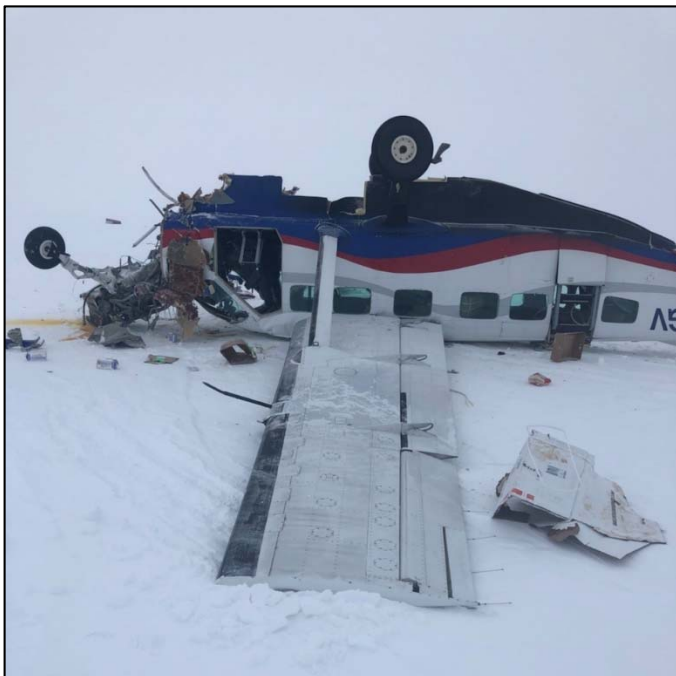
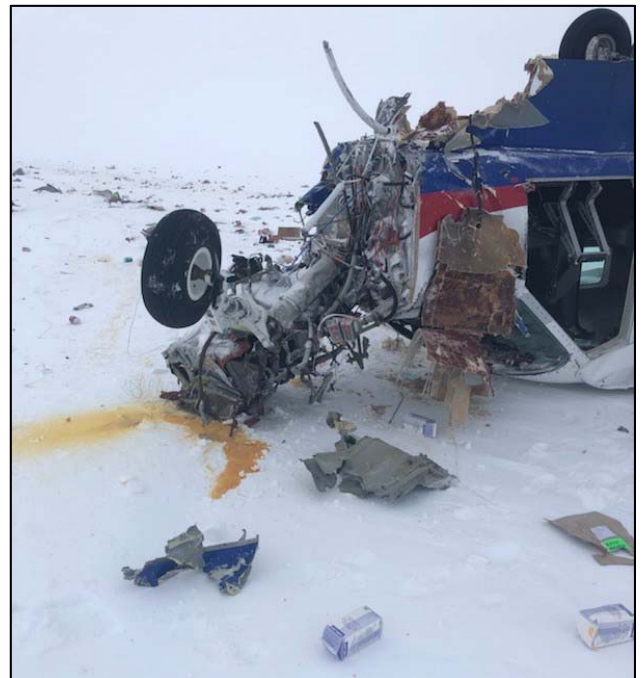
**Figure 13.** Post-accident photographs of N814GV (courtesy of NTSB Investigator-In-Charge).

As noted above, aerodynamic data for the Cessna was provided by Textron Aviation during previous investigations. A gross weight of 7,500 lb. (see Table 1) is assumed in the performance calculations. The flaps are up in photos of the airplane at the accident site (see Figure 13), so this *Study* assumes that the flaps were up at the time of the accident.
