## **NATIONAL TRANSPORTATION SAFETY BOARD**

### **Weather Study**

# **METEOROLOGY**

ANC20FA017

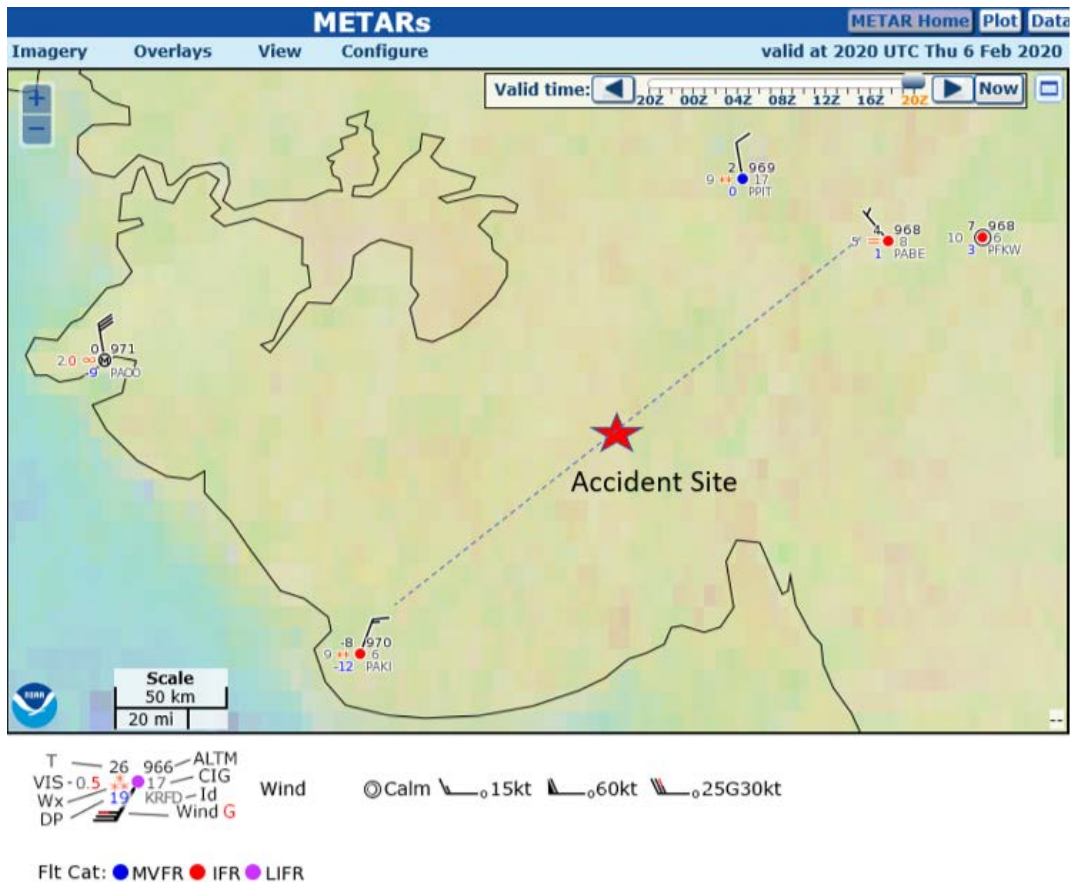
**Figure 4 - NWS METAR display after the accident at 1020 AKST with the approximate accident site marked by a red star and the general route of flight**

A display of the conditions from the NWS Aviation Weather Center's website<sup>3</sup> for 1120 AKST taken after the accident is included as figure 4, with the estimated route of flight and the accident site marked as a red star. At the time of the image both PABE and PAKI were reporting IFR conditions due to low ceilings and visibility restricted in mist at PABE and light snow at PAKI. No other official METAR sites are shown between the 85 miles between PABE and PAKI on the image; however, the FAA has a weather camera at Tuntutuliak Airport (A61) approximately 12 miles east of the accident site (see section 8.0 for additional details).

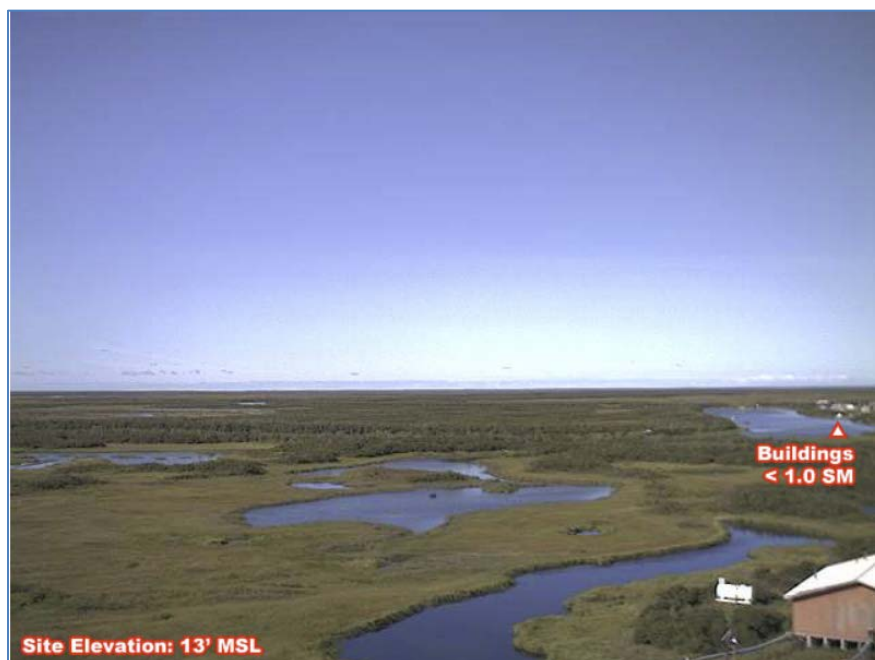
Figure 17 - Tuntutuliak West Weather Camera view on a clear day

Figure 17 is the Tuntutuliak west camera view on a clear day with the various landmarks and elevations noted. Only a single visibility marker or buildings was identified at less than 1 mile from the camera, which is set at 13 ft elevation.

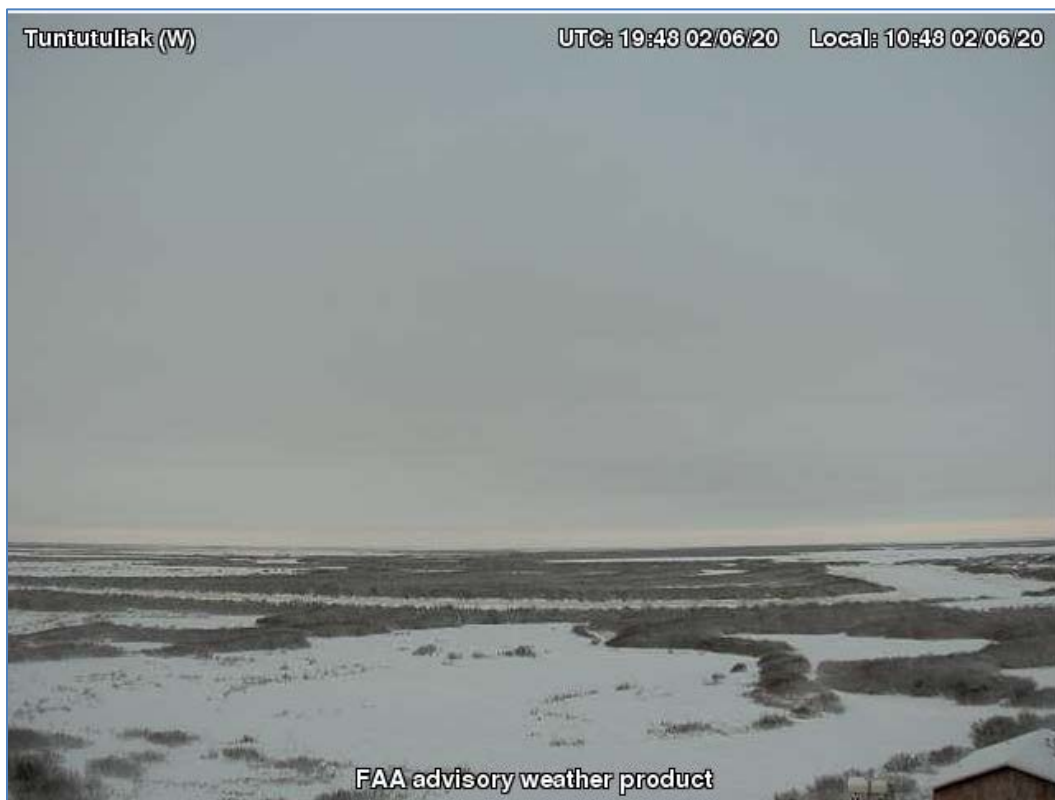
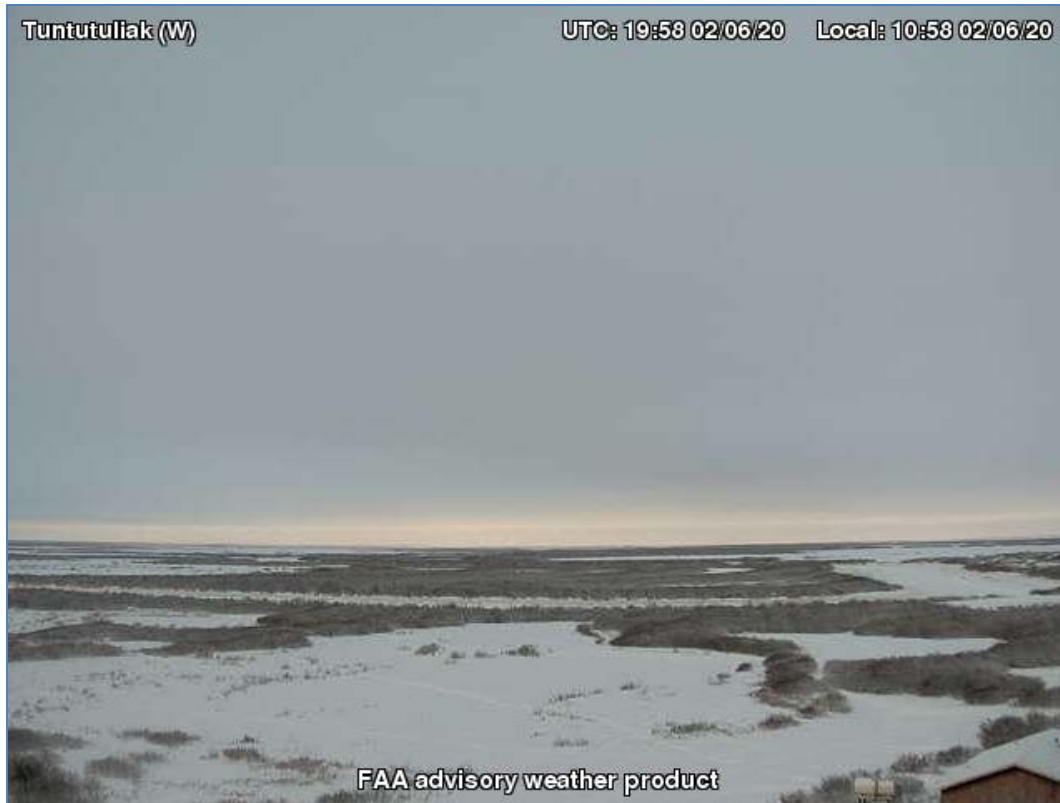
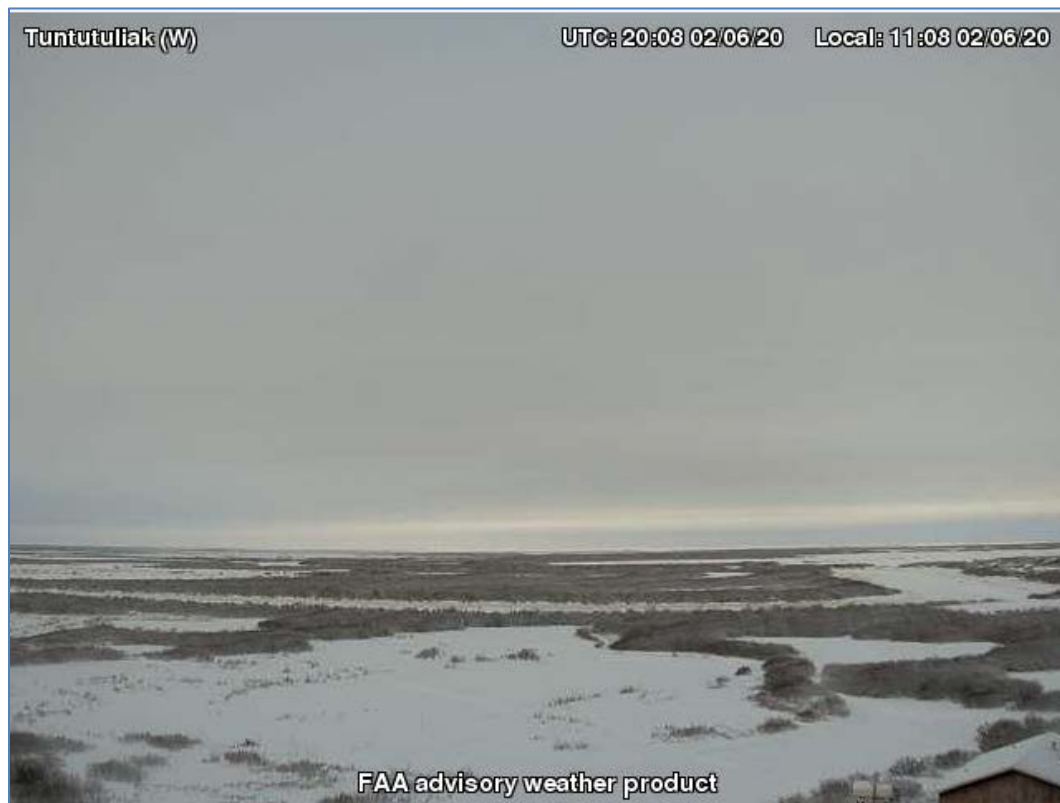
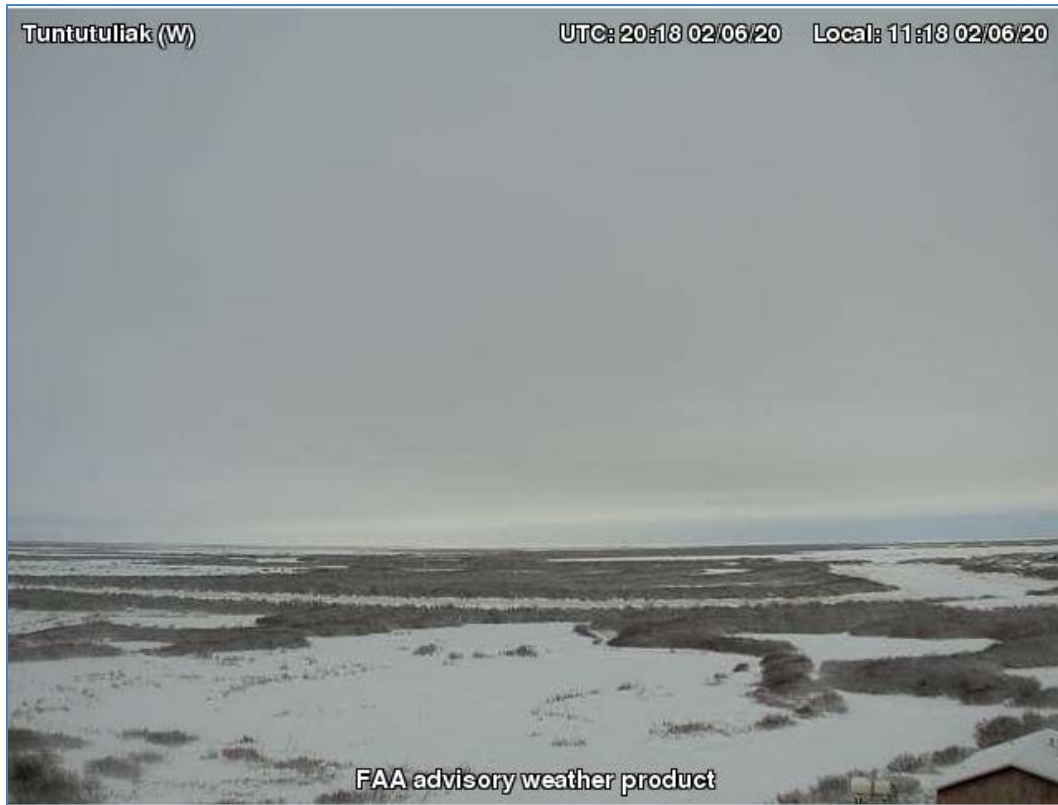
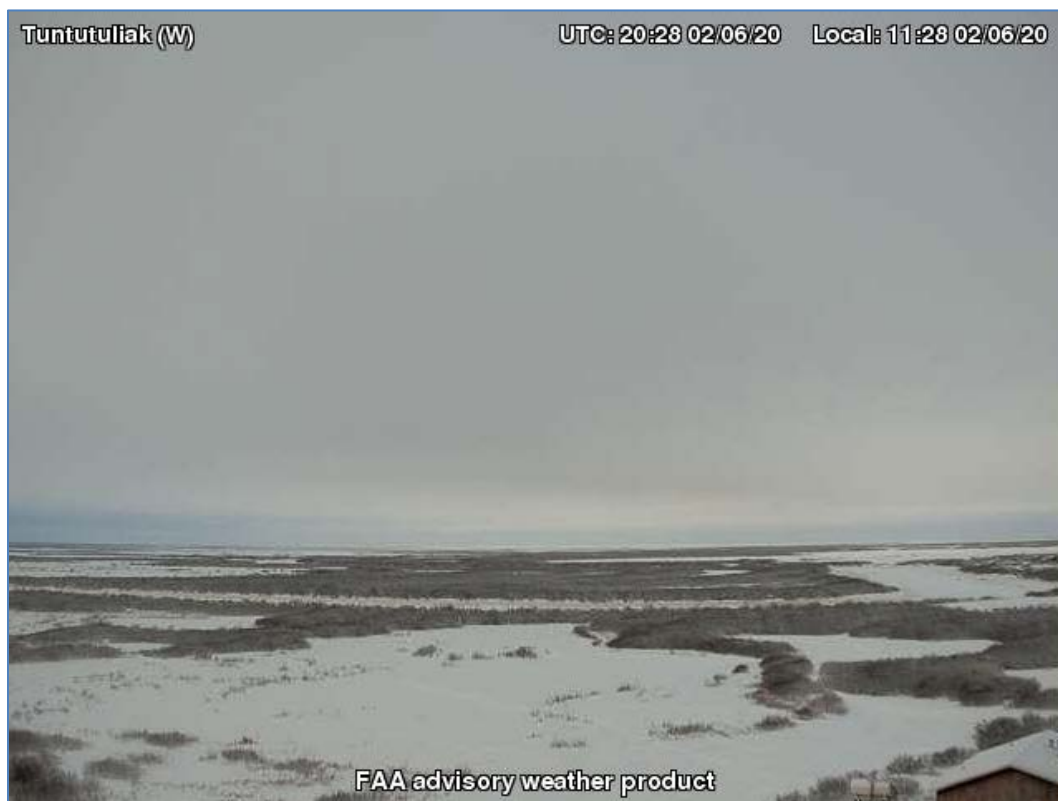
Figures 18-22 are the Tuntutuliak west camera views for 1048, 1058, 1108, 1118, and 1128 AKST. The images depict an overcast layer of clouds with no appreciable changes in visibility in the limited range of the camera.
