**NATIONAL TRANSPORTATION SAFETY BOARD**  
Vehicle Recorder Division  
Washington, D.C. 20594

## **Onboard Image Recorder**

### **Specialist's Factual Report** **By Kyle Garner**

Location: Kalapana, Hawaii  
Date: March 5, 2020  
Aircraft: Eurocopter EC130  
Registration: N11QK  
Operator: Blue Hawaiian Helicopters  
NTSB Number: ANC20LA028

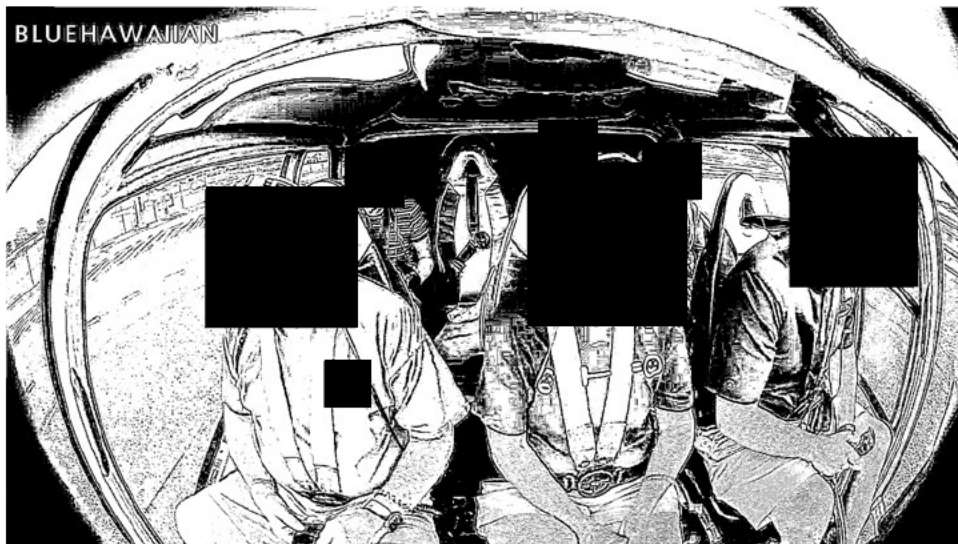
**Figure 3. An illustrated image of the view from the internal-facing camera on the accident helicopter.**

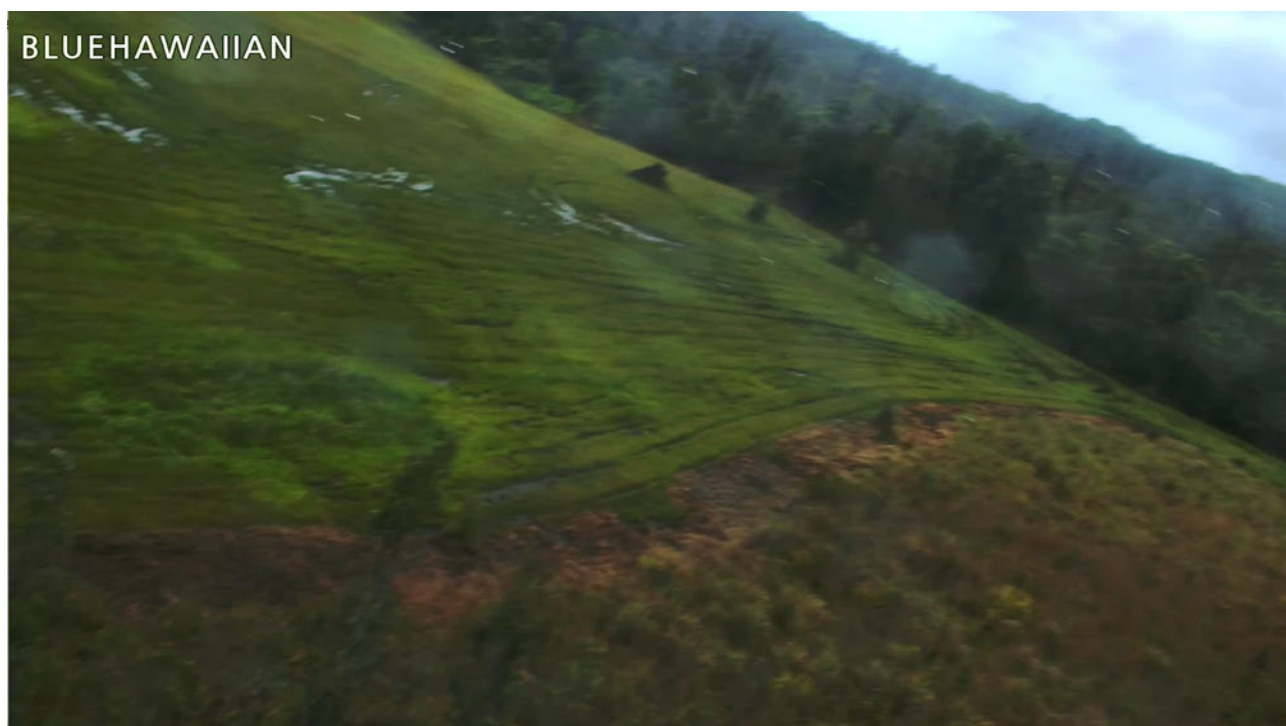
| HD4S System Time<br>(HH:mm:ss) | Comment |
|---|---|
| 11:26:50 | The passengers could be heard screaming. The video file abruptly ended before the helicopter impacted the ground. The final view from the right external-facing camera before the video ended and the helicopter impacted the ground is shown in Figure 5. [End of video file 4] |

**Figure 5. Event helicopter - final snapshot from the video before impact.**

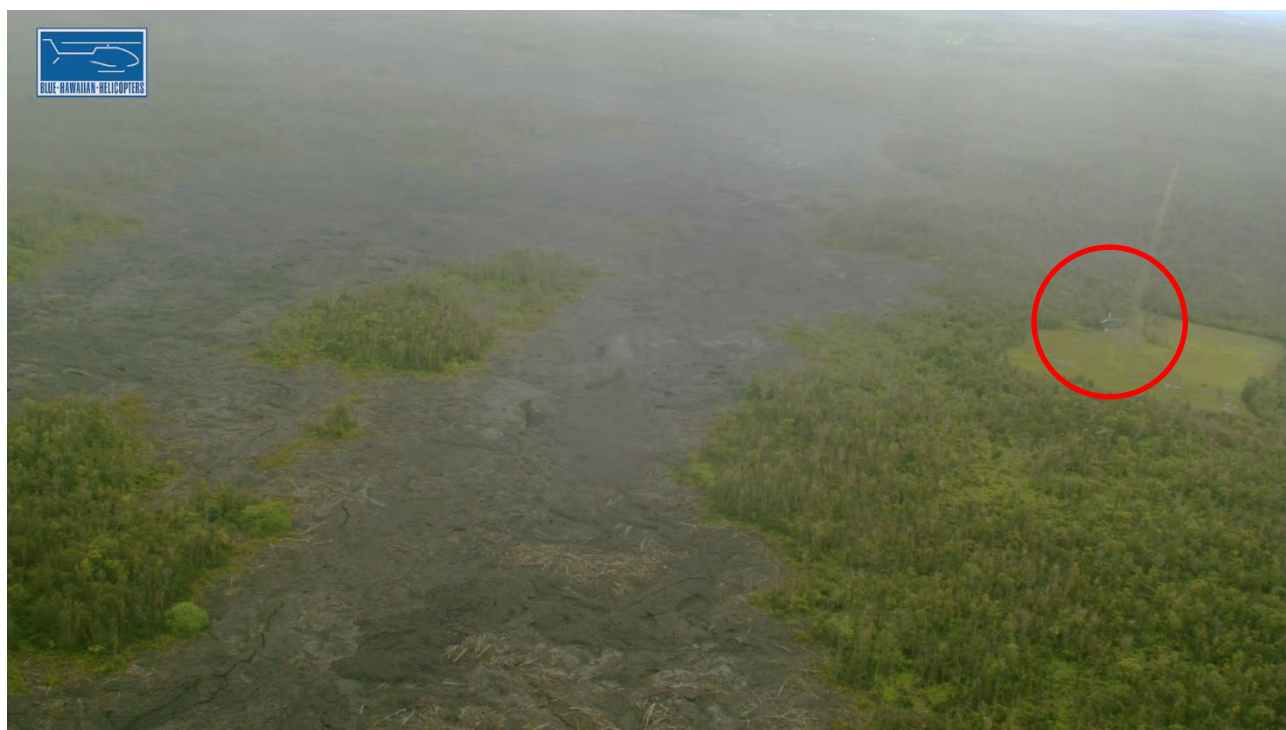
| HD4S System Time<br>(HH:mm:ss) | Comment |
|---|---|
| 11:20:46 | The view was from the left external-facing camera. The accident helicopter was visible on the camera, as shown in Figure 6. The accident helicopter was over a clearing in the trees. The main rotor was visible and rotating. The tail rotor was not visible. |

**Figure 6. Witness helicopter's initial view of accident helicopter. The accident helicopter is outlined in red.**

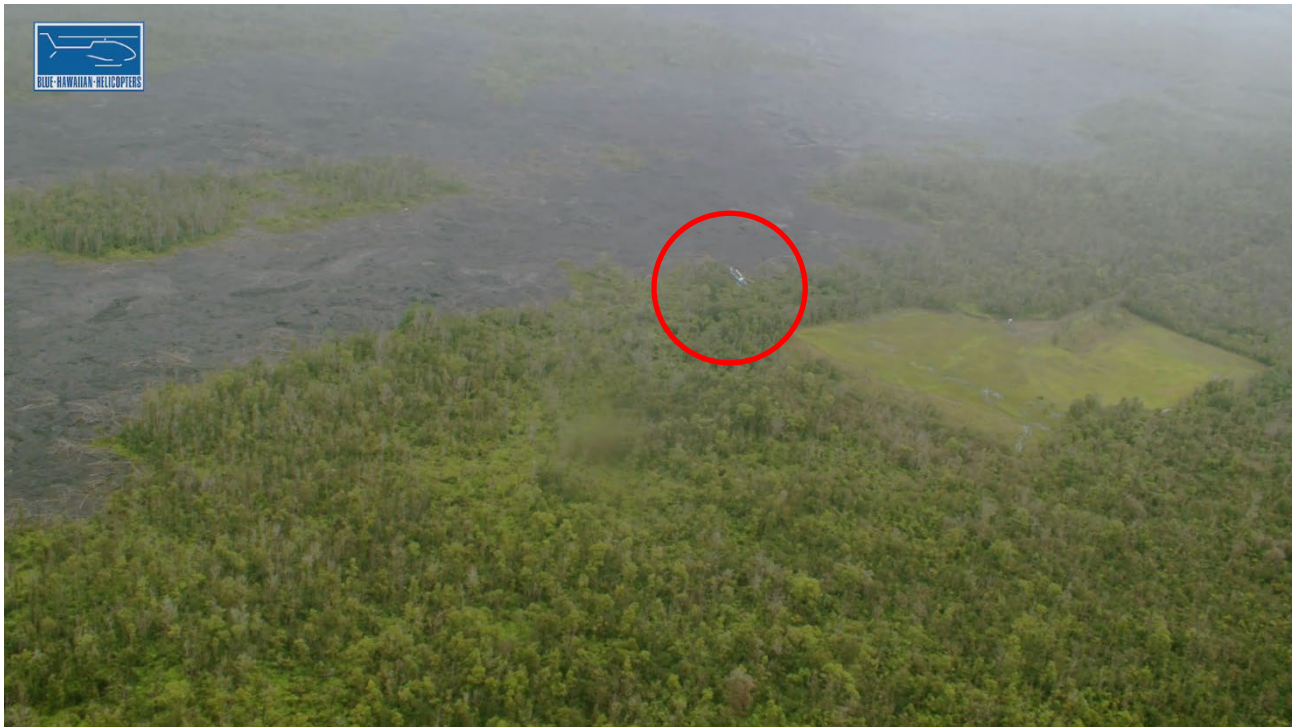
| HD4S System Time<br>(HH:mm:ss) | Comment |
|---|---|
| 11:20:51 | The accident helicopter began to rotate counterclockwise, as shown in Figure 7. As the witness helicopter traveled closer to the clearing in the trees, the rate at which the accident helicopter was rotating began to increase. |

**Figure 7. Witness helicopter's view of accident helicopter beginning to rotate counterclockwise. The accident helicopter is outlined in red.**

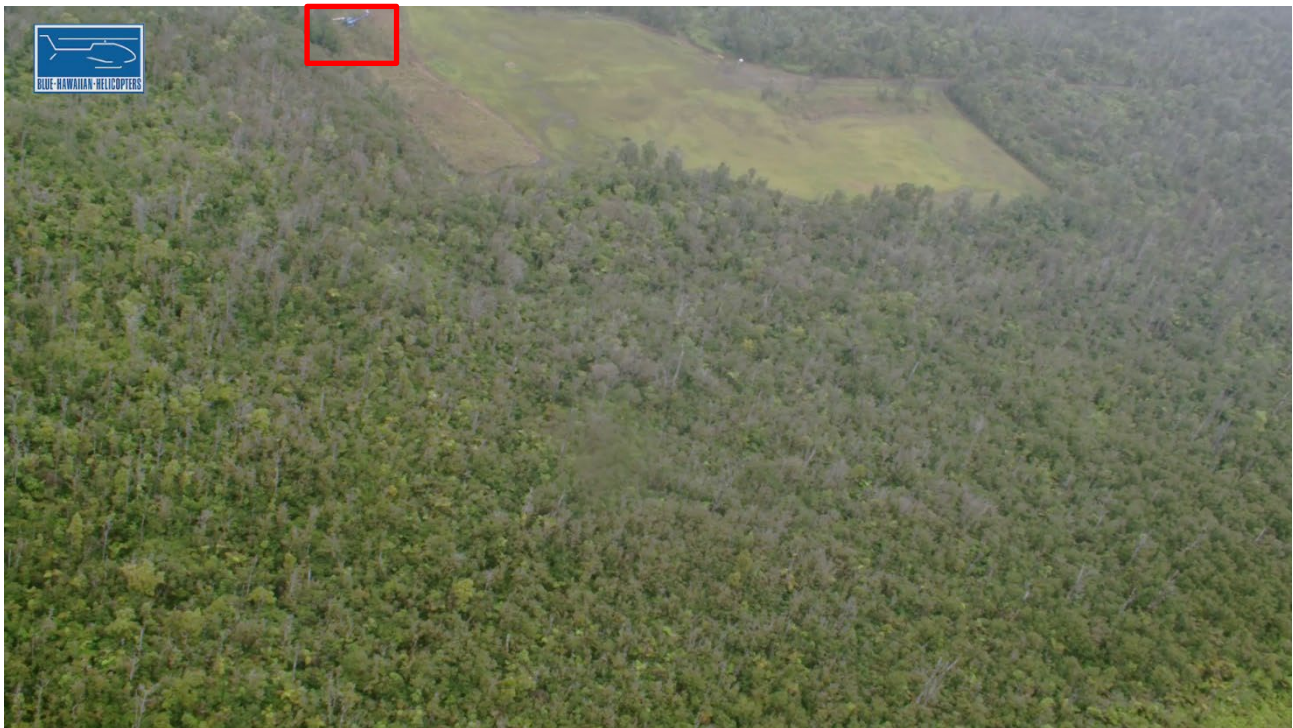
| HD4S System Time<br>(HH:mm:ss) | Comment |
|---|---|
| 11:21:08 | The accident helicopter was seen rotating rapidly counterclockwise and losing altitude. The witness helicopter pilot stated, "Oh no...oh no." The accident helicopter impacted the ground and turned over on its right side. The moment of impact is shown in Figure 8. |

**Figure 8. Witness helicopter's view of accident helicopter impacting the ground. The accident helicopter is outlined in red.**

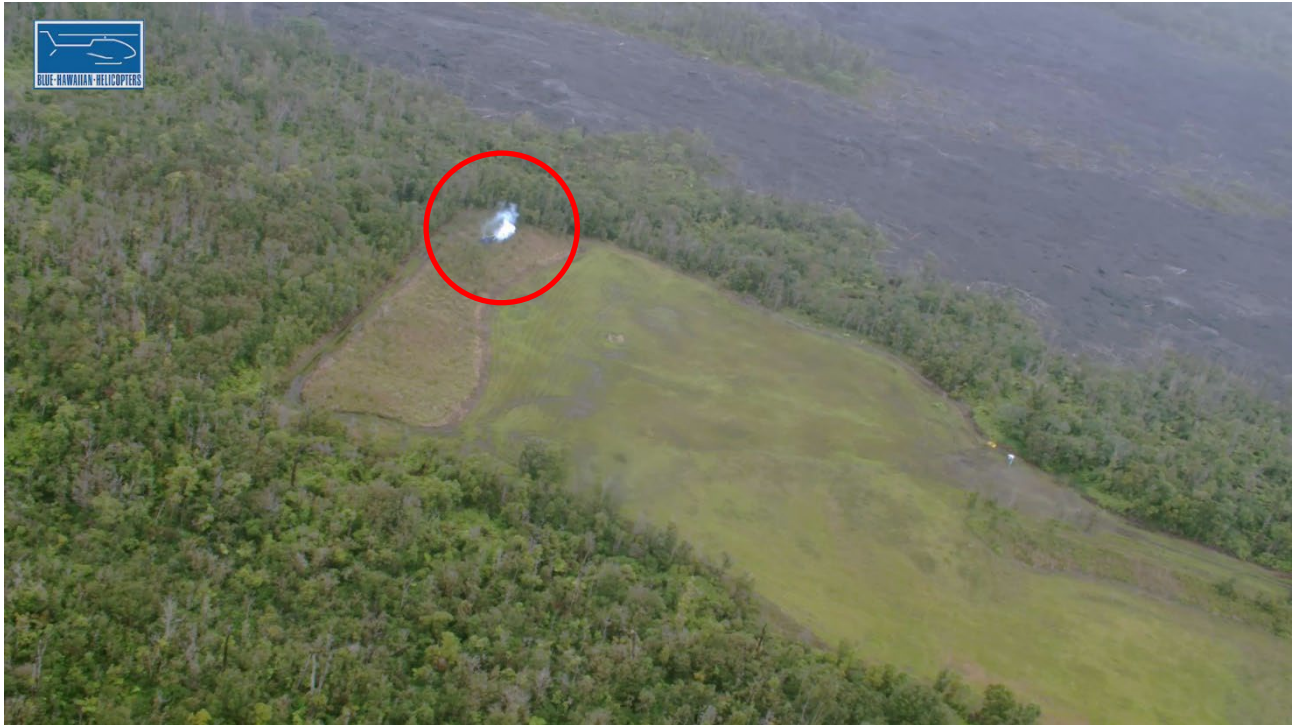
| HD4S System Time<br>(HH:mm:ss) | Comment |
|---|---|
| 11:21:14 | Smoke was seen emanating from the accident helicopter, as shown in Figure 9. The witness pilot stated, "Okay guys, hang on. I've got to handle this." The accident helicopter was no longer visible on the video. |

**Figure 9. Witness helicopter's view of accident helicopter with smoke. The accident helicopter is outlined in red.**
