**ENGINE TEST REPORT  
OF ONE MODEL LTS101-700D-2  
TURBOSHAFT ENGINE  
SERIAL NUMBER LE-46018C**

**August 30, 2023**

**ENGINE TEST REPORT**  
**Ninilchik, Alaska**  
**Eurocopter AS350B2, Registration N160SH**  
**August 25, 2020**  
**NTSB Investigation ANC20LA082**

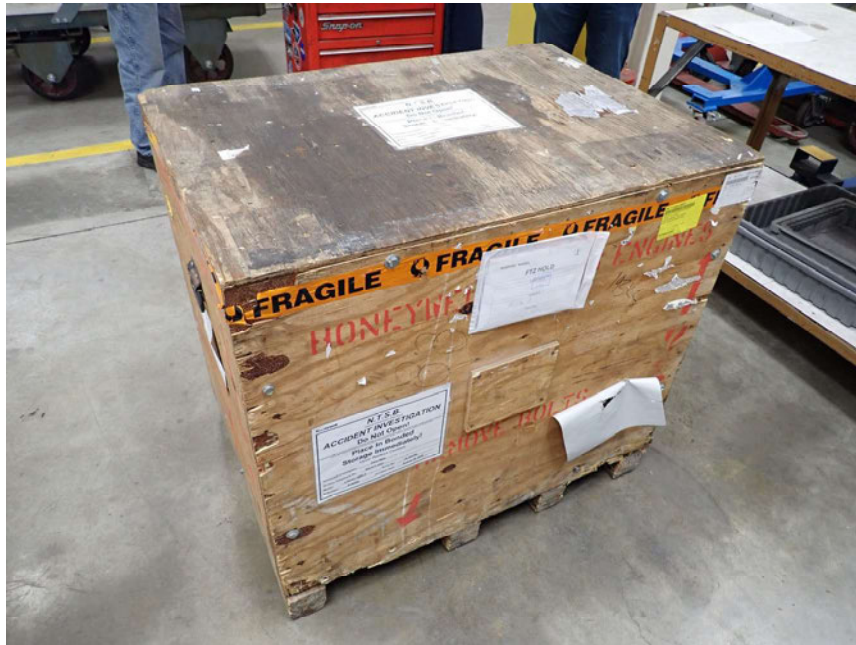
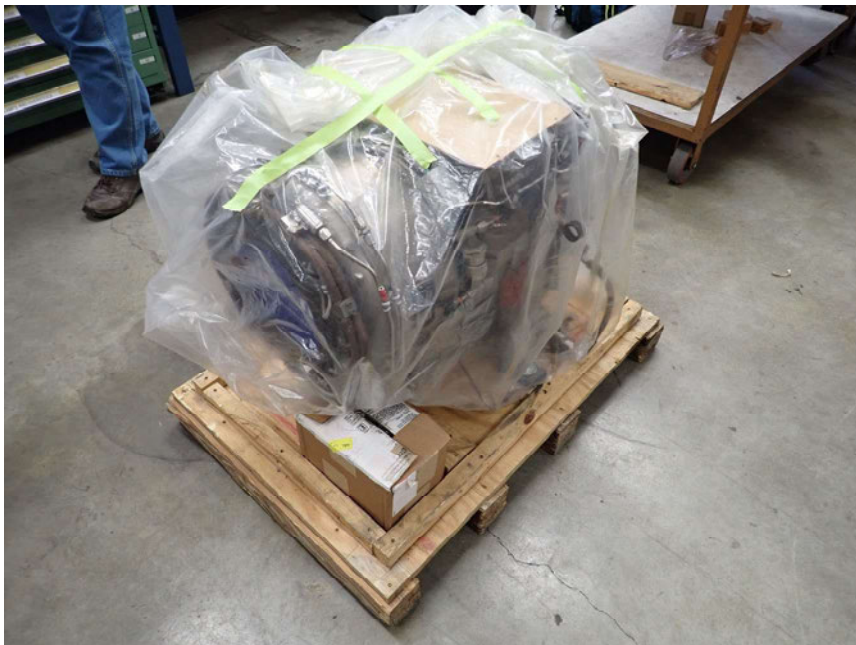
- The engine was received in a standard wooden LTS101 shipping container, wrapped in a plastic bag ([Figure 1](#) and [Figure 2](#)).
- The logbook and engine overspeed controller were stored in the bottom of the shipping container ([Figure 3](#)).
- The name plated identified the engine as: ([Figure 4](#))
  - o Model: LTS101-700D-2
  - o MFR Serial No.: LE-46018C
- There was no evidence of fire damage ([Figure 5](#) -[Figure 11](#)).
- There was no evidence of impact damage with the exception of a clamp / bracket on the top of the rear bearing support housing (RBSH) which was bent toward the RBSH ([Figure 12](#)).
- One of the thermocouple leads was damaged ([Figure 13](#)).
- An insert on the top of the plenum was missing ([Figure 14](#)).
- The power turbine was free to rotate.

Figure 1. Engine S/N LE-46018C, As Received

Figure 2. Engine S/N LE-46018C, As Received

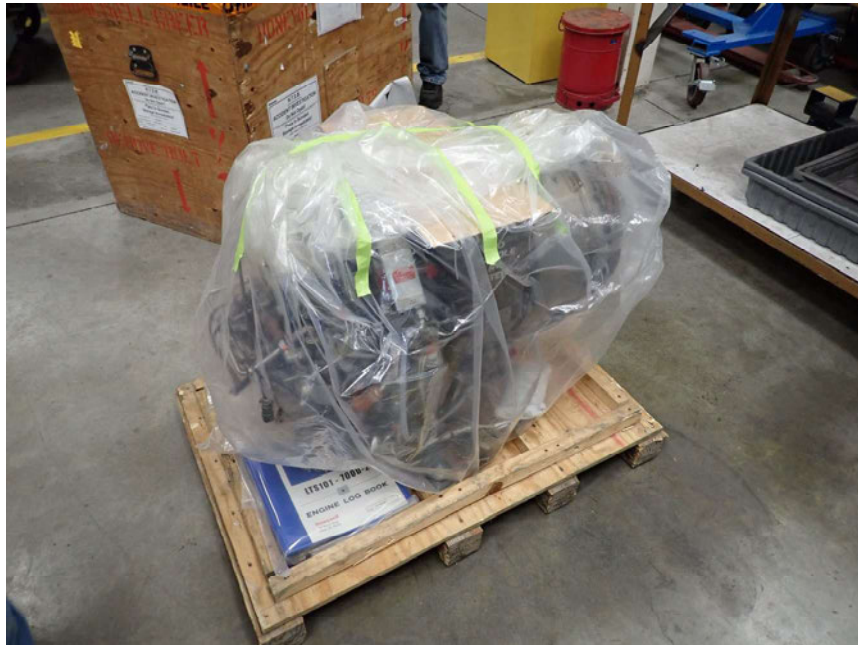
Figure 3. Engine S/N LE-46018C, As Received

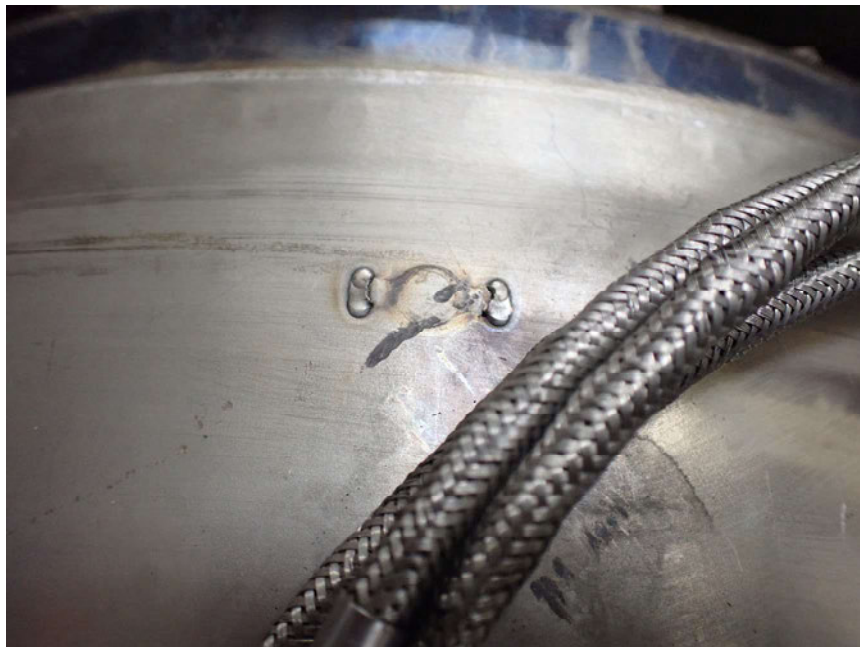
Figure 14. Engine S/N LE-46018C, As Received

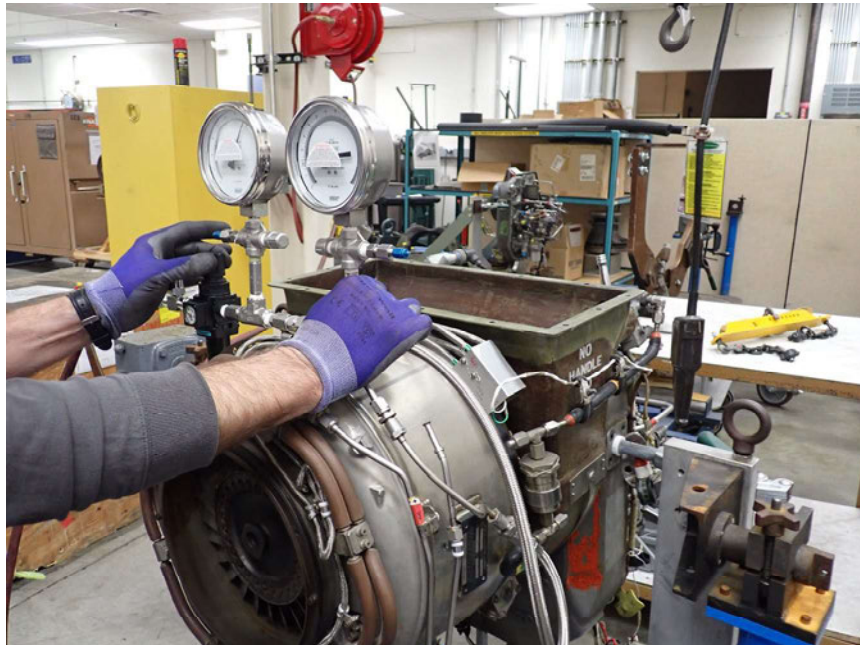
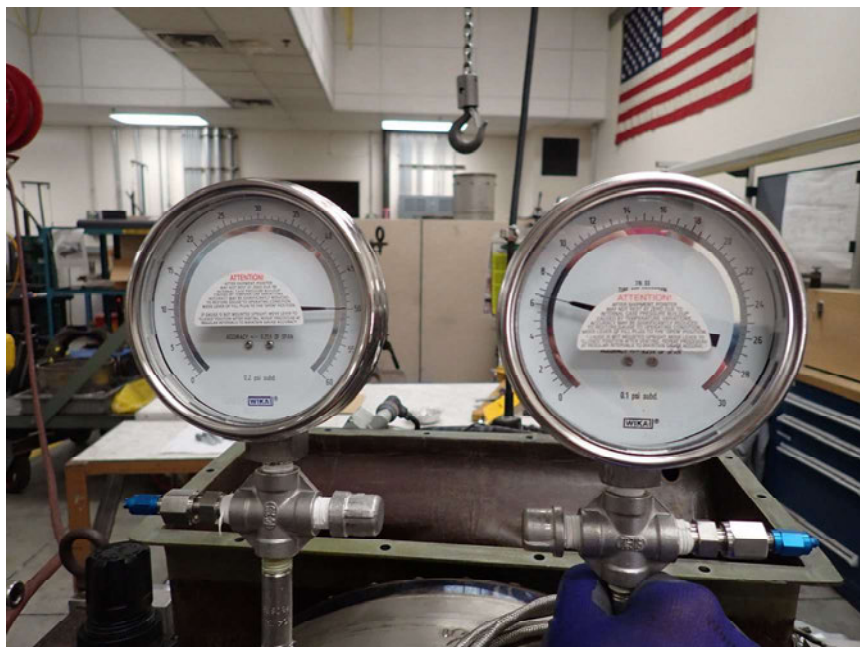
- The gas producer was free to rotate.
- The accessory gearbox (AGB) mag plug was free of debris (Figure 15 and Figure 16).
- A rear sump Delta Pressure check was conducted in accordance with HTS900-71-00 - 0004 (Figure 17 and Figure 18).
  - o Input P1 = 50 / 14.5 upper limit
  - o Output P2 = 6.5 (offset of 0.5 psi)
  - o 41.4% Acceptable
  - o Orifice 0.040 S/N A, Kit No. 79000171-1
- The cover on the power turbine governor (PTG) was removed to facilitate inspection of internal bearing (Figure 19). The cover broke at the hole for the cotter pin during removal.
- Visual inspection under the cover on the PTG showed no debris present, which was confirmed via borescope. The PTG flyweights were in place and rotated with the power turbine (Figure 20 - Figure 24).
- Safety wire was in place on the PTG in place of the broken cover.

Figure 17. Engine S/N LE-46018C, As Received

Figure 18. Engine S/N LE-46018C, As Received

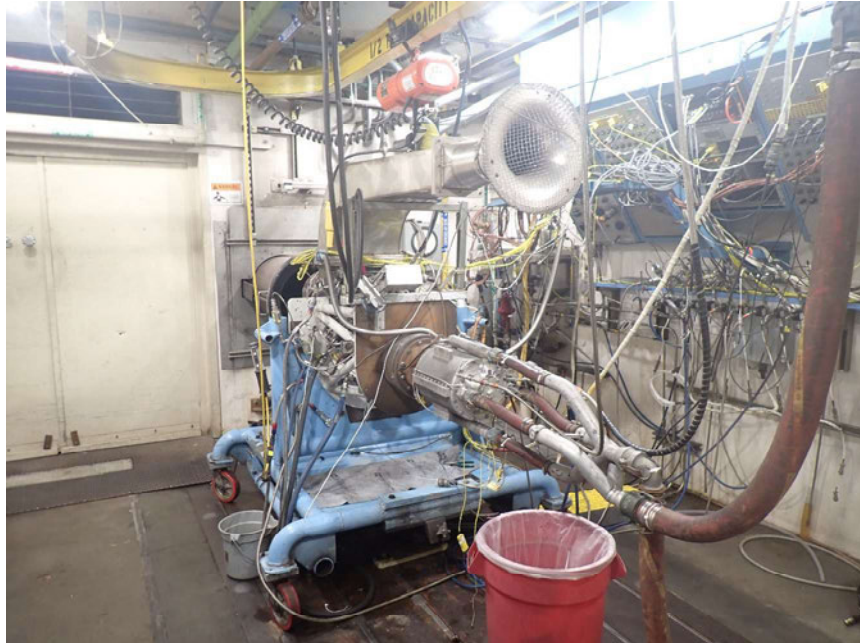
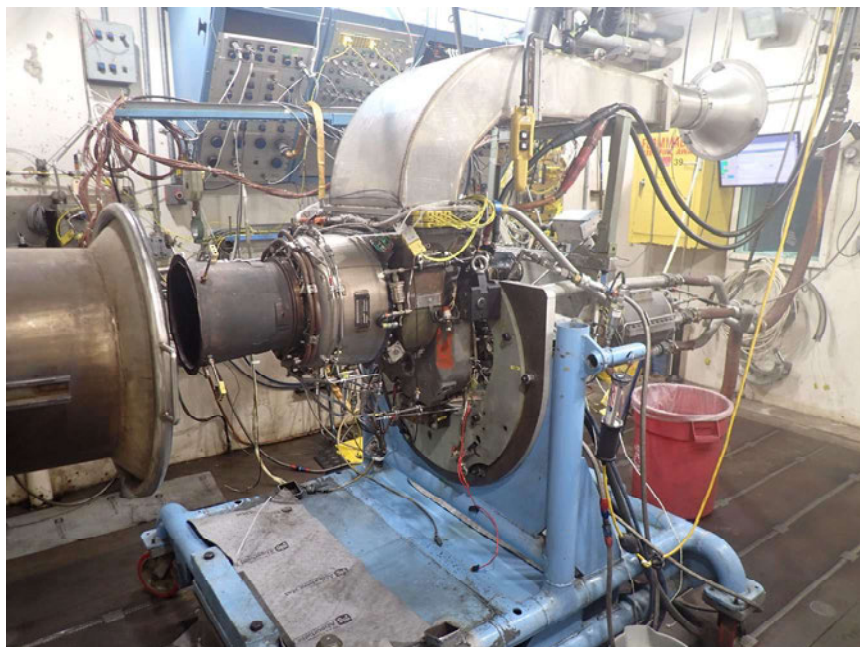
Engine testing was initiated on February 18, 2021. The engine was installed and operated in accordance with Test Instruction TI-8361C (Figure 25 - Figure 28). After successful dry and wet motors to verify oil flow, vibration levels, start fuel flows, and the ability to terminate fuel flow on command, an engine start was conducted. The initial start was terminated by the cell safety system at the N2 speed limit of 60%. The cell N2 speed limit was raised 70% and a second attempt to start was initiated. The engine successfully reached and stabilized at idle conditions. Engine operating parameters were within acceptable limits. The engine was then accelerated to flight idle conditions, verifying flow fence operation and power turbine governor operation. The engine was then returned to idle and shutdown. The engine was started again and accelerated to maximum continuous power (MCP) setting to establish performance of the engine. Engine performance at MCP Measured Gas Temperature (MGT) appeared slightly low, however an engine performance calibration was not conducted (Figure 29). The power turbine high limit check was also successfully demonstrated. No additional testing was conducted. The engine demonstrated the ability to meter and control fuel flow, power turbine governor operation, and performance. No abnormal operation of the engine was observed. Total operating time was 1 hour 14 minutes and five starts. The engine was preserved and then removed from the test cell, placed back in its shipping container and returned the bonded storage in the Product Integrity Teardown Lab. The engine overspeed controller was not installed or tested during this run.

Figure 25. Engine S/N LE-46018, Installed in Test Cell

Figure 26. Engine S/N LE-46018C, Installed in Test Cell

Figure 27. Engine S/N LE-46018C, Installed in Test Cell

Figure 28. Engine S/N LE-46018C, Installed in Test Cell
