# NATIONAL TRANSPORTATION SAFETY BOARD

## Personal Electronic Devices

**Specialist's Factual Report  
by Gerald Kawamoto**

Location: Ketchikan, Alaska  
Date: August 5, 2021  
Aircraft: DeHavilland DHC-2  
Registration: N1249K  
Operator: Southeast Aviation LLC  
NTSB Number: ANC21FA069

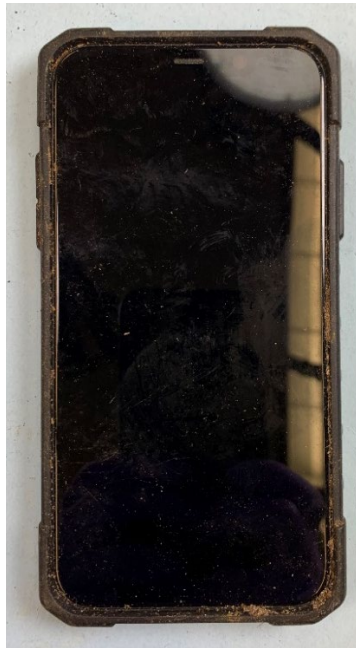
**Figure 1.** iPhone 11 as received.

- The iPhone 11 and iPhone XR were undamaged, as shown in Figures 1 and 2, and powered on normally.
- The iPhone 8 Plus, iPad Mini 5, and iPad Pro sustained impact damage, as shown in Figures 3 through 5, rendering the devices inoperable. Due to the damage sustained, the batteries from the iPhone 8 Plus, iPad Mini 5 and iPad Pro were removed prior to being shipped to the laboratory. The iPhone 8 Plus powered on normally using surrogate parts. Both iPads were unable to power on due to the damage sustained to the internal components, thus no data were recovered from these two devices.

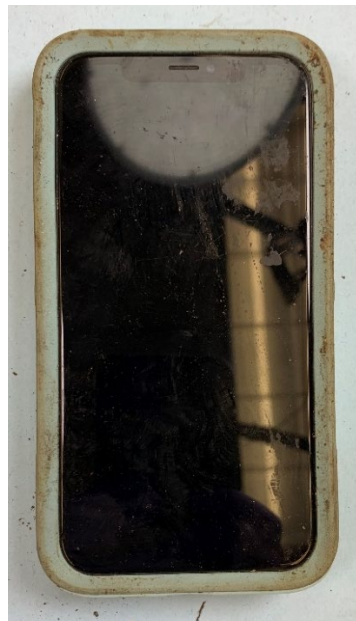
**Figure 2.** iPhone XR as received.

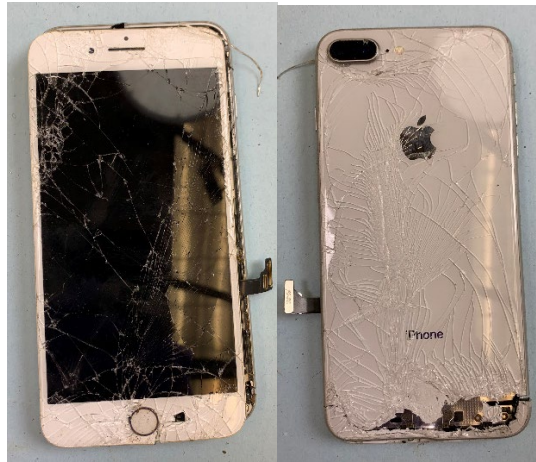
**Figure 3.** iPhone 8 Plus as received.

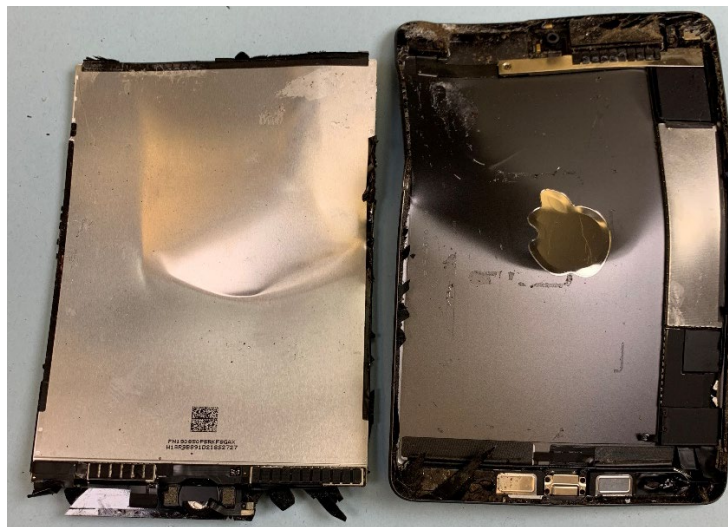
**Figure 4.** iPad Mini 5 as received.

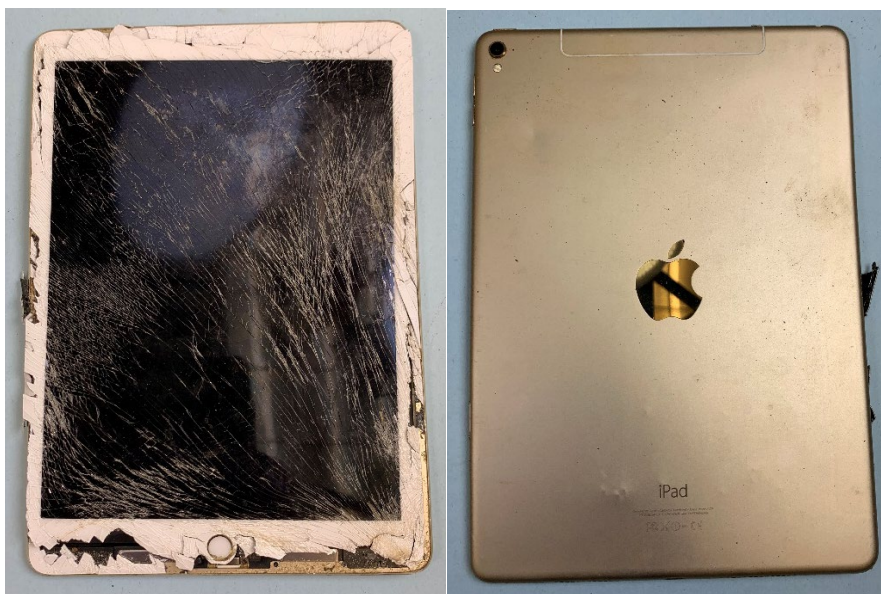
**Figure 5.** iPad Pro as received.

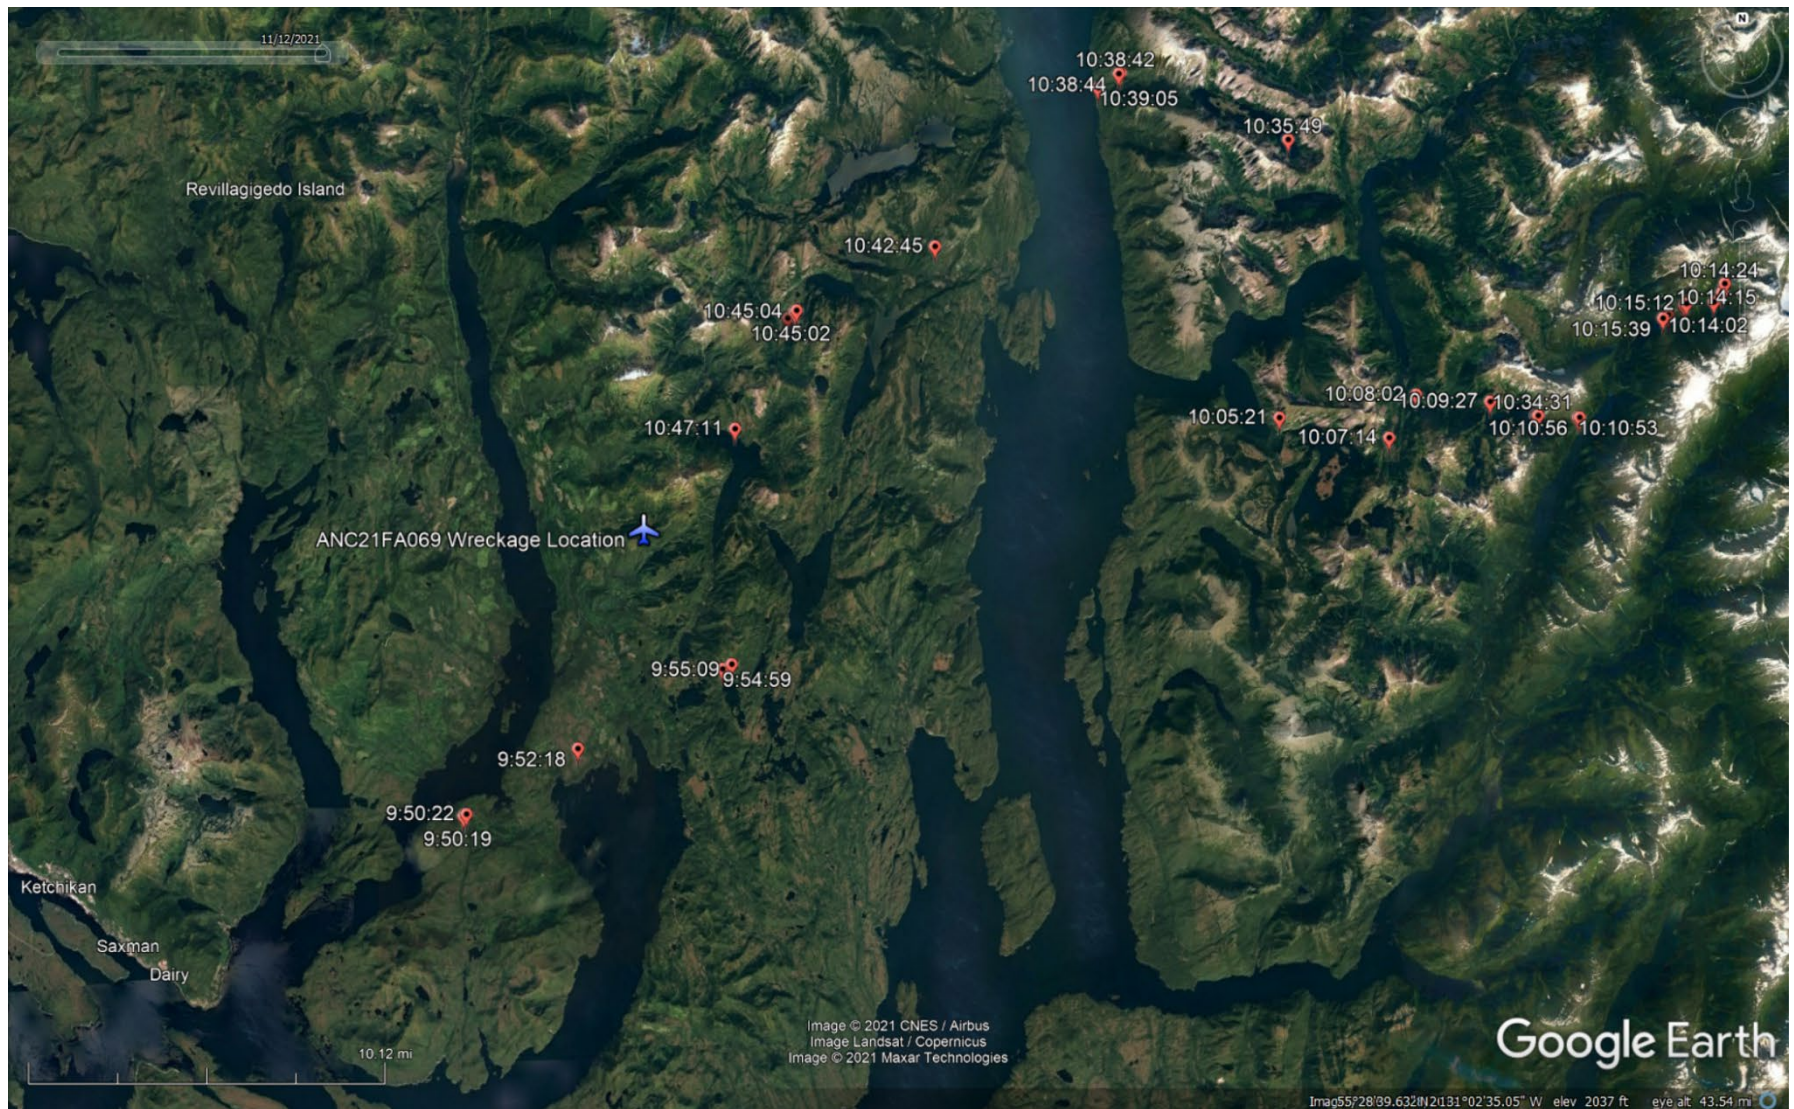
The iPhone 11 contained 40 photos captured between 9:50:19 and 10:47:11 Alaska Daylight Time (AKDT). GPS location information was contained in the photo metadata. Figure 6 is a Google Earth overlay of the position data and the wreckage location. The weather and lighting conditions in Google Earth are not necessarily the weather and lighting conditions present at the time of the accident.

**Figure 6.** Google Earth overlay of the position data recovered from the iPhone 11 photos.
