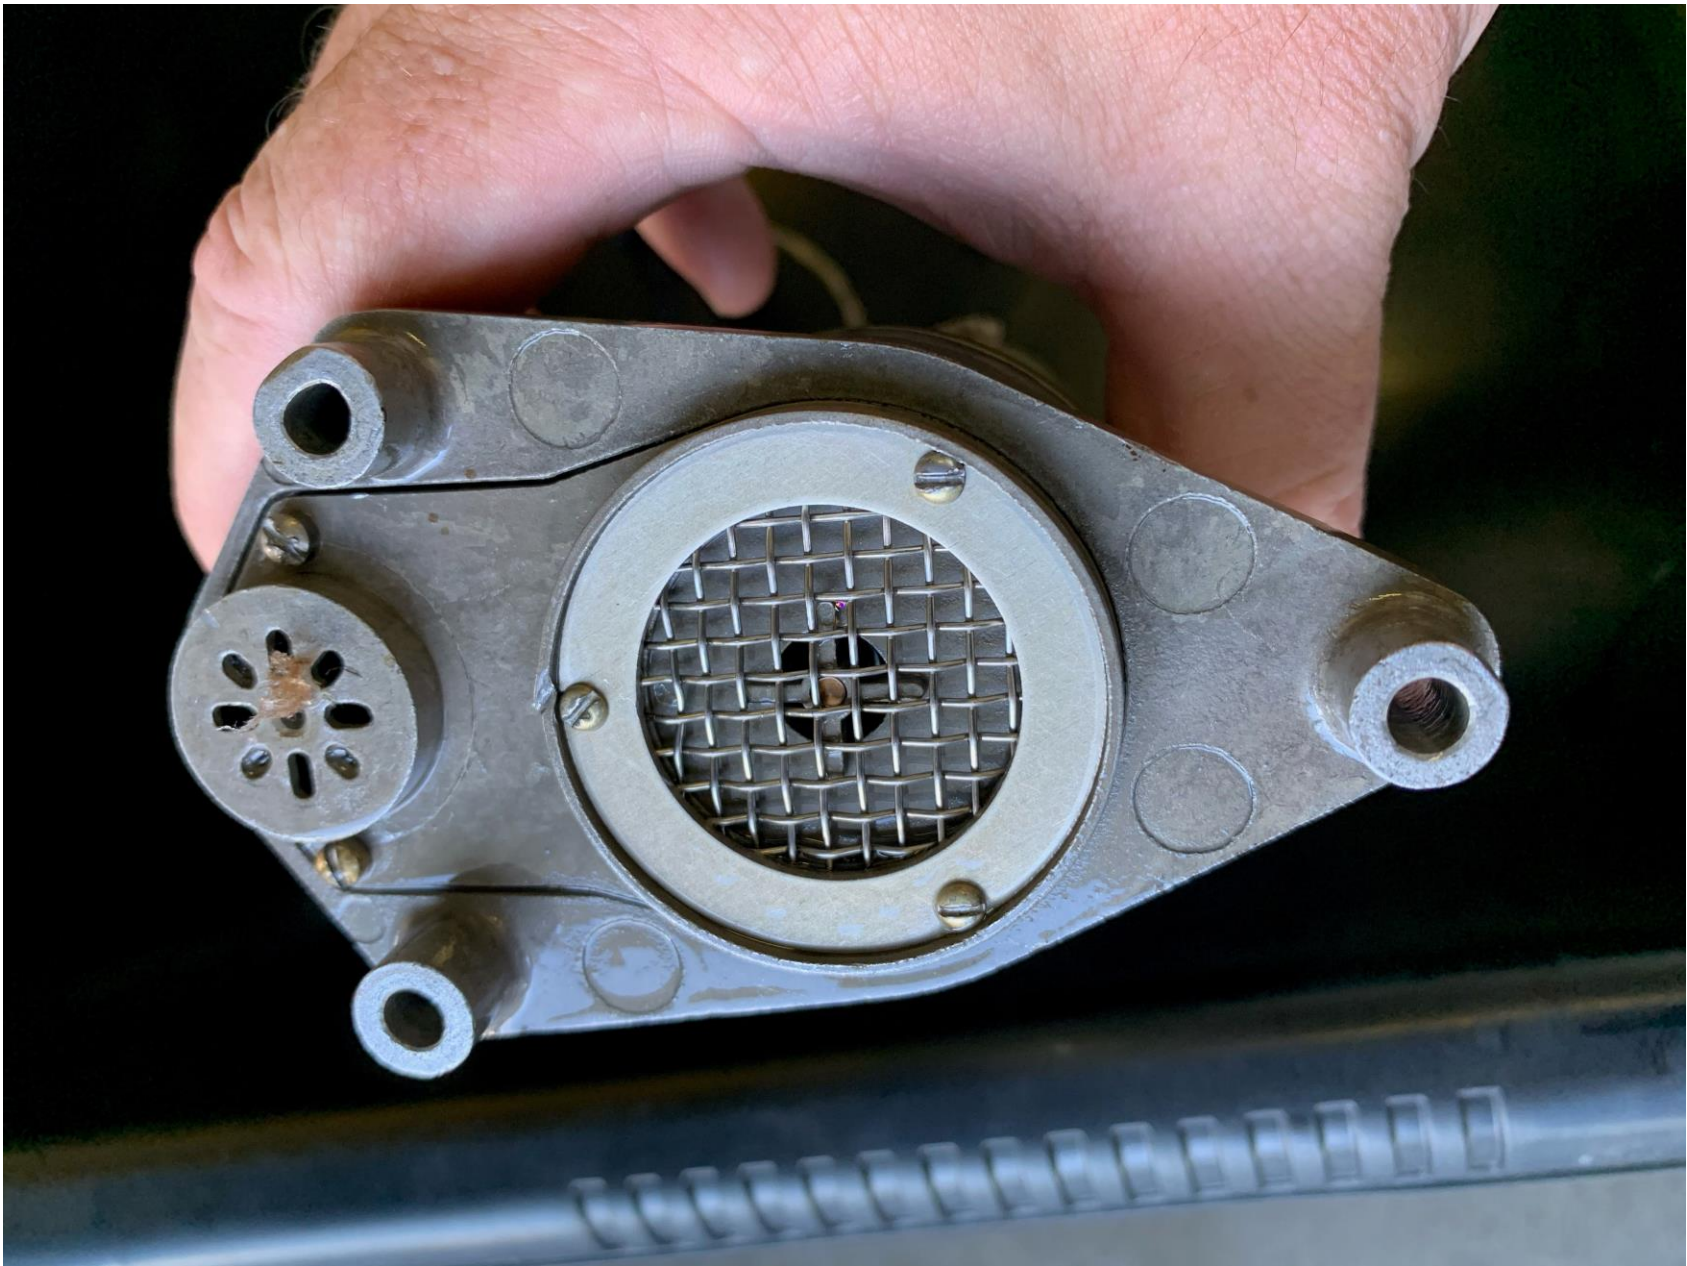
**Photo 1 – View of the accident fuel pump (Photo courtesy of the FAA)**

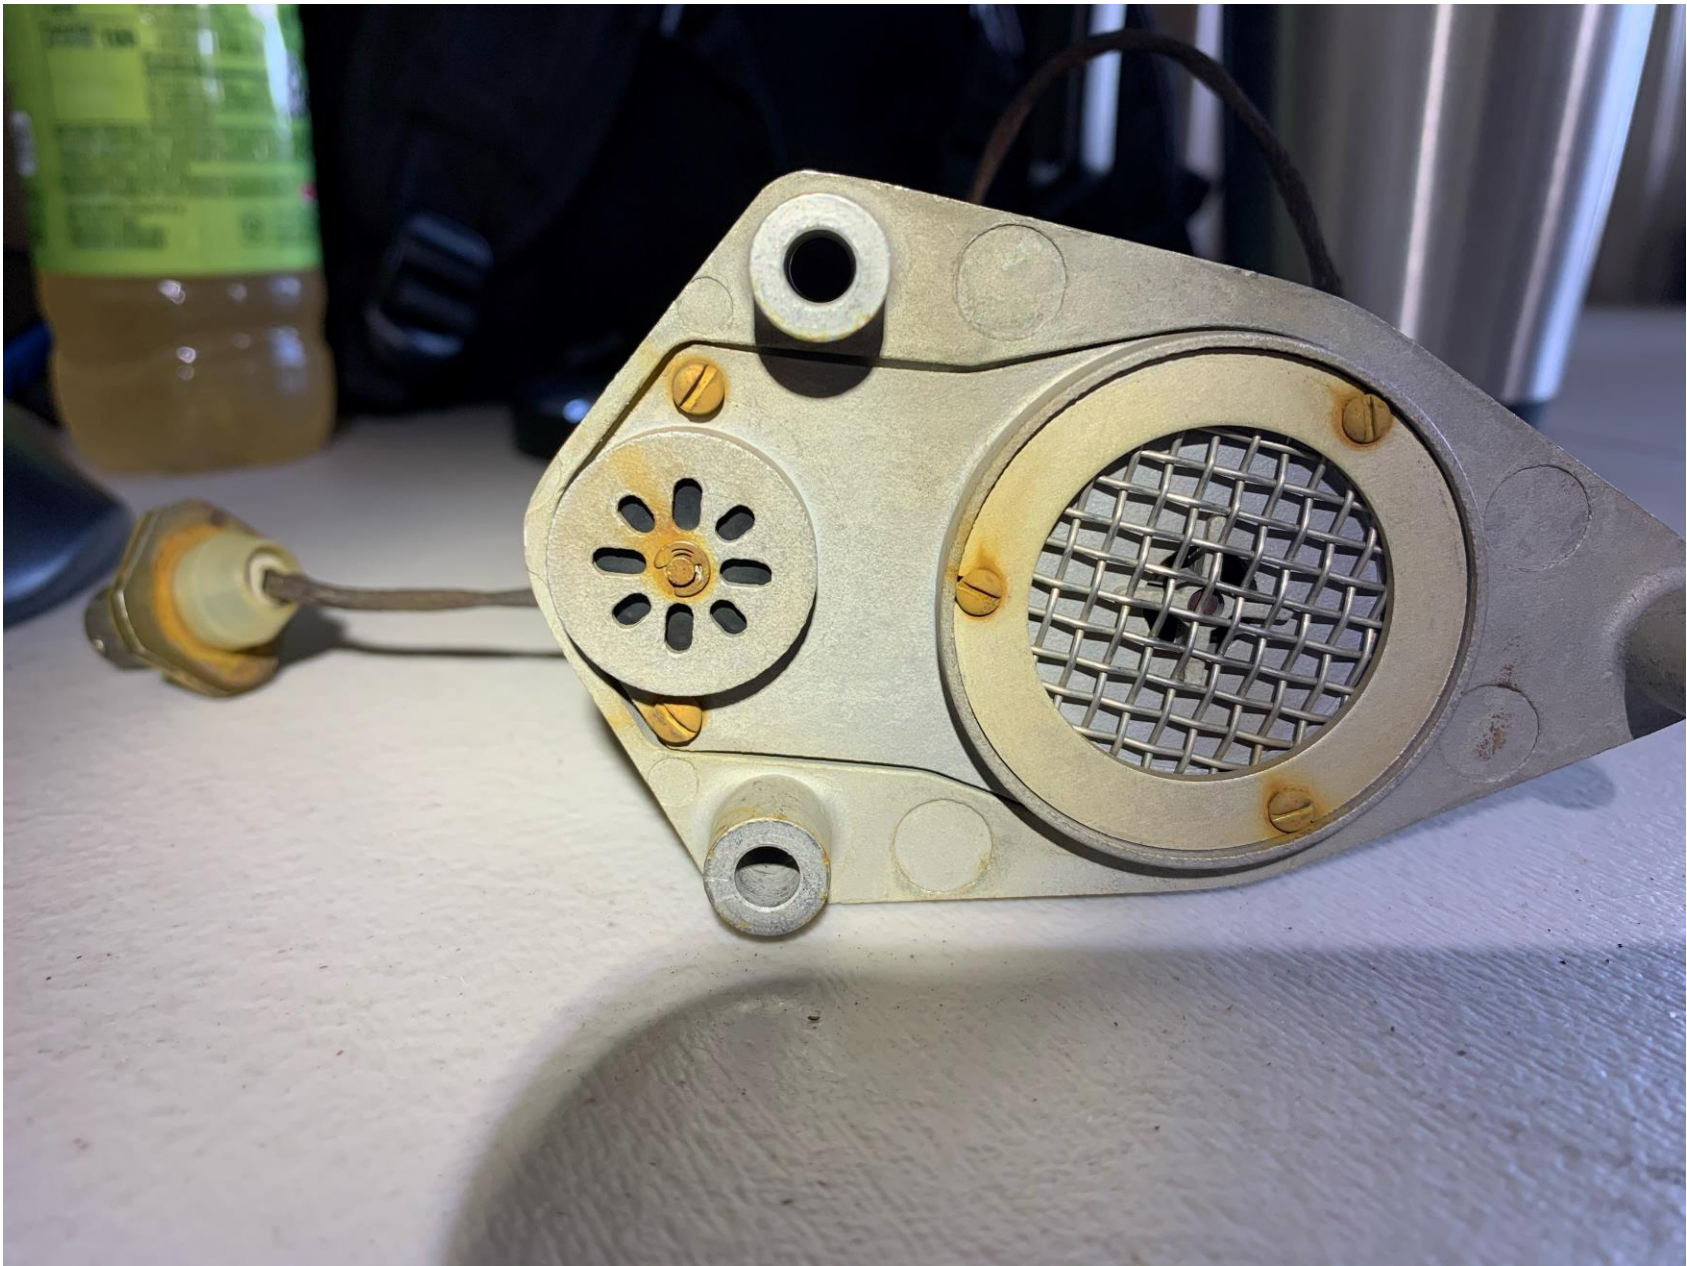
**Photo 2 – View of the reference fuel pump (Photo courtesy of the FAA)**

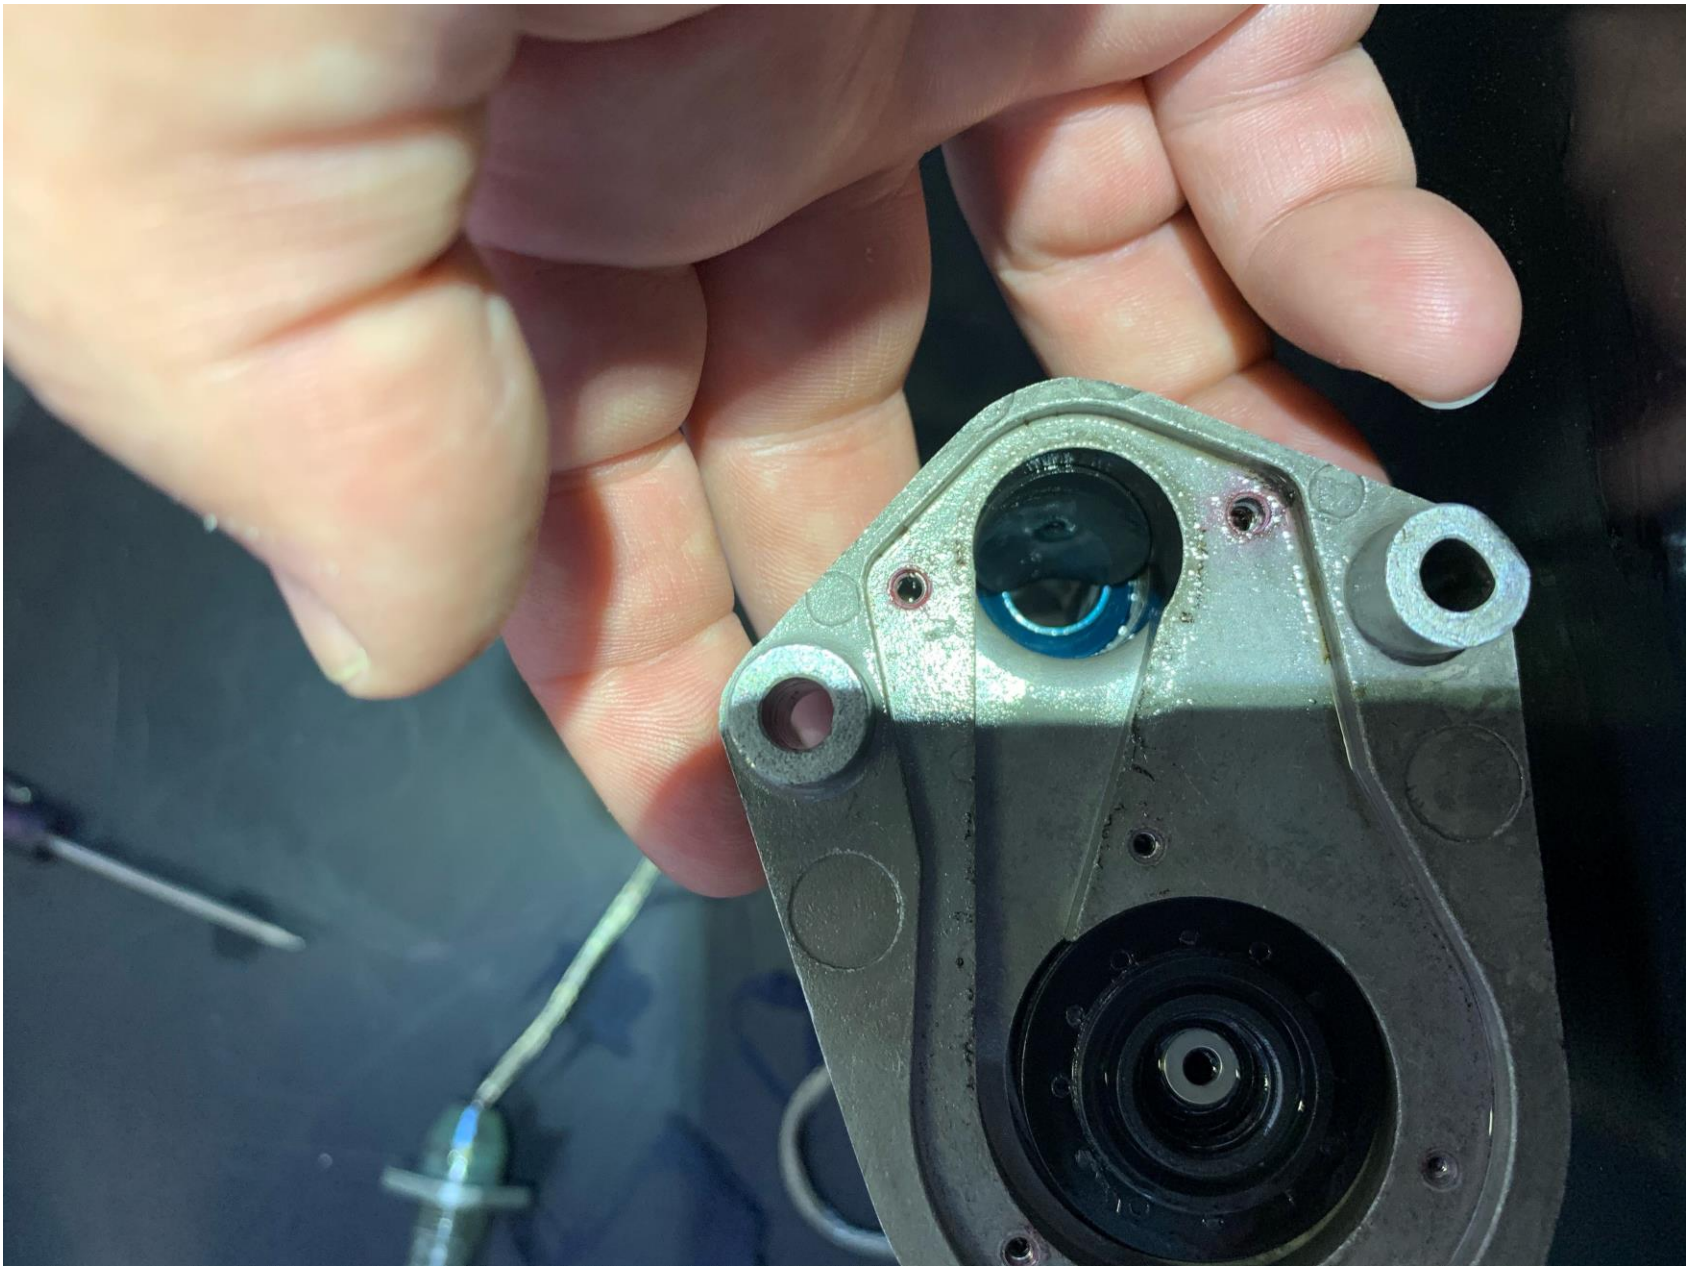
**Photo 3 – Internal view of the accident fuel pump (Photo courtesy of the FAA)**

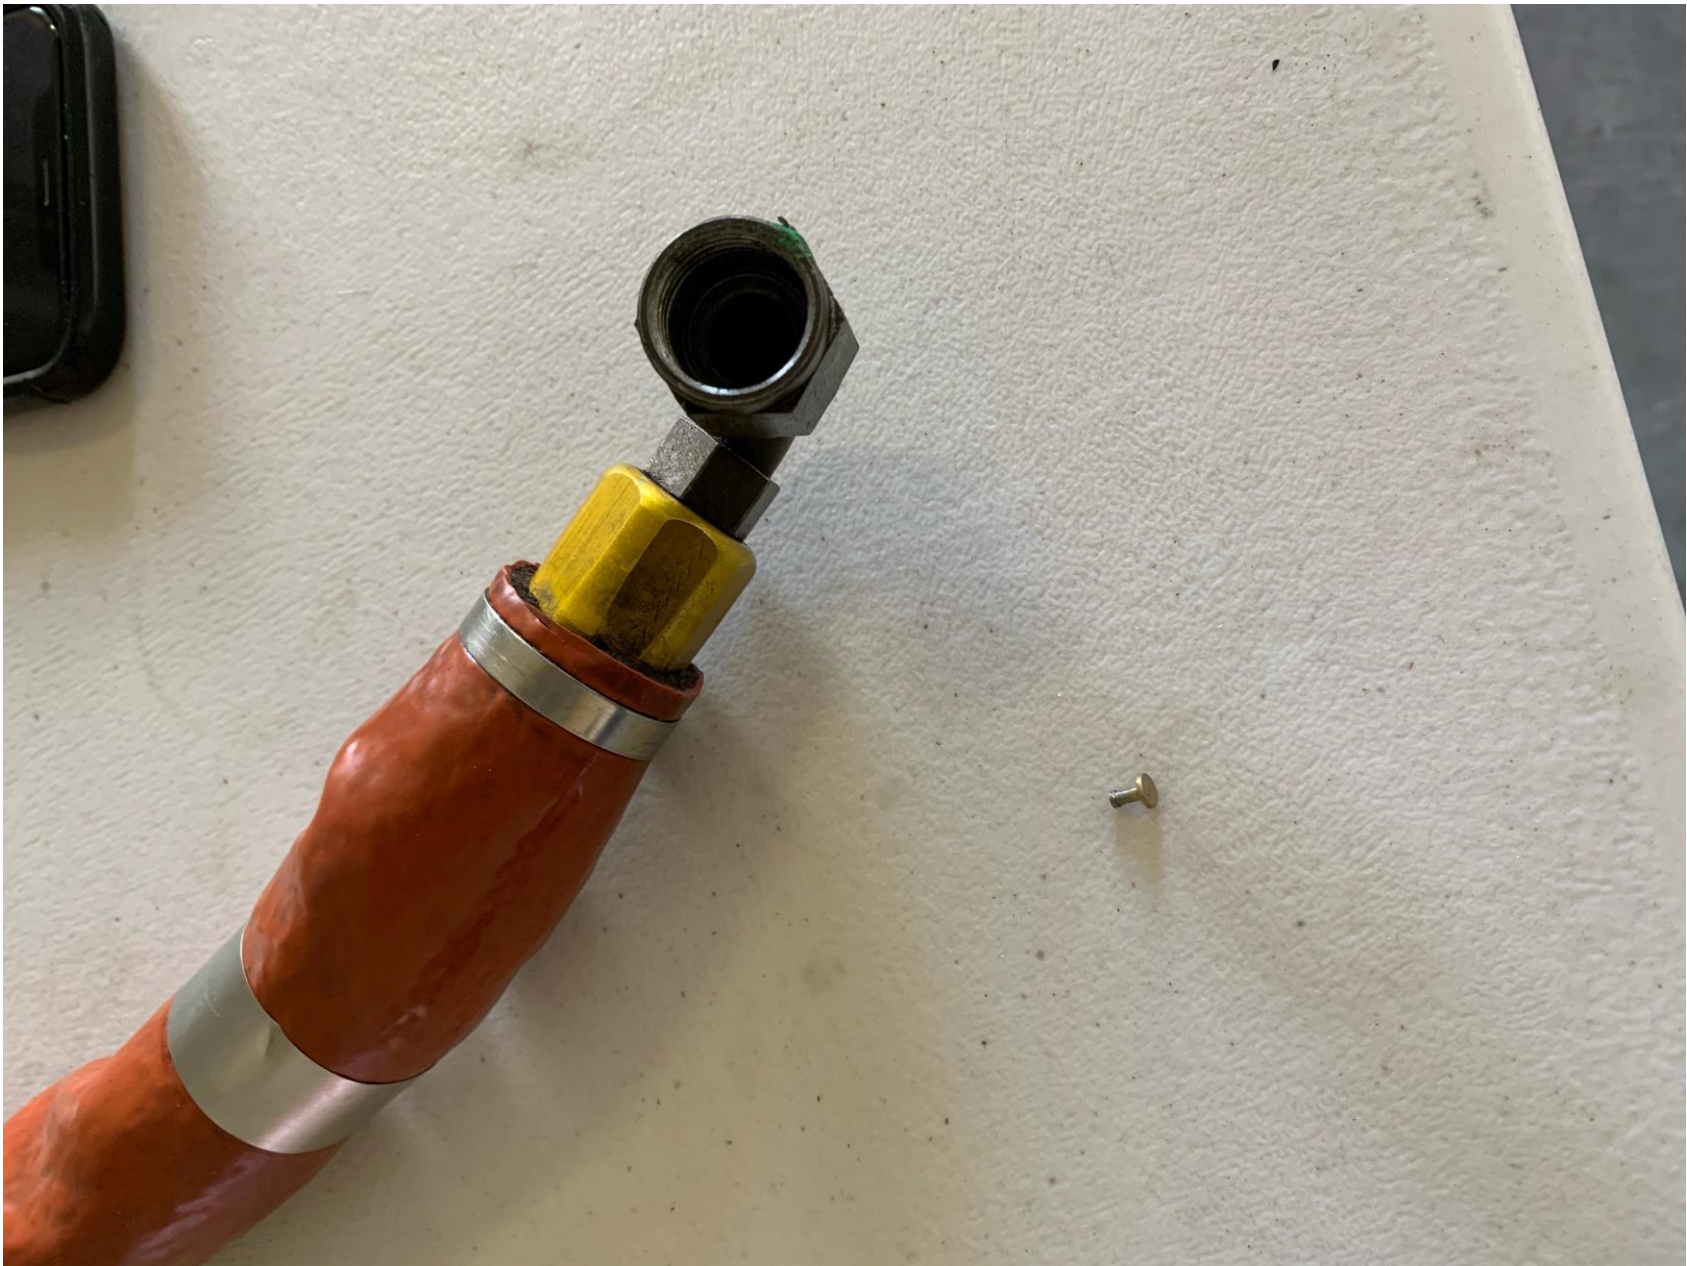
**Photo 4 – View of the fuel line and pin from the accident fuel pump (Photo courtesy of the FAA)**

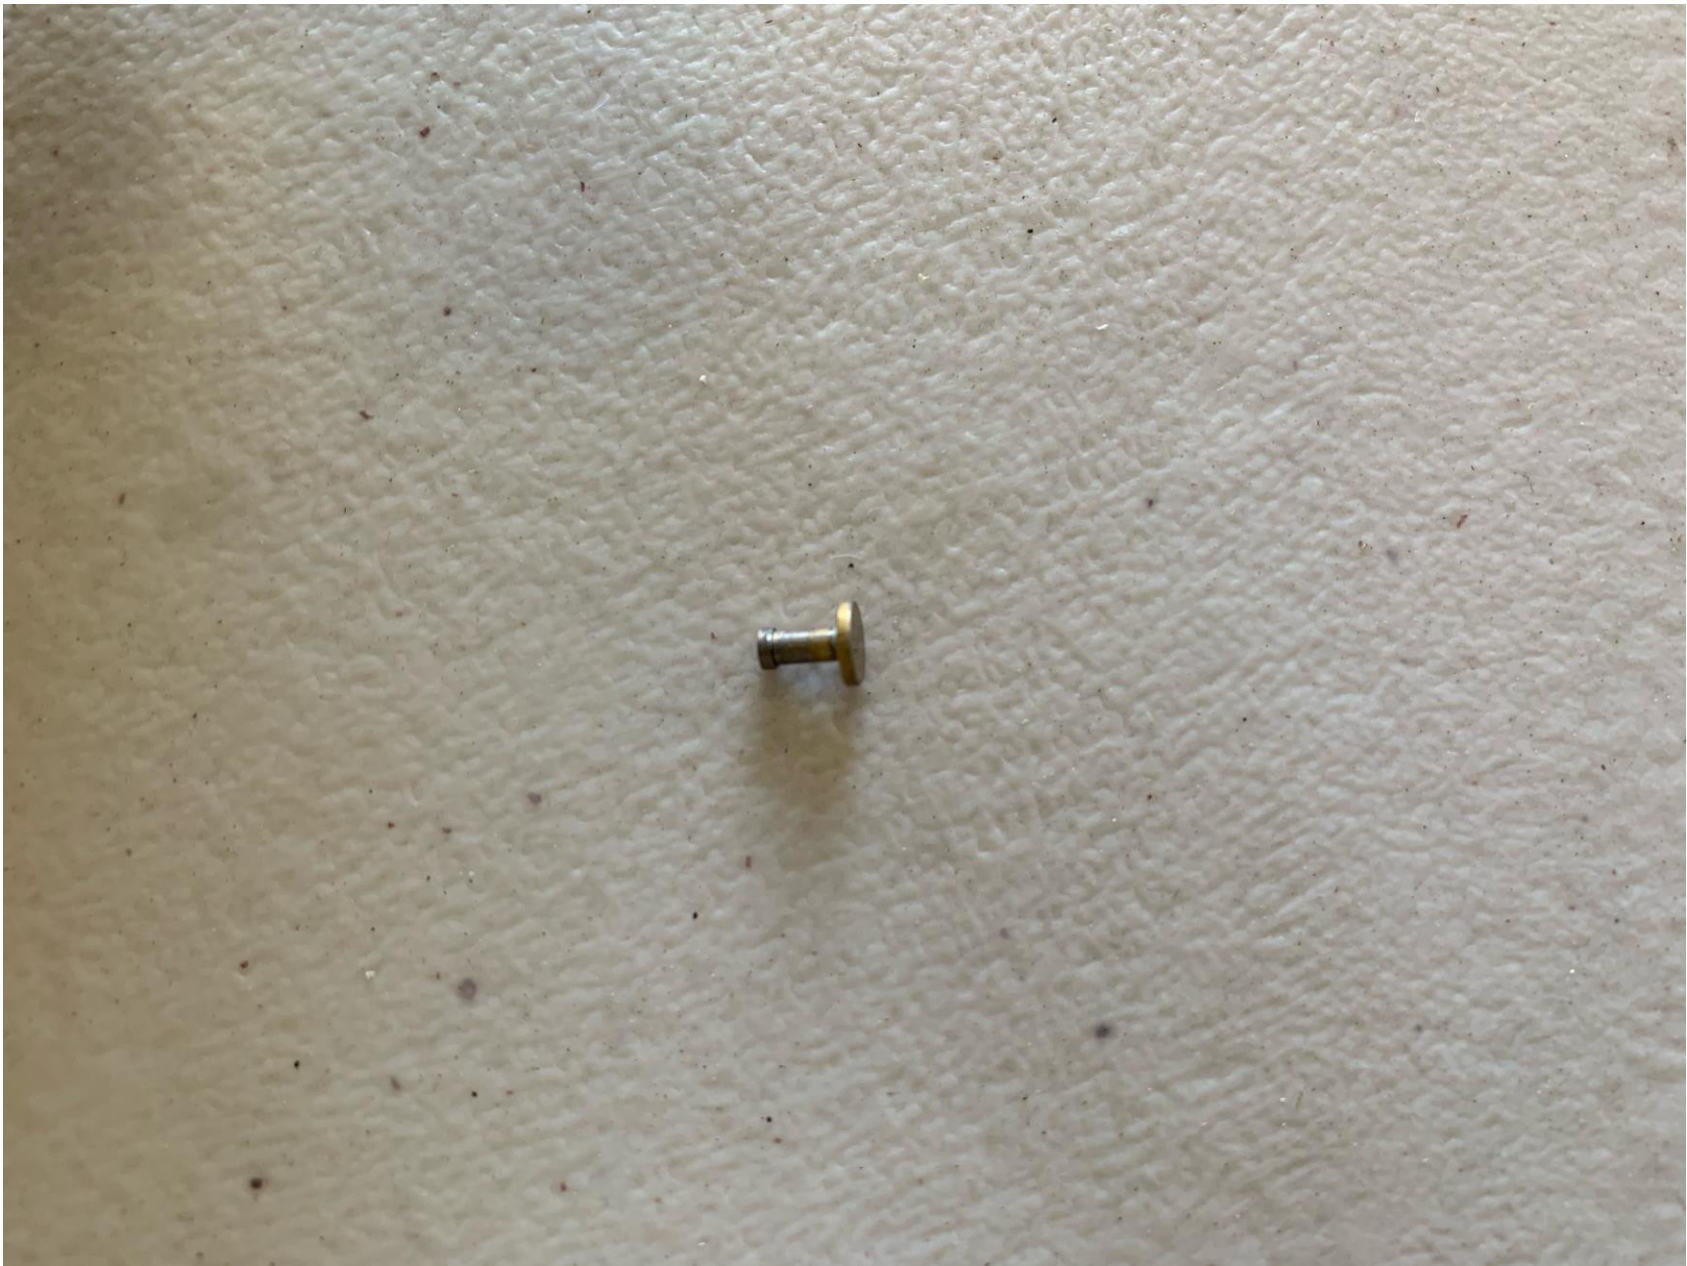
**Photo 5 – View of the accident fuel pump pin that was found in the fuel line (Photo courtesy of the FAA)**

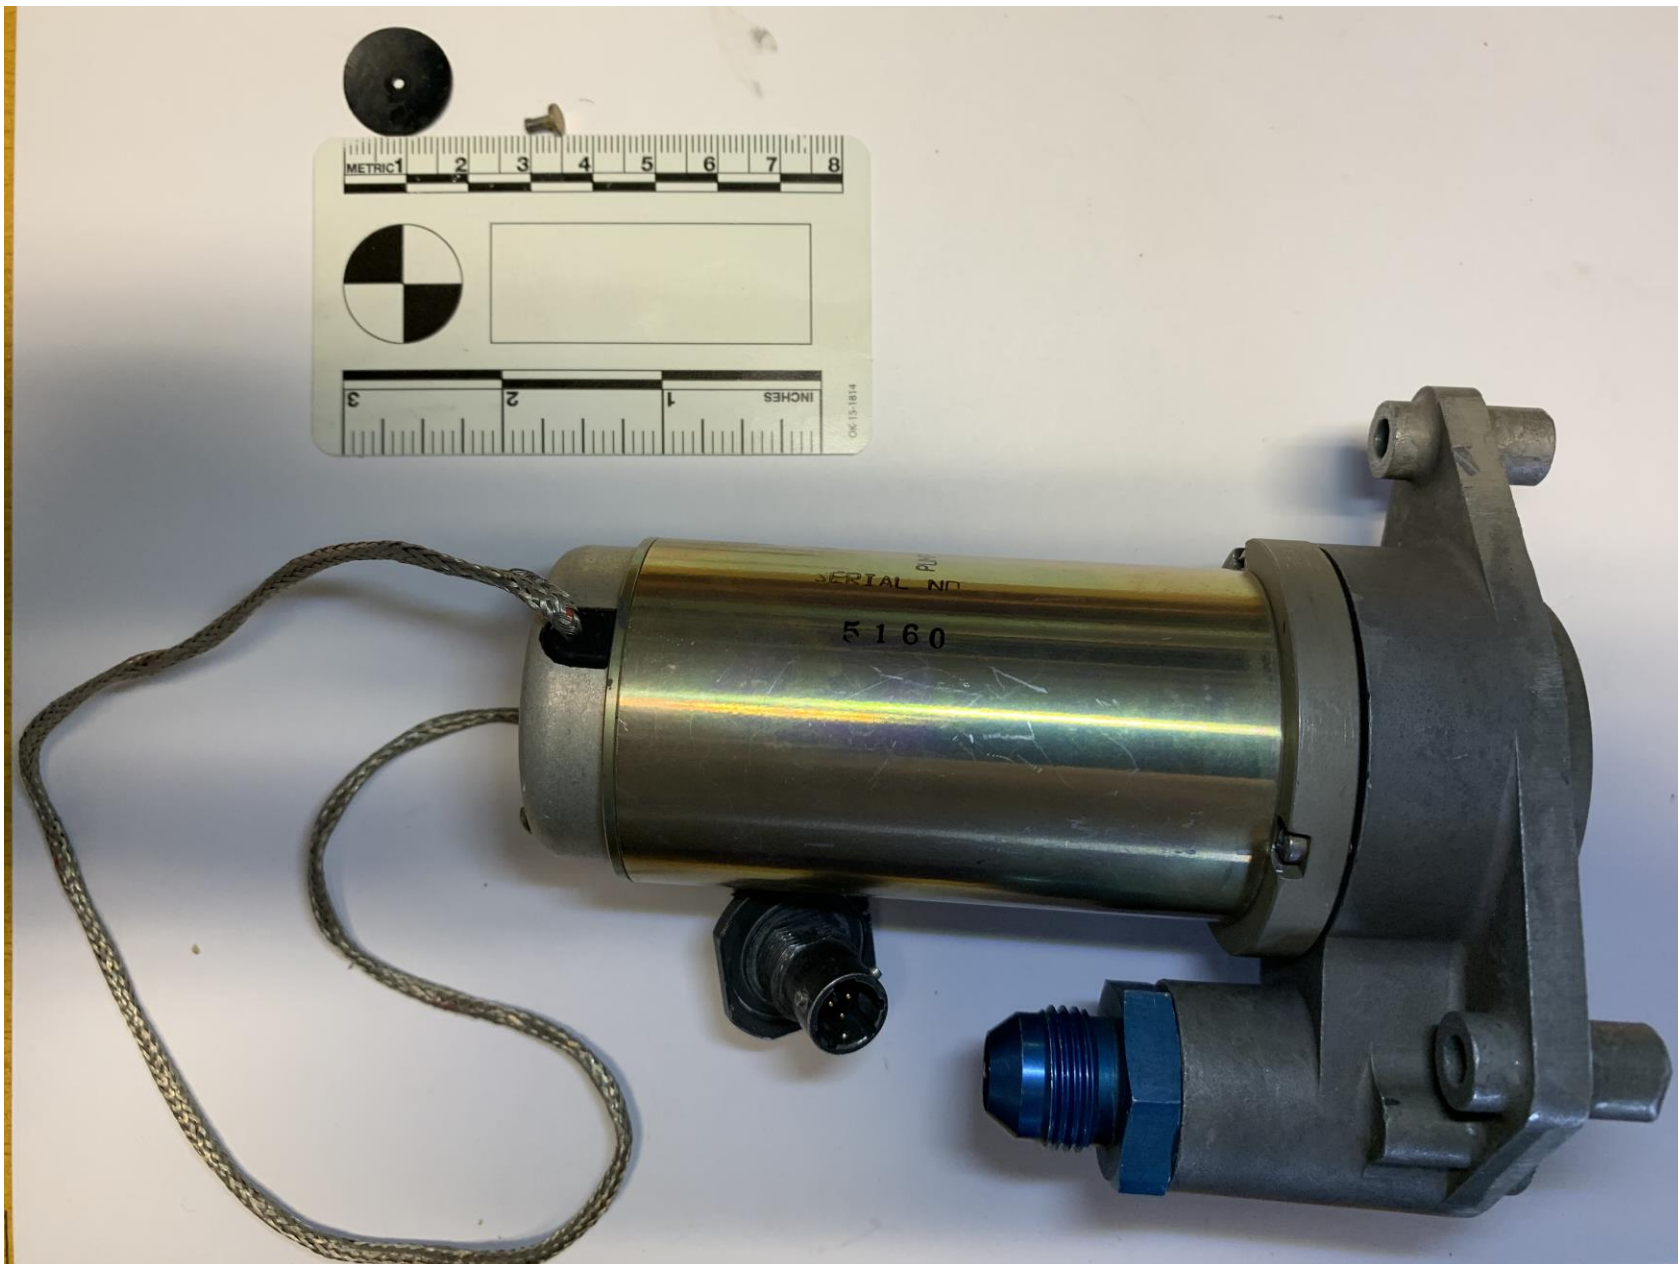
**Photo 6 – View of the accident fuel pump, pin, and flapper valve (Photo courtesy of the FAA)**
