## **NATIONAL TRANSPORTATION SAFETY BOARD**

### **Specialist's Factual Report**

# **METEOROLOGY**

ANC21LA073

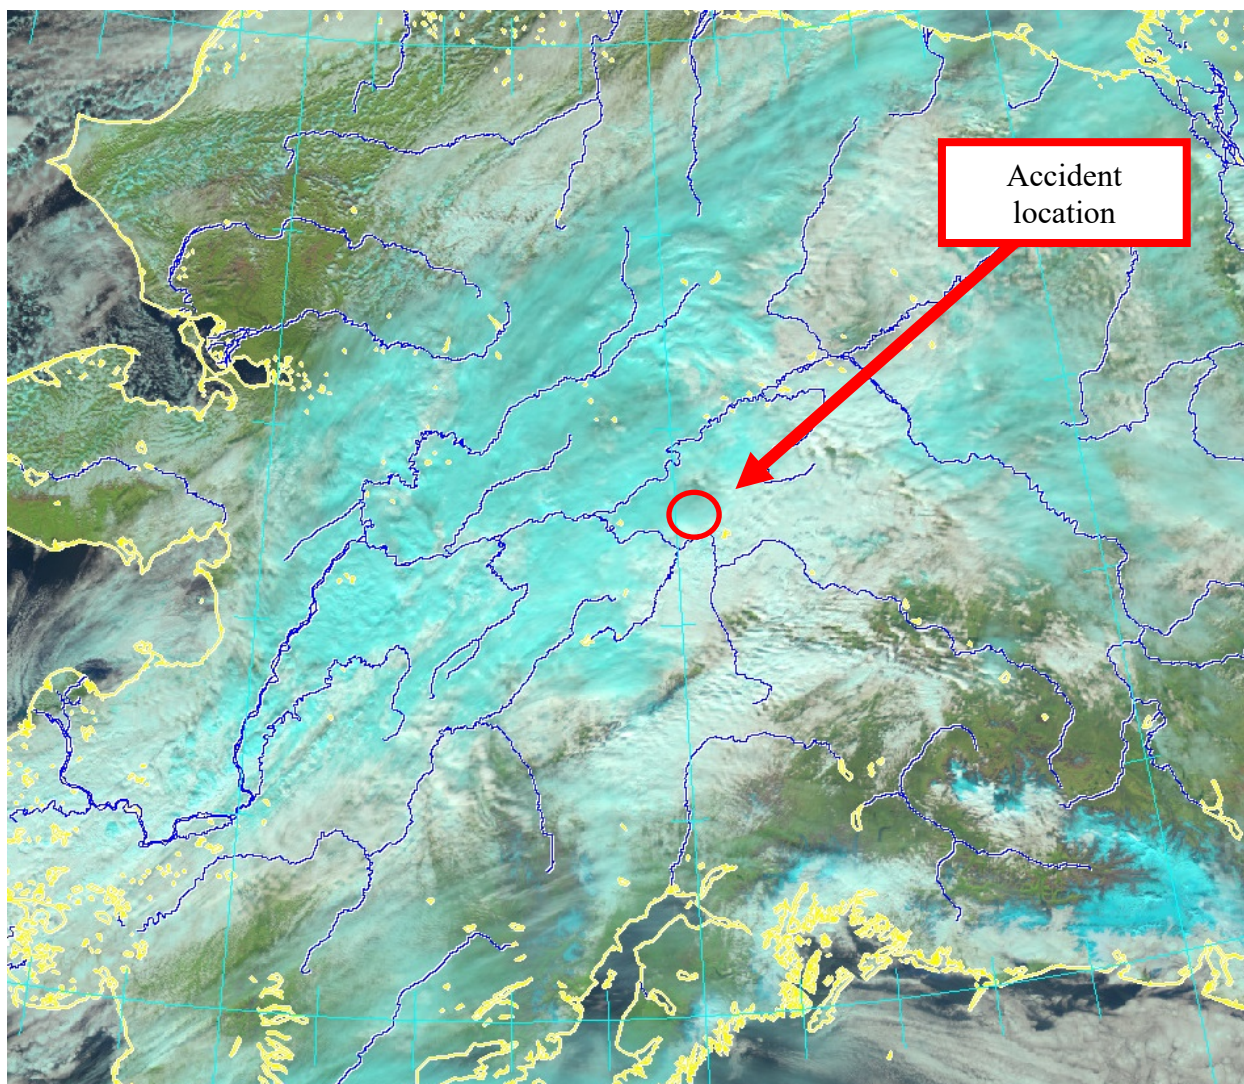
Additional satellite imagery was obtained from the Geographic Information Network of Alaska (GINA) and is provided in figure 6 and attachment 2<sup>17</sup>. Imagery from the Polar Operational Environmental Satellites (POES)<sup>18</sup> from 1447 AKDT (figure 6) continued to highlight the cloud cover above the accident location with the cloud tops above 20,000 ft msl (attachment 2).

**Figure 6 – POES imagery at 1447 AKDT.**

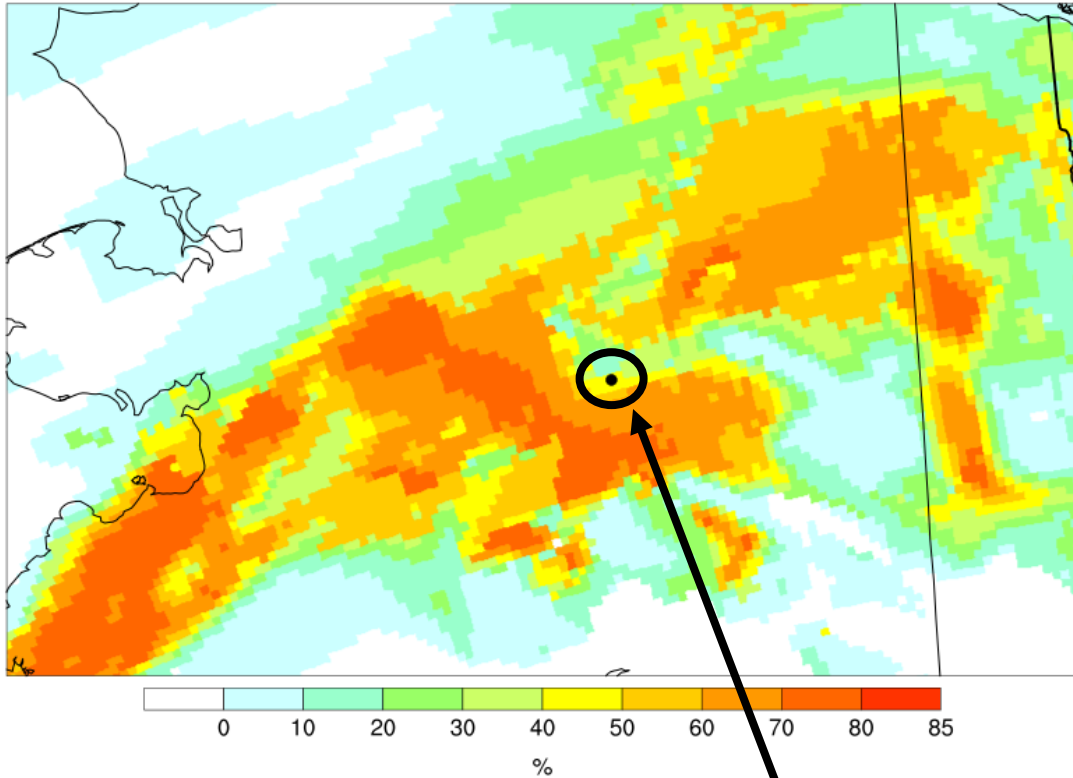
**Figure 14 – (top) FIP probability of icing at 11,000 ft above msl and (bottom) FIP severity of icing at 11,000 ft above msl 2-hour forecast valid for 1500 AKDT.**

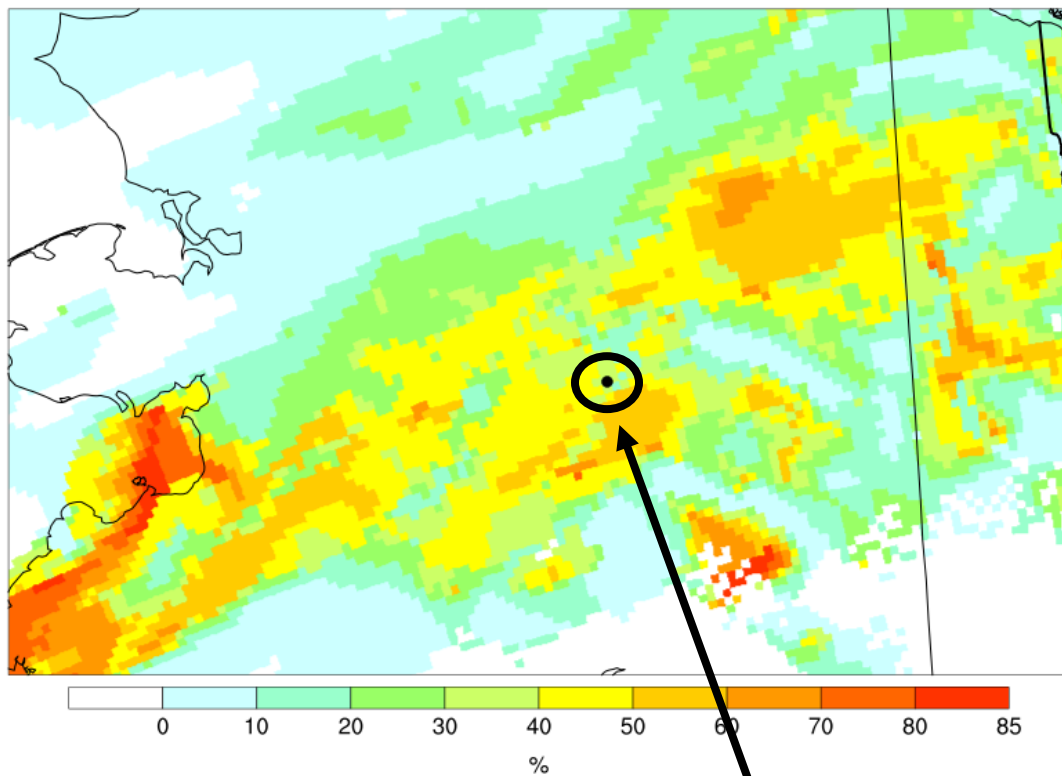
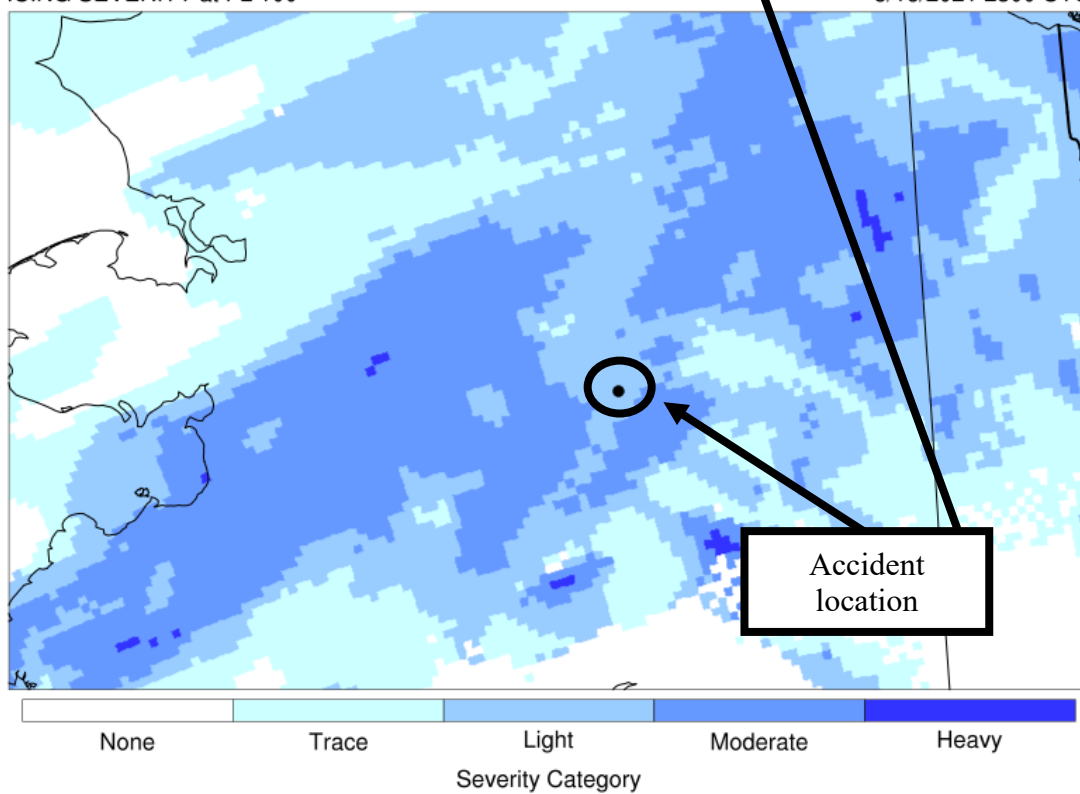
**Figure 16 – (top) CIP probability of icing at 10,000 ft above msl and (bottom) CIP severity of icing at 10,000 ft above msl valid for around 1500 AKDT.**

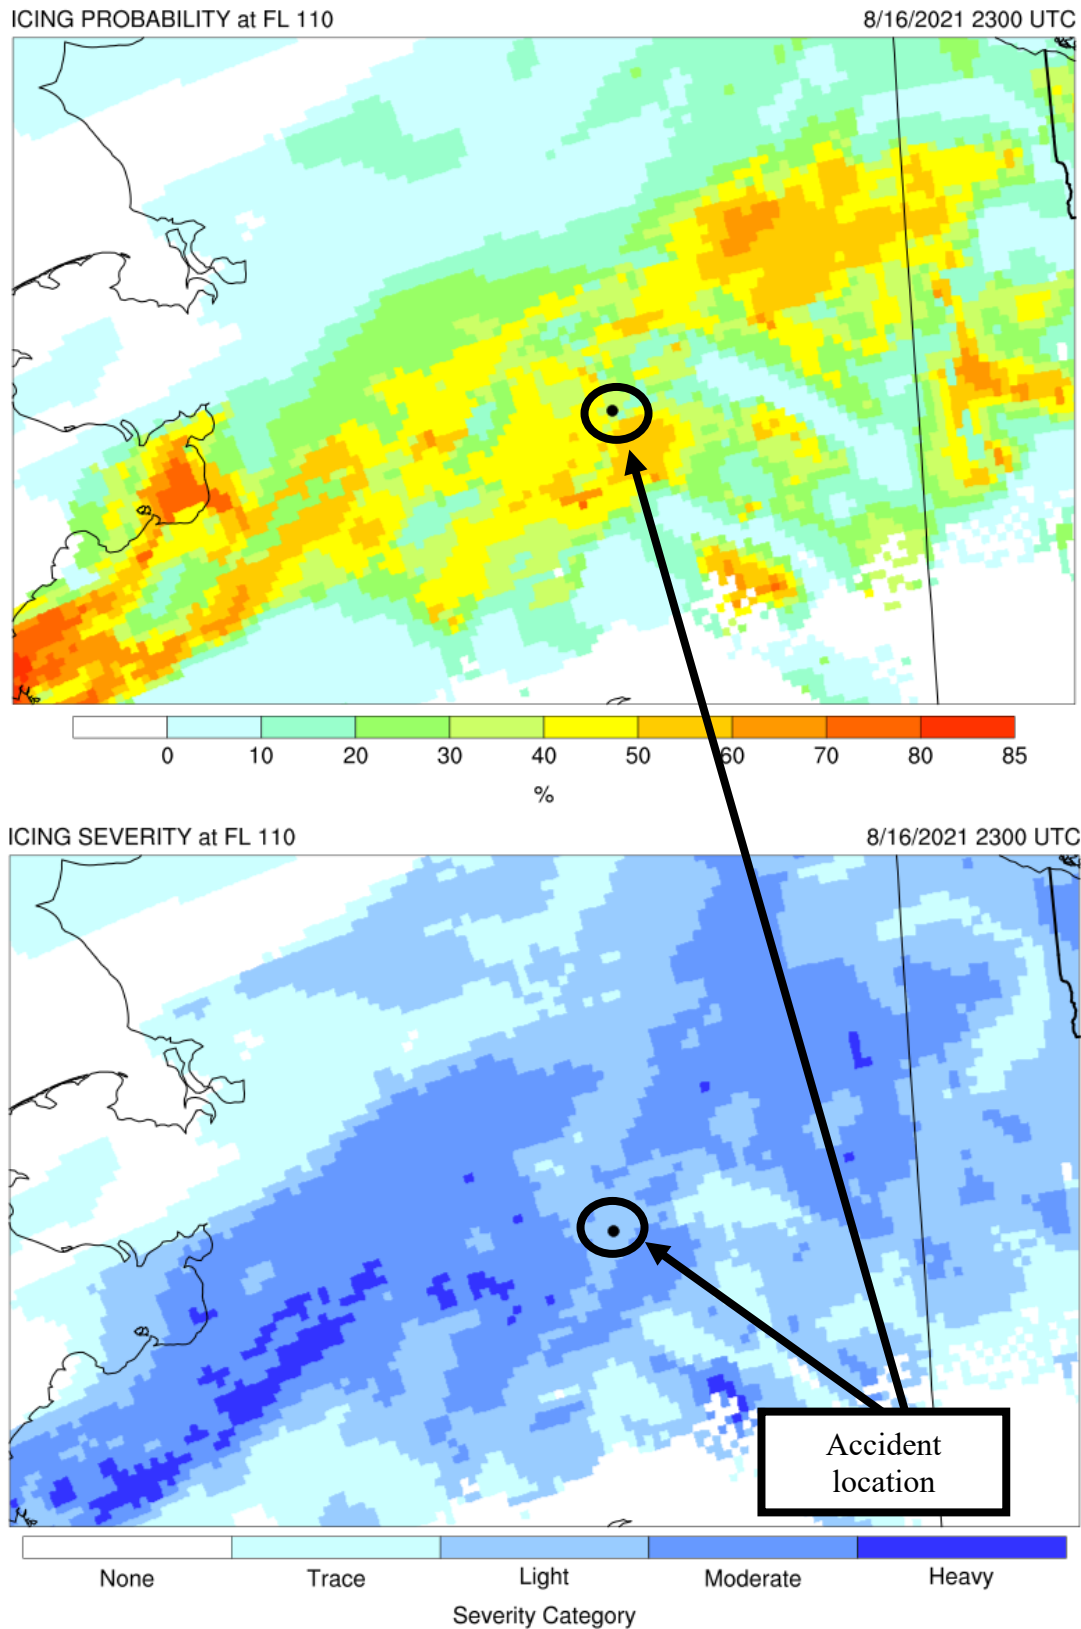
**Figure 17 – (top) CIP probability of icing at 11,000 ft above msl and (bottom) CIP severity of icing at 11,000 ft above msl valid for around 1500 AKDT.**

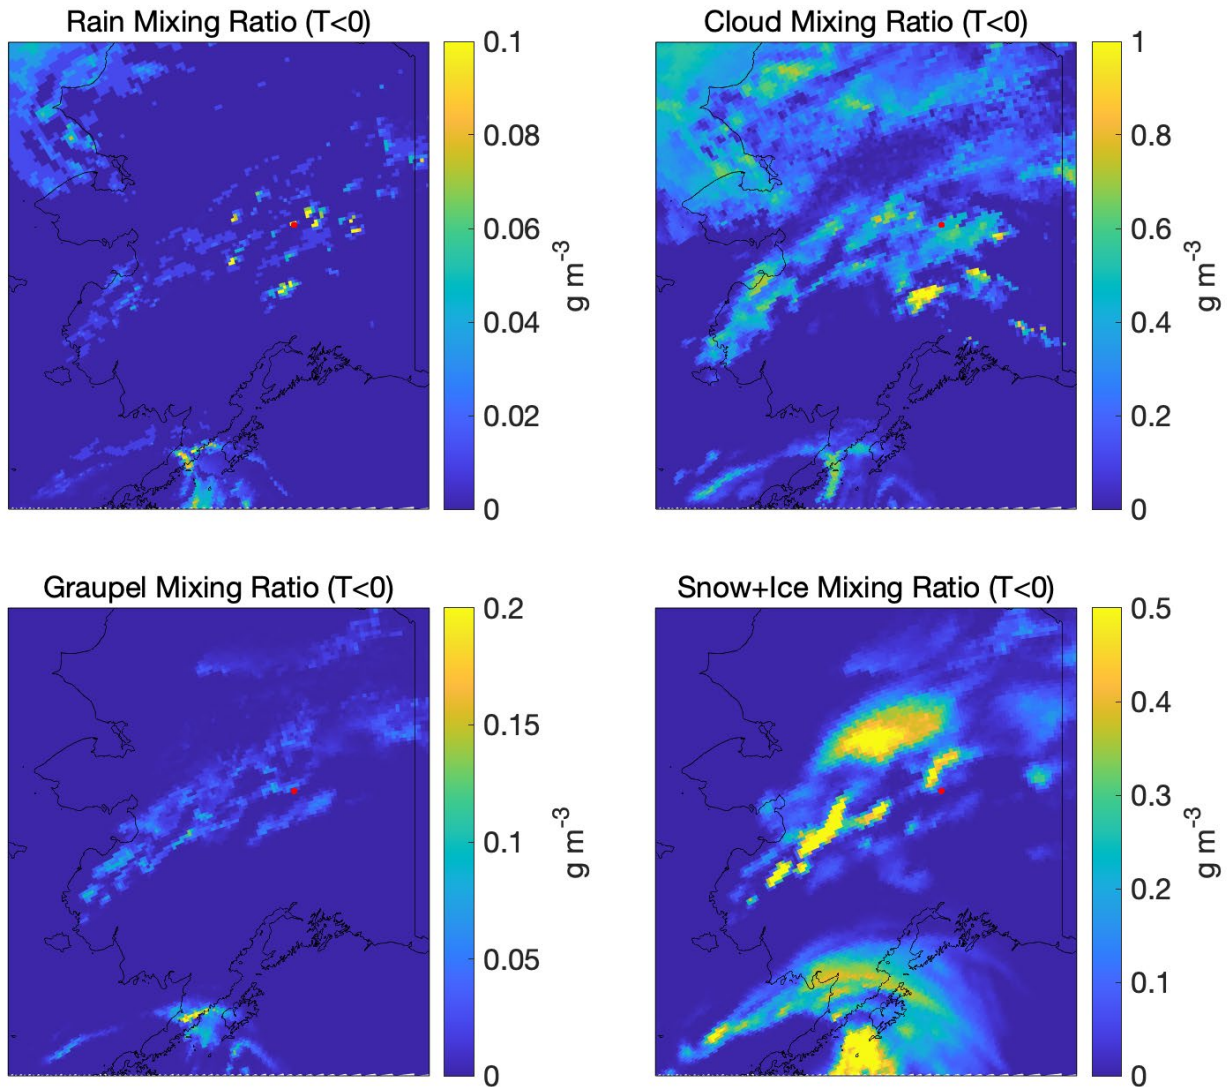
**Figure 18 – Column-maximum (where  $T < 0^\circ\text{C}$ ) mixing ratios for different hydrometeor classes from the Weather Research and Forecast model (WRF)- Rapid Refresh (RAP) model (~11.25 km horizontal resolution) initialized at 1200 AKDT and valid at 1500 AKDT. A red dot marks the location of the accident.**

Additionally information was received from the National Center for Atmospheric Research (NCAR) which showed favorable conditions for SLD (figures 18 through 20 and attachment 8).
