**Specialist's Factual Report - Errata 001**

**METEOROLOGY**

ANC21LA073

### **Specialist's Factual Report**

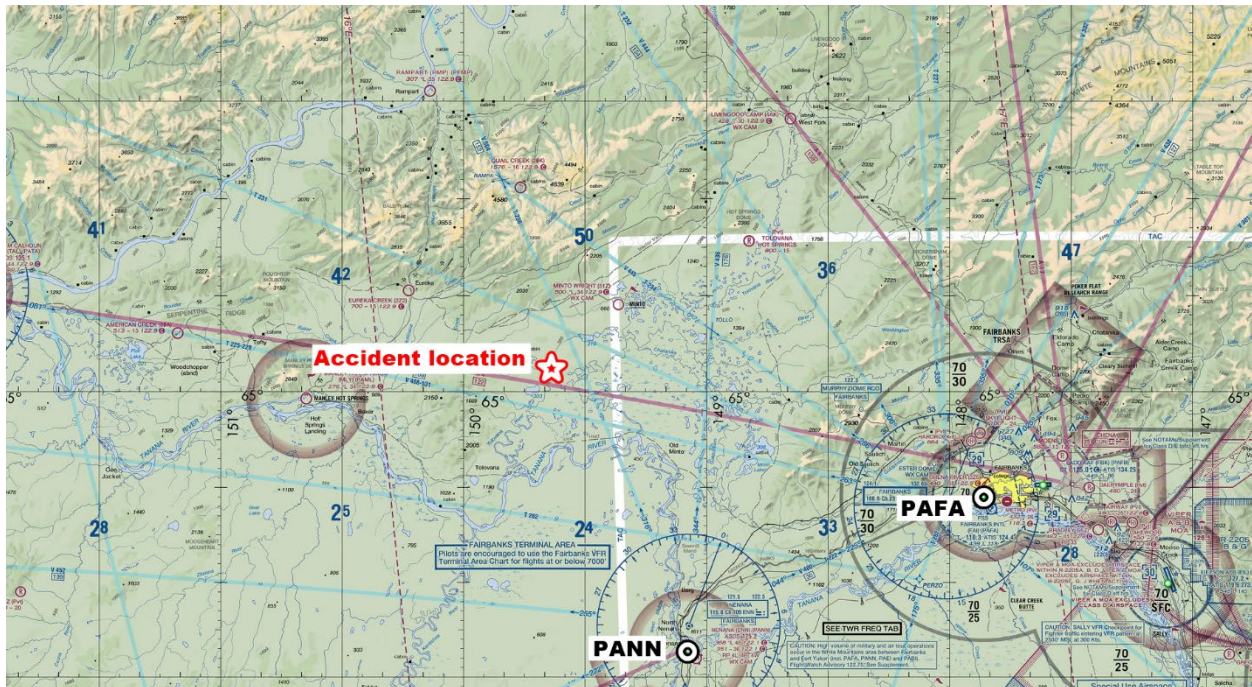
**Figure 2 – Sectional map of the accident area with the location of the accident and surface observation sites.**

The area surrounding the accident location was documented using official Aviation Routine Weather Reports (METARs) and Specials (SPECIs). The following observations were taken from standard code and are provided in plain language. Figure 2 is a local sectional chart with the accident location and the closest weather reporting locations marked.

Fairbanks International Airport (PAFA) was the departure airport and had an ASOS whose longline reports were supplemented by an official weather observer. PAFA ASOS was located 47 miles east-southeast of the accident location (figure 2), at an elevation of 439 ft, and had a 17° easterly magnetic variation. The following automated longline observations were disseminated during the times surrounding the accident and the departure:
