# National Transportation Safety Board

ANC22LA035

## **GLOBAL POSITIONING SYSTEM DEVICE**

Specialist's Factual Report

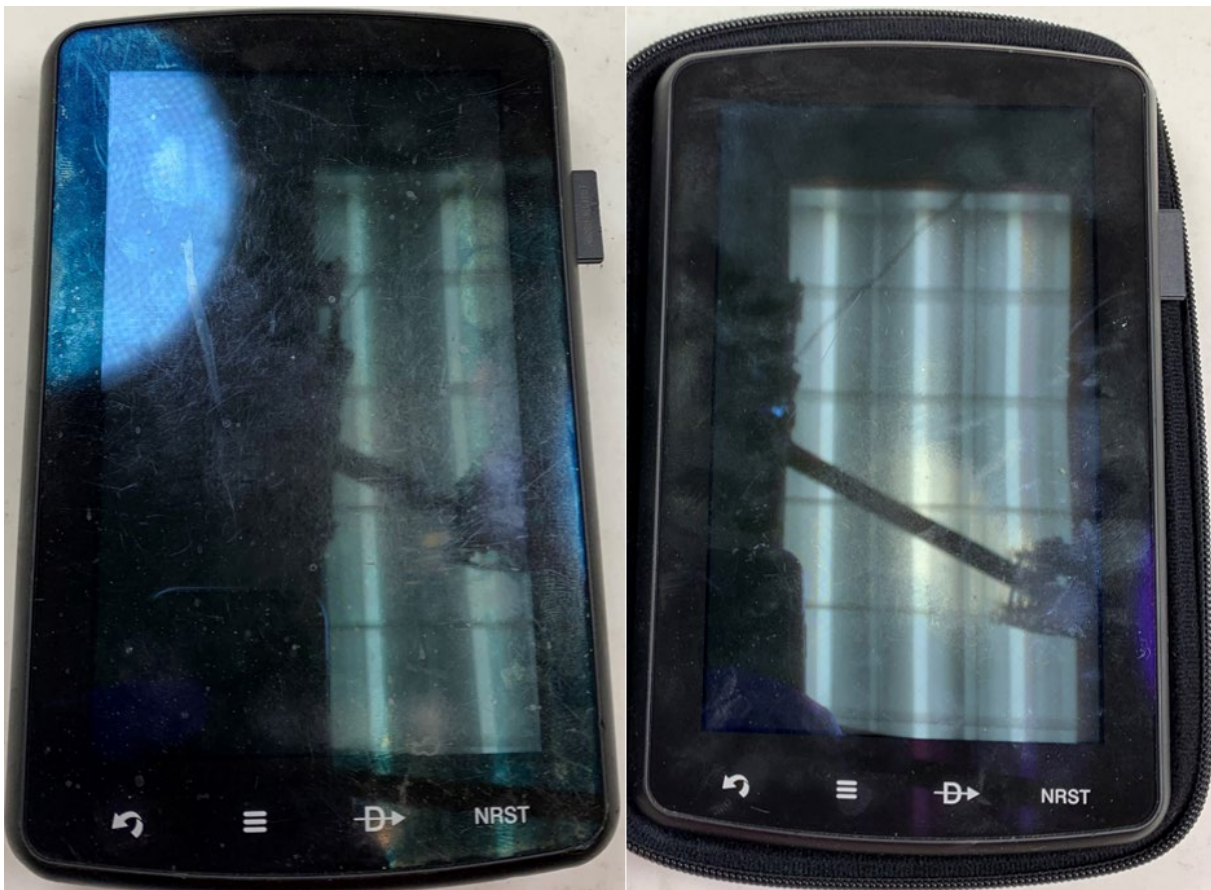
Both Garmin aera 796 GPS units were in good condition and the data were downloaded normally using laboratory tools. Figure 1 shows the devices as it was received at the Recorder's Lab.

**Figure 1.** Photo of both Garmin aera 796 GPS units as received in the Vehicle Recorder lab.

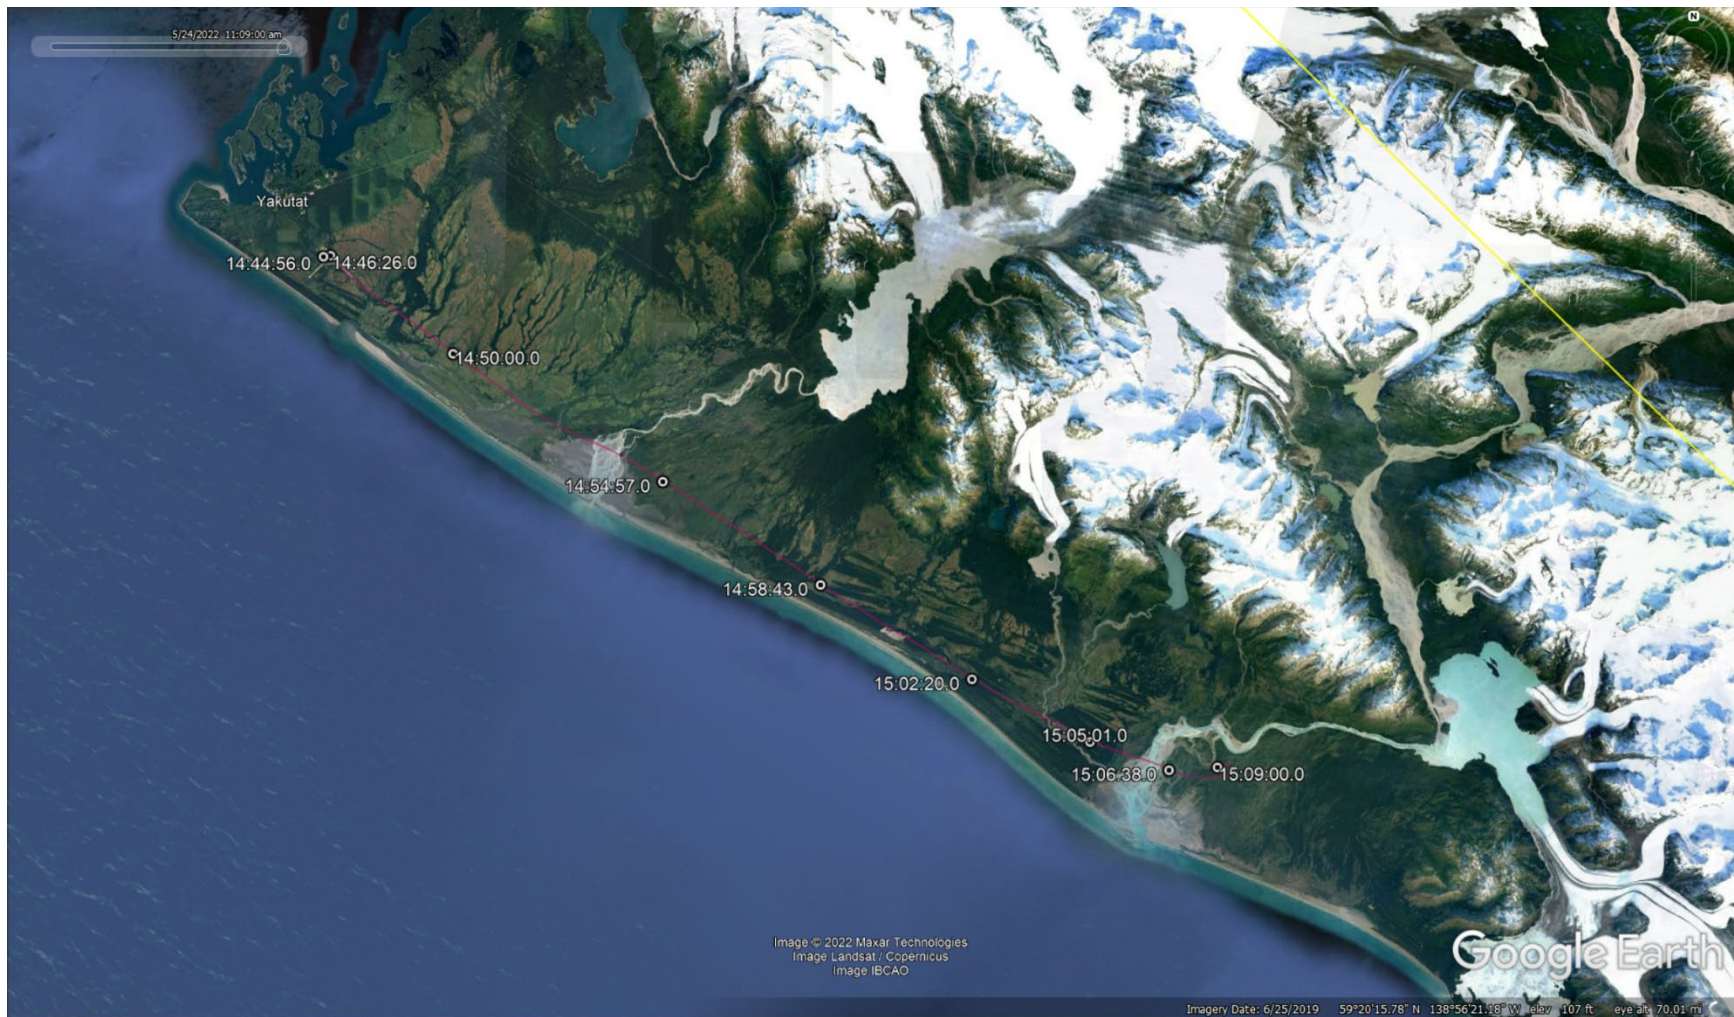
**Figure 4.** Google Earth overlay showing the entire flight.

Figure 2 and Figure 3 show time histories of the entire flight and the final 2 minutes of the recording, respectively. Figure 4 through Figure 8 show Google Earth overlays of the entire incident flight track, taxiing, takeoff roll, the aircraft in pattern, and an overlay of the end of the recording, respectively. Note that the weather and lighting conditions in Google Earth are not necessarily the weather and lighting conditions present at the time of the recording.

In summary, the aircraft began taxiing at approximately 14:44:00 ADT, and began the takeoff roll at approximately 14:46:11 ADT from Yakutat Airport (KYAK). The aircraft headed southeast for the entirety of the flight before entering pattern at approximately 15:07:02 ADT. The last recorded data point collected by the Garmin aera 796 GPS was at approximately 15:09:00 ADT.

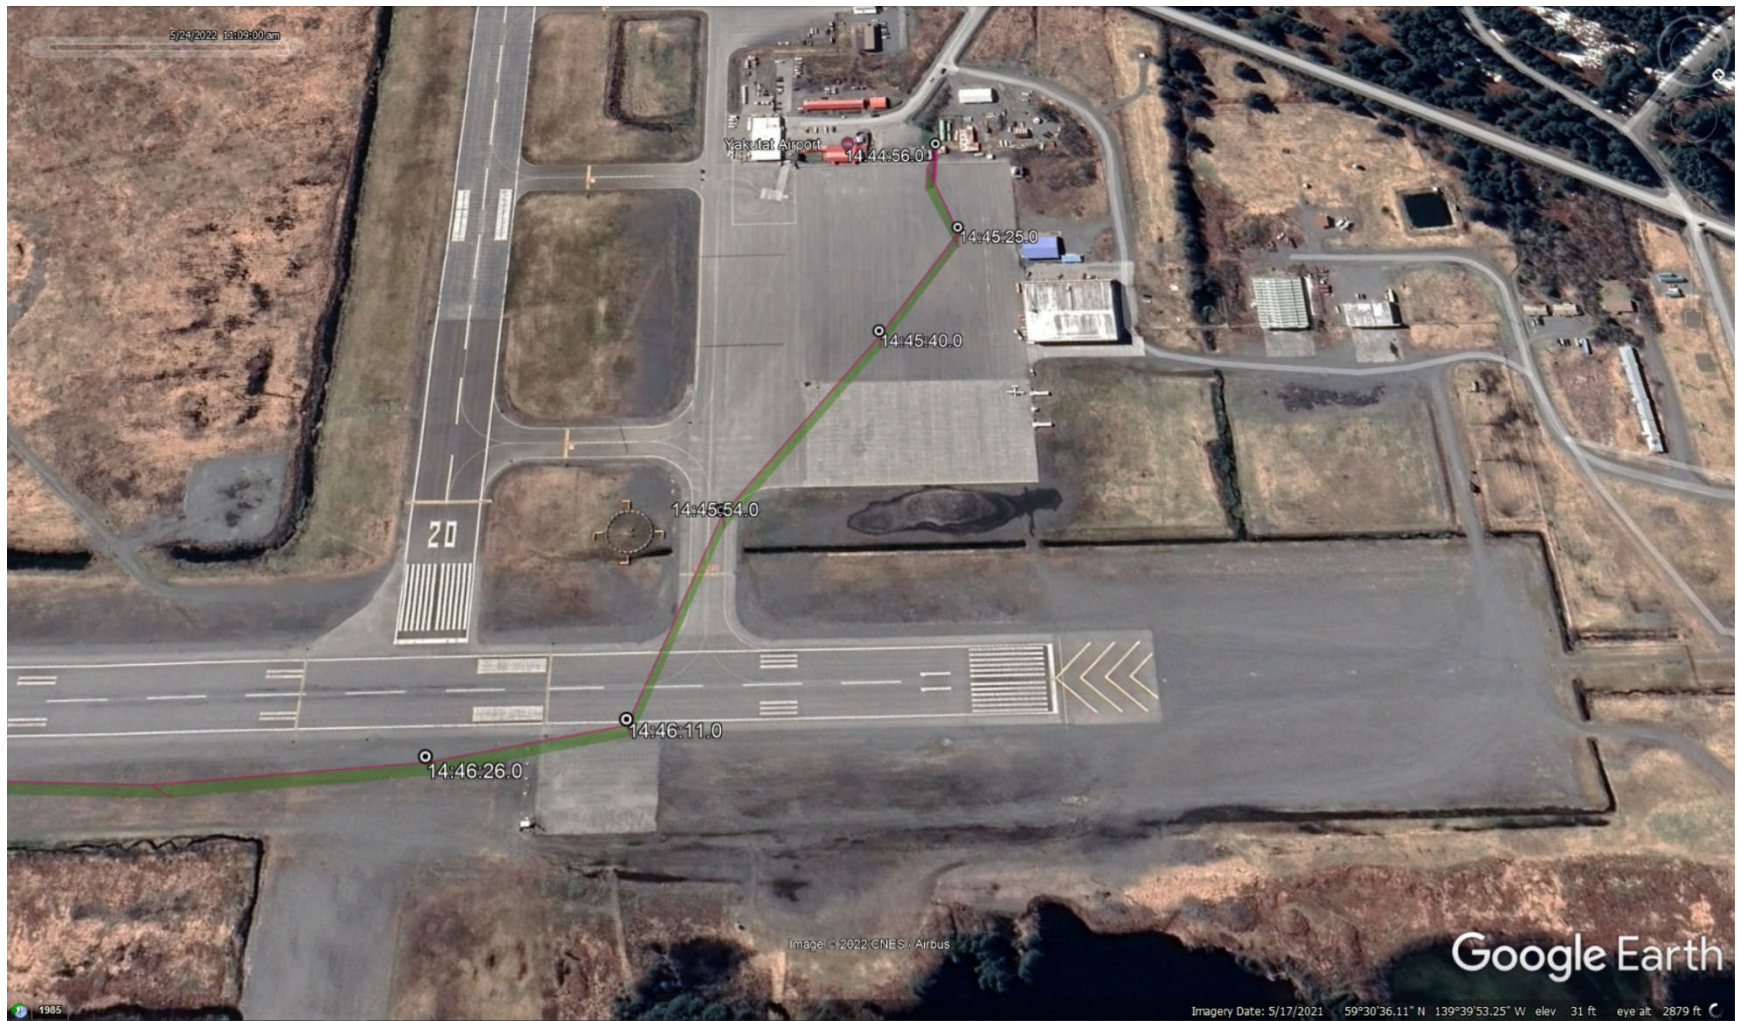
**Figure 5.** Google Earth overlay of the aircraft taxiing.

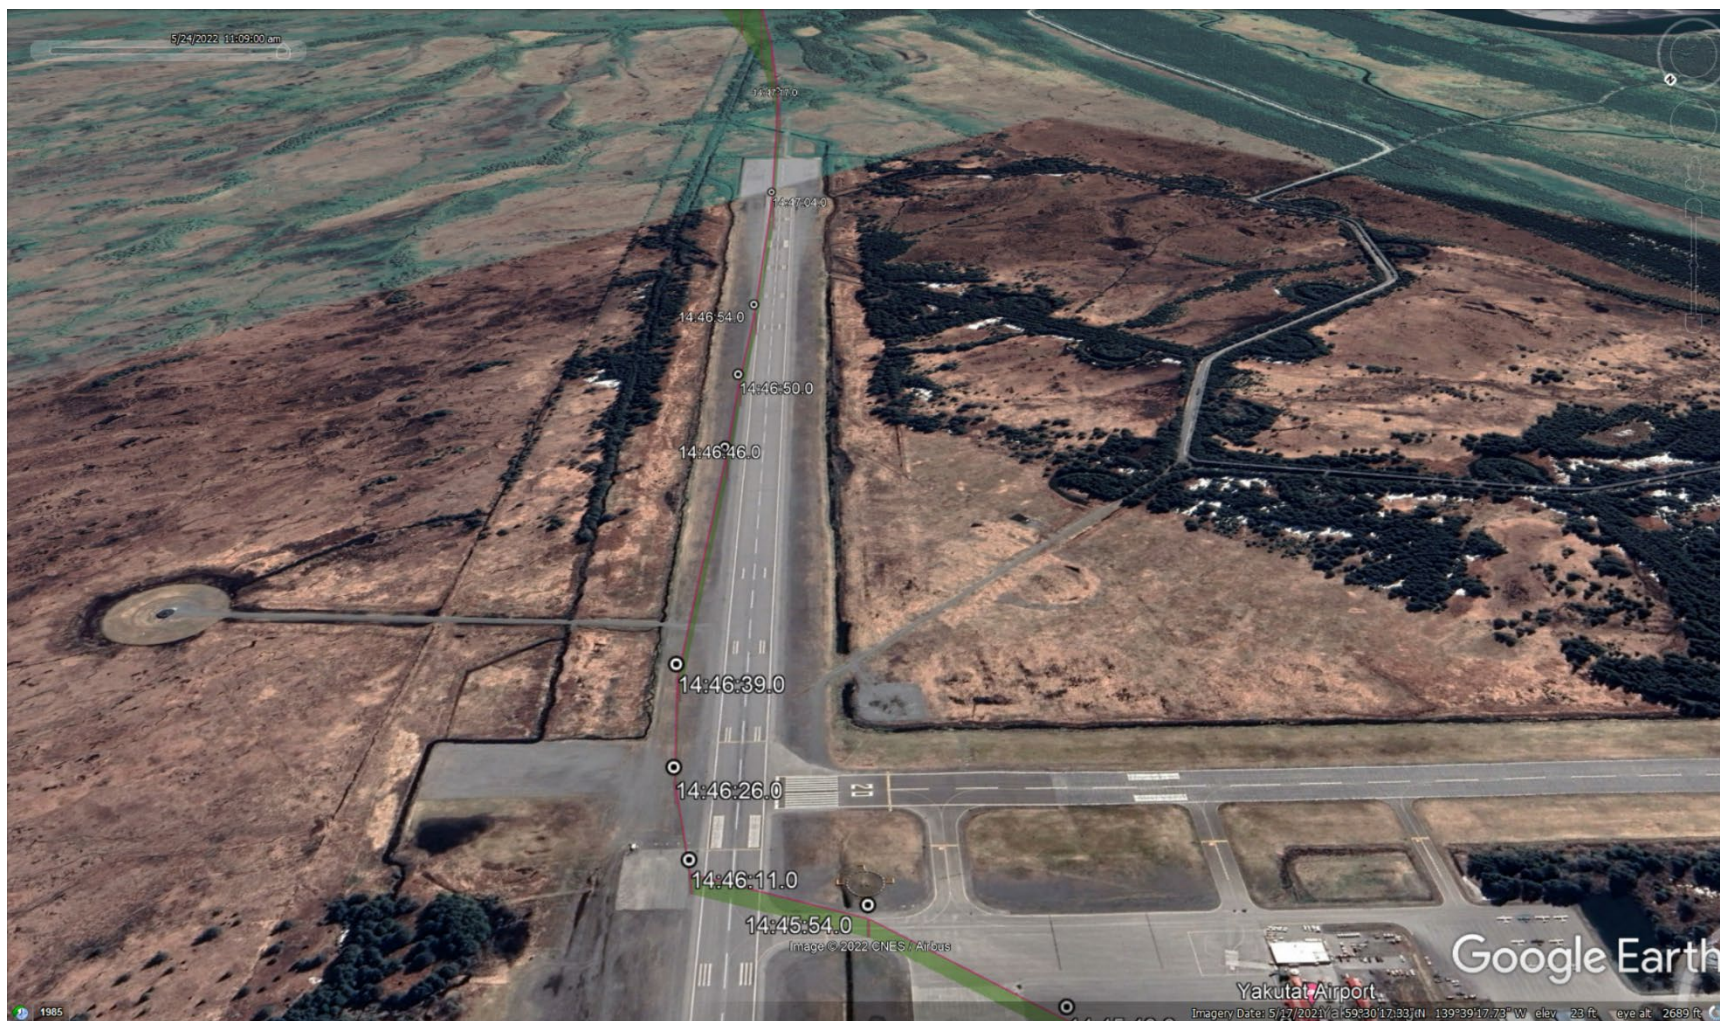
**Figure 6.** Google Earth overlay of the aircraft on takeoff rollout.

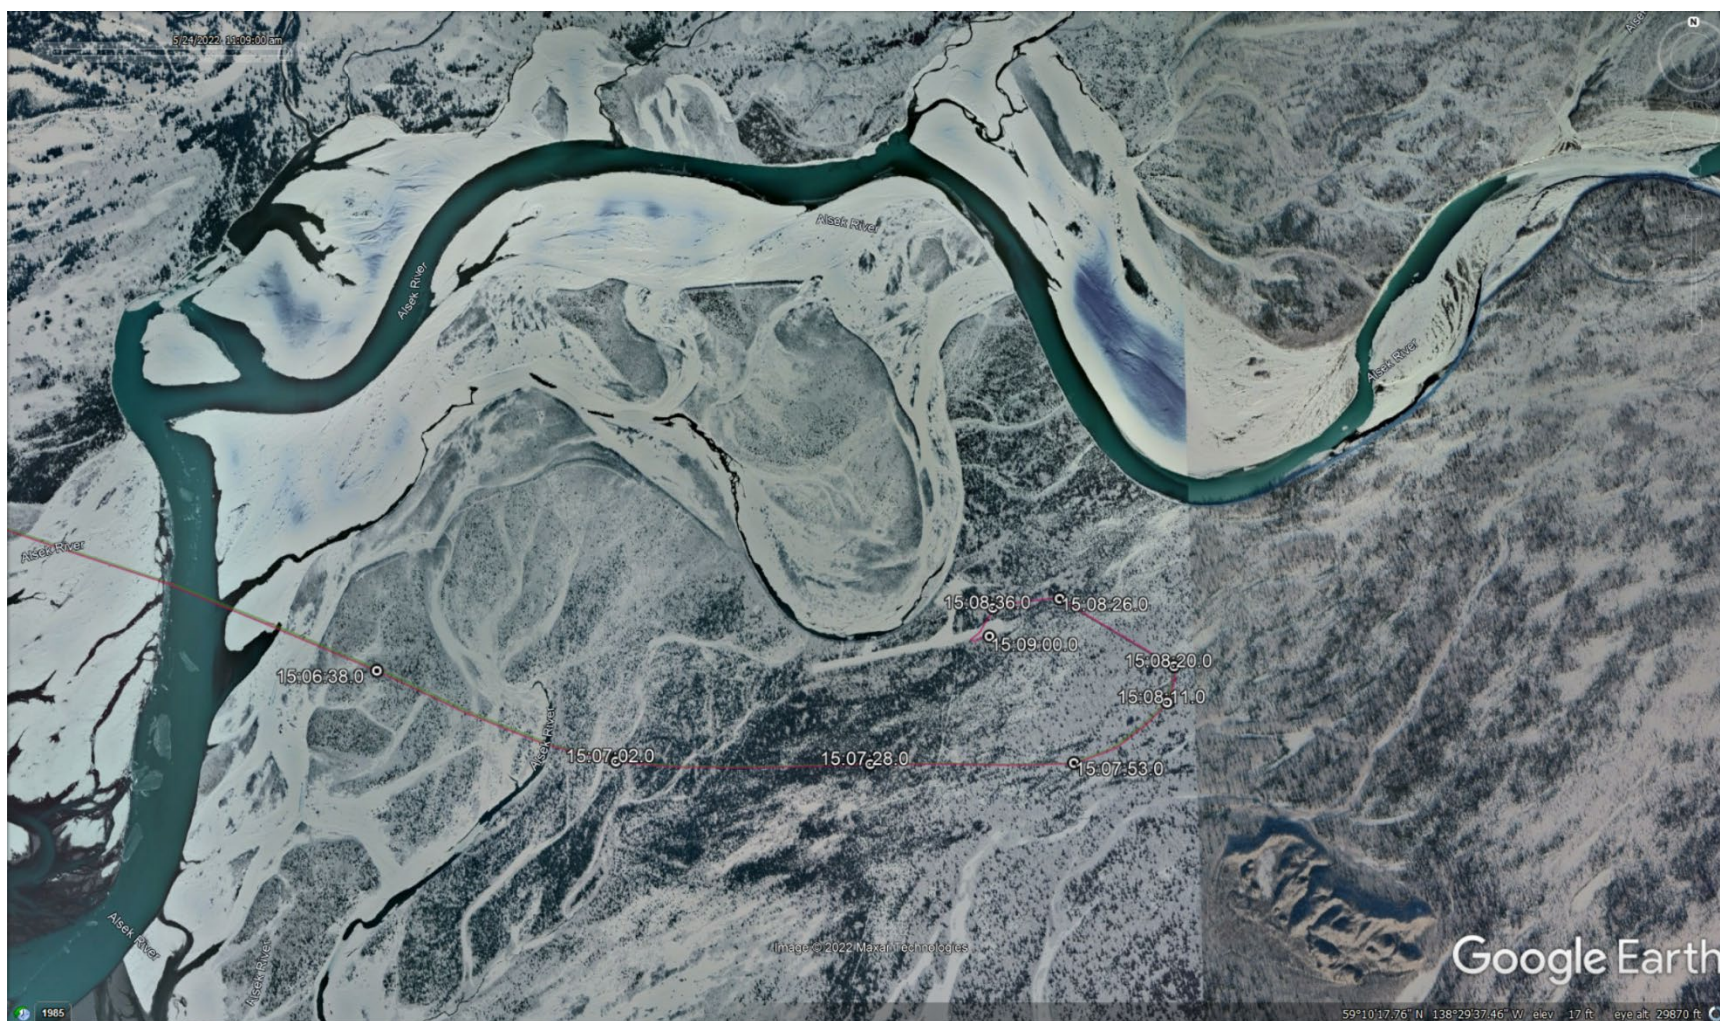
**Figure 7.** Google Earth overlay of the aircraft entering pattern and approach.
