**100-Hour/Basic Type of Engine Examination**  
**N6577A Continental Engine**

Conducted by Mark Ward ASI NTSB [REDACTED]

October 12, 2022

At Owner's Hangar [REDACTED] Wasilla AK

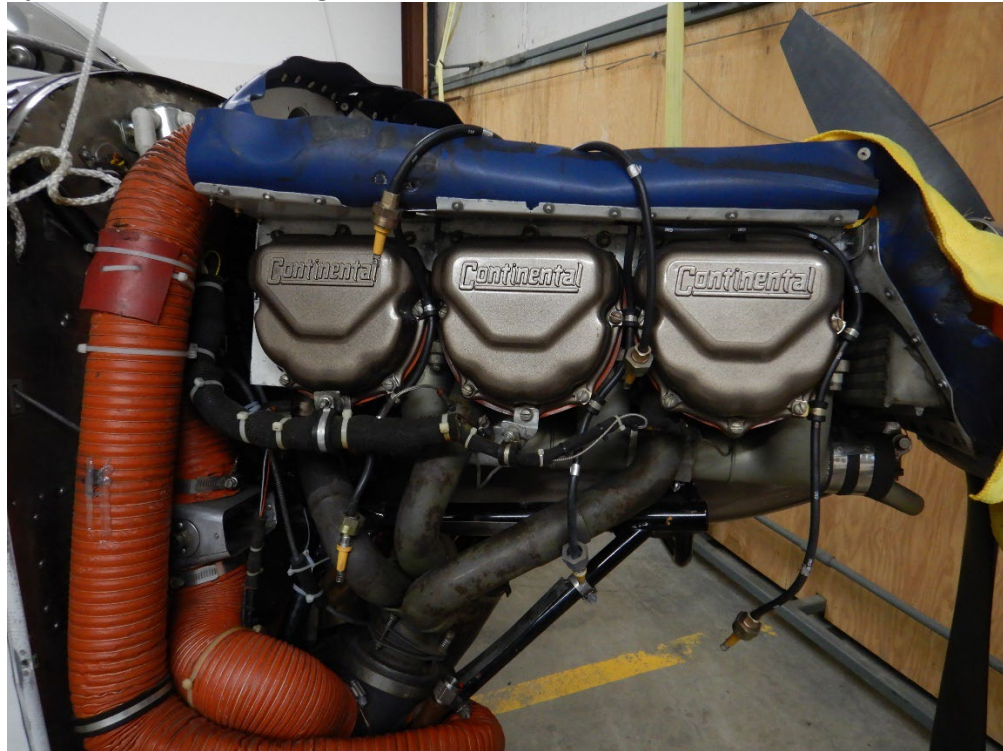
- Overall Engine Damage (cylinder damage, crankcase damage, pre-impact fire, etc.)
  - **Cylinders looked undamaged**

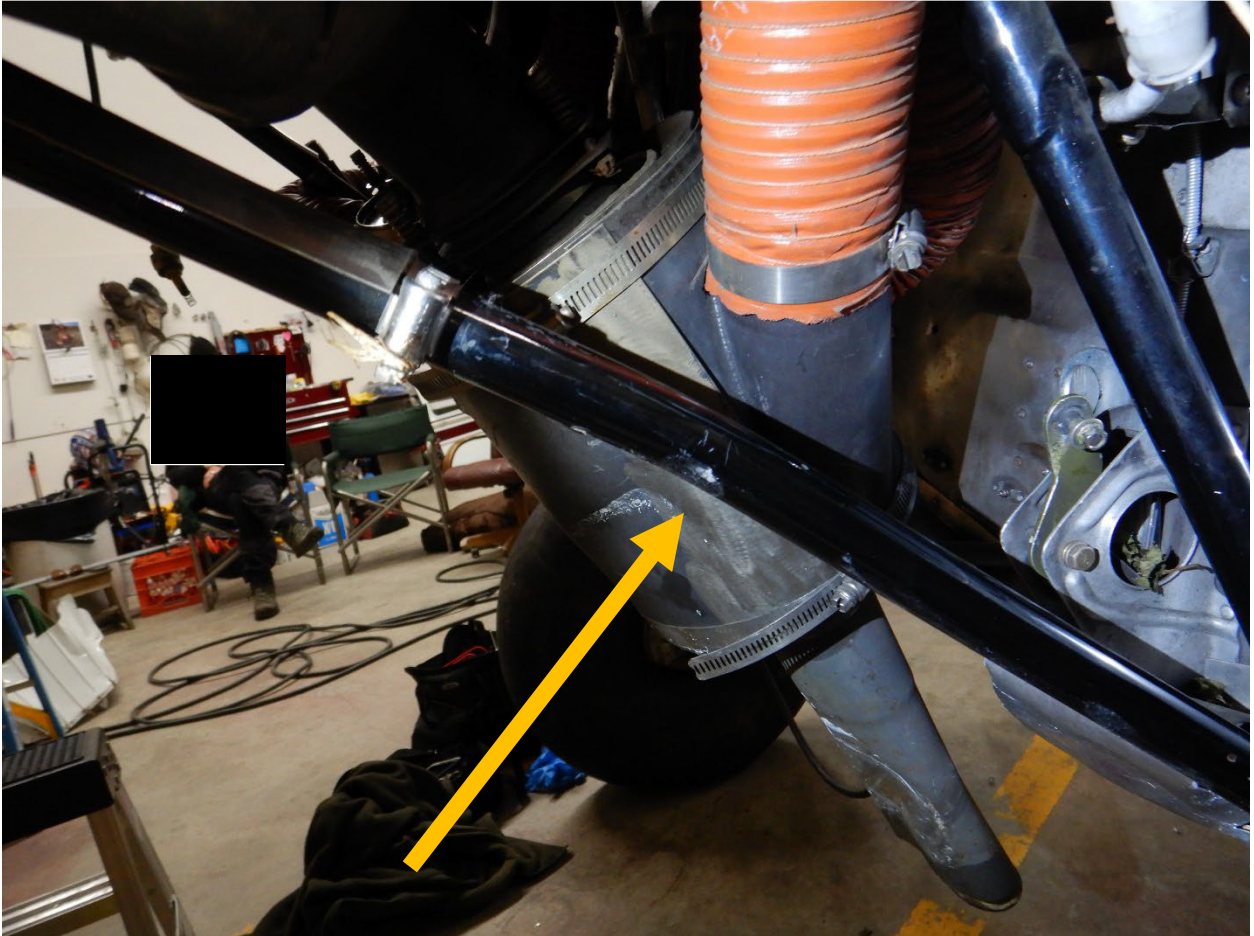
- Engine Mount(s) Condition – **Impact damage to the left engine mount tube.**

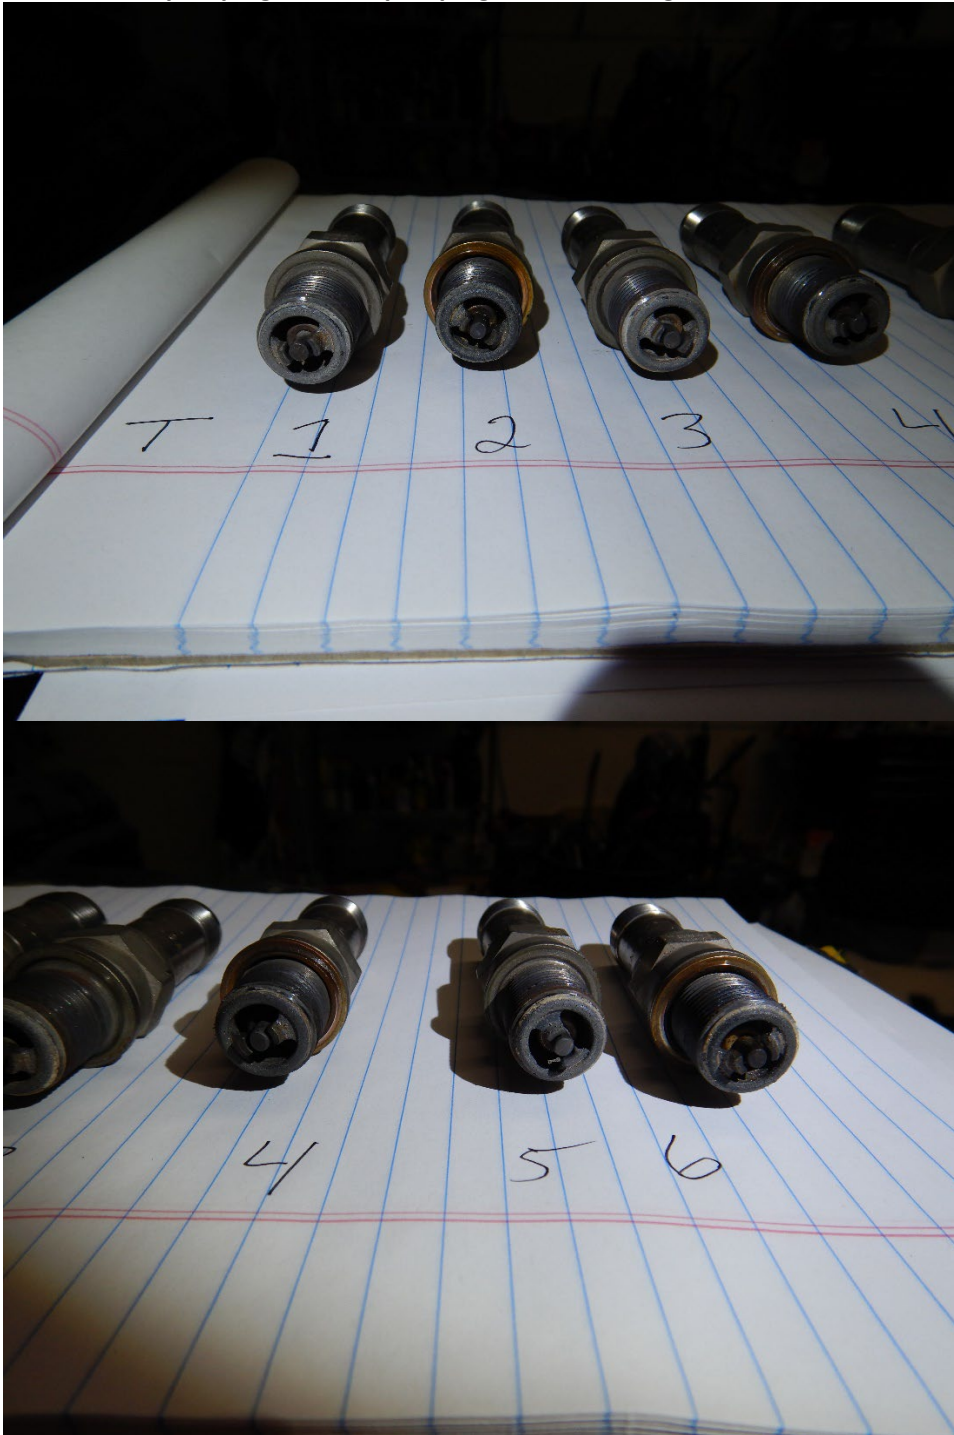
- Remove and label all top spark plugs (label what cylinder they came from!) **Completed except for the # 2,4,6 bottom sparkplugs due to cylinders full of oil from the sloping engine.**
- Inspect spark plug electrode for mechanical damage. Damaged electrodes could be an indicator of foreign object ingestion or internal mechanical malfunction of the engine. **All top sparkplugs and bottom sparkplugs #1,3,5 sparkplugs had undamaged electrode in normal condition.**

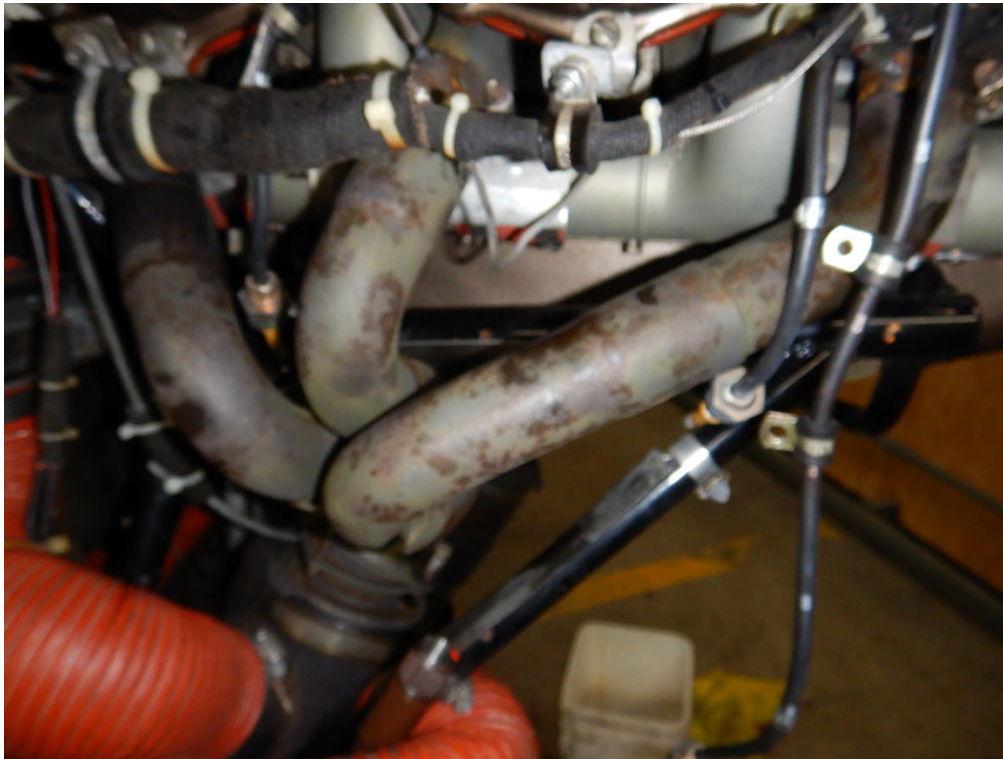
- Document the air intake tubes/ air filter-screen for overall condition, damage, blockages, and leaks. **None found**
- Document the exhaust system for overall condition, damage, ductile bending. Also be sure to inspect the exhaust gas path for possible oil film, soot. Attempt to inspect internal exhaust baffles to see if they are in place (they can separate and restrict air flow, thus reducing engine performance). **The exhaust looked undamaged except for impact damage to the exhaust tips. Looked up into the exhaust and it looked normal.**
