# National Transportation Safety Board

ANC23FA008

## COMMUNICATIONS MODULE

Specialist's Factual Report

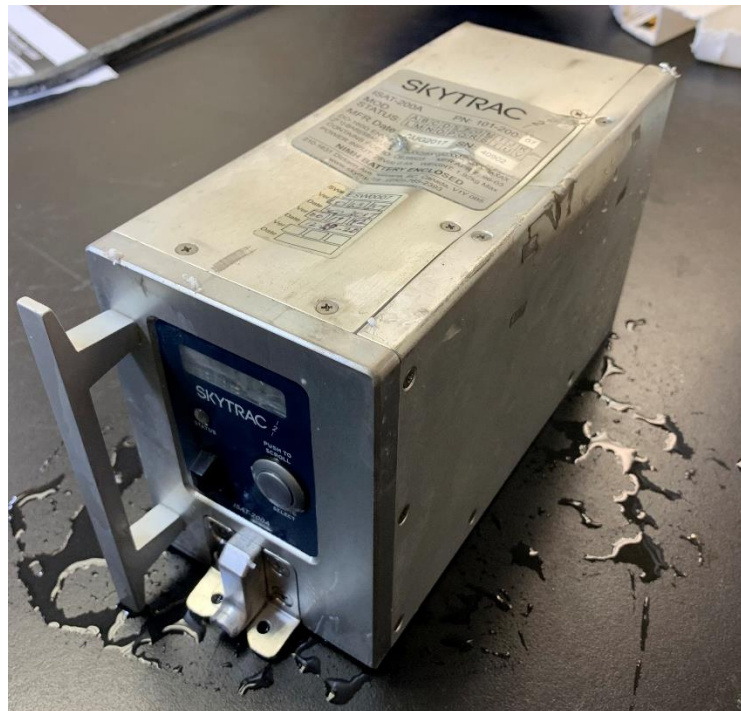
The SkyTrac ISAT-200A received by the NTSB Recorders Lab was shown to have suffered impact damage and water damage, as shown in figure 1. The device was transported to the laboratory in fresh water. The unit was disassembled to extract the device's memory unit. In this version of the device, the memory unit is a microSD card which is housed in a protected area near the device's front screen, as shown in figure 2. Figure 3 shows the same region after the backing plate had been removed. Note that there is a concave impression in this area. The area containing the microSD card is circled in red. Figure 4 is an alternate view of the same concave impression.

**Figure 1.** The SkyTrac ISAT-200A as received by the NTSB Recorder's Lab.

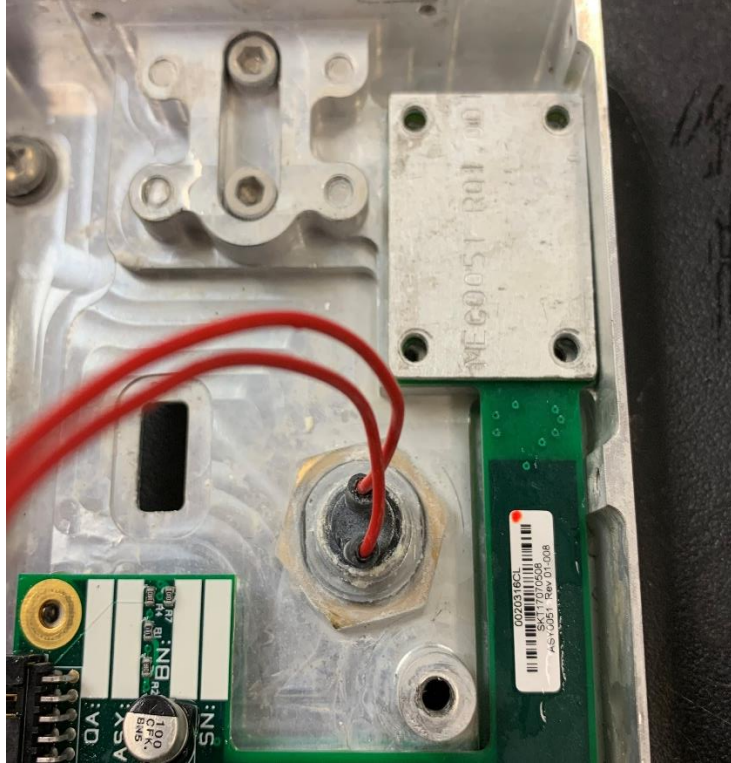
**Figure 2.** The area of the unit that holds the microSD card. Note in this image, the screws holding the backing plate have been removed by the specialist.

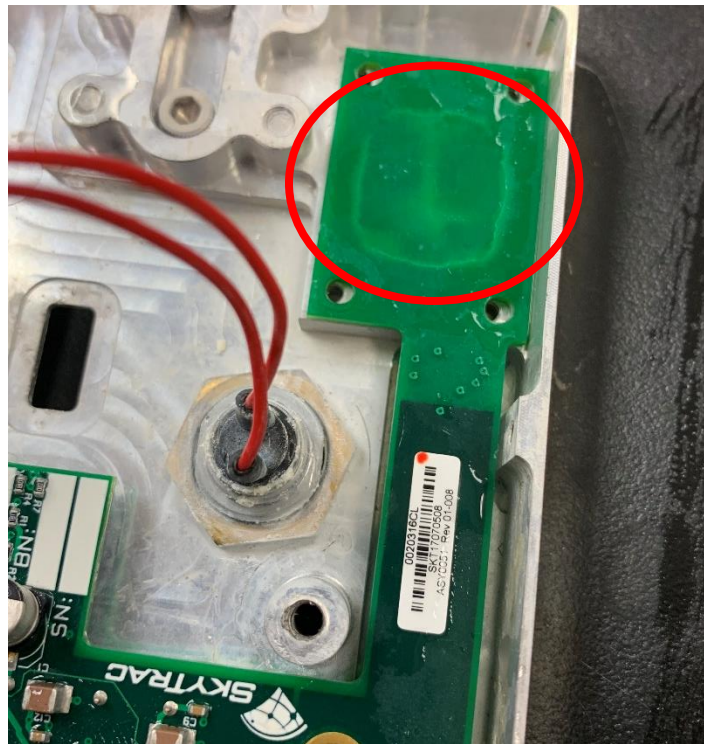
**Figure 3.** The area of the unit that holds the microSD card with the backing plate removed. Note the area of the concave impression.

The unit sank with the wreckage and was recovered from a depth of approximately 6000 feet of sea water. The water pressure at this depth is approximately 2600 pounds per square inch (psi). The unit's memory device is contained within a sealed gasketed area containing a void space. The area that housed the microSD card in the area of the void space exhibited a concave area consistent with crush damage. The microSD card, which was mounted to this area by design, was found cracked and data was unrecoverable. No data was recovered from this device.

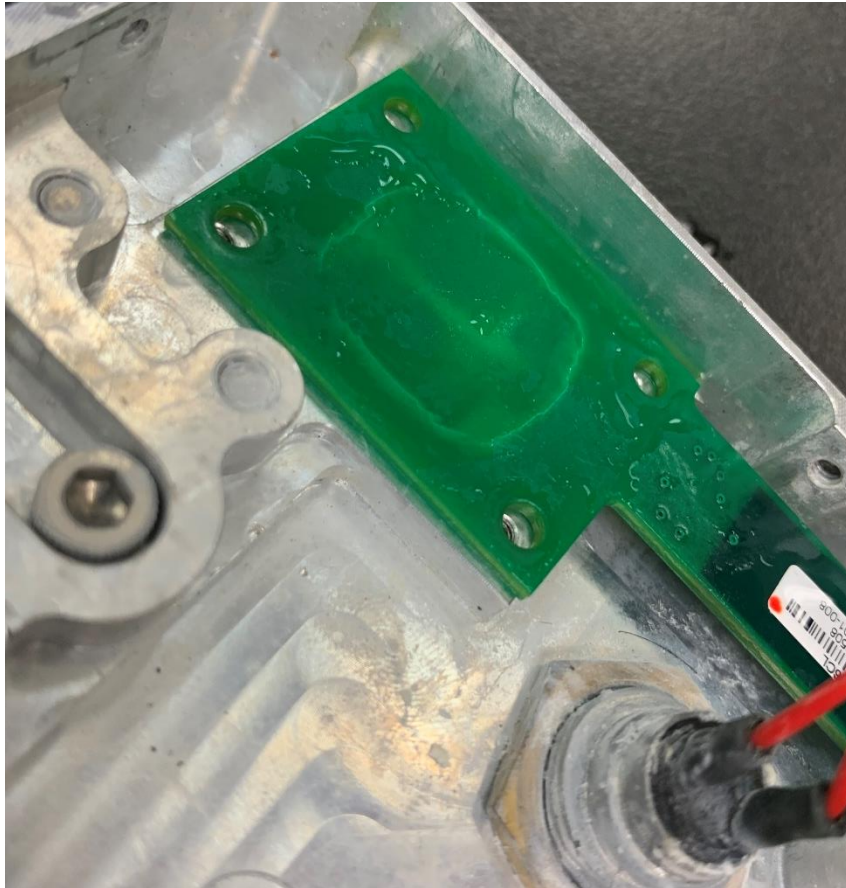
**Figure 4.** An alternative view of the same area with the concave impression.

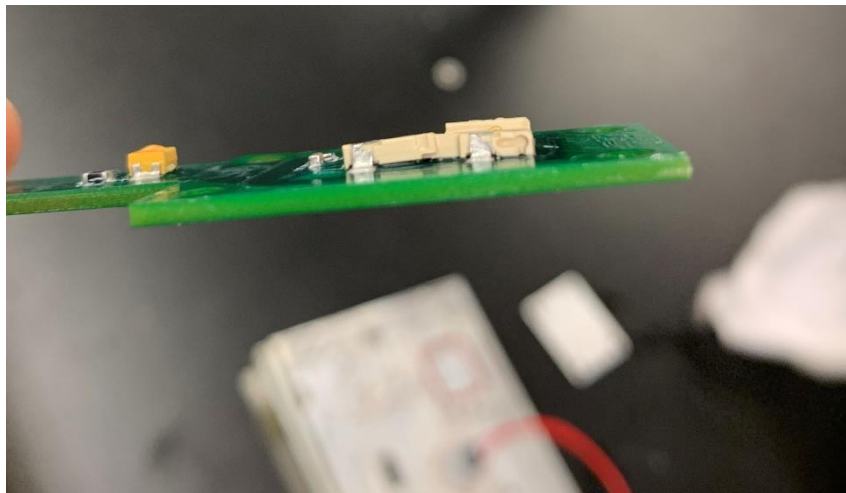
Figure 5 is a view of the cross-sectional area where the concave impression was present. This area also houses the microSD card chassis, which is tan in color. Figure 6 is the same area, but with the board containing the concave impression/microSD card removed. This area contains a gasket and a void space.

**Figure 5.** A side view of the mounting area of the SD card. This partially shows the reverse side of the area of concave impression. Note that the microSD card chassis is visible in tan. There is a small amount of deformation to the microSD card chassis.

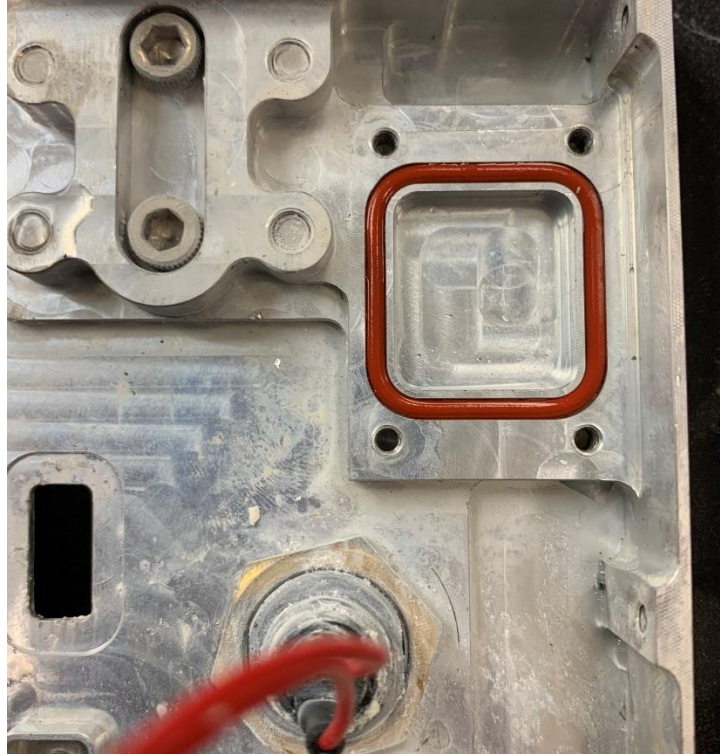
**Figure 6.** The area of the unit that holds the microSD card with the backing plate removed and the board containing the concave impression/microSD card mount removed. A sealed void space is present.

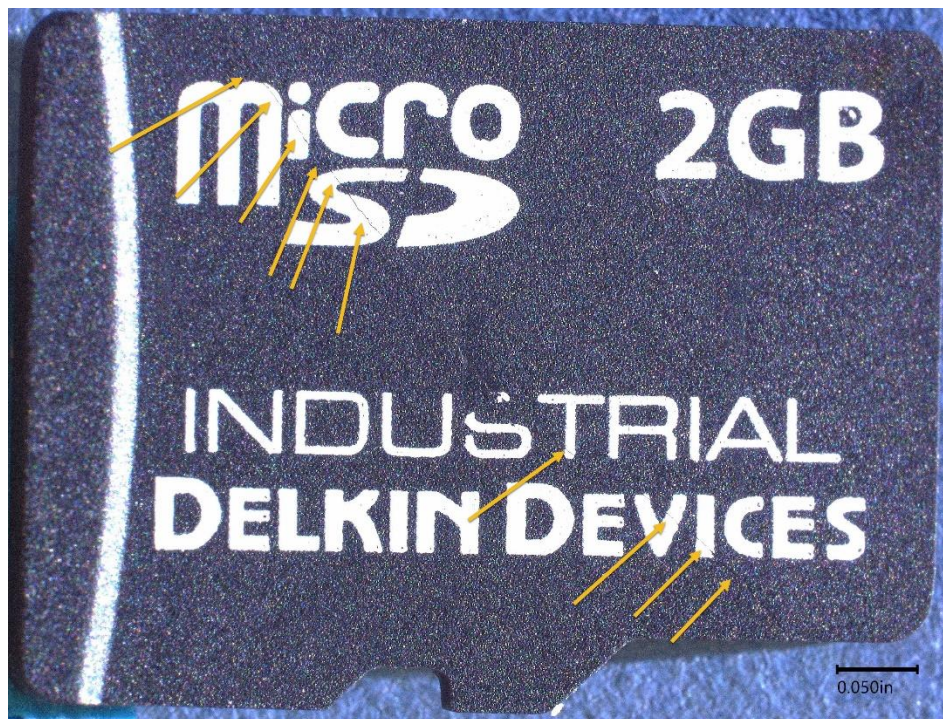
The recovered microSD card is pictured in figure 7 under 20x magnification. The microSD card contained a crack that appeared to extend across the front face of the microSD card, annotated in the figure with yellow arrows. The back of the microSD card appeared largely undamaged and is shown in figure 8.

**Figure 7.** The front the microSD card. The area of the crack is noted with yellow arrows.

The microSD card was unable to be read on various laboratory PCs using a variety of methods. The microSD card was sent to a third party laboratory for additional data recovery attempts. The third party lab reported that the data was unrecoverable.

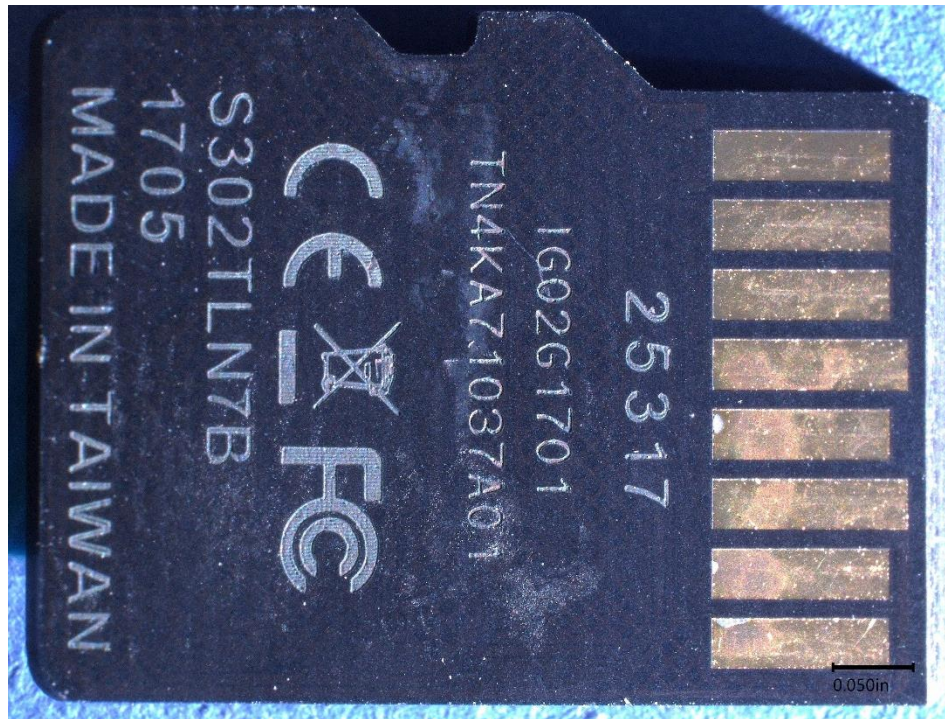
**Figure 8.** The reverse side of the microSD card.
