# National Transportation Safety Board

ANC23FA056

## **METEOROLOGY**

Specialist's Factual Report

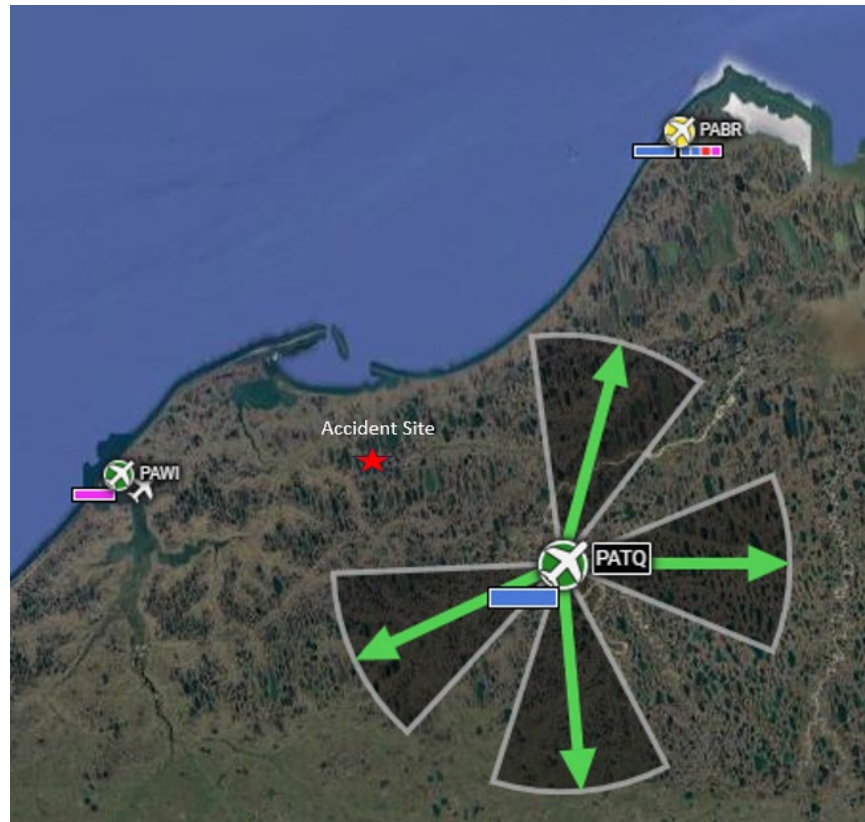
The Atqasuk (PATQ) camera viewing area is depicted in figure 9, with the north camera viewing the area towards PABR, and the southwest camera to the area south of the accident site. No cameras from PATQ were viewing in the general direction of the accident site.

**Figure 9 - Atkasuk camera viewing areas with the accident site marked by the red star.**

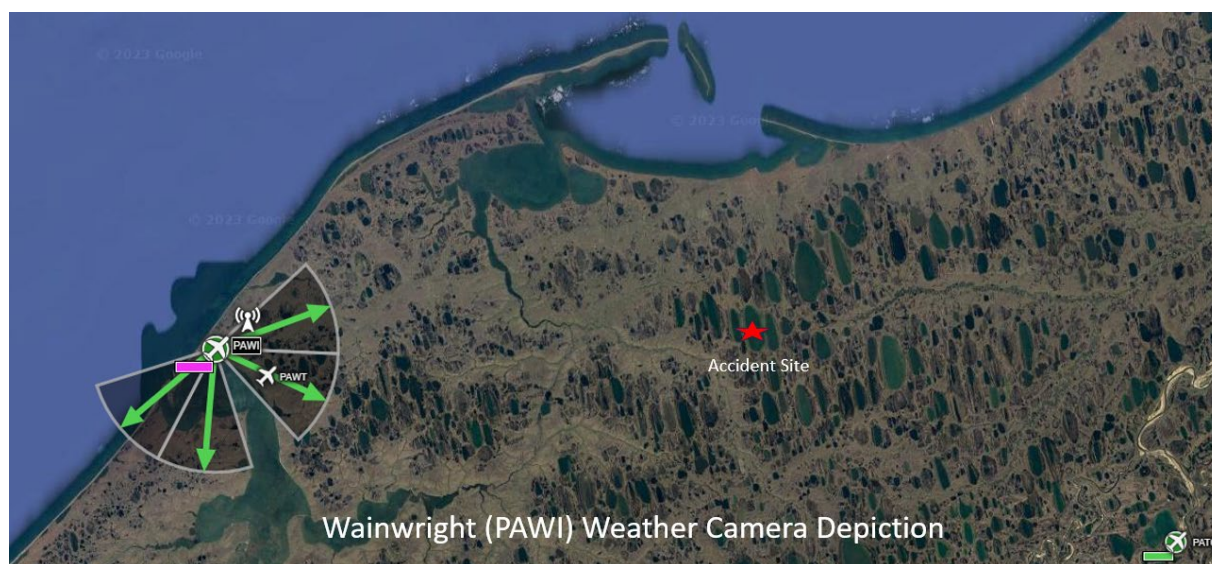
Figure 12 is a map of the Wainwright (PAWI) FAA Weather Camera's viewing and the approximate accident site marked by the red star. Figures 13 and 14 are the PAWI east and southeast weather camera images on a clear day (left) and at the approximate time of the accident (right).

**Figure 12 - Wainwright (PAWI) Weather Camera Depiction.**
