# National Transportation Safety Board

ANC23FA061

## **METEOROLOGY**

Specialist's Factual Report

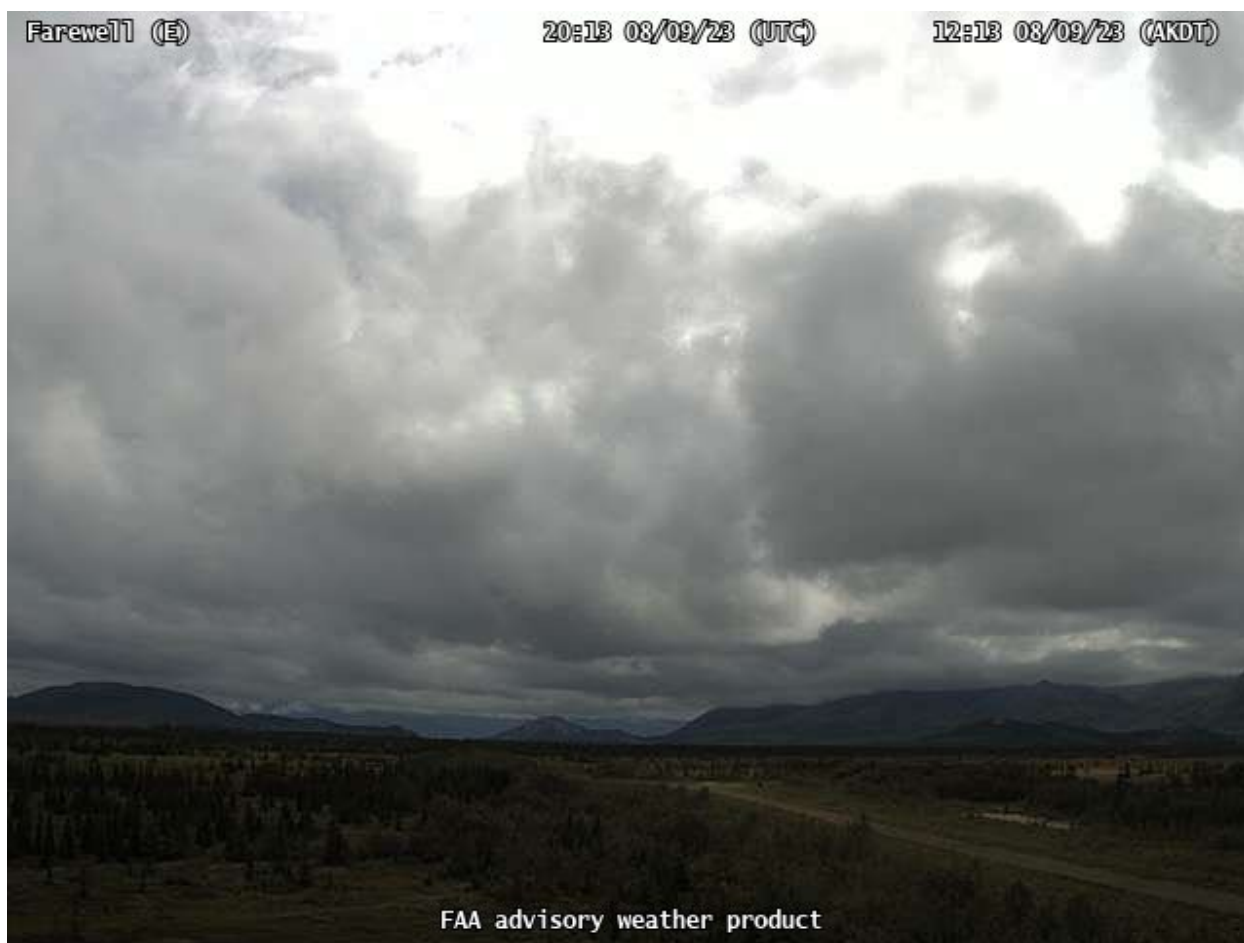
**Figure 11** - East-facing Farewell weather camera image at 1213.

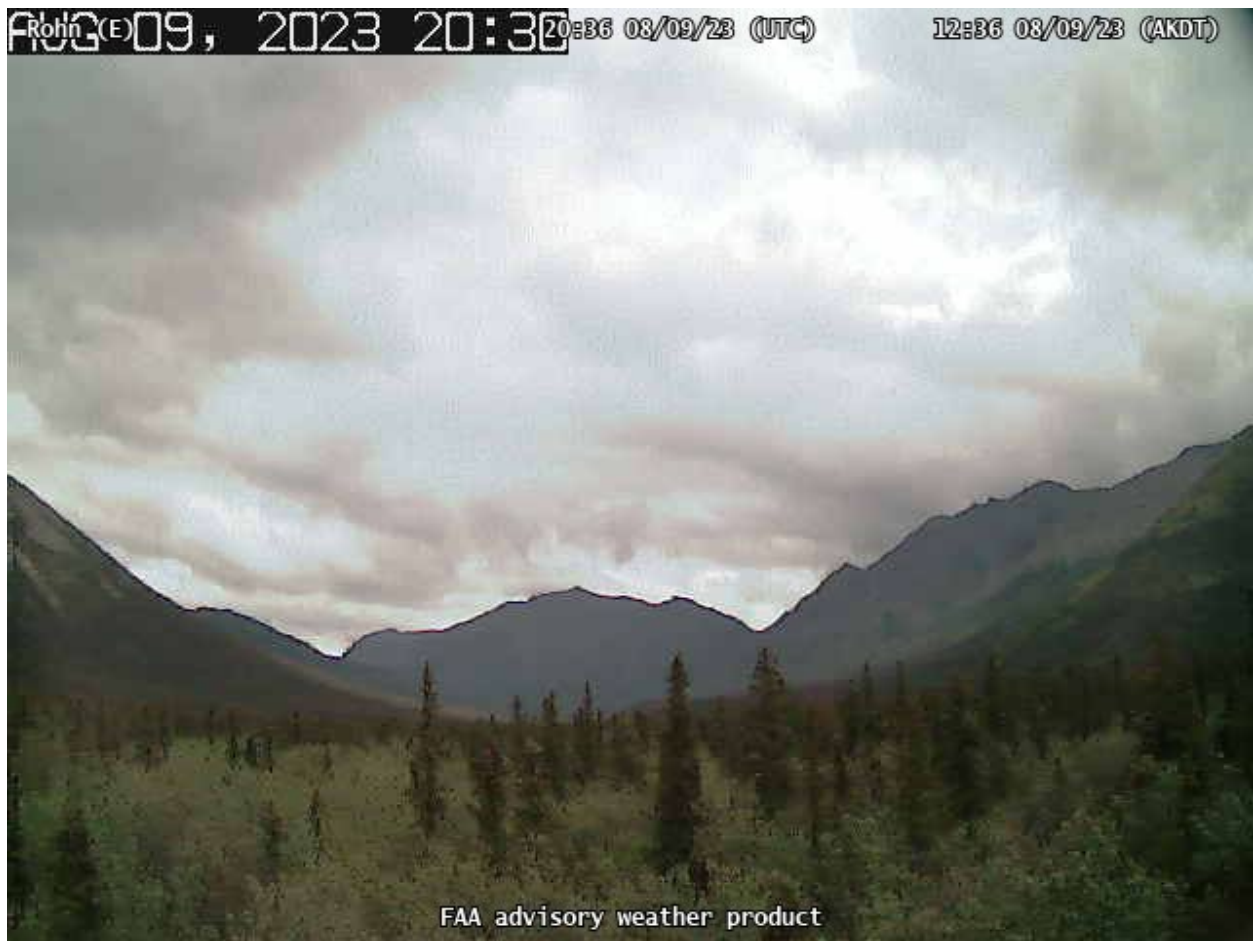
**Figure 13** - East-facing Rohn weather camera image at 1236.

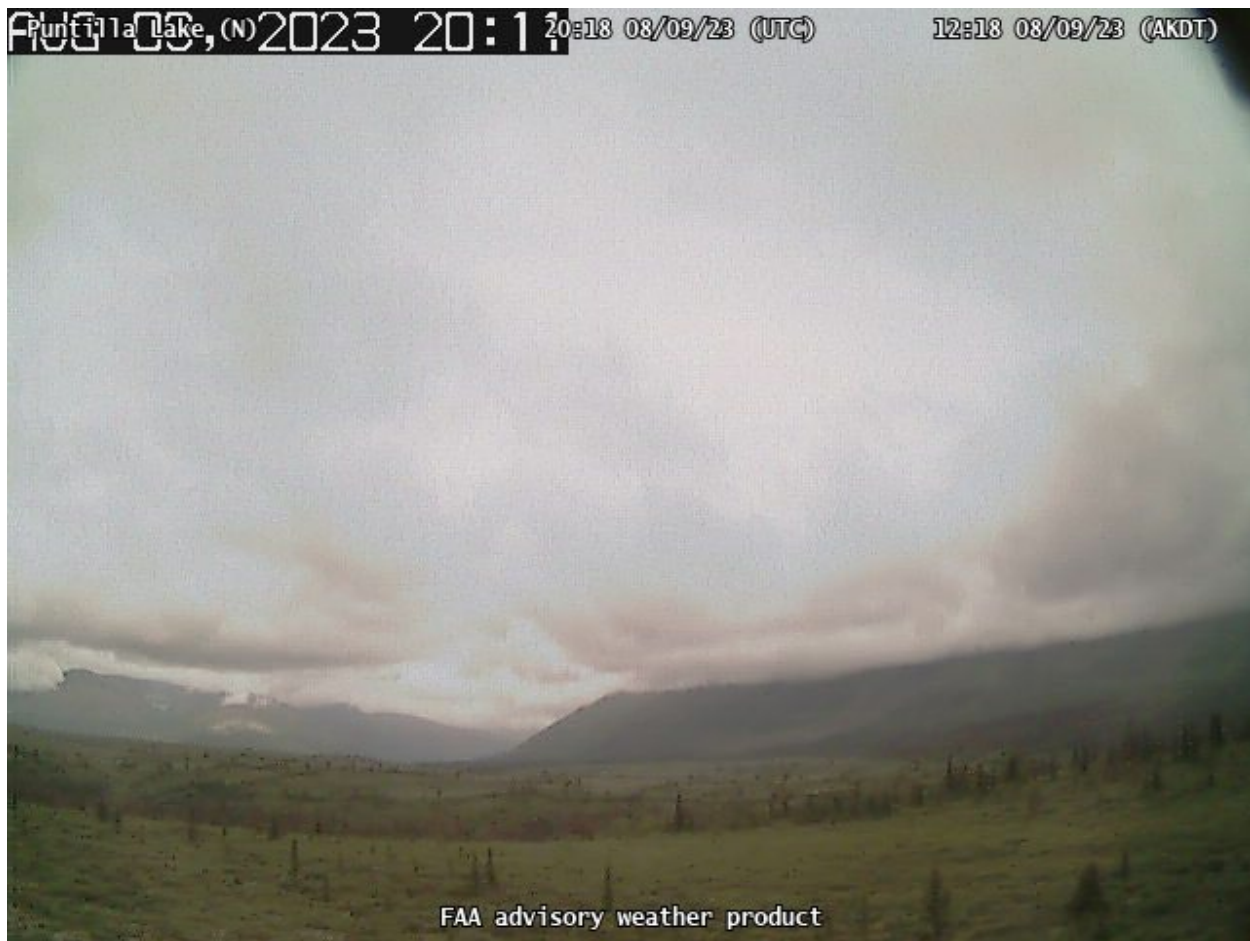
**Figure 15** - North-facing Puntilla Lake weather camera image at 1218.
