# National Transportation Safety Board

ANC24FA008

## **ELECTRONIC DEVICES**

Specialist's Factual Report

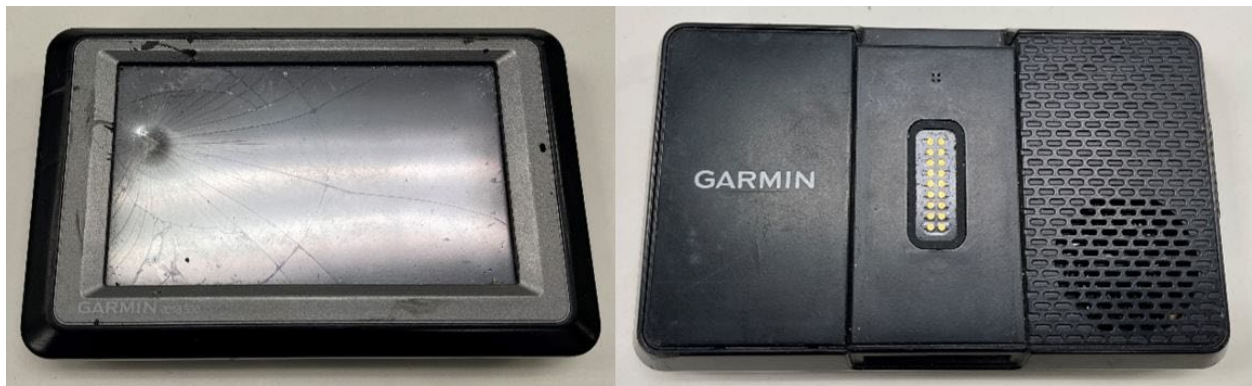
The device sustained impact damage to its display, as shown in figure 1. The device was able to power on, however, the touchscreen was not functional. The damaged touchscreen was replaced with a functional lab surrogate and data were extracted normally using the manufacturer's procedures.

**Figure 1.** Front and back of the Garmin aera 500 as received.

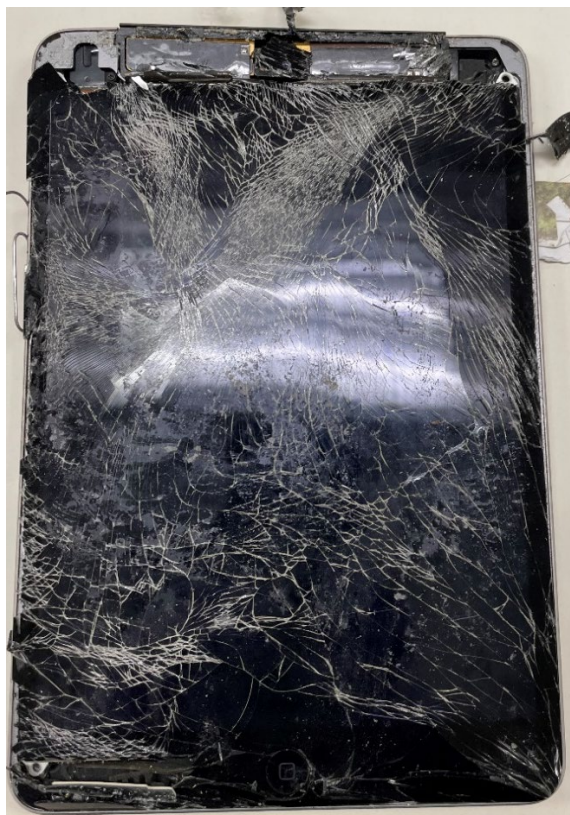
The condition of the 4 PED devices (Apple iPad Mini 2, Apple iPad Mini, Apple iPhone 6S Plus, and iPhone XS) as received at the Vehicle Recorder Laboratory is shown in figure 2 through figure 5. Both iPads sustained damage rendering them inoperable. The internal motherboards were removed from each iPad and installed in functioning lab surrogates. The iPad Mini 2 powered on normally in the lab surrogate. No relevant accident data were present upon review of its contents. The iPad Mini was unable to power on normally in a lab surrogate due to damage sustained to the motherboard, thus no data were recovered. Both iPhones powered on normally and were protected by 4-digit numeric passcodes. The devices were unable to be unlocked, therefore, no data were recovered.

**Figure 2.** iPad Mini 2 as received.

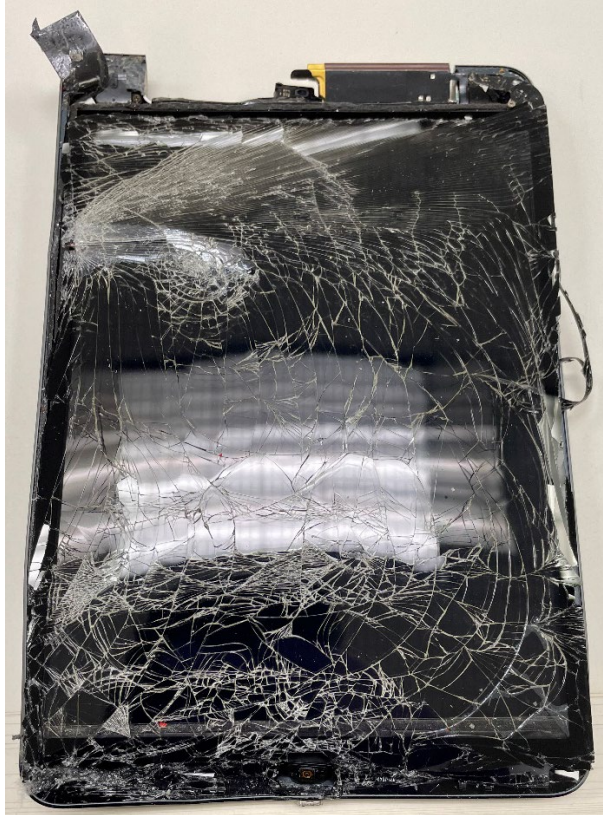
**Figure 3.** iPad Mini as received.

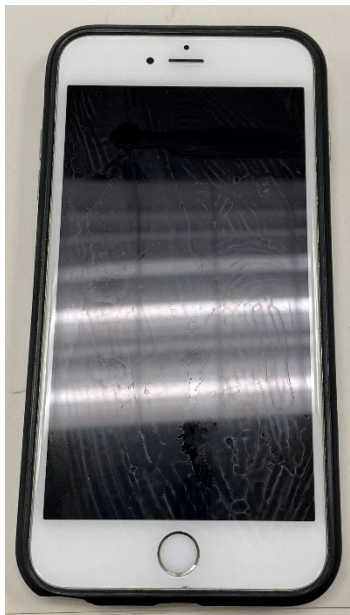
**Figure 4.** iPhone 6S Plus as received.

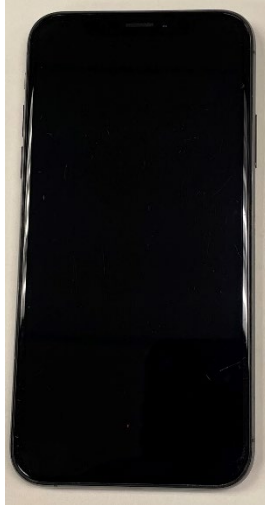
**Figure 5.** iPhone XS as received.

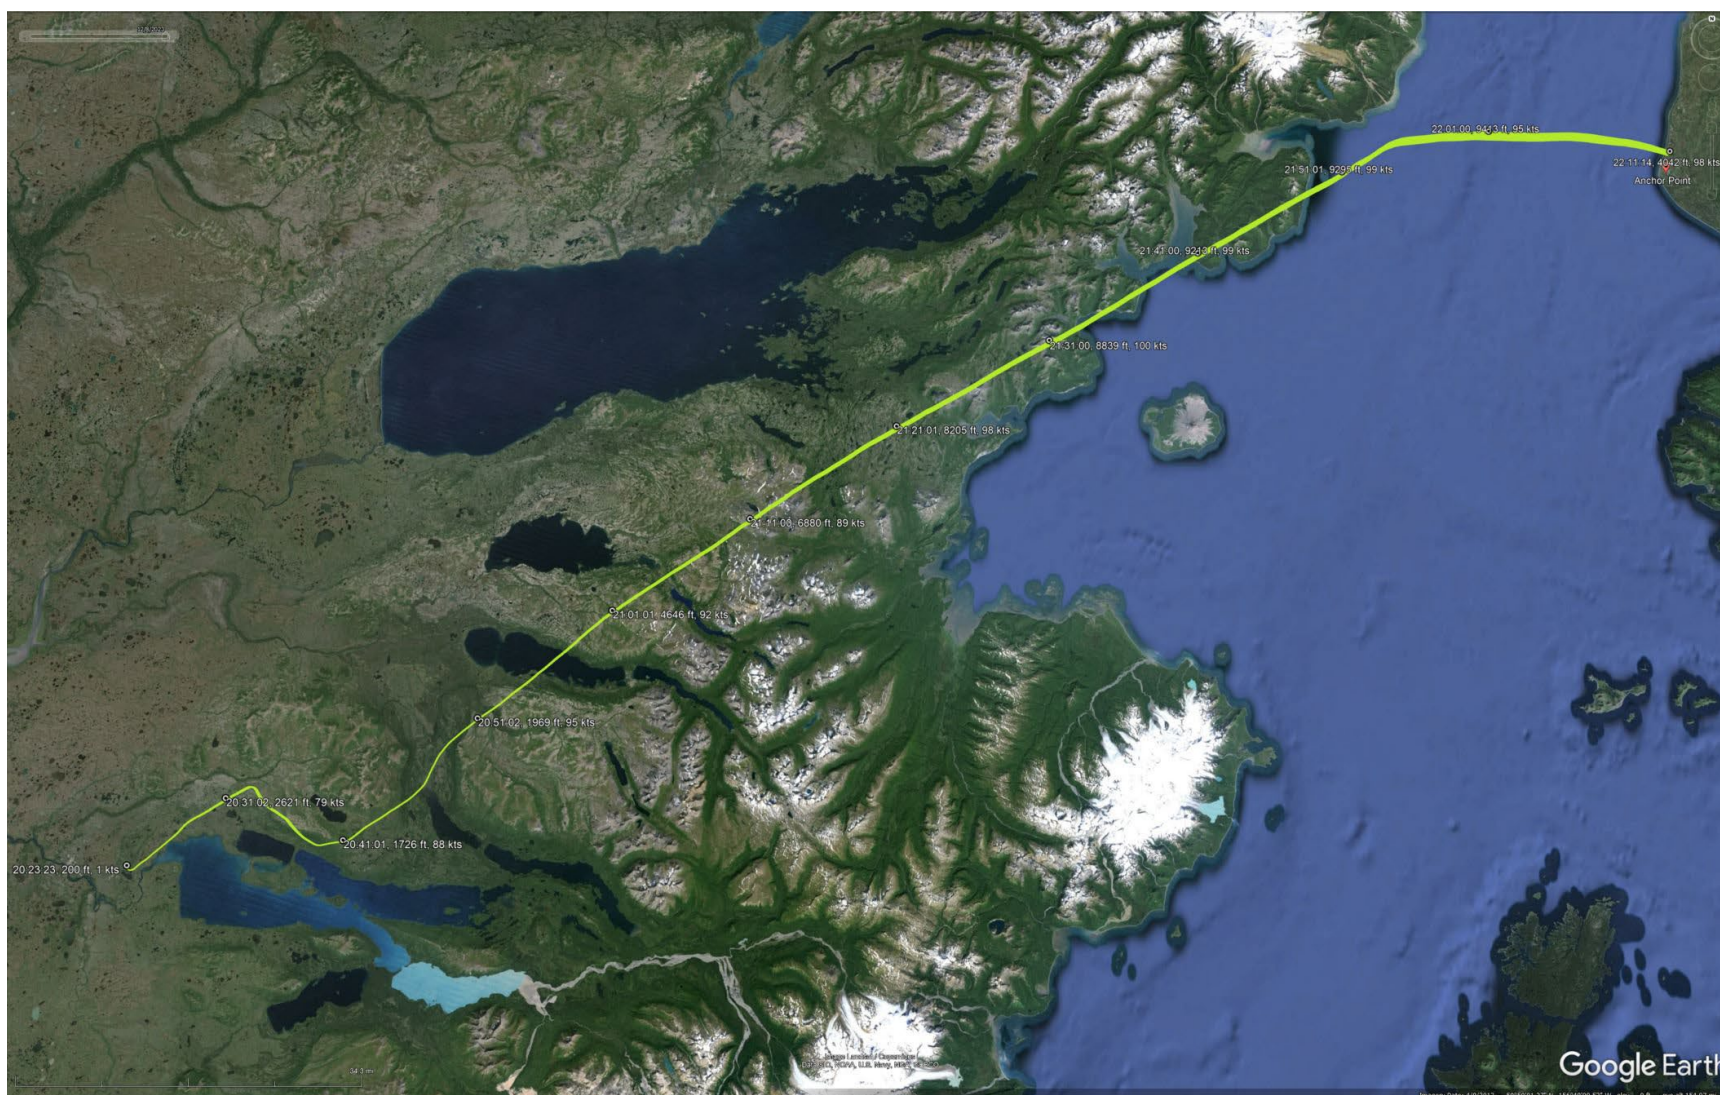
Figure 6 shows the entire accident flight.

**Figure 6.** Google Earth overlay of the accident session.

Figures 6 through 8 contain data from the Garmin aera 500 recorded during the event on December 8, 2023. Figures 6 and 7 are graphical overlays generated in Google Earth. The weather and lighting conditions in Google Earth are not necessarily the weather and lighting conditions present at the time of the accident flight.

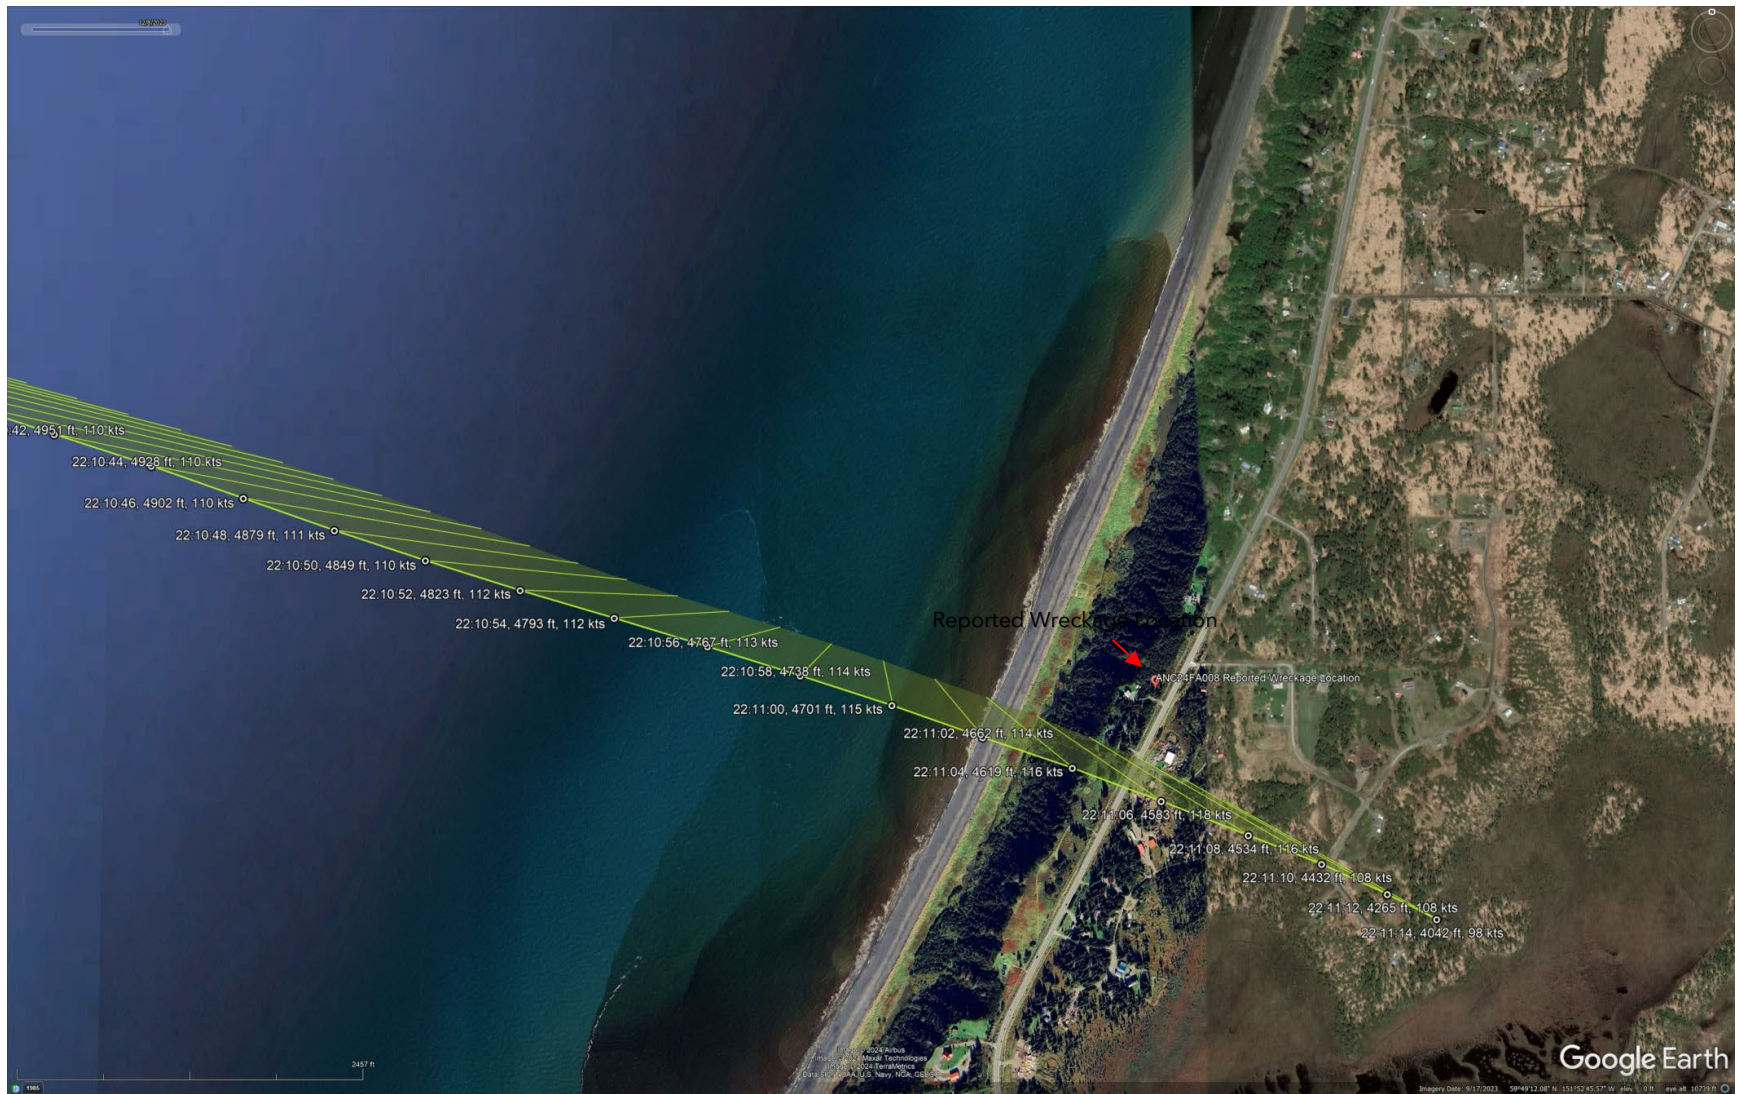
Figure 7 shows the end of the accident flight and the reported wreckage location shown with a red dot.

**Figure 7.** Google Earth overlay of the end of the accident session and the reported wreckage location.
