# National Transportation Safety Board

ANC24FA063

## PERSONAL ELECTRONIC DEVICE

Specialist's Factual Report

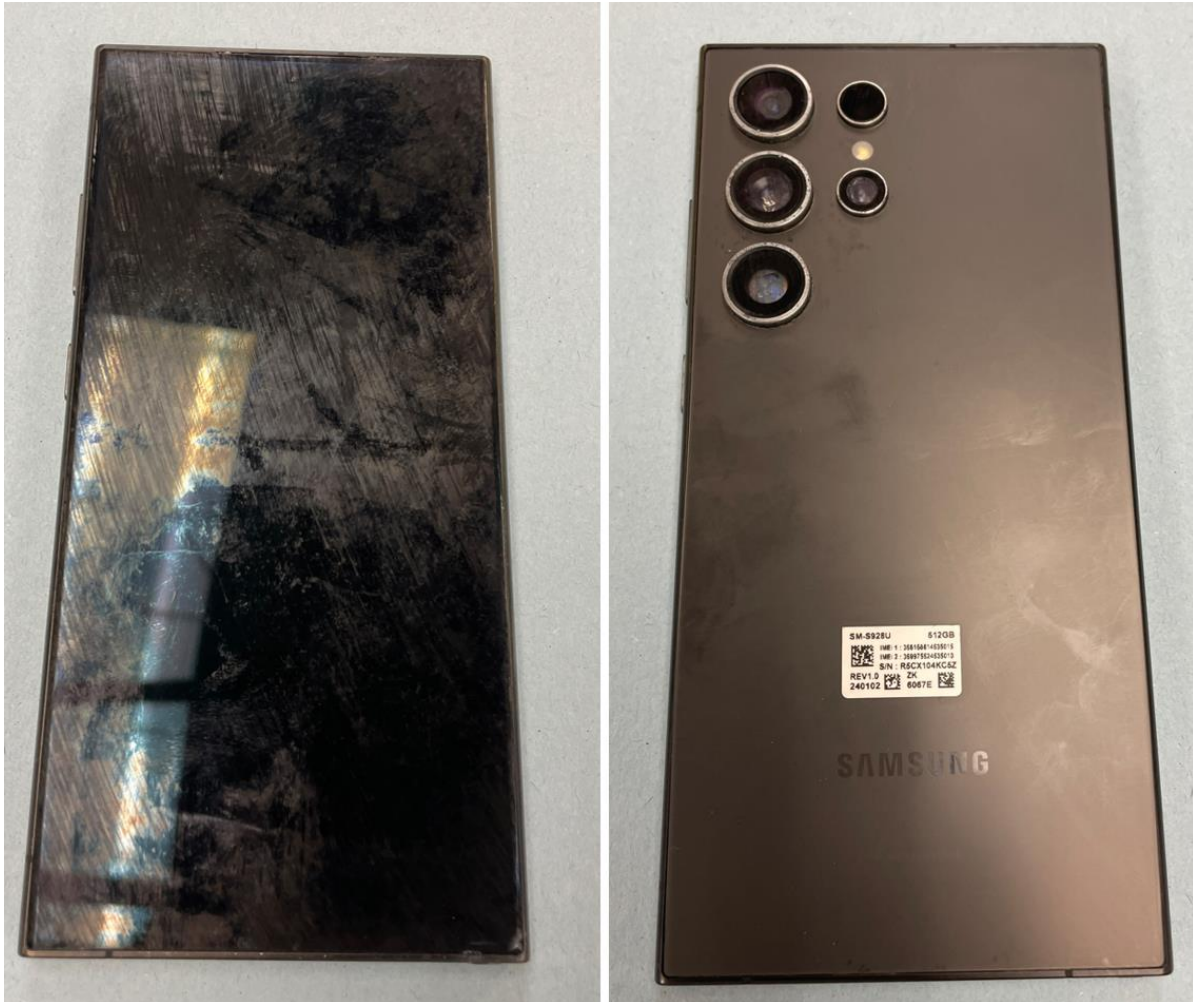
**Figure 1.** Front and back of the Samsung phone after being wiped with a dry cloth.

Upon arrival at the Vehicle Recorder Division, the Samsung Galaxy S24 Ultra was within a zip bag and was wet with a foul smell. Figure 1 shows the device after it was wiped with a dry cloth. The interior of the device showed severe corrosion from water damage, as shown in figures 2 and 3. The main circuit board on which the data stored was removed from the device, ultrasonic cleaned, and vacuum dried. The device was then placed into a surrogate device; however, the device did not power on. The extent of the damage precluded normal and advanced recovery procedures of the laboratory, and additional attempts were unsuccessful in yielding usable data.

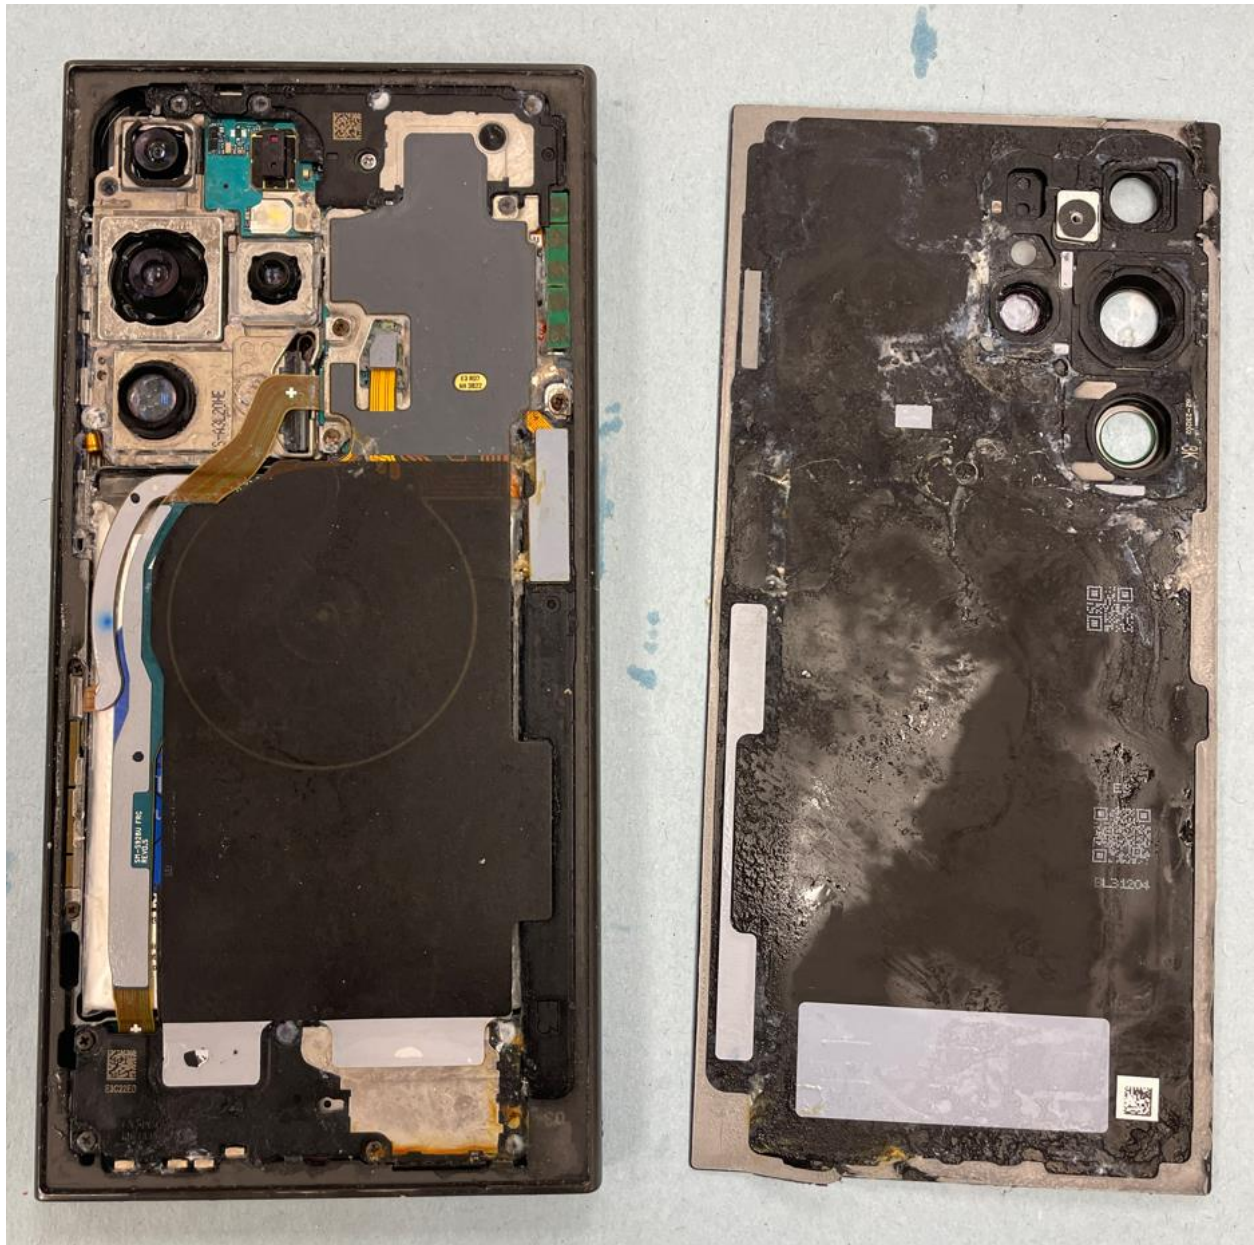
**Figure 2.** The interior of the Samsung phone after being opened.

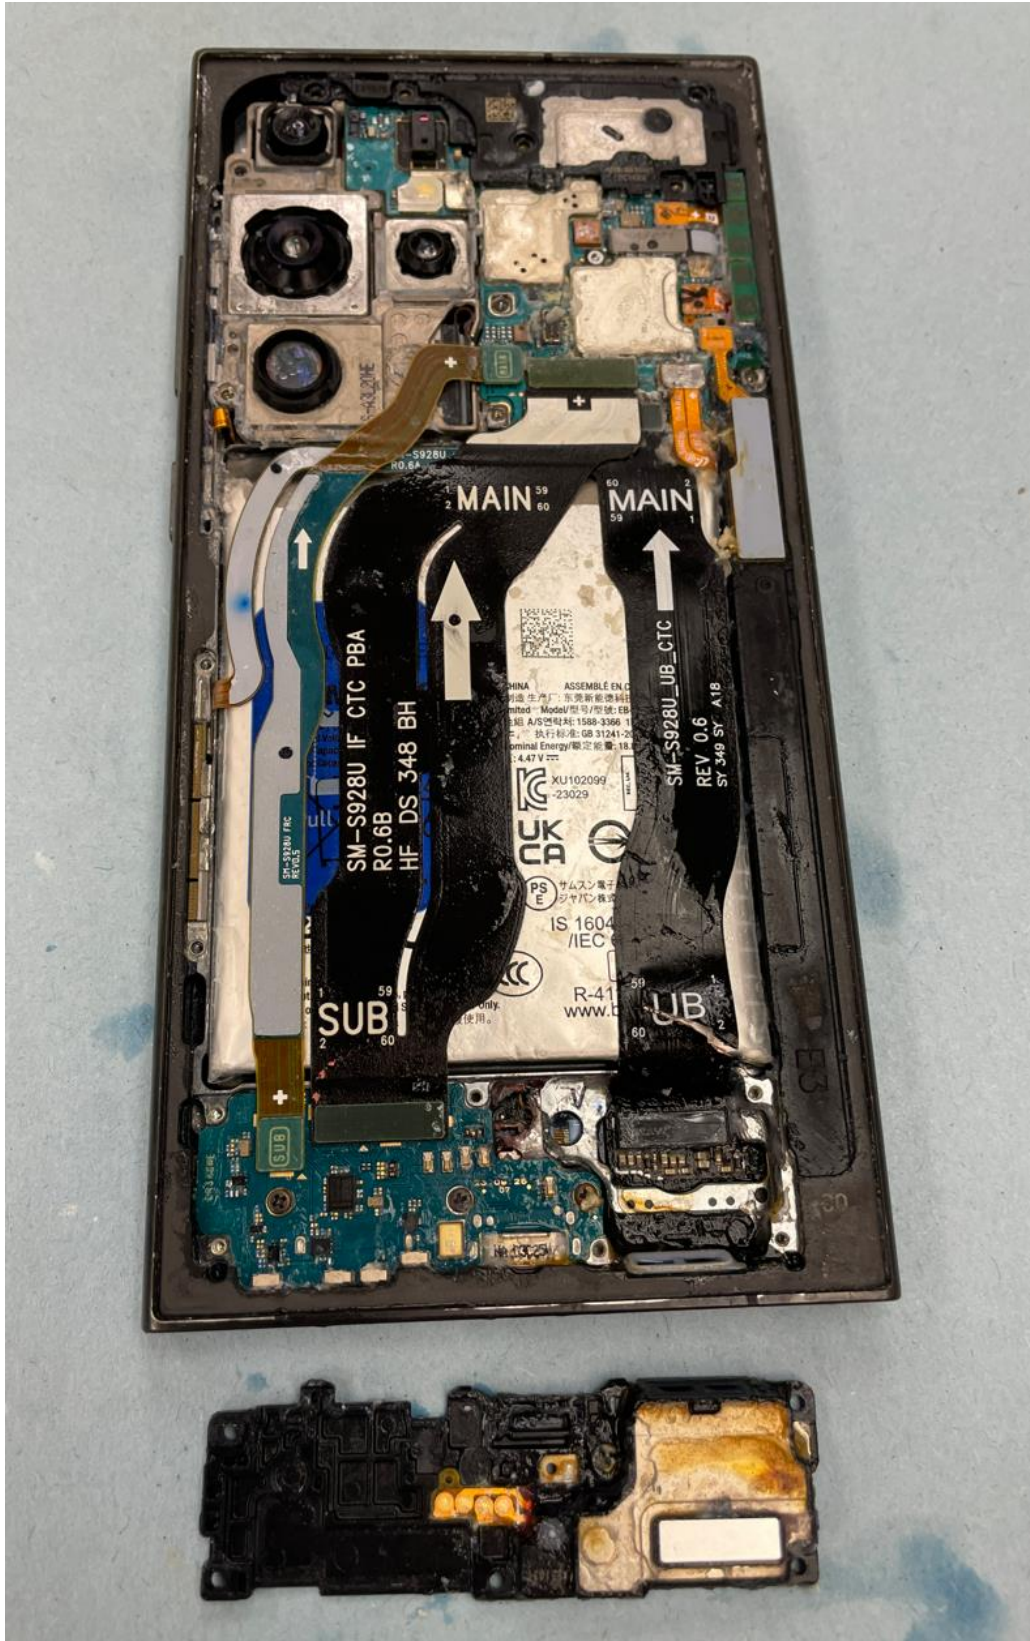
**Figure 3.** The interior of the Samsung phone showed severe water damage.
