ANC24FA092

## INVESTIGATION PHOTOGRAPHS

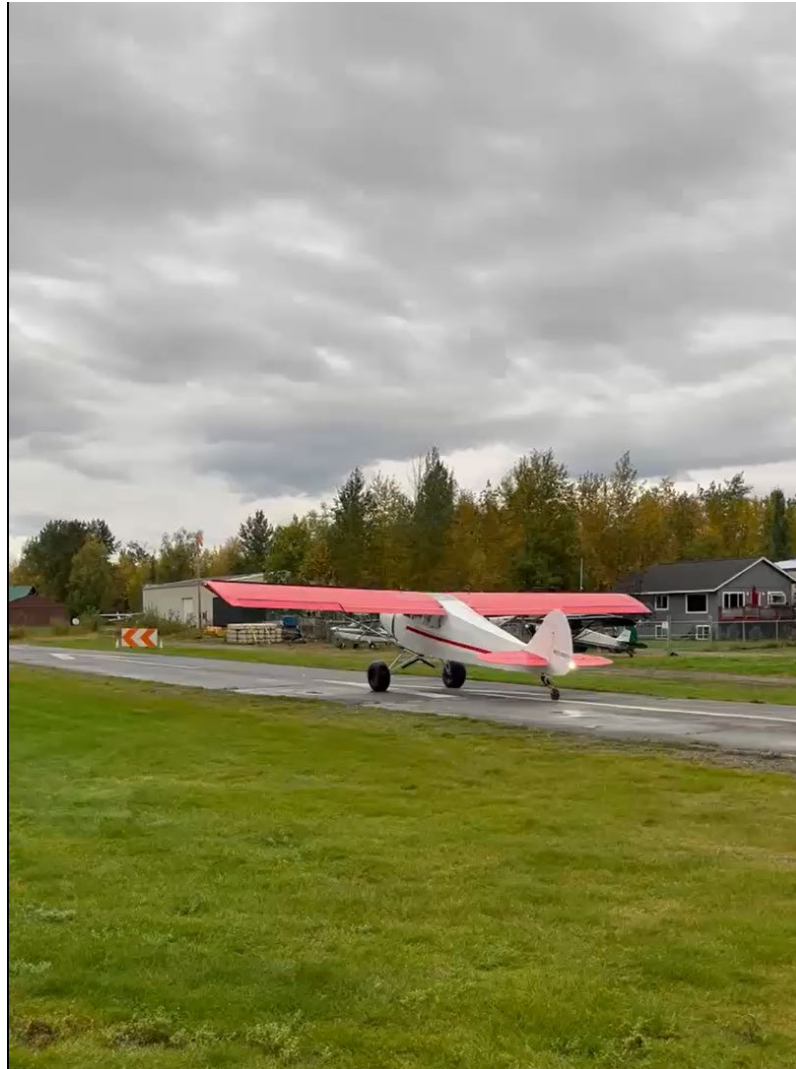
**Photograph 1 - A screenshot from a video of the takeoff that shows the airplane on the runway.  
(Courtesy of witness)**

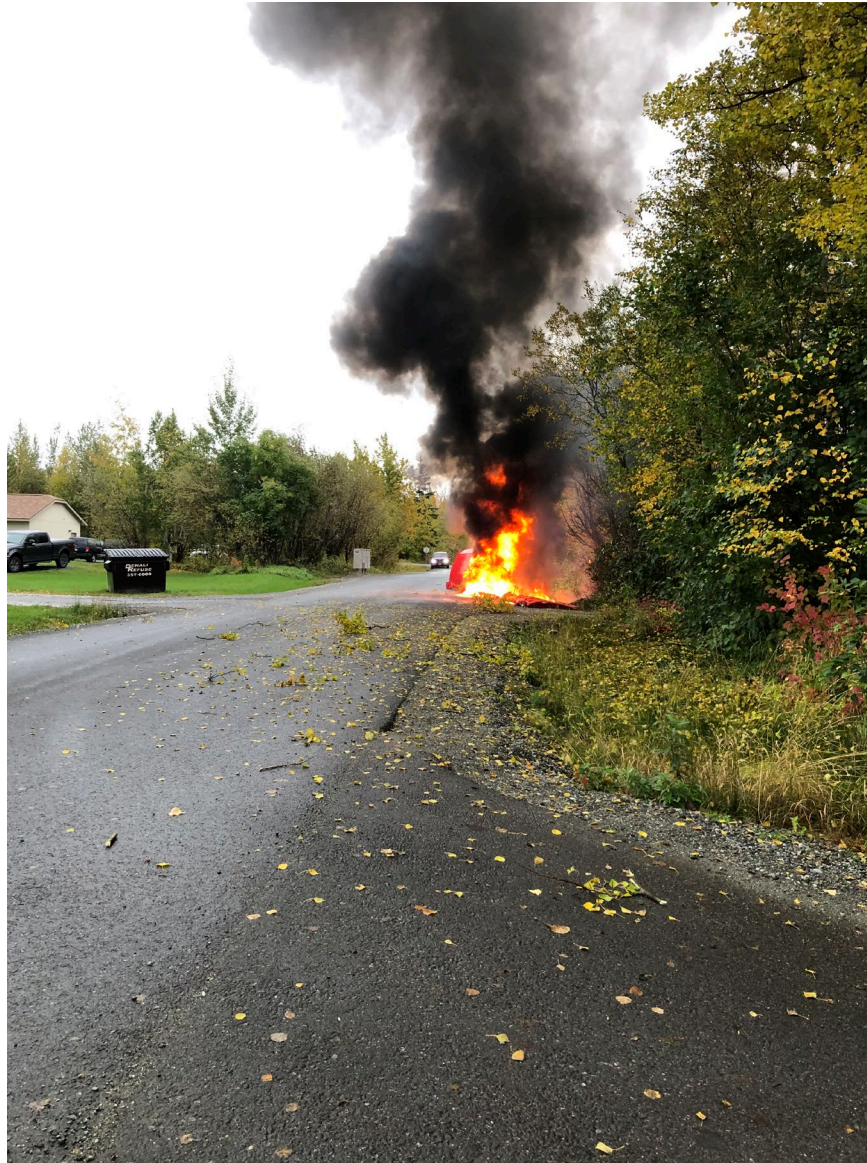
**Photograph 2 - View of the wreckage on fire after the accident.**

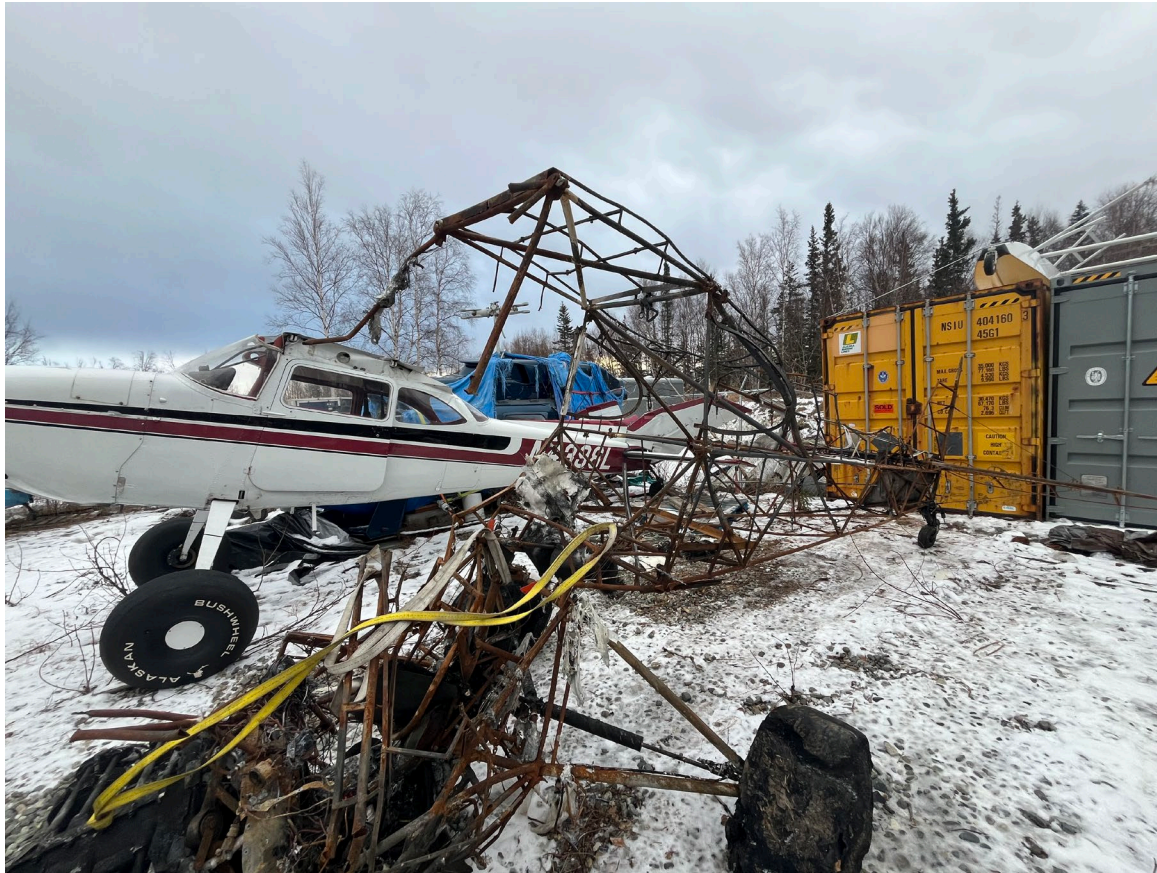
**Photograph 3 - View of the burned wreckage after recovery.**

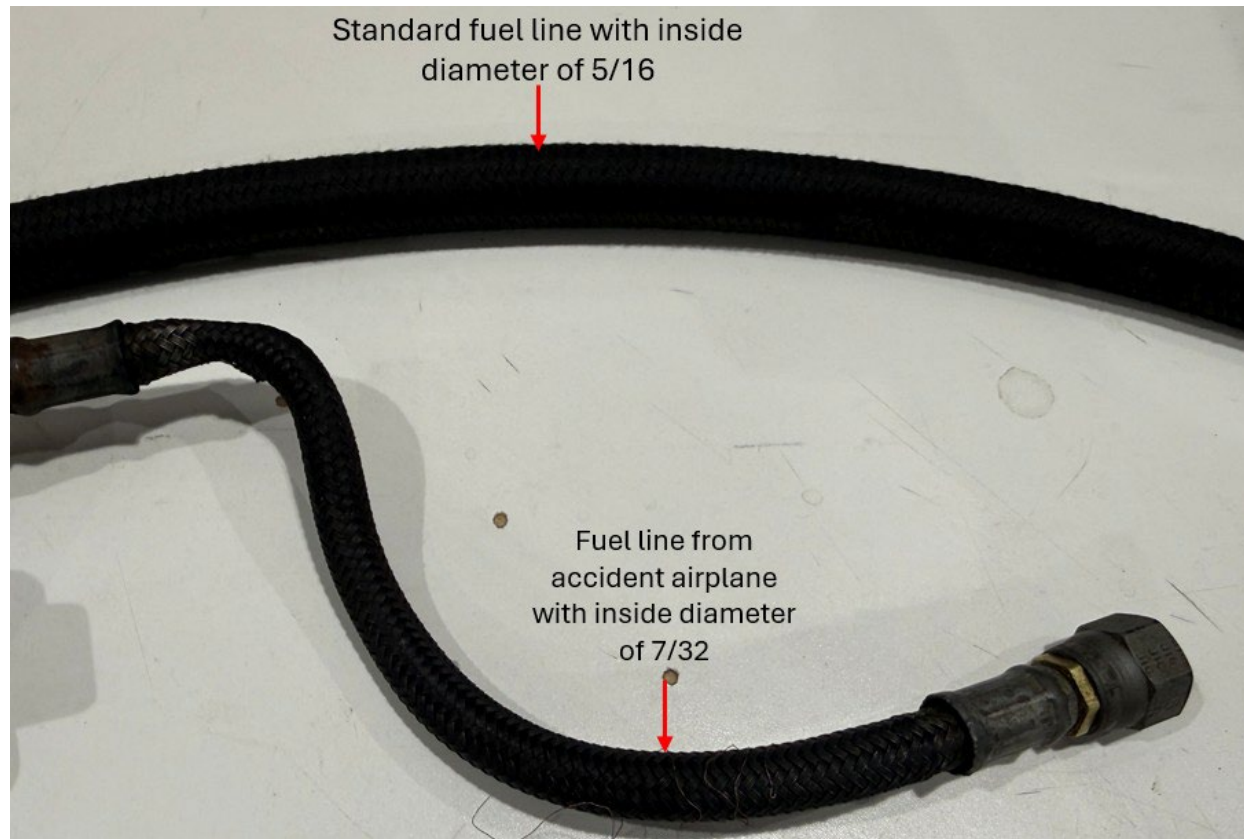
**Photograph 4** View of a standard fuel hose (above) and the steel braided hose installed on the airplane (below).

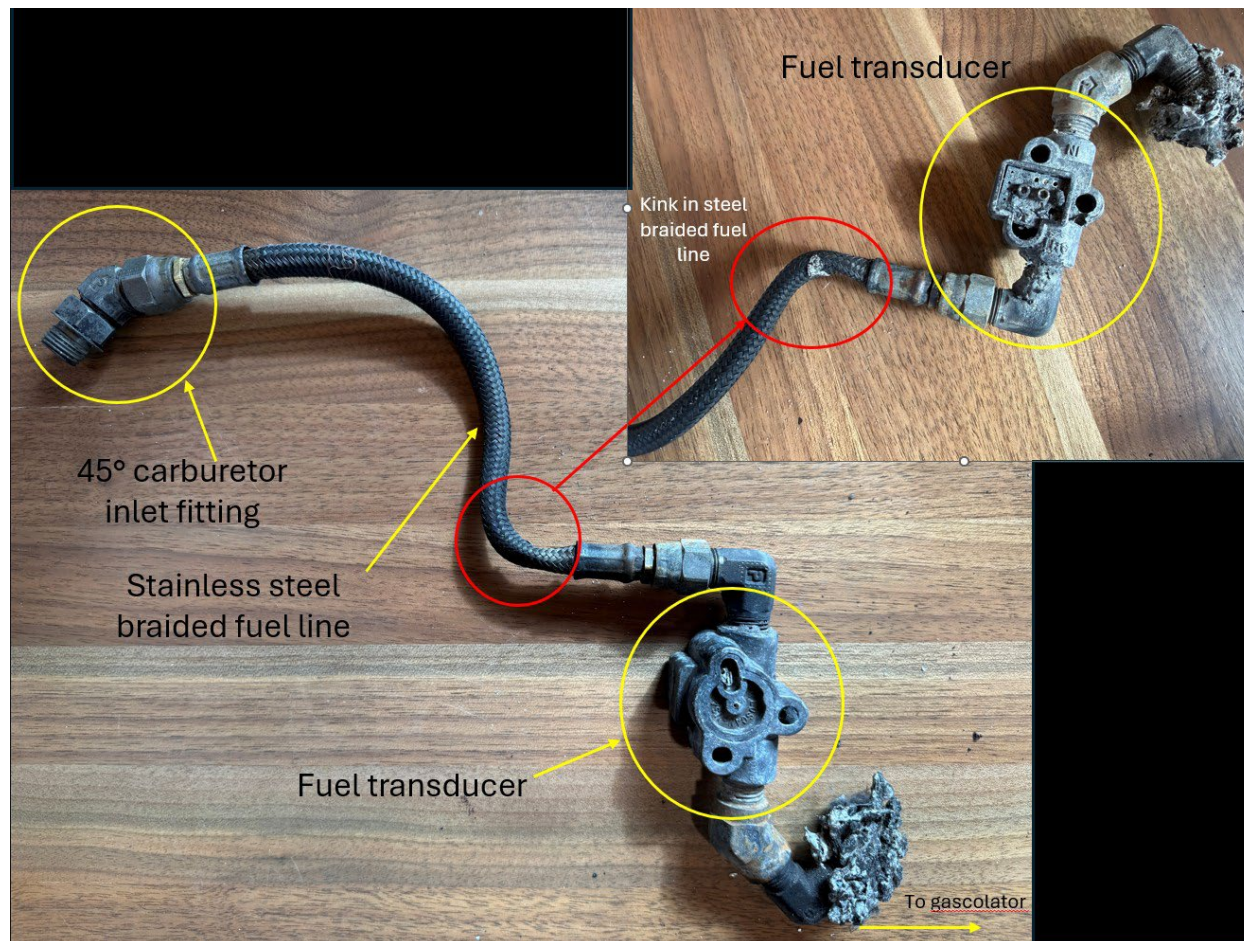
**Photograph 5 View of the kink in the steel braided hose from the carburetor to the gasoclator.**
