# Carburetor Icing Probability Graph – ANC24LA011

Airplane: Cessna 172P

Accident Date: 12/23/2023

Accident Location: Kahului, HI

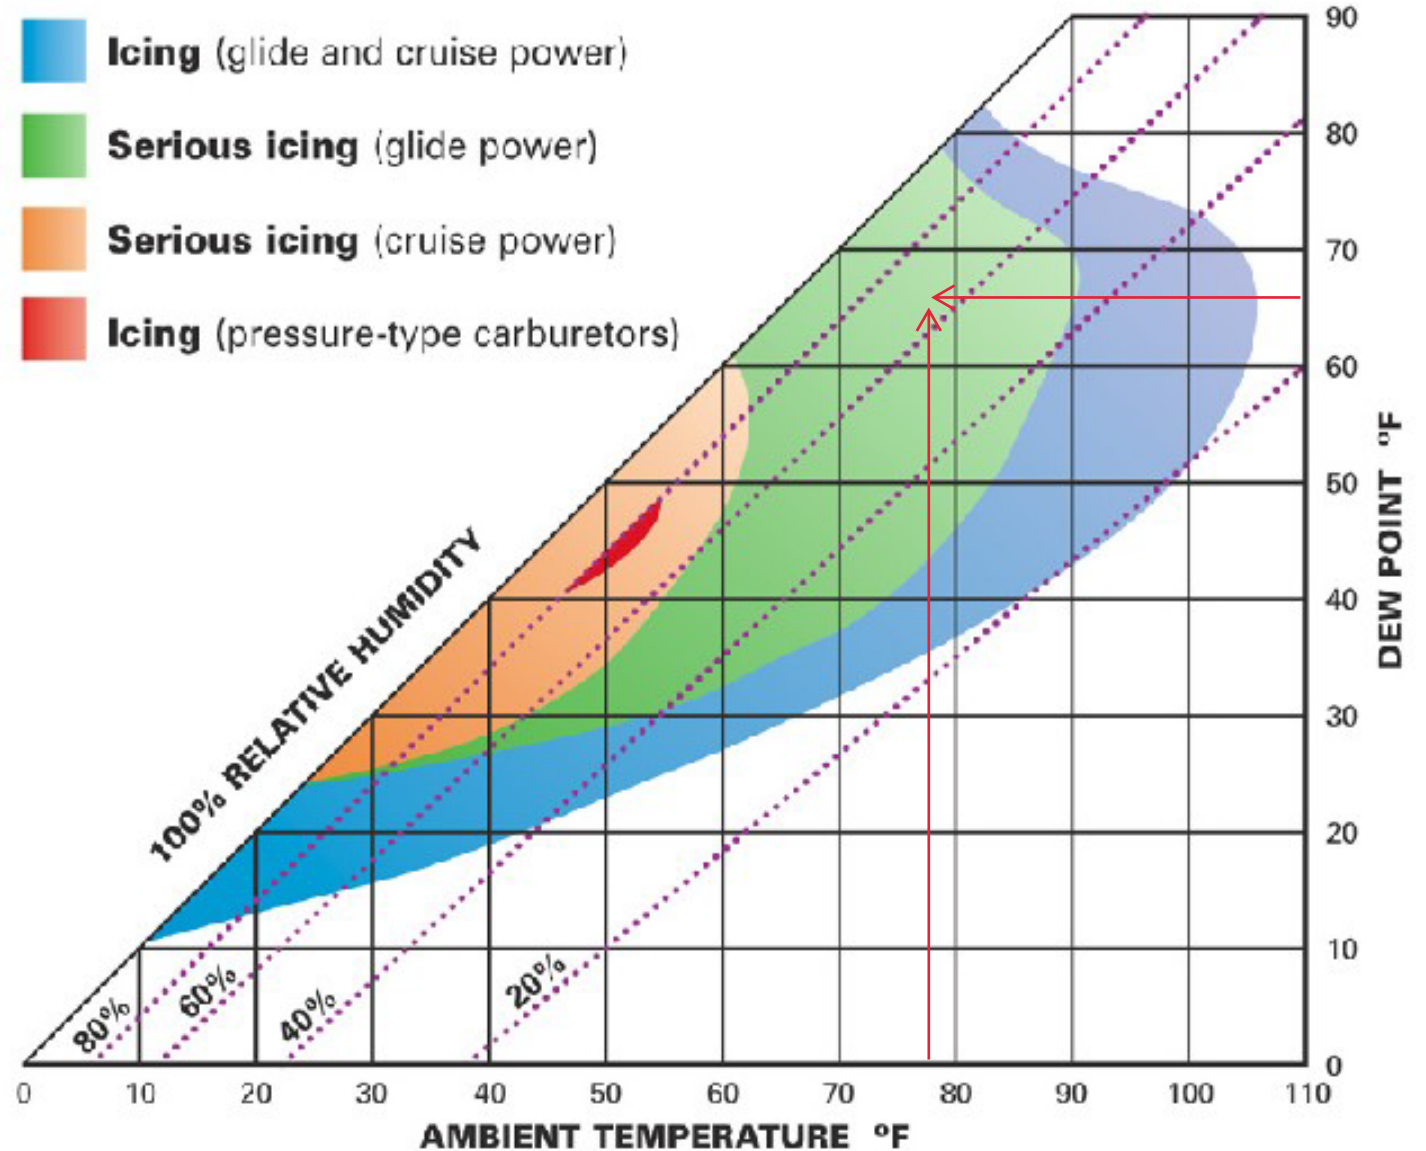
Weather: Observation facility (HOG) reported  
temperature 77° F; dew point 66° F

Source: Federal Aviation Administration  
Special Airworthiness Information Bulletin CE-09-35  
Carburetor Icing Prevention
