# National Transportation Safety Board

ANC25LA021

## **WRECKAGE EXAMINATION**

Location: Lihue airport, Lihue, Hawaii  
Date: February 28, 2025  
Time: 1100L  
Airplane: Gippsland GA-8 N699AV

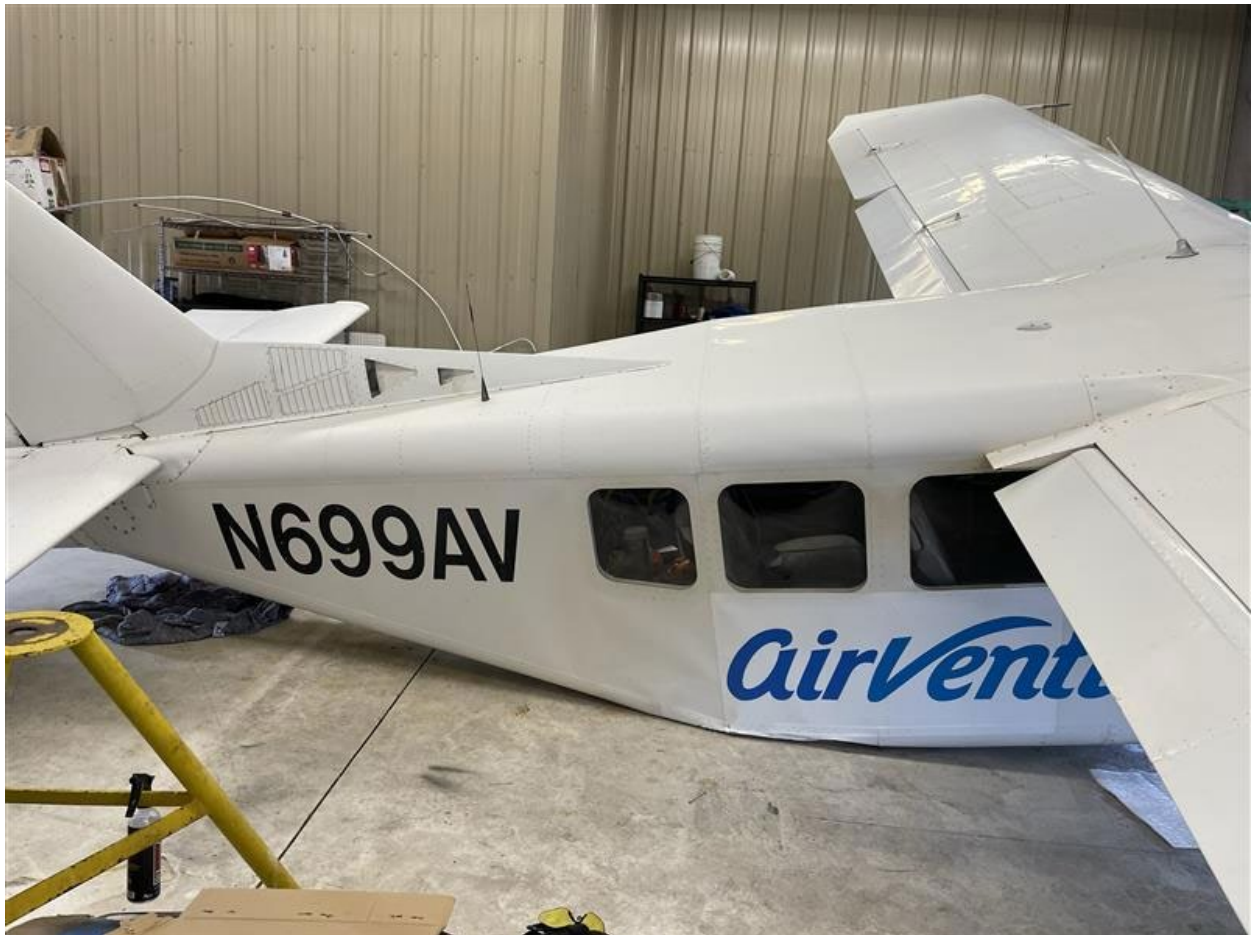
**Figure 1 Right side of the airplane.**

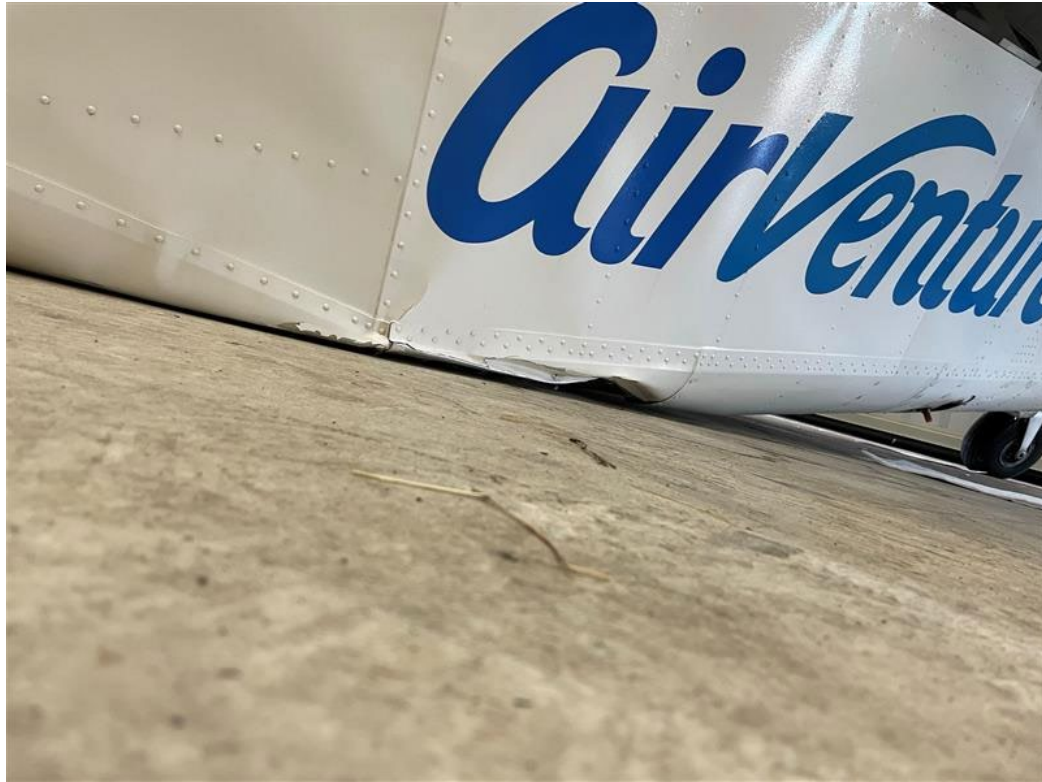
The pilot reported that he made a normal approach with full flaps and landed on runway 21 at the Lihue Airport (LIH). While taxiing to parking he made a slow right turn off the runway. As the pilot straighten the airplane out of the turn on to the taxiway, the right landing gear leg collapsed resulting in substantial damage to the fuselage.

**Figure 2 Damage to the right side of the fuselage**

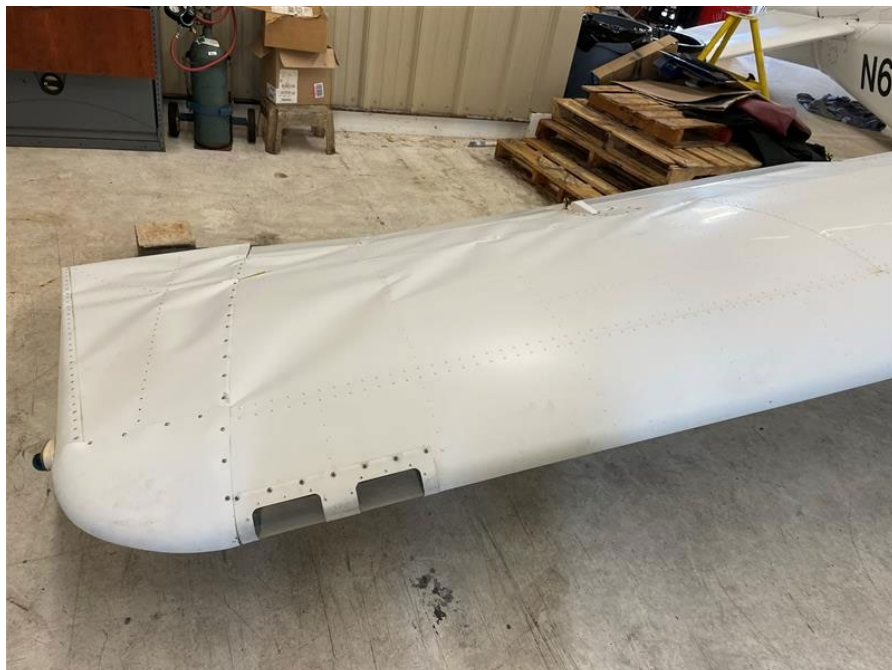
**Figure 3 Top side of the right wing.**

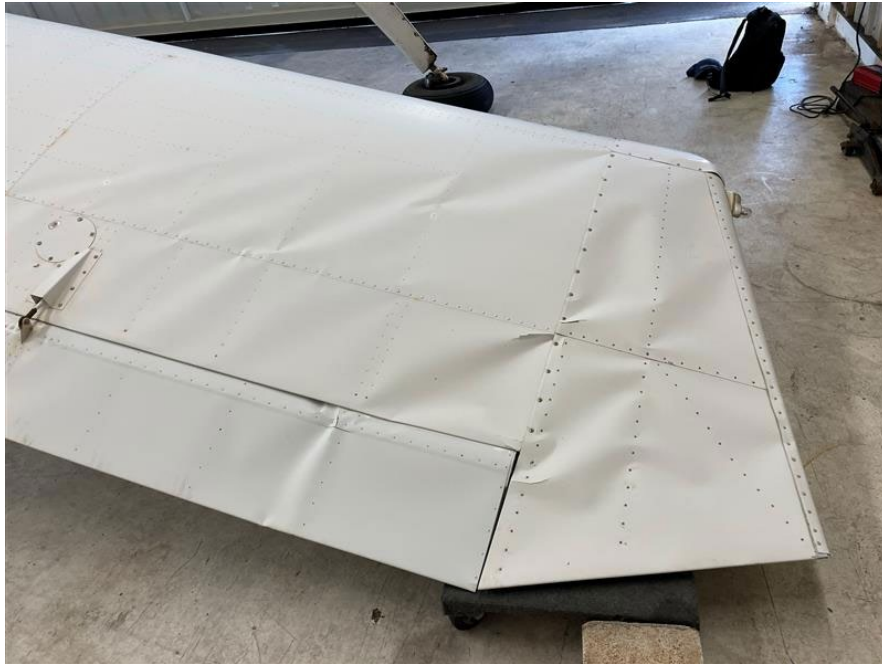
**Figure 4 Top aft view of the right wing.**

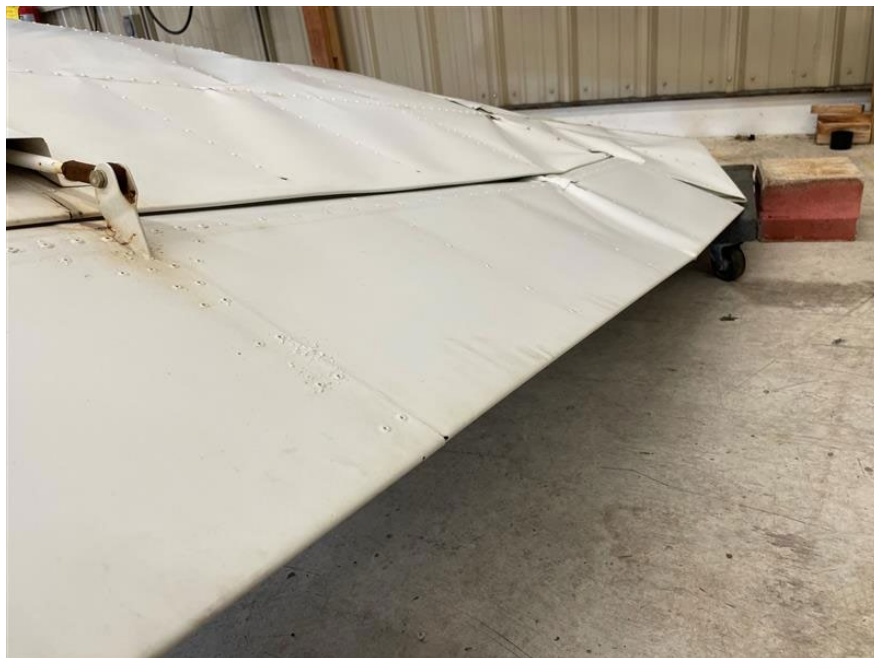
**Figure 5 Top aft view of the right wing.**

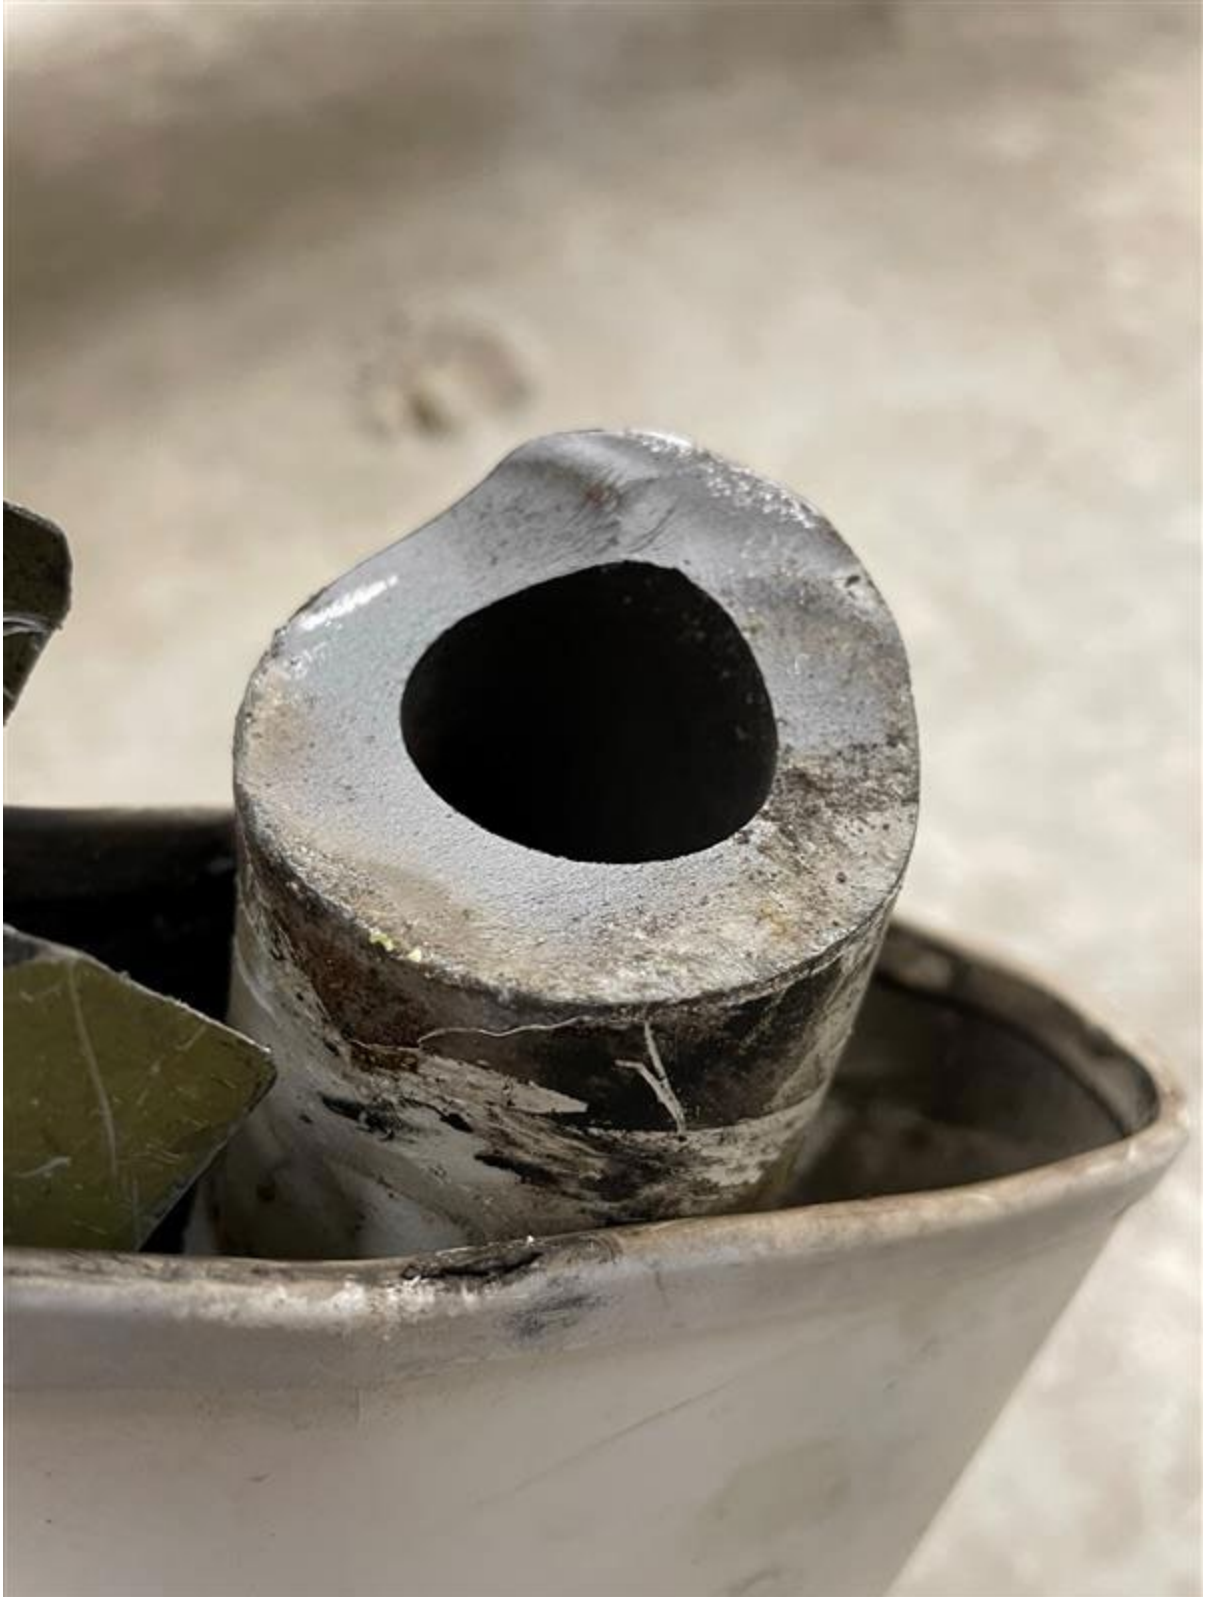
As reported N699AV suffered collapse of the right main landing gear during attempt to turn off taxiway post landing on 2/28/2025. Initial overall visual inspection of aircraft identified damage suffered during incident and from removal from taxiway. Inspection of the Right Main Landing gear is showing discoloration and offset grain

structure where it sheared indicating to our belief that corrosion had weakened the assembly allowing for failure.

**Figure 6 Fracture surface of the right landing gear.**

Air Venture mentioned ordering new and replacing the landing gear. After reviewing the maintenance program and checklist for 100 hour inspections it is stated that access panels should be removed and the aircraft cleaned, also that when inspecting the landing gear the attachment points should be inspected which would we believe require the removal of the landing gear boot/shield and cleaning and inspection of the landing gear leg/strut. The interval for the 100hr for these aircraft appears to be roughly every two months. The level of effort required to remove the shields during our visit and the amount of build up of dirt and contaminants on the majority of the fleets landing gear seem to indicate that there may be a need for further investigation of how this inspection is being performed.

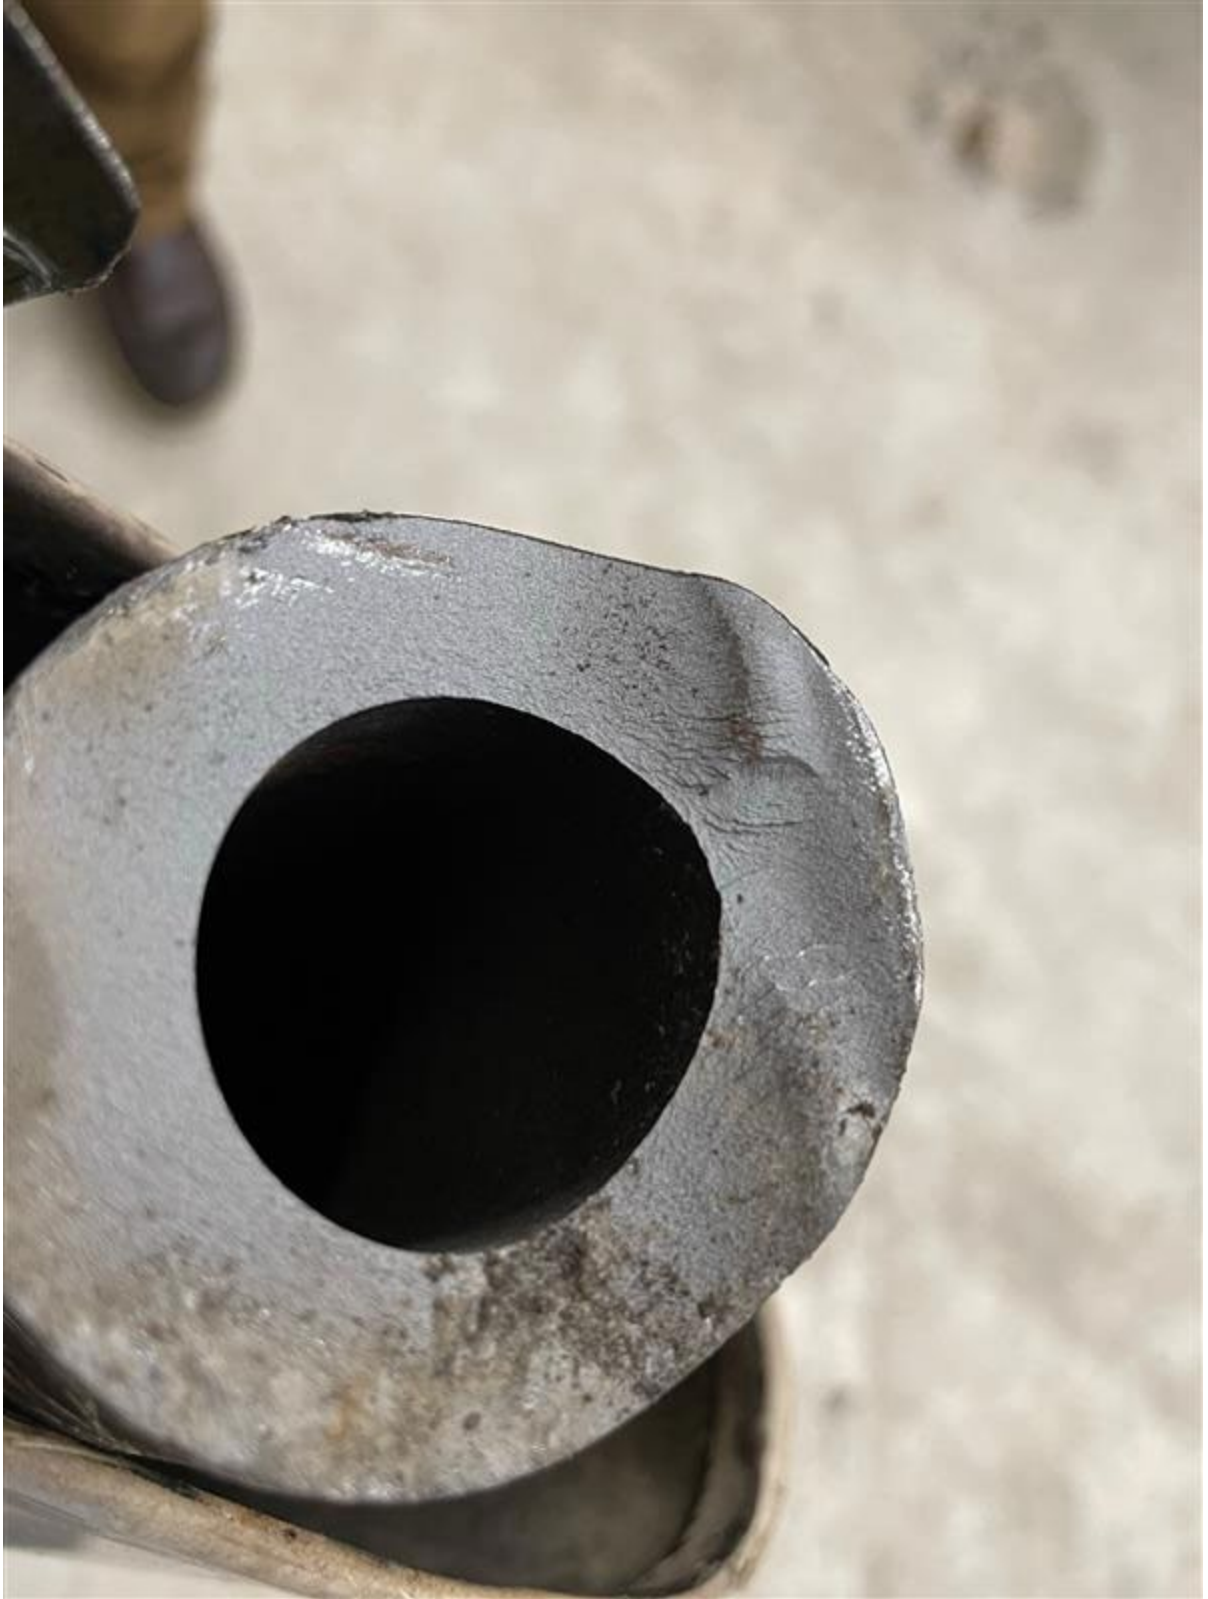
**Figure 7 Fracture surface of the right landing gear.**

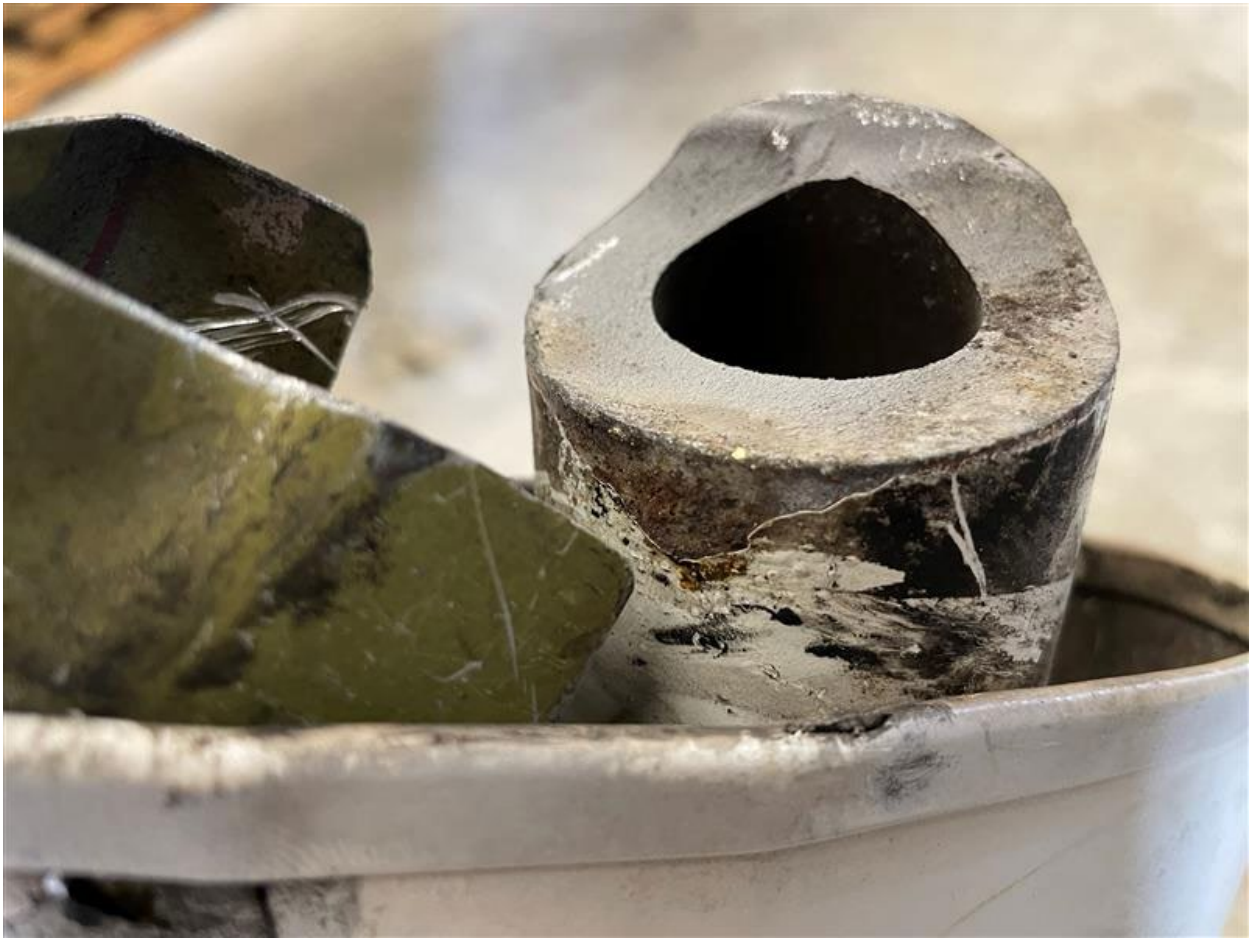
**Figure 8 Fracture surface of the right landing gear.**

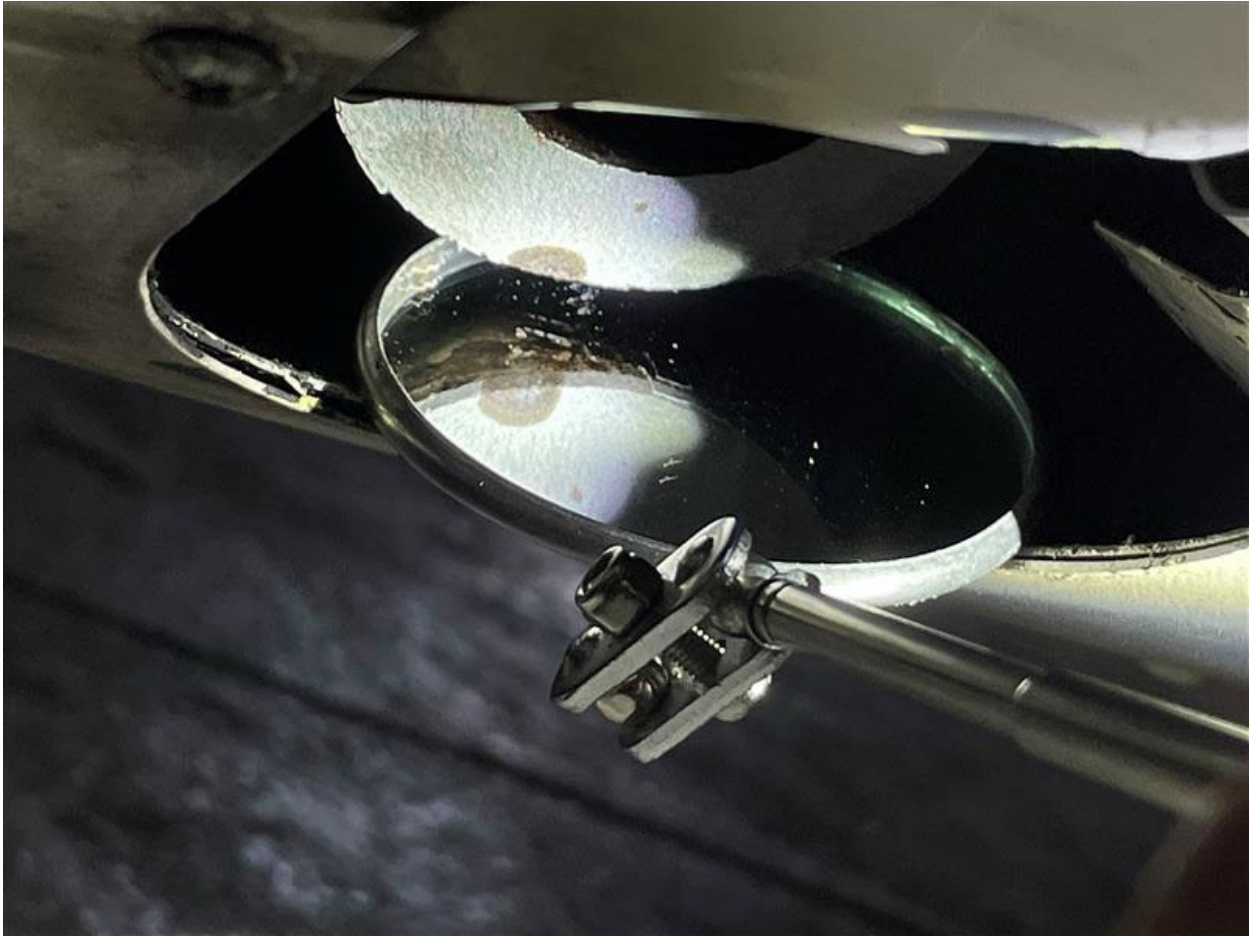
**Figure 9 View of the fracture surface of landing gear that is still attached to the airplane.**

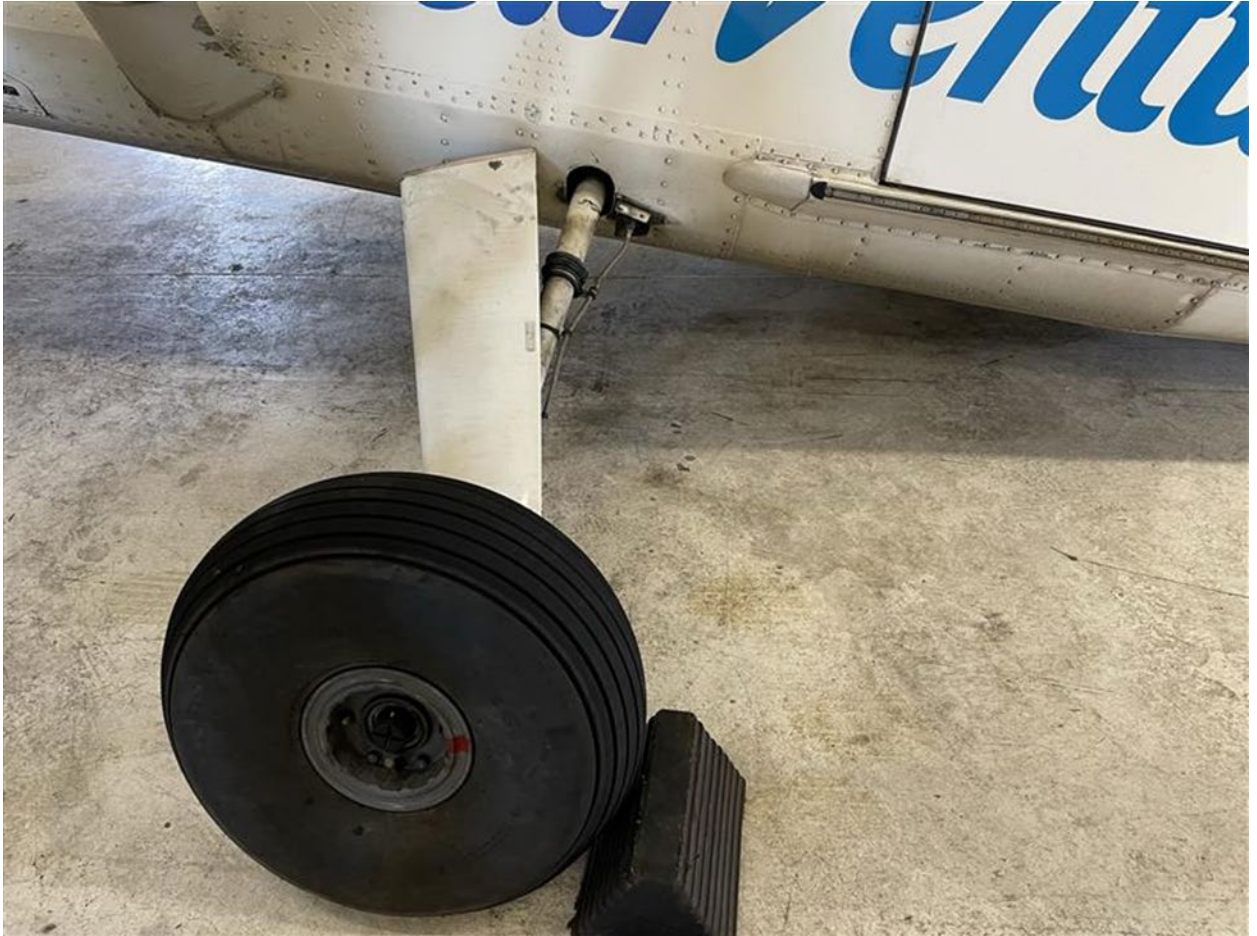
The left main landing gear cover was removed, and the landing gear leg was cleaned and inspected to find a crack in nearly identical location of the shear/failed landing gear.

**Figure 10 View of the left landing gear.**

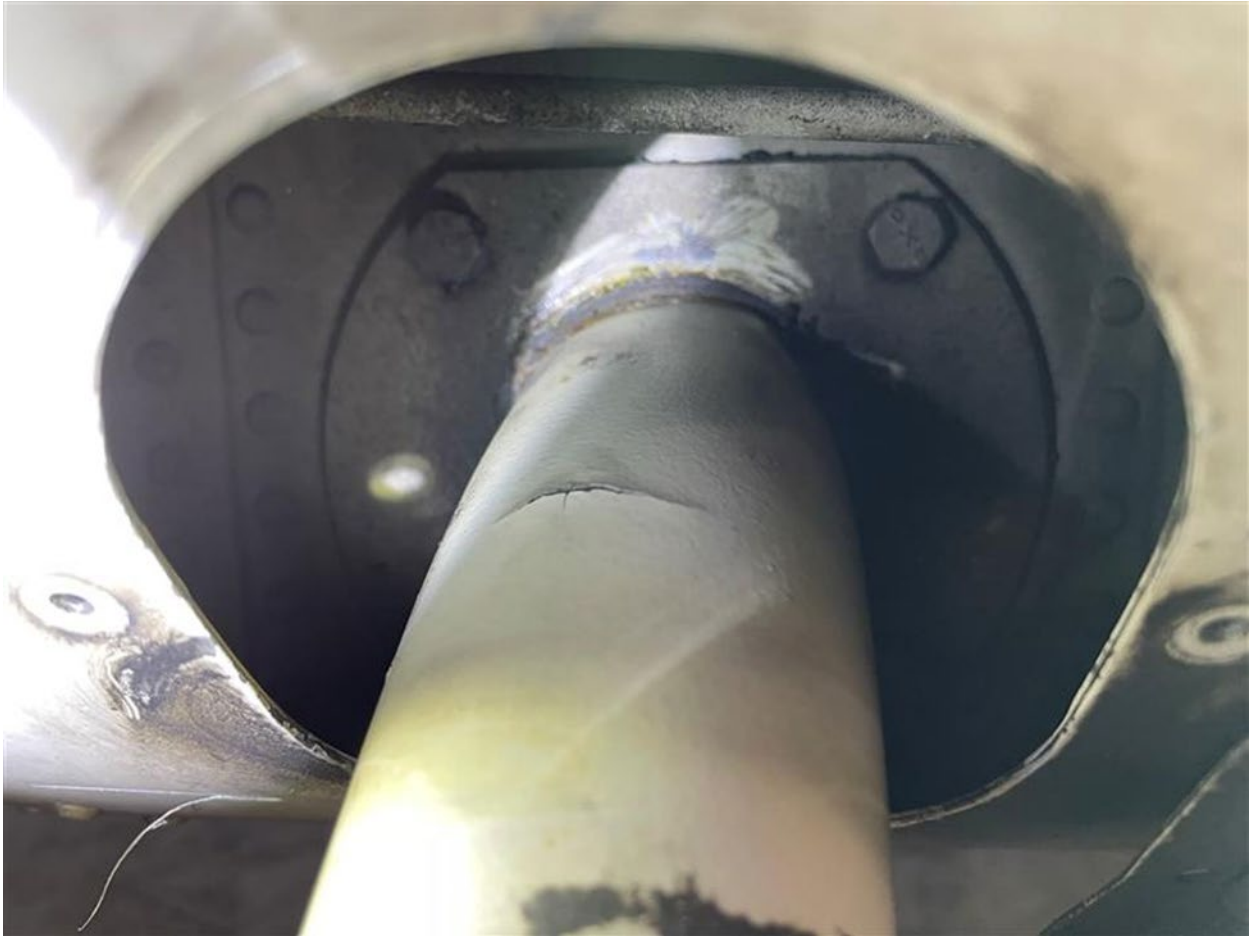
**Figure 11 View of the left landing gear near the fuselage attachment point. Corrosion is visible in the same location as the fracture on the right-side landing gear.**

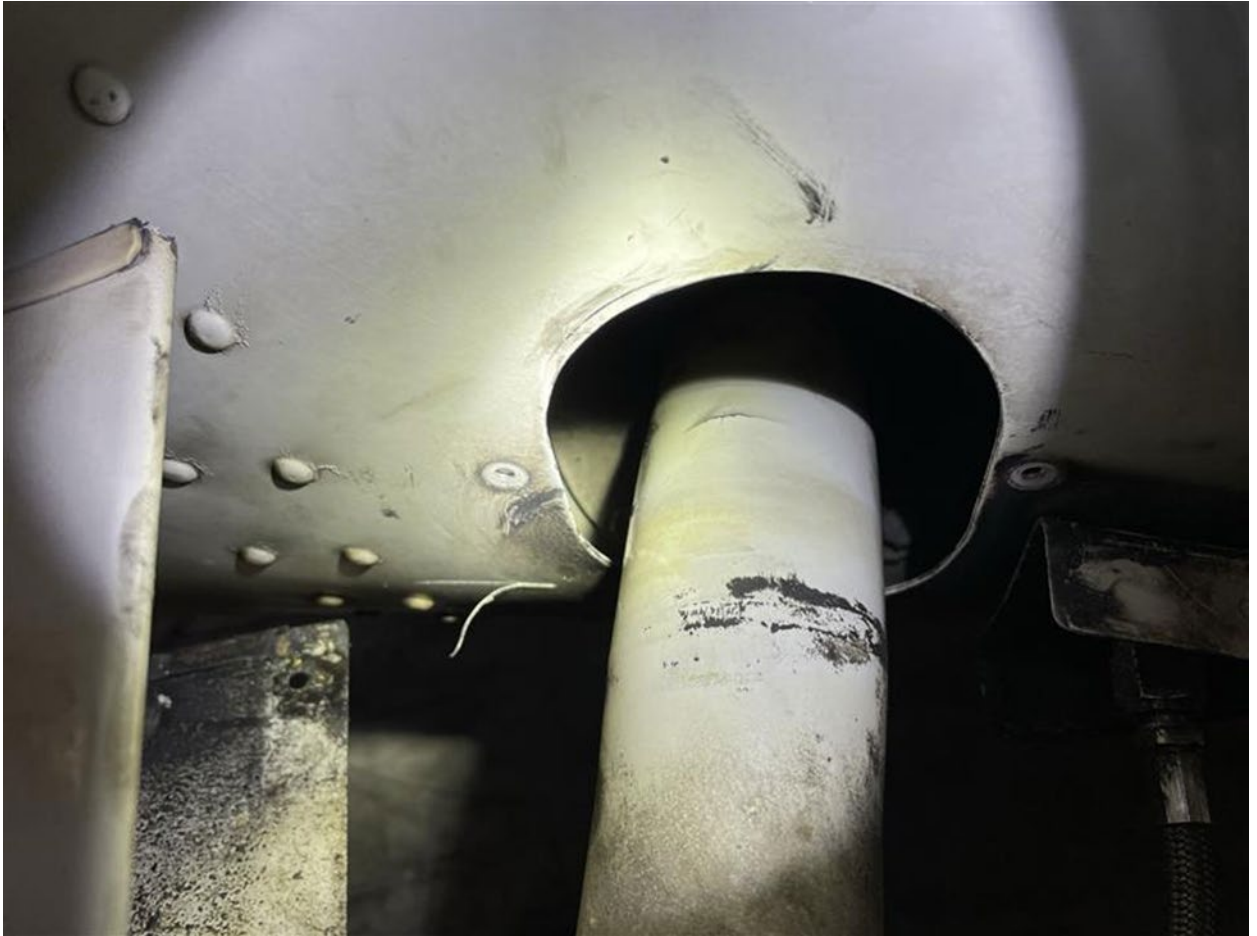
**Figure 12 View of the left landing gear near the fuselage attachment point. Corrosion is visible in the same location as the fracture on the right-side landing gear.**
