# National Transportation Safety Board

ANC25MA018

## **METEOROLOGY**

Specialist's Factual Report

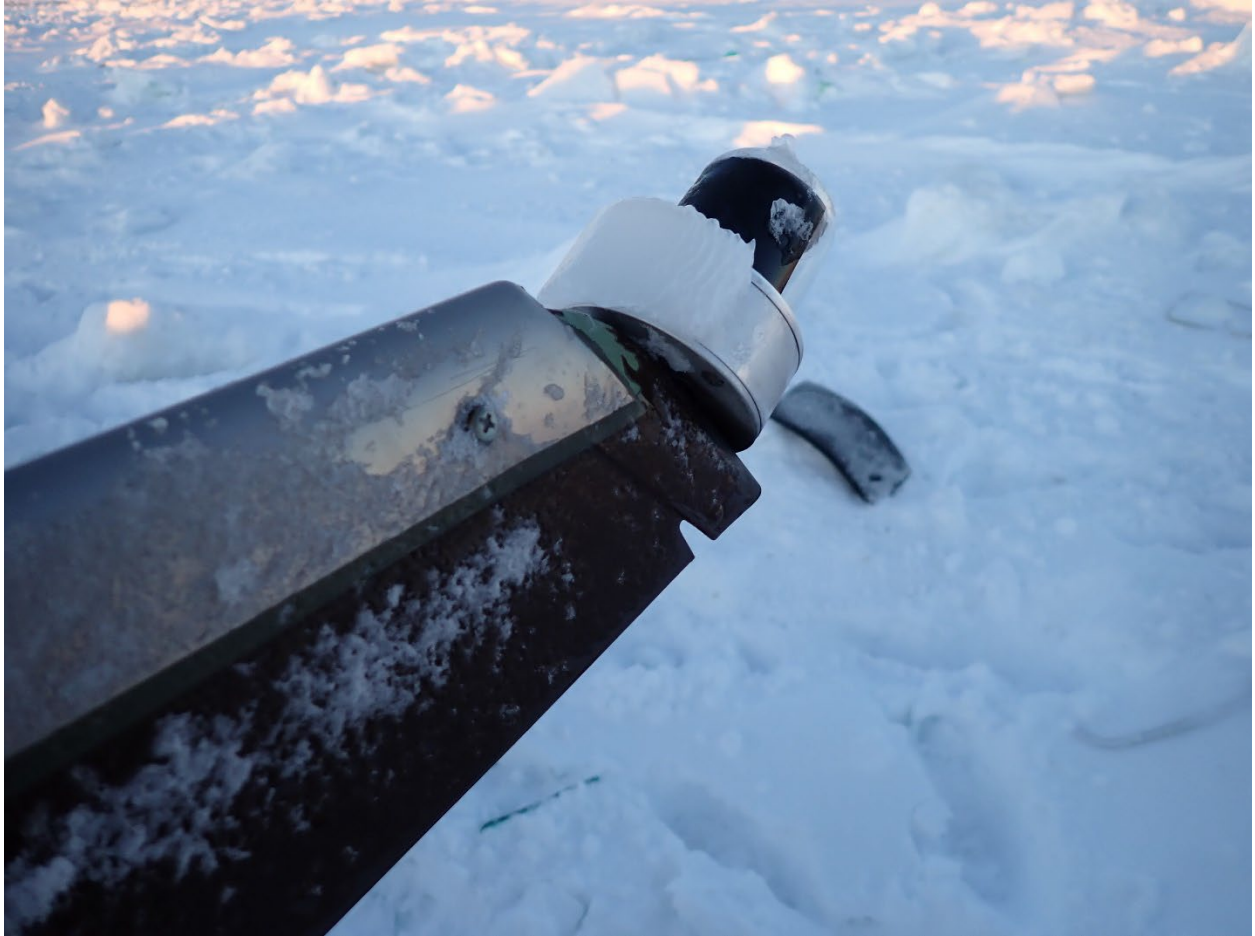
The first responders to the accident site documented the accident wreckage and provided imagery to the investigation. One of the images depicts the tail section of the aircraft with icing noted on the airframe (figure 19).

**Figure 19.** Accident wreckage tail section with icing noted on the airframe.

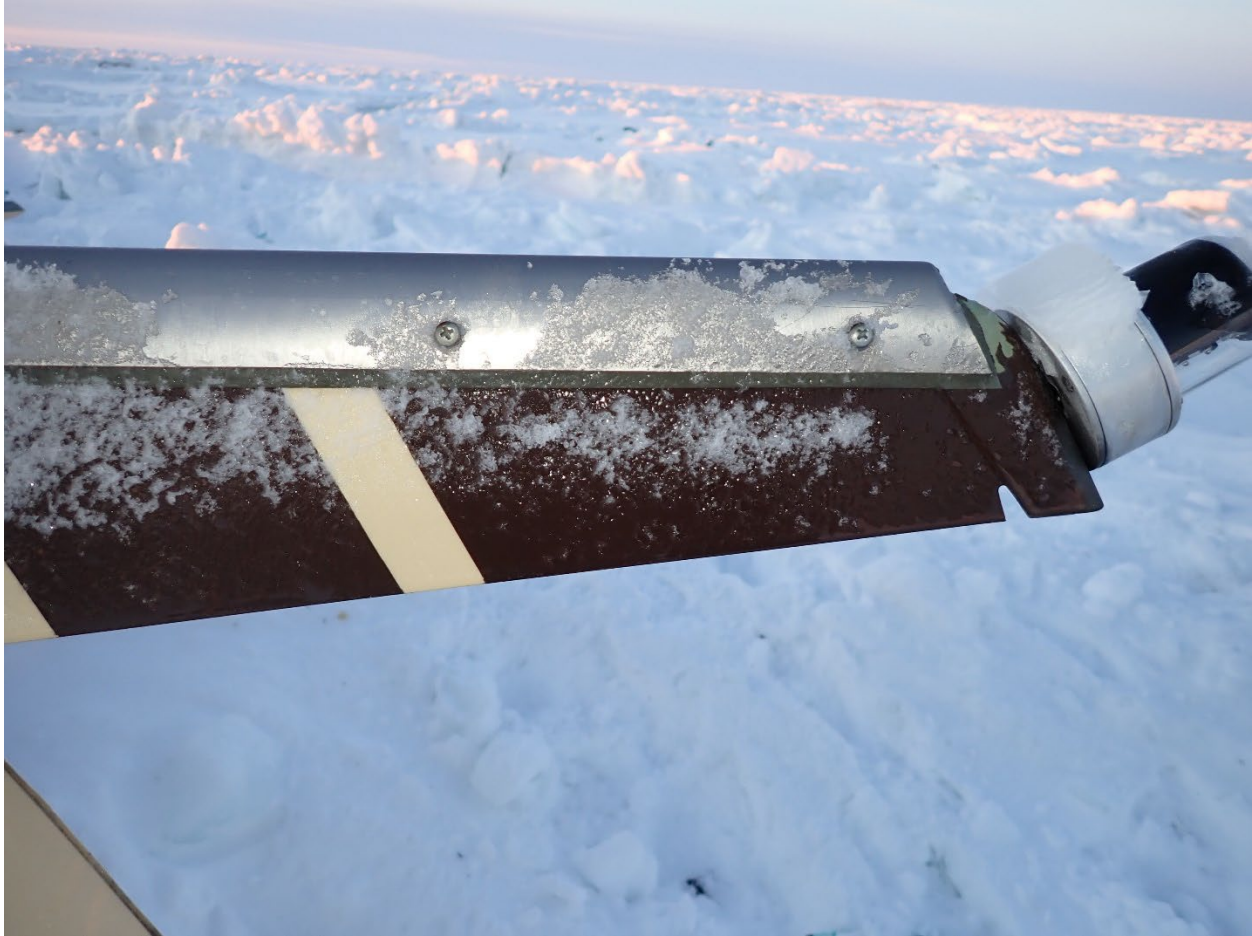
**Figure 20.** Accident wreckage tail section with icing noted on the airframe aft of the TKS porous membranes.
