# National Transportation Safety Board

ANC25MA018

## **PERSONAL ELECTRONIC DEVICES**

Specialist's Factual Report

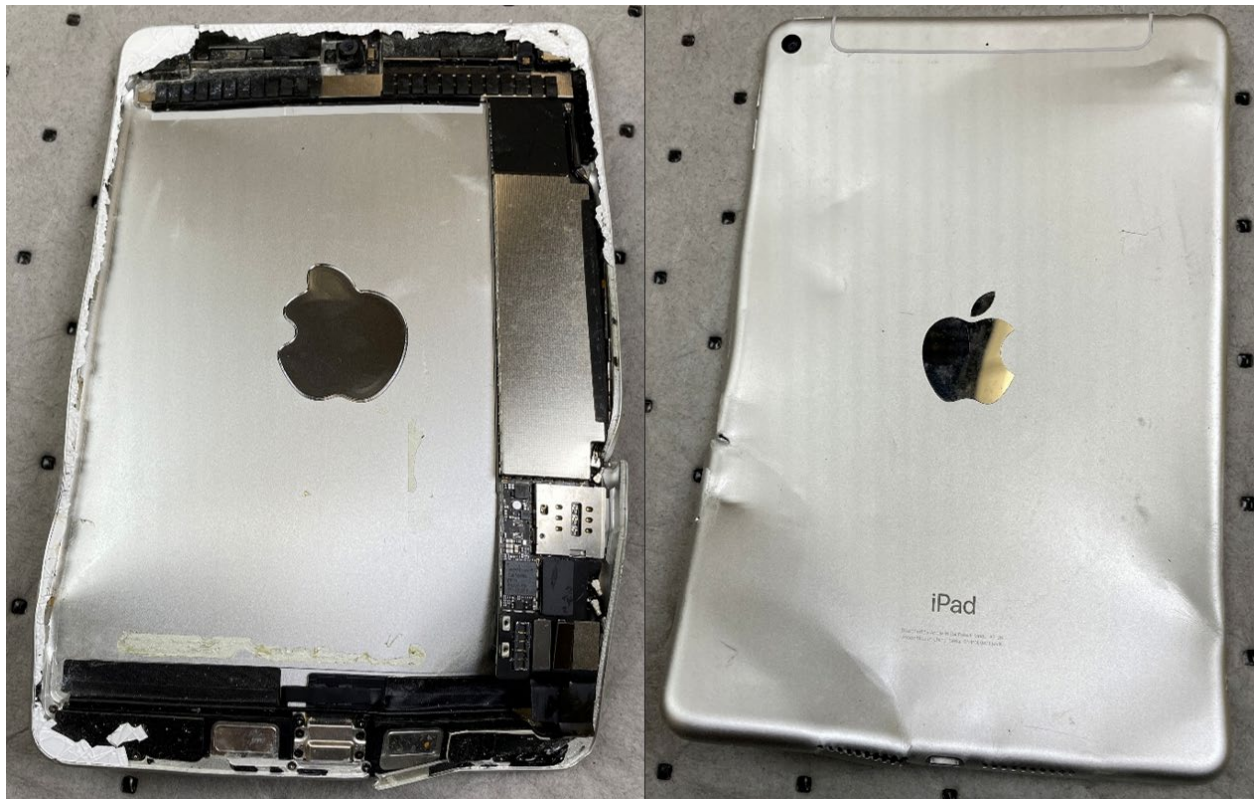
**Figure 2.** Front and back of the iPad Mini 5 as received.

The iPhone and iPad, as shown in figures 1 and 2 respectively, sustained impact damage rendering each inoperable. The iPhone was able to power on with exemplar laboratory components and prompted a 4-digit numeric passcode. Potential passcodes provided to the investigation team were unable to unlock the device, as were generic passcodes attempted. It is unknown whether there were any stored data pertinent to the event. No further attempts were made to access the data.

The extent of the damage on the iPad precluded normal recovery procedures and on August 26, 2025, the device was brought to an advanced repair facility for further evaluation. After various troubleshooting methods were unsuccessful in restoring the motherboard into a functional condition, the central processing unit (CPU), NAND flash memory, and erasable programmable read-only memory (EPROM), chips were removed from the motherboard and installed on an exemplar donor board. The donor board powered on normally and prompted a 4-digit numeric passcode. Potential passcodes provided to the investigation team were unable to unlock the device, however, a generic passcode unlocked the device and its contents were accessed normally.

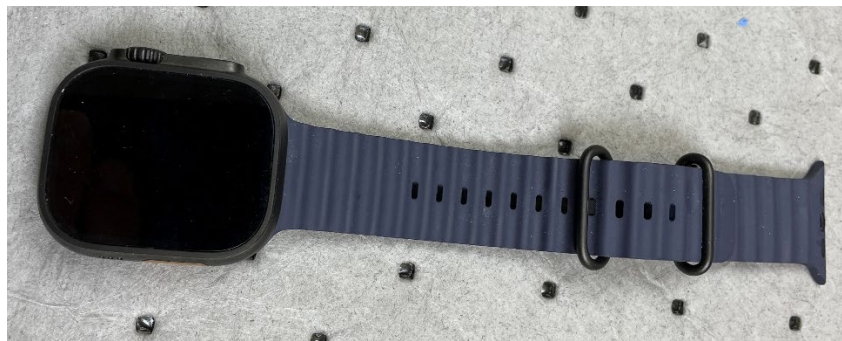
**Figure 3.** Apple Watch Ultra 2 as received.

The Apple Watch, as shown in figure 3, powered on normally and prompted a 4-digit numeric passcode. Potential passcodes provided to the investigation team were unable to unlock the device, as were generic passcodes attempted. It is unknown whether there were any stored data pertinent to the event. No further attempts were made to access the data.
