# National Transportation Safety Board

ANC25MA018

## **AIR TRAFFIC CONTROL**

Group Chair's Factual Report

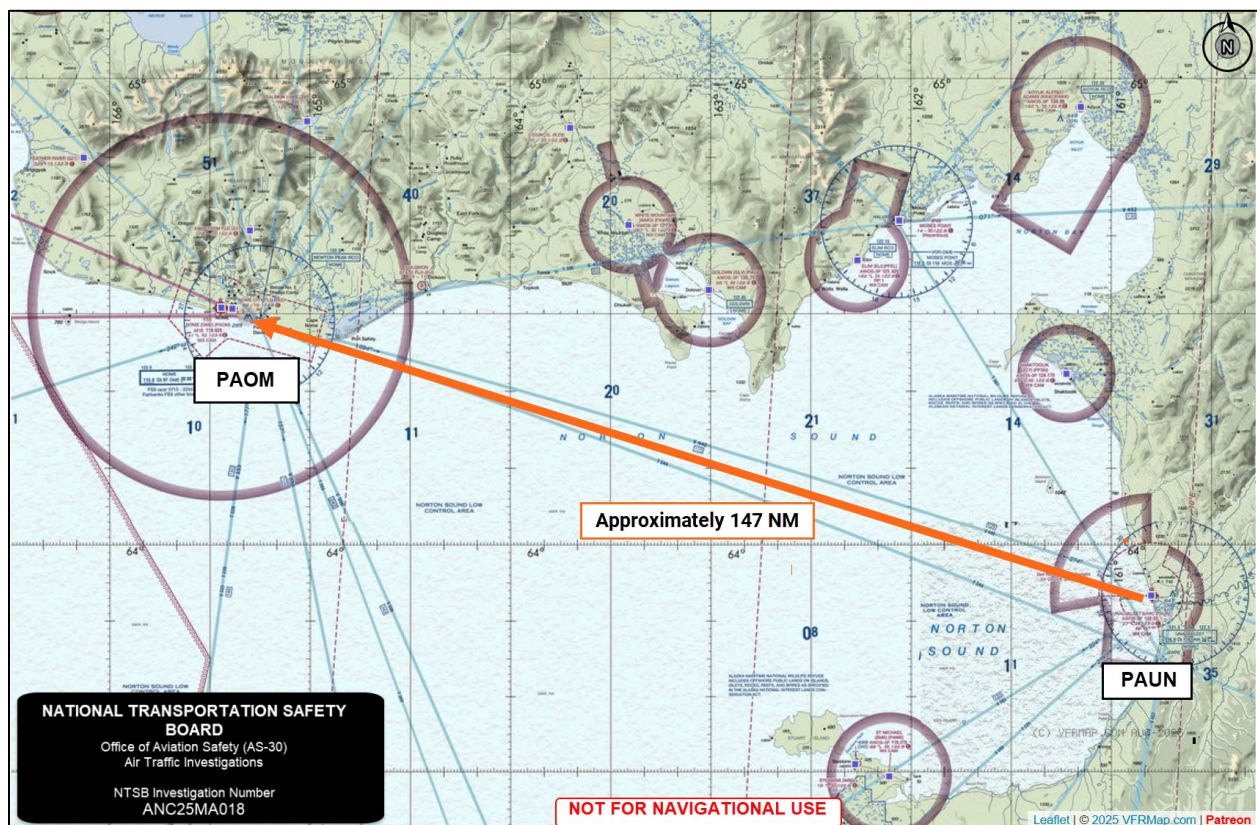
**Figure 1.** Intended flight route of BRG445 shown on sectional chart.

Figure 1 is a screenshot of the sectional aeronautical chart showing the locations of PAUN (on the right side) and PAOM (on the left side) of the chart. An orange arrow is used to indicate the relative positions of the two airports and their approximate distance of 147 miles. This arrow does not represent the actual flight track of BRG445.

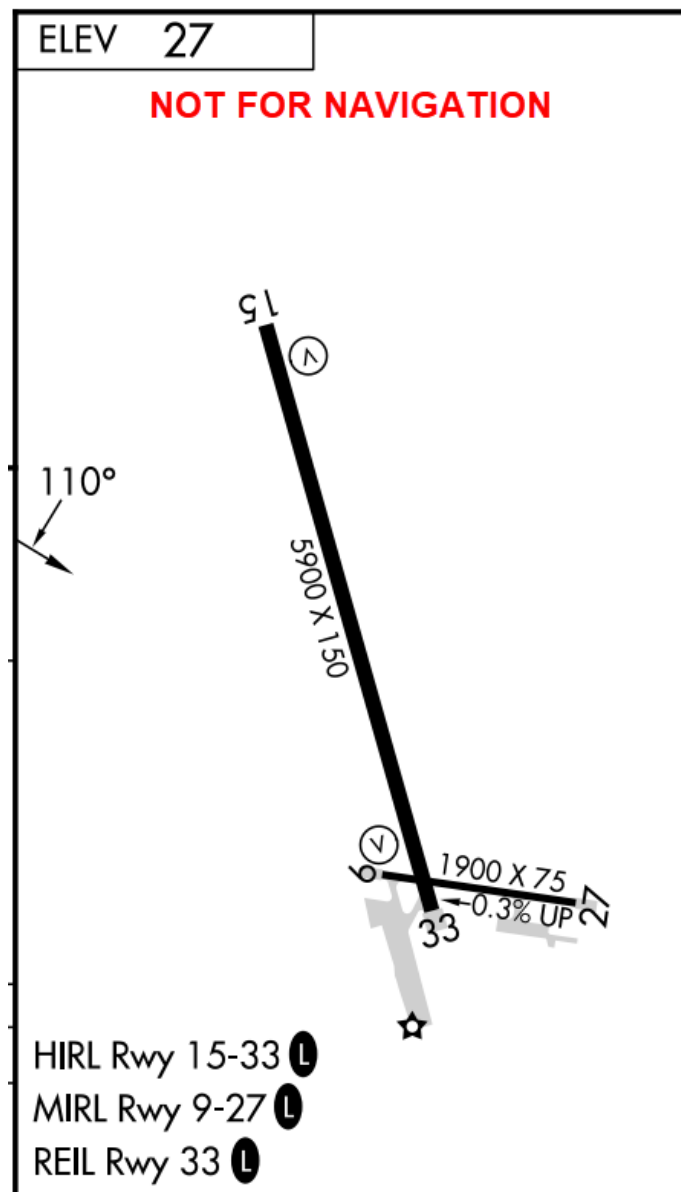
**Figure 2.** Airport diagram of PAUN.

Figure 2 is the airport diagram for PAUN, depicting the layout of runways, taxiways, and ramp areas. Runway designations and dimensions are also provided on the diagram.

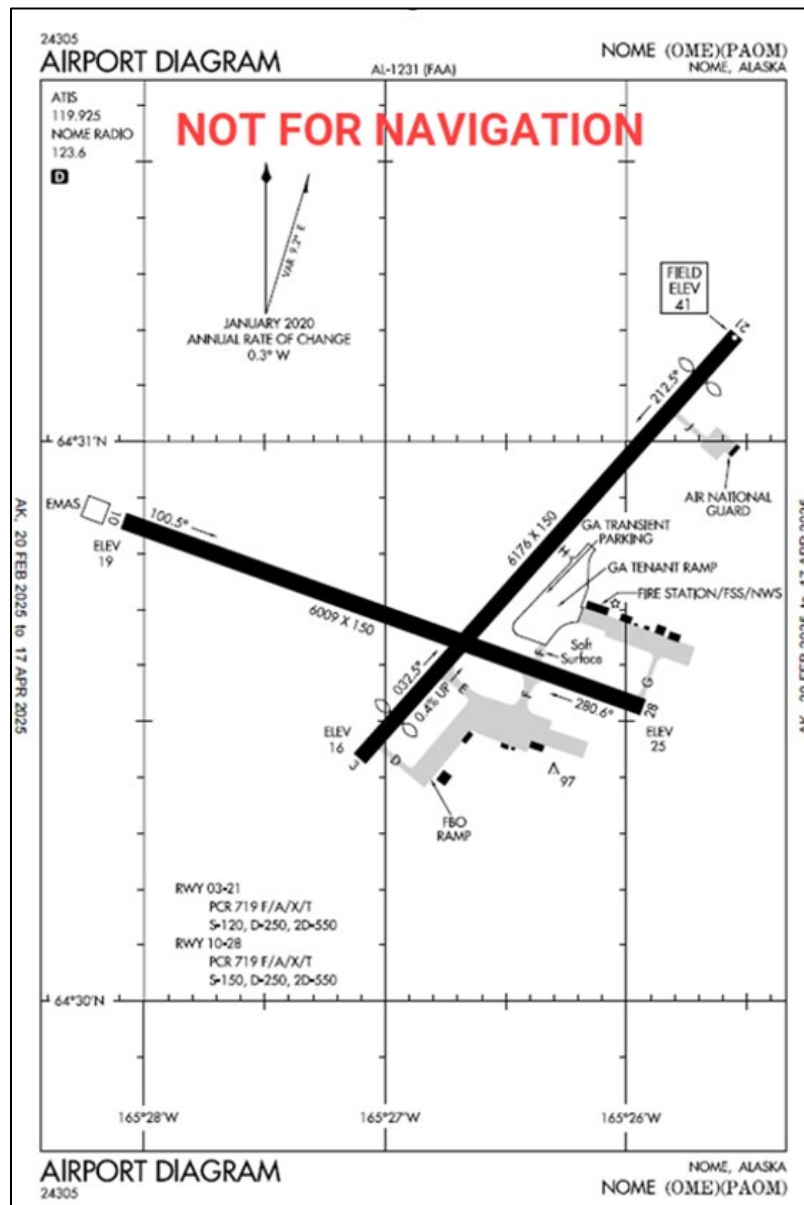
**Figure 3.** Airport diagram of PAOM.

Figure 3 shows the airport diagram for Nome Airport (PAOM), including the layout of runways, taxiways, ramps, buildings, and facilities. Runway designations and dimensions are also provided.

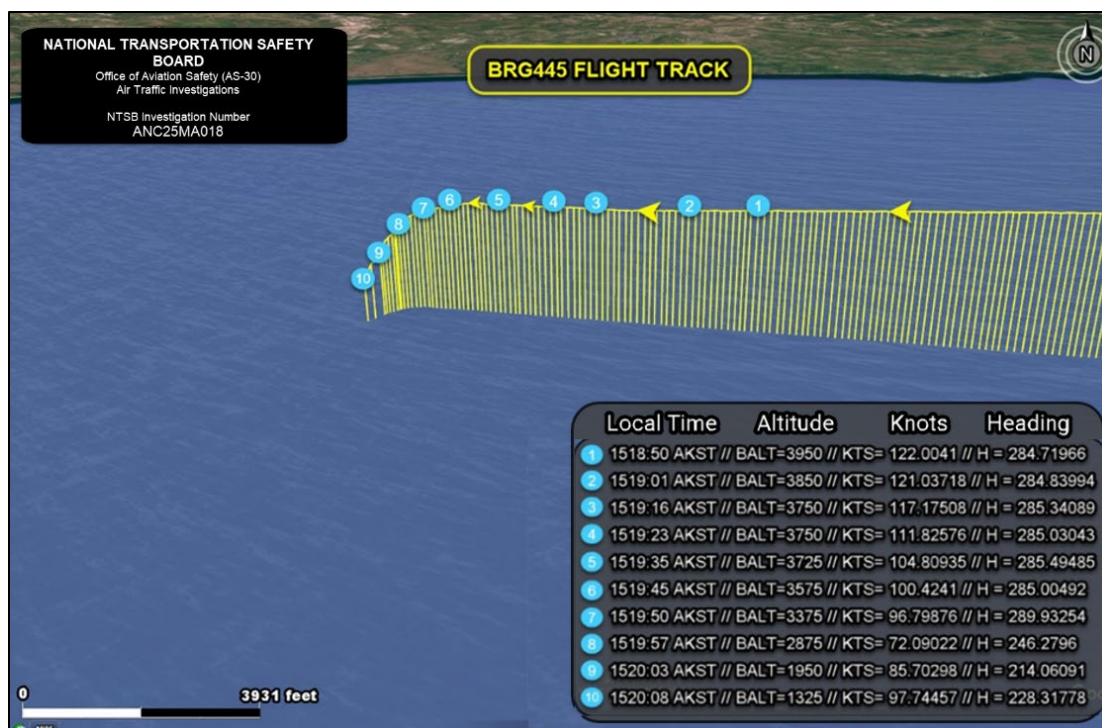
**Figure 4.** Side view of Flight track of BRG445; detailed information.

Figures 4 and 5 are visual representations of BRG445's flight path, created by overlaying ADS-B data onto Google Earth satellite imagery.

Figure 4 provides a side view of the final portion of the flight. Numbered blue dots represent individual ADS-B data points, with corresponding details displayed in the dark gray box located in the bottom left corner of the graphic. Each data point includes local time, altitude, groundspeed (in knots), and heading, illustrating the aircraft's trajectory during the final two minutes of flight.<sup>16</sup>

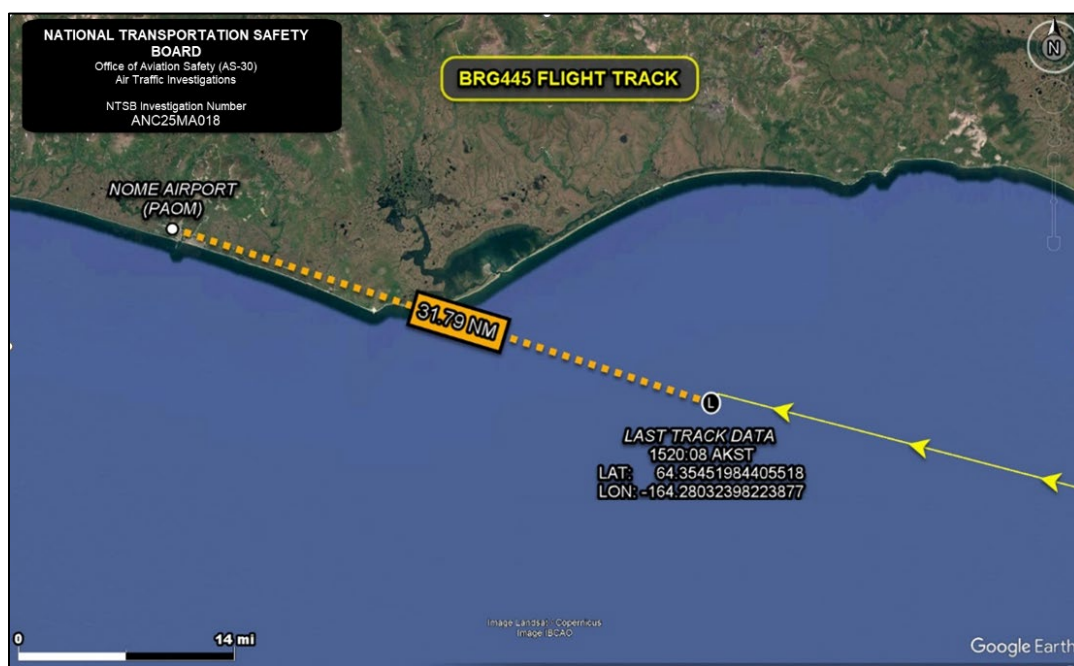
**Figure 5.** Google Earth graphic depicts the position of BRG445's last target.

Figure 5 provides an overhead view of the final segment of BRG445's flight. Yellow arrows indicate the direction of travel, while the last recorded ADS-B target is marked with its corresponding time, latitude, and longitude below the depicted circle. An orange dotted line represents the approximate distance between the final target location and PAOM Airport.

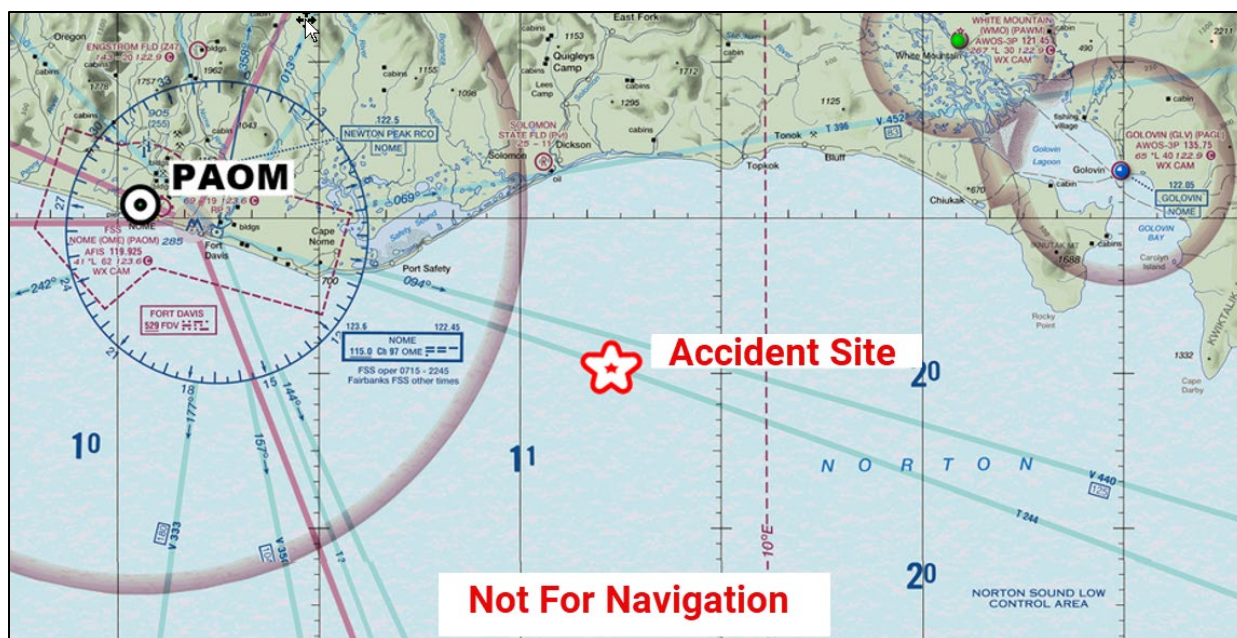
**Figure 6.** PAOM surface observation site noted on sectional chart.

Figure 6 is a FAA sectional aeronautical chart of the accident area with the locations of the accident site and surface observation site noted near PAOM.

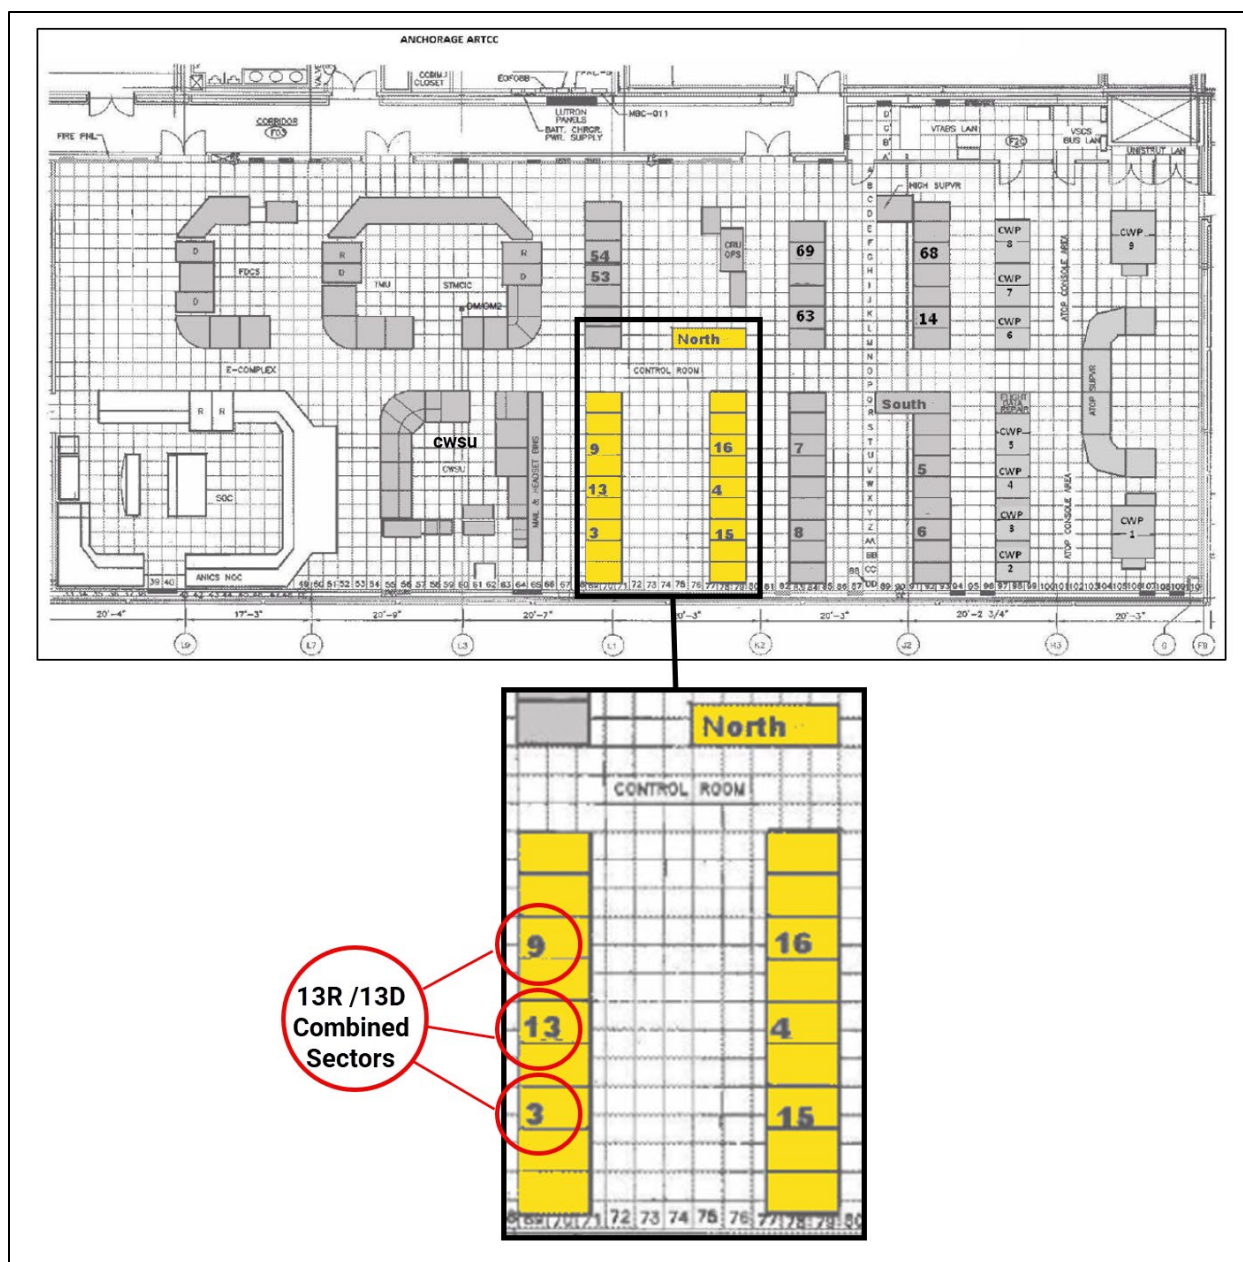
**Figure 8.** ZAN facility layout chart.

Figure 8 shows the facility layout of ATC operational and support areas. The sectors comprising the North area are highlighted in yellow. The breakout illustrates the three sectors, 9, 13, and 3, which were combined into a single position, designated as either 13R or 13D, as appropriate.

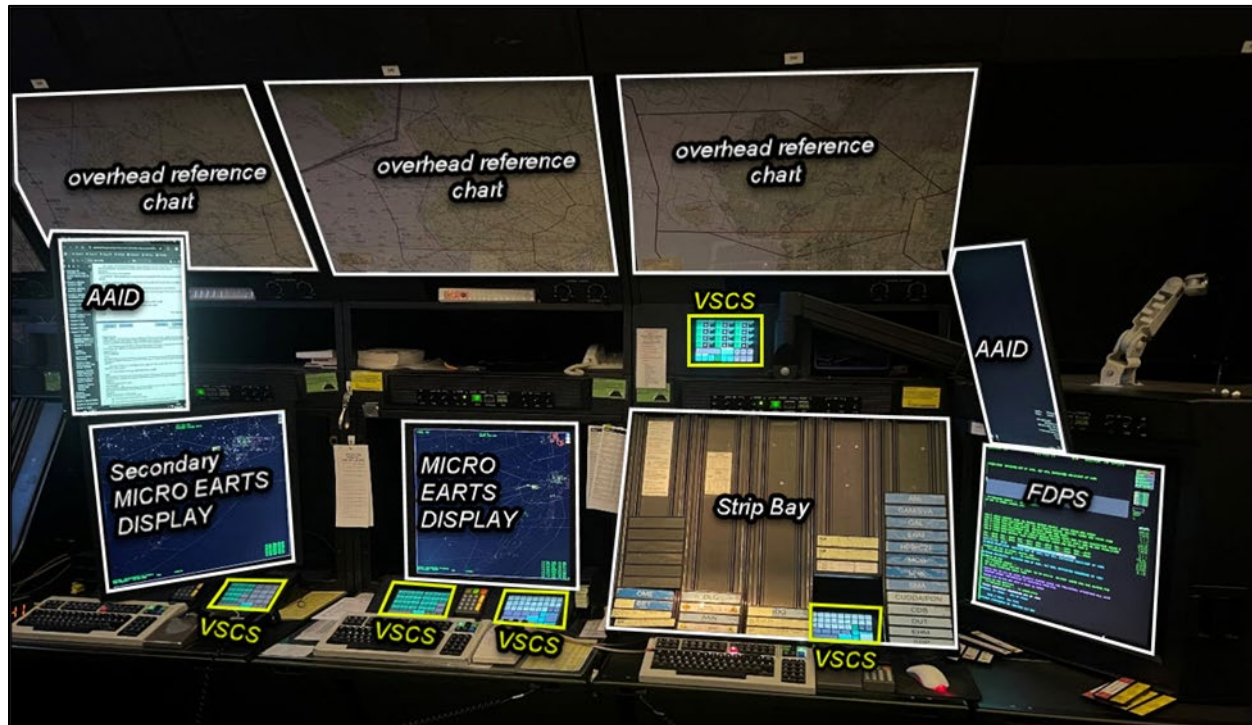
**Figure 9.** Sector equipment and visual references. Photo credit: NTSB.

Figure 9 shows a photograph of the 13R control position, including its equipment and visual reference materials.

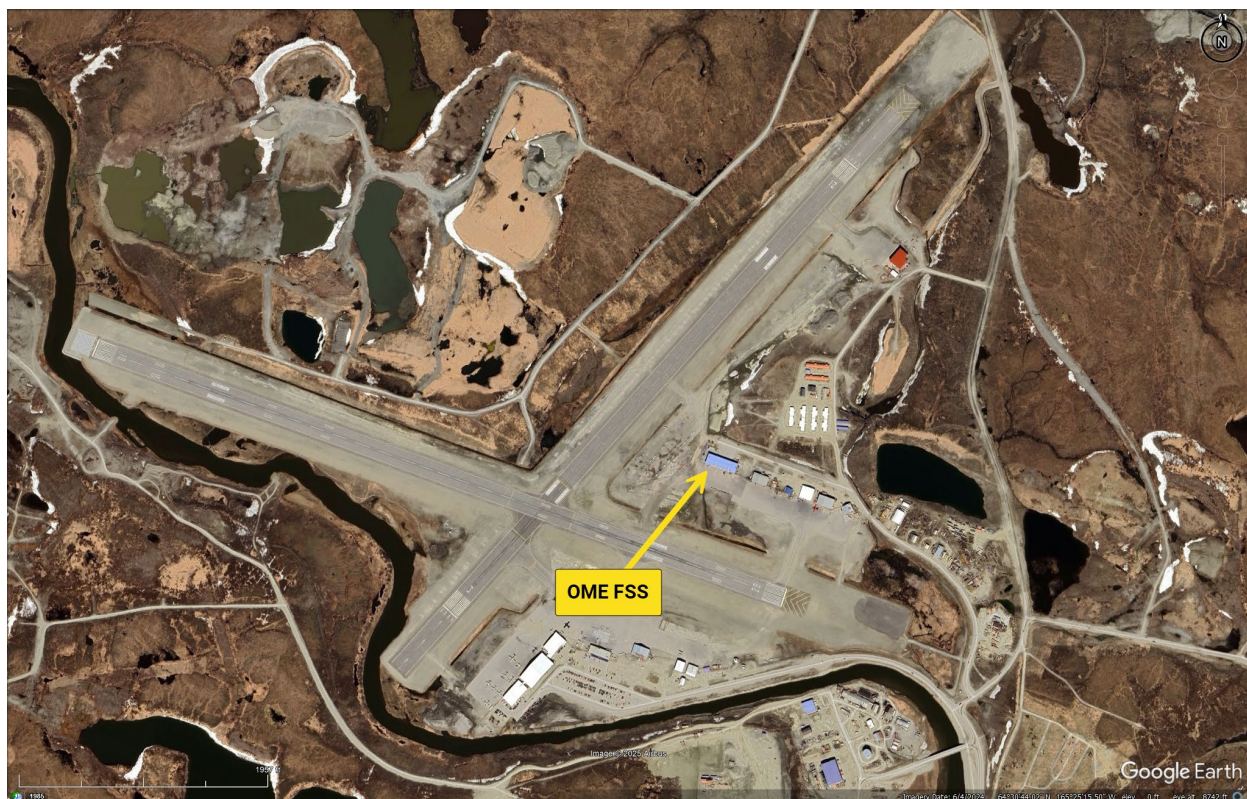
**Figure 10.** Google Earth Screenshot of OME FSS building at PAOM.

Figure 10 is a google earth screenshot depicting the location of the OME FSS building at PAOM airport.

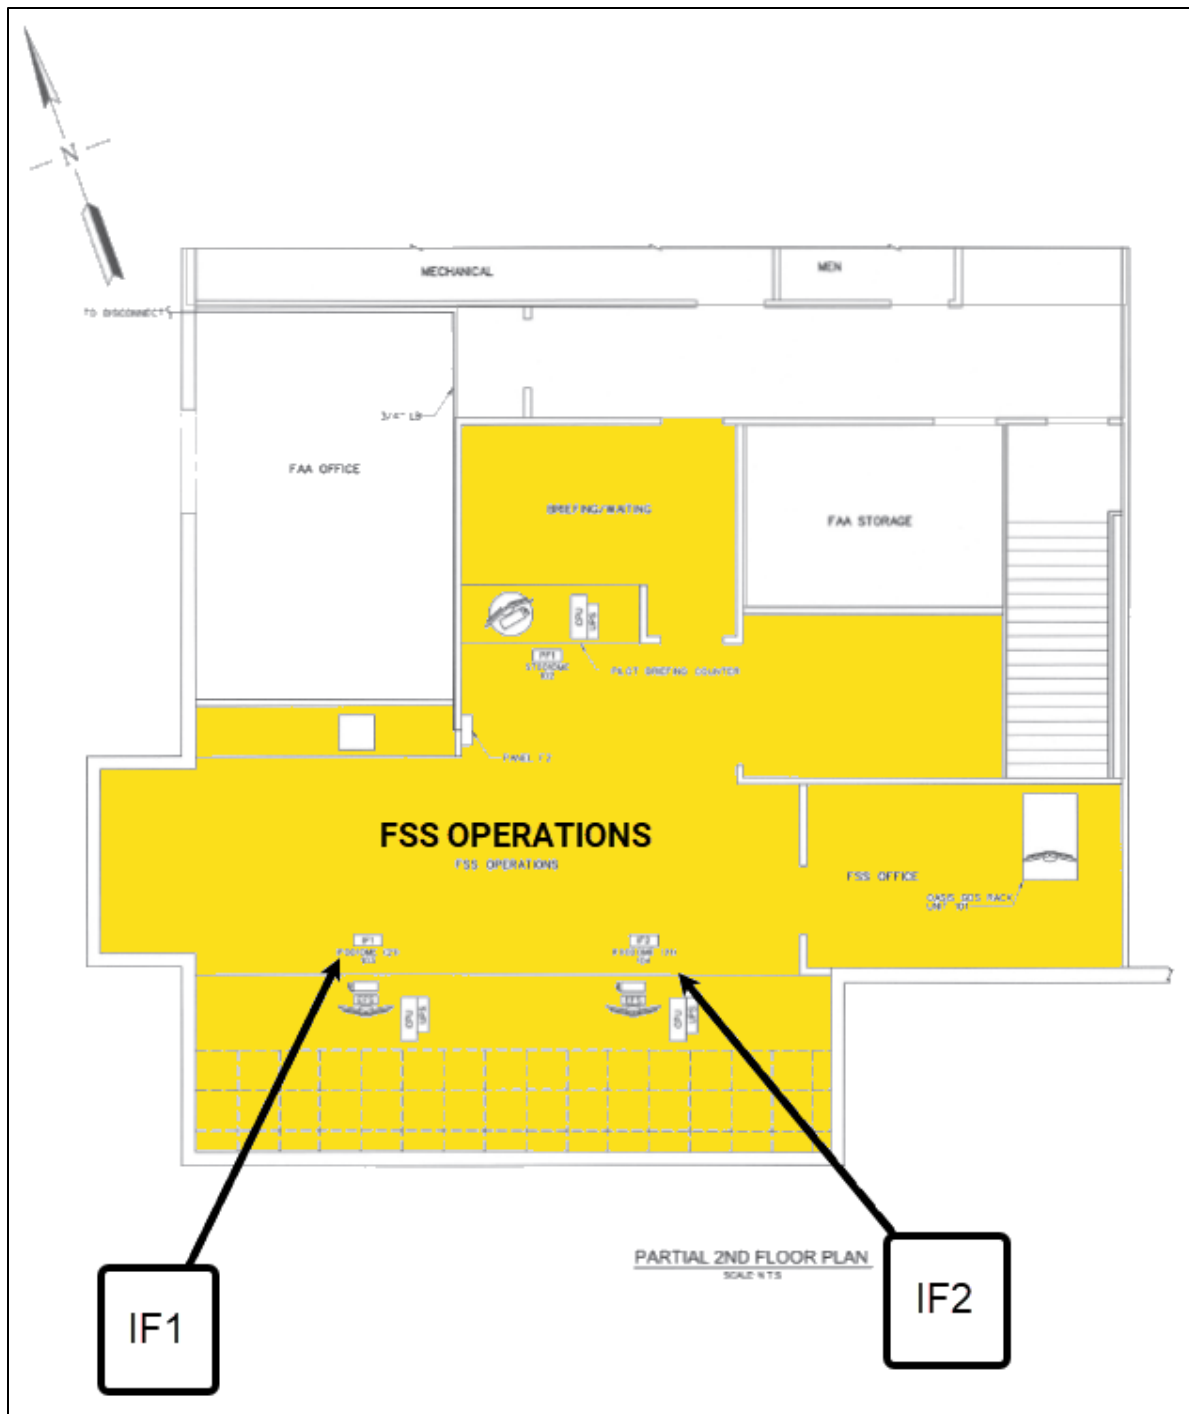
**Figure 11.** OME FSS operations layout.

Figure 11 is the OME FSS facility layout, illustrating the location of the FSS operations areas (highlighted in yellow), including the IF1 and IF2 positions.
